403 SHAWMUT AVE
SOUTH END LANDMARKS DISTRICT
COMMISSION

PROPOSED WORK: FAÇADE REBUILD
NOVEMBER 4, 2025

SUMMARY: FAÇADE EXISTING CONDITIONS

Reference: Existing Masonry Conditions Assessment
403 Shawmut Avenue
Boston, Massachusetts

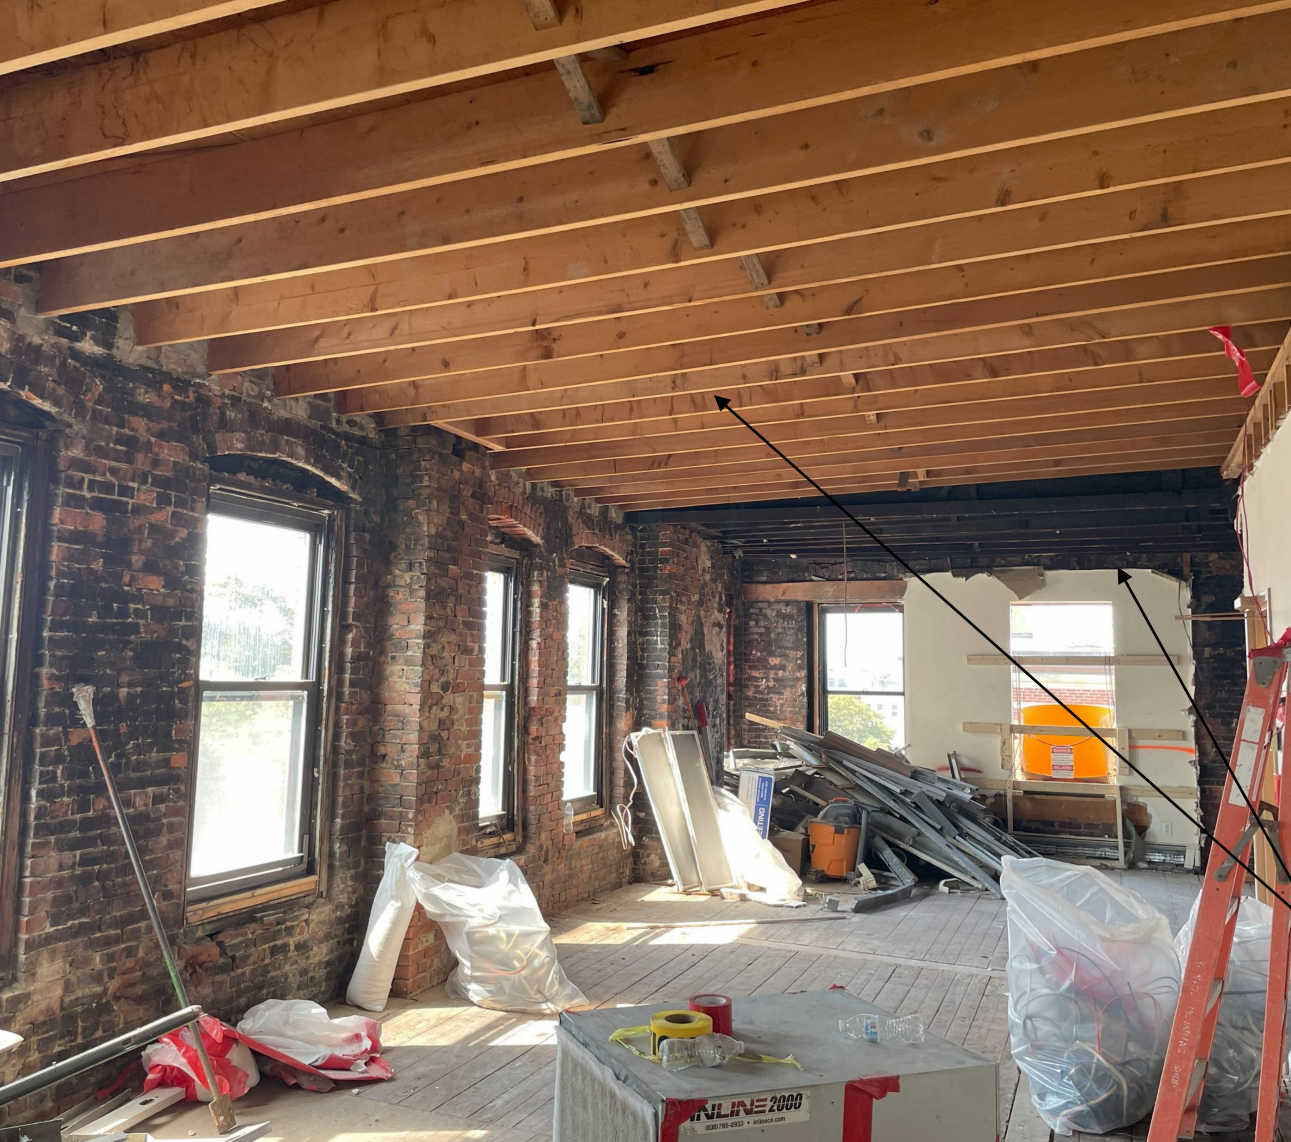
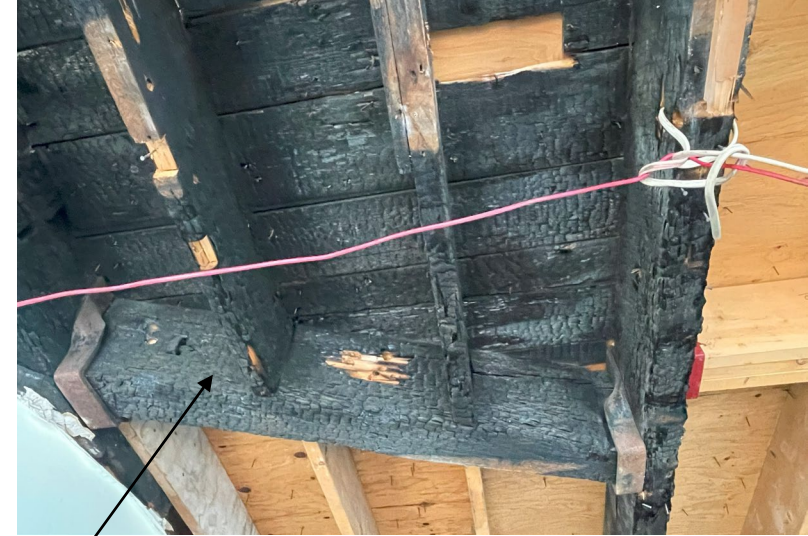
Original charred framing and roof decking alongside new framing and roof decking

Majority of roof was reframed due to extent of fire, with lightly charred section along W. Brookline remaining

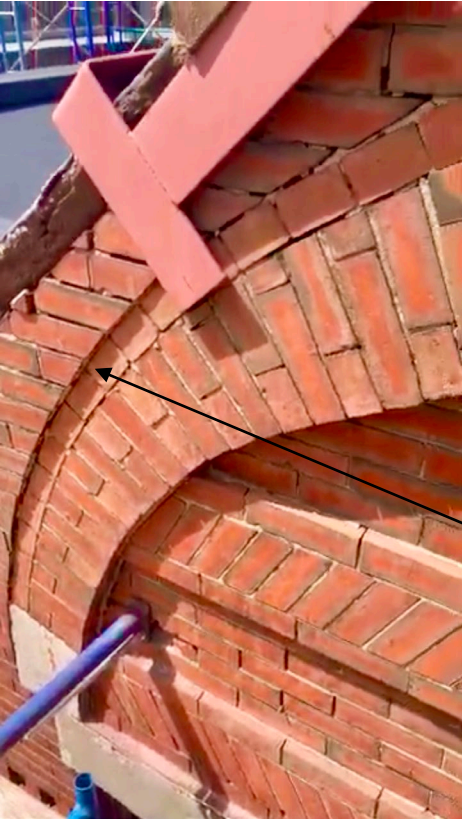
Structure and stone cap currently restrained by bracket system and tie back to roof structure

Ornate brick inlay and detailing

Sections of brick seen bowing out from original face of pediment

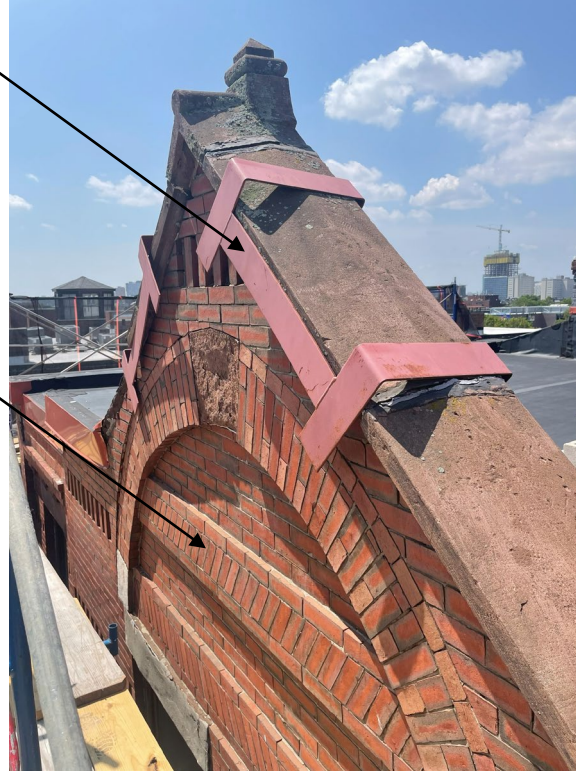
Unique to building, arch width increases in size from bottom to top

Brownstone was parged over at some point to protect stone, not original to structure

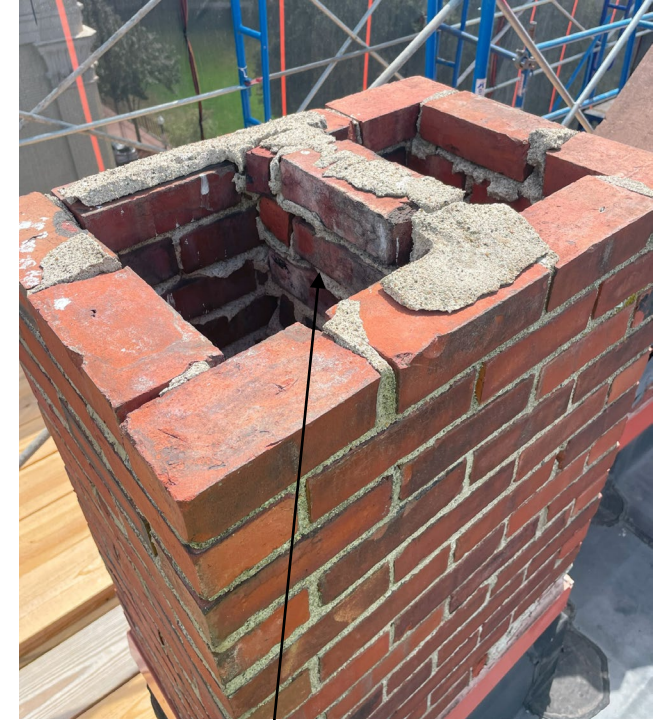
Many of the original interior fireplaces had shared chimney stacks with one course of brick to provide multiple shafts

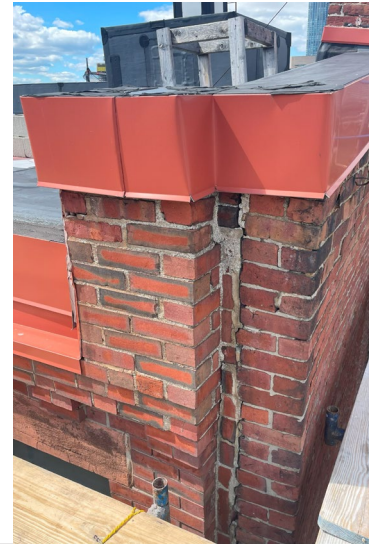
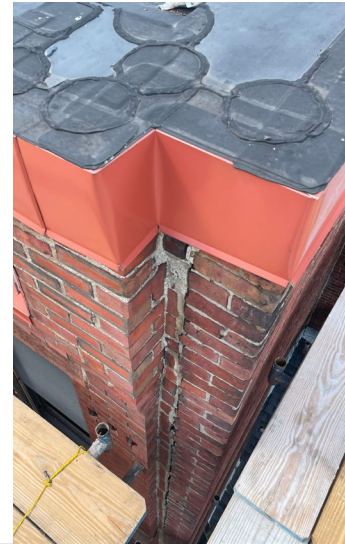
- Furthest exterior wythe of brick on corner of 403 Shawmut and 401 Shawmut has been separating from the main structure causing a significant gap on the top two floors of the building
- Impacts of separation includes:
 - Chimneys on façade facing 401 Shawmut Ave
 - Parapets
 - Window conditions on 5th and 6th floors in this corner (cracked and misaligned headers and sills, non-plumb window openings, etc.)
 - Failed corbel conditions

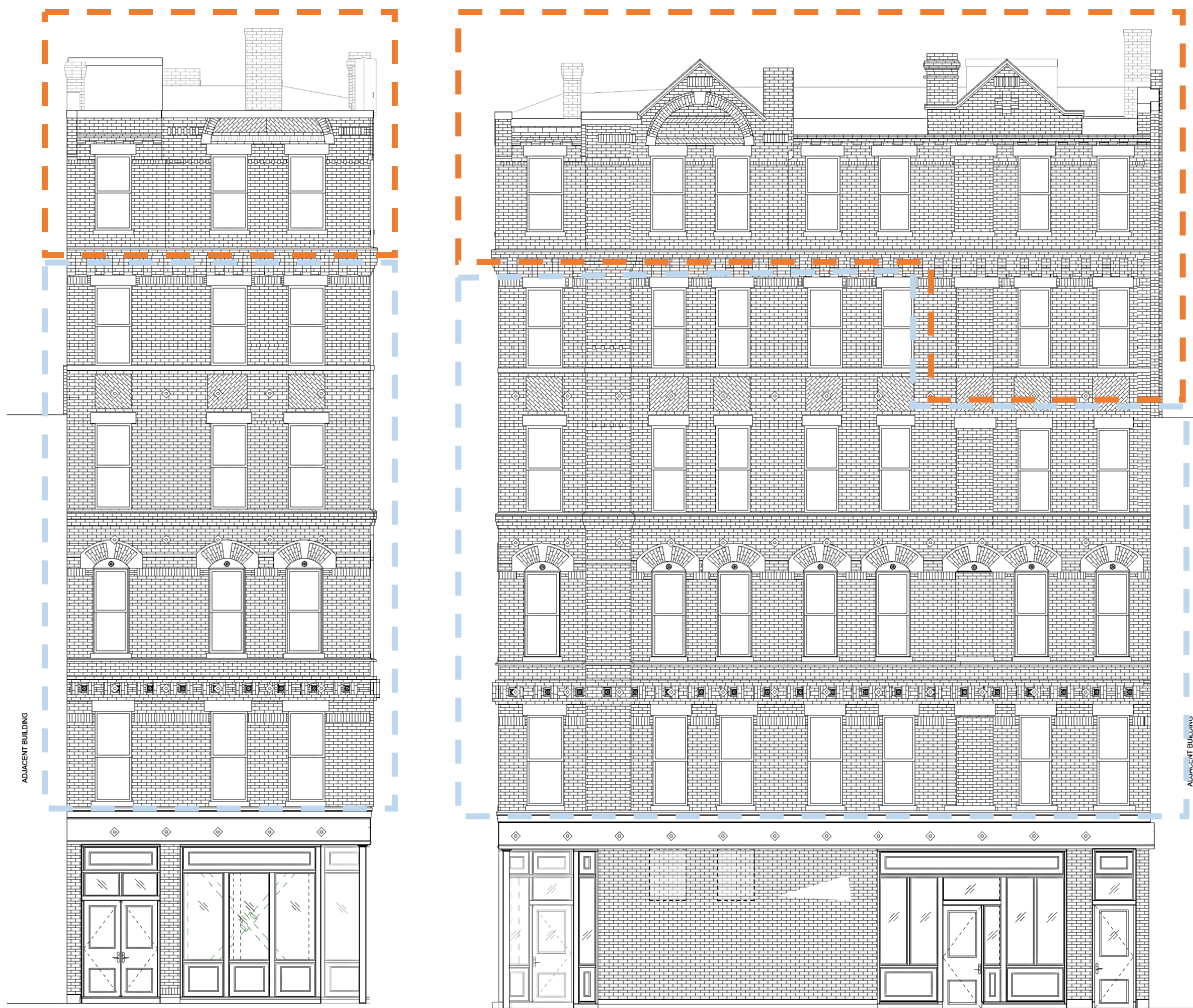
Scope outlined in orange are the sections of exterior wall, parapet, chimneys, and pediments that are proposed to be removed and entirely rebuilt as per the recommendations of the structural engineering report. The existing floor and roof framing within the building would remain.

As noted in the structural engineering report and as seen in the existing conditions section of this presentation, there is the possibility that other sections of the building below the sixth and fifth floors will need to be rebuilt. The new structural wall would be tied into the lower unreinforced masonry wall using “vertical straight bar dowels, drilled and epoxied into sound brick with 10” embedment” and the interior steel plates being mounted to the face of the wall require code-compliant masonry conditions. Therefore, the brick below the new wall cannot be loose or break when being drilled for the dowels or plates. Due to the significant frost/thaw action over the history of the building, portions or all of the upper five floors could require rebuilding to be safe for the significant future.

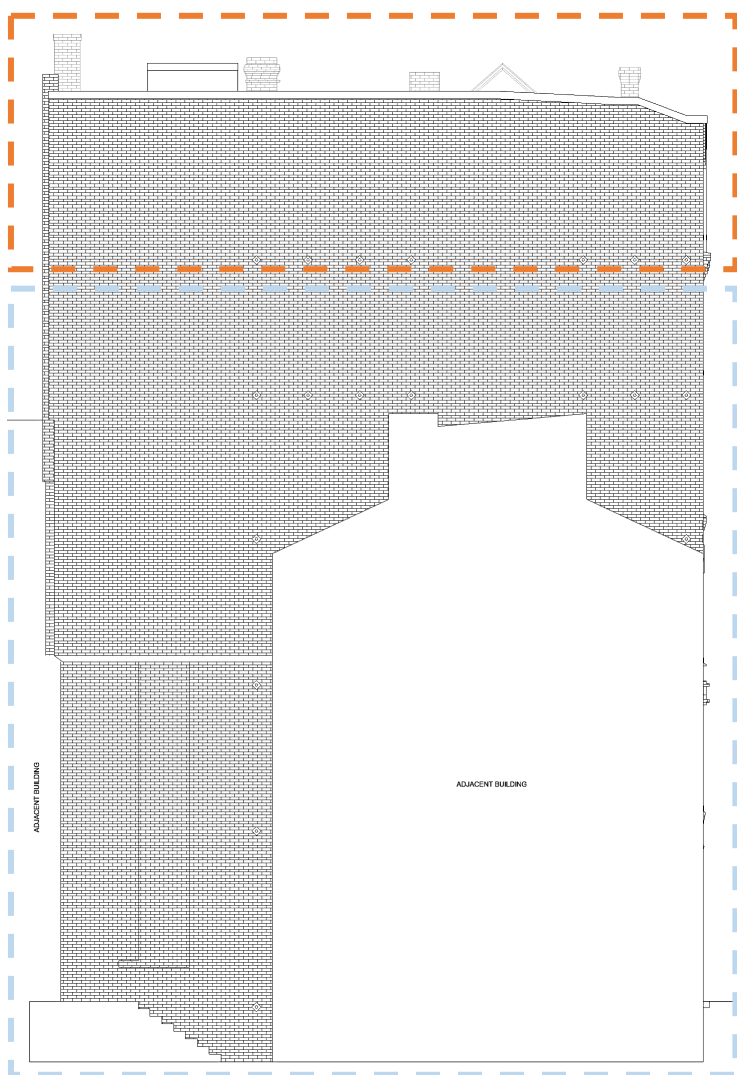
REAR ELEVATION

Scope outlined in orange are the sections of exterior wall, parapet, chimneys, and pediments that are proposed to be removed and entirely rebuilt as per the recommendations of the structural engineering report. The existing floor and roof framing within the building would remain.

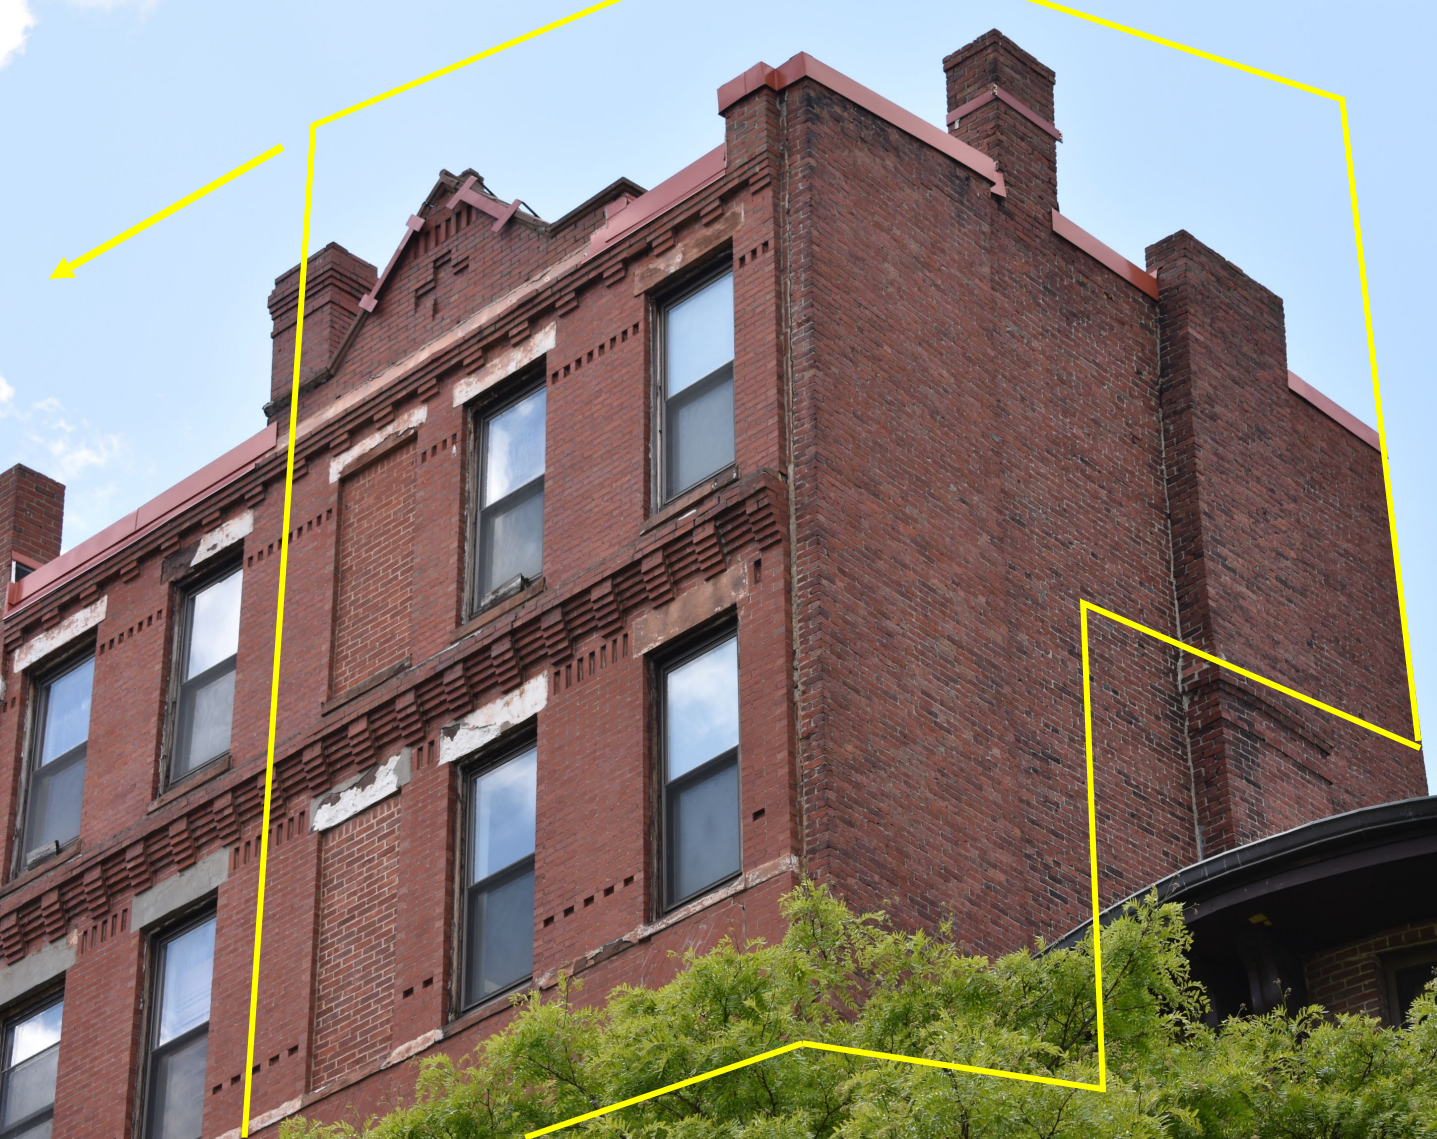
Deconstruction of the building will begin on the Northeast corner where 403 Shawmut and 401 Shawmut meet.

This is the corner where the building's worst masonry condition is on both the sixth and fifth floors.

Once solid/usable existing masonry is reached, the corner will be fully rebuilt to match its exact historical condition including corbels, façade details, window sizes, headers and sills, etc.

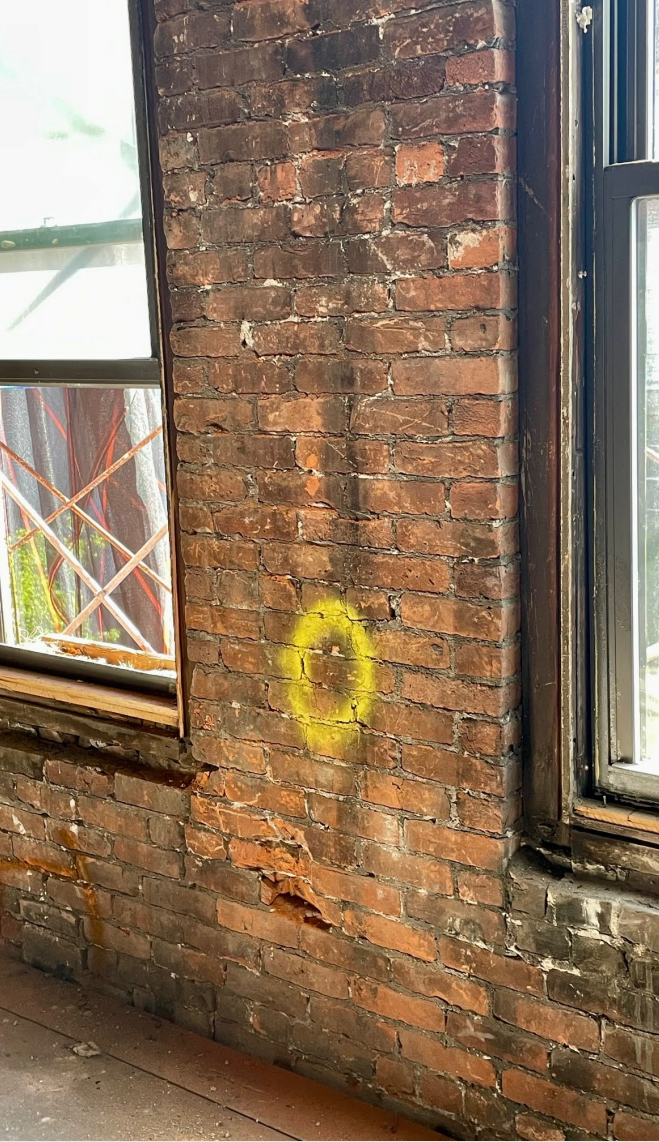
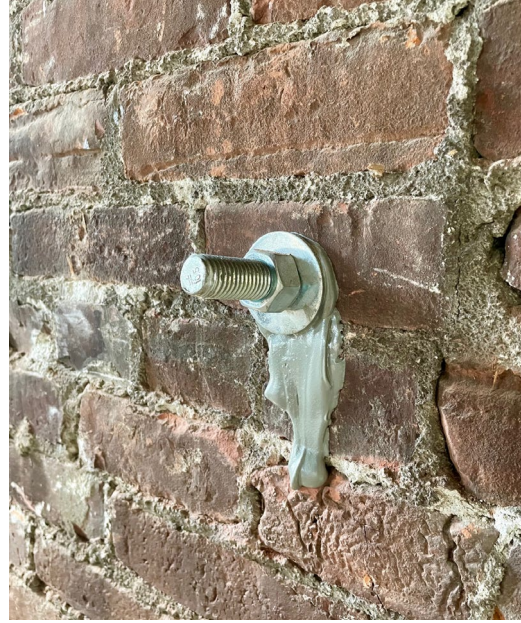
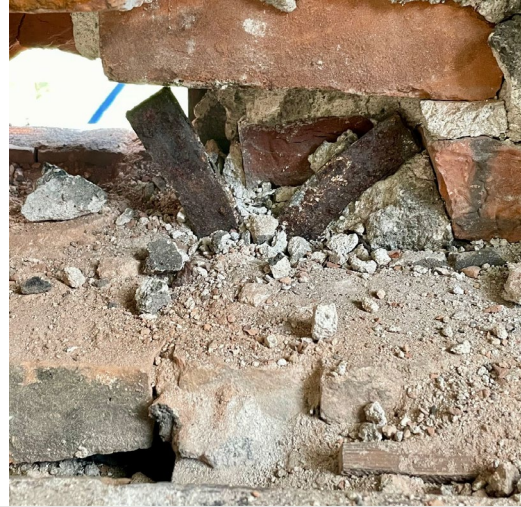
To test the strength of the existing masonry walls prior to demolition, the project team has done drilled epoxy anchor tension testing on all floors on the interior side of the perimeter wall on the Shawmut Ave and W. Brookline facades. The tests needed to meet 1000psf minimum and were tested incrementally to up to 2000psf. All tests passed with no signs of failure to the brick, anchor, or epoxy. If they had not, the structural engineer was going to require exterior anchor plates every 4' and placed on each floor.

Additionally, further explorations of floor joist-to-wall conditions revealed steel floor joist anchors embedded within the walls and documented at regular intervals. With this finding, the structural engineer stated further testing of these existing anchors for re-use can reduce the proposed anchor scope across the entirety of the building.

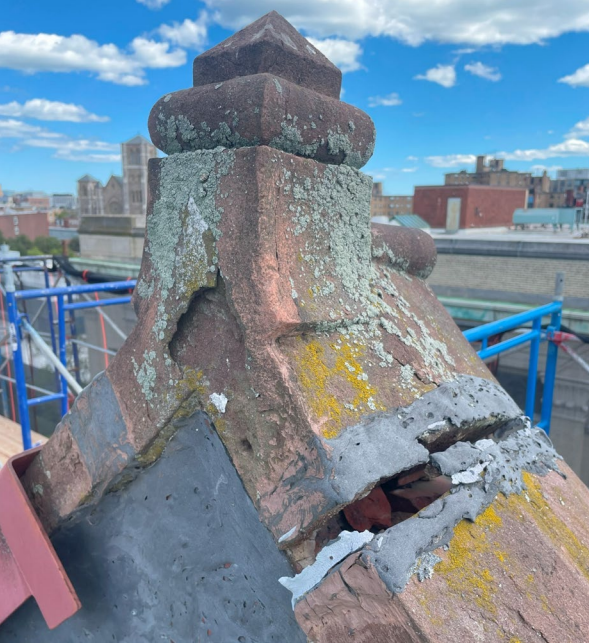
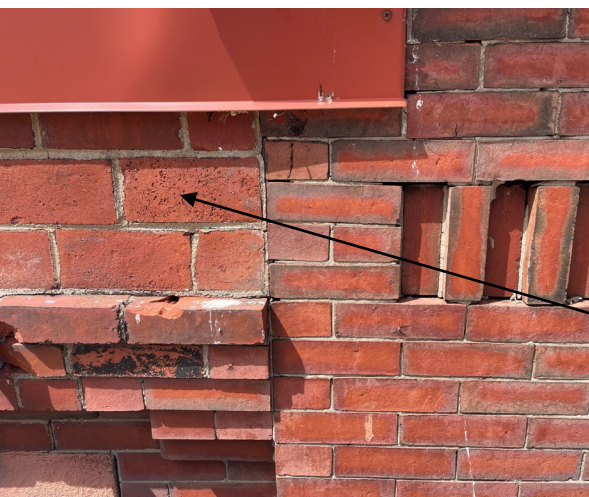
The project team has identified areas where there are sections of non-original infill that will be discarded as opposed to higher-quality adjacent original brick that will try to be reclaimed

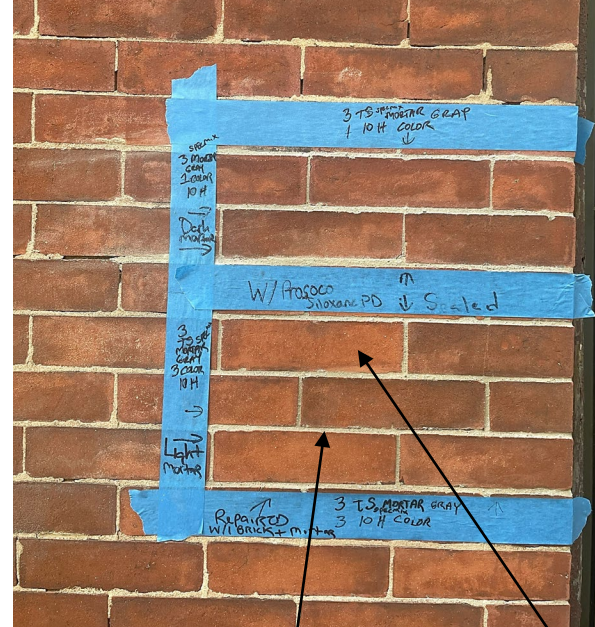
Two mortar options were explored where brick replacement and repointing will be needed. The top option had a whiter mortar, the lower option was a lighter and more gray option. The lower option matched perfectly.

We also matched a new brick to existing for any sections that need to be rebuilt

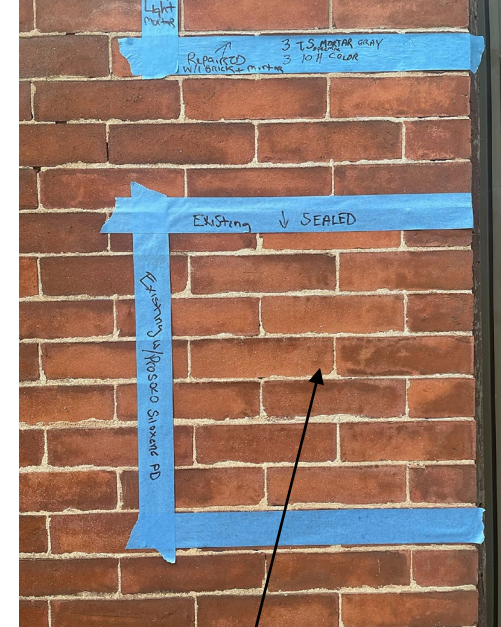
Sealed Existing Brick

Lastly, we cleaned and provided a sealer over the existing brick to protect it without changing its color

As part of our current work at 403 Shawmut and across the Casas Borinquen portfolio, we went through a process of matching brick and mortar to be approved by MHC/NPS. Additionally, after work is completed, the entire building will be receiving a soft wash and a sealer will be applied to the brick which allows it to still breathe but protects it from the elements while not changing its color or texture.

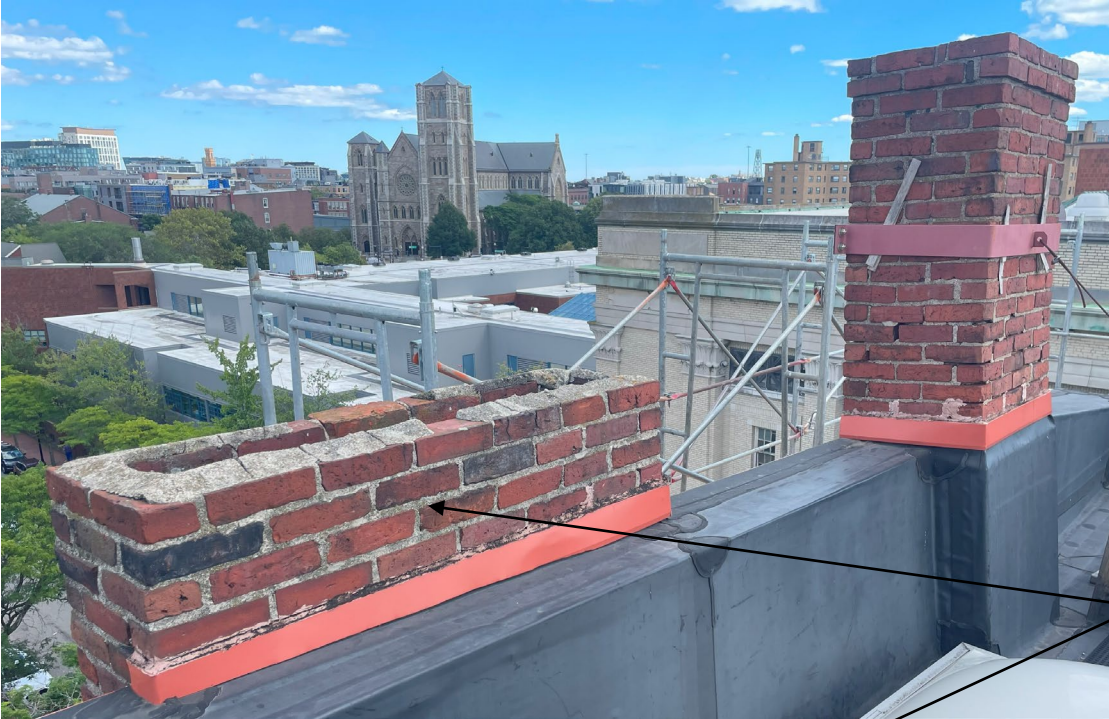
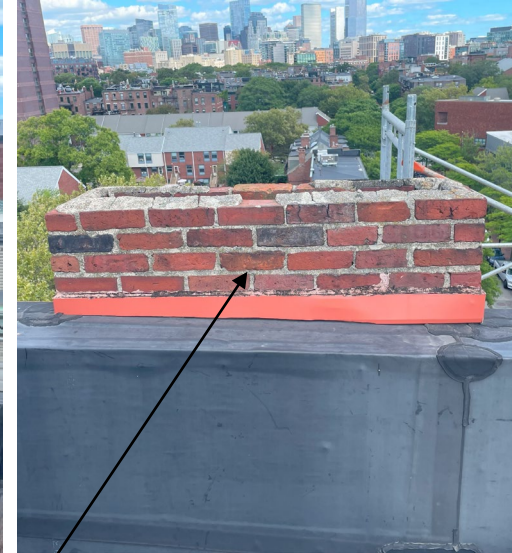
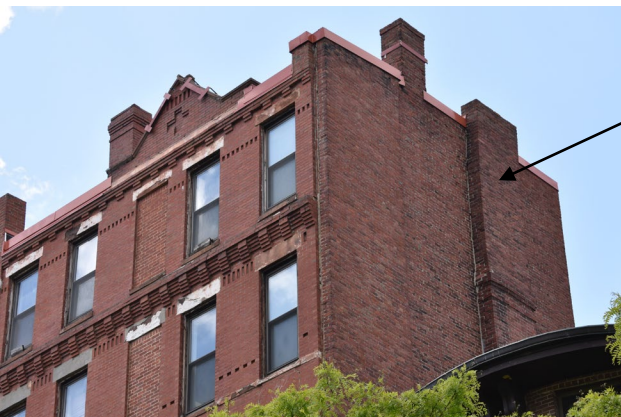
The longer, shorter chimney is the remnant of a once-functional chimney for the IBA-owned adjacent building located at 401 Shawmut.

Due to the risk of the chimney detaching from the outside of the 403 Shawmut façade, we are proposing to remove this chimney as part of the scope of work. This will provide long-term safety of surrounding buildings, especially the residents in the adjacent building at 401 Shawmut, and reduce the stress of that portion of the façade on 403 Shawmut Ave.

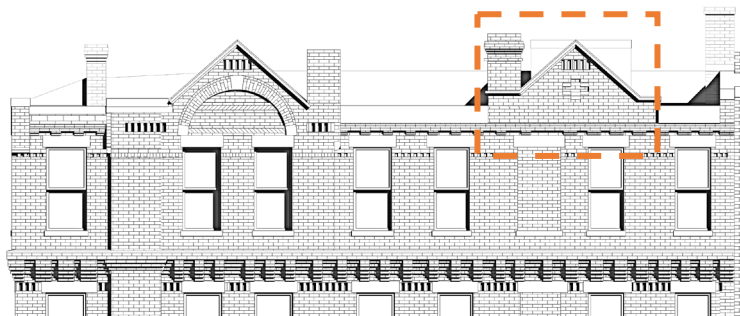
Brownstone pediment caps have separated joints and only remain due to temporary brackets

Brownstone pediment cap and surrounding masonry have become disconnected

A (failed) mastic waterproofing membrane was applied to the back and stone cap joints of the pediment

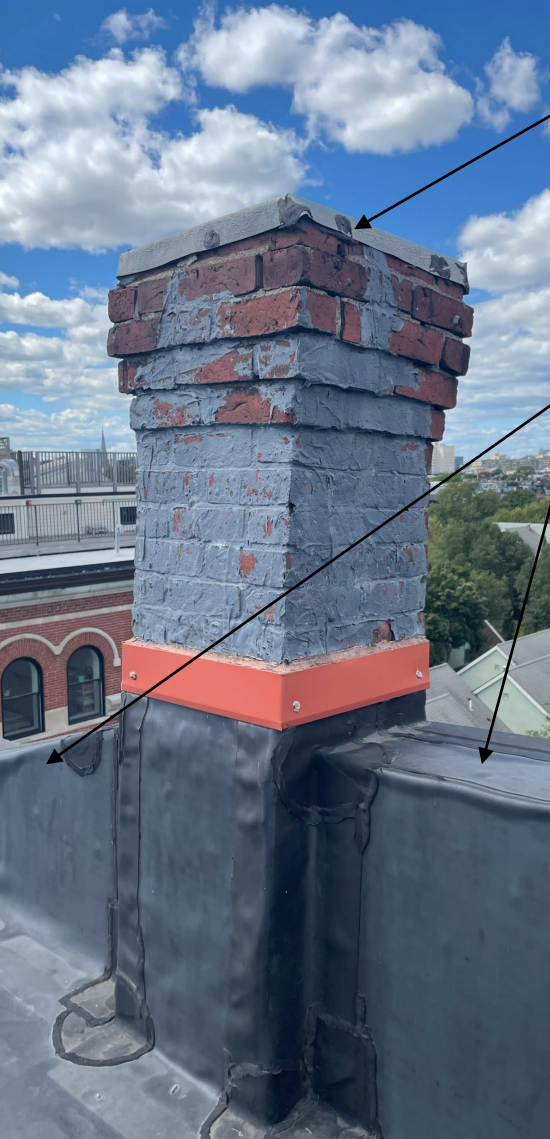
This is the only chimney that is covered

Parapets tend to change heights along various lengths of the roof

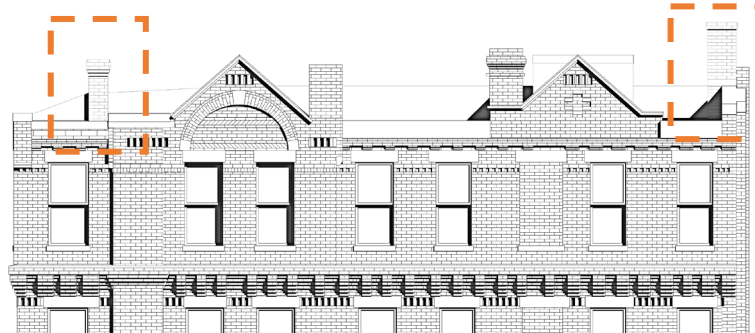
This chimney, located adjacent to the IBA-owned building at 401 Shawmut, is bowing significantly and being restrained by brackets and ties to the roof structure

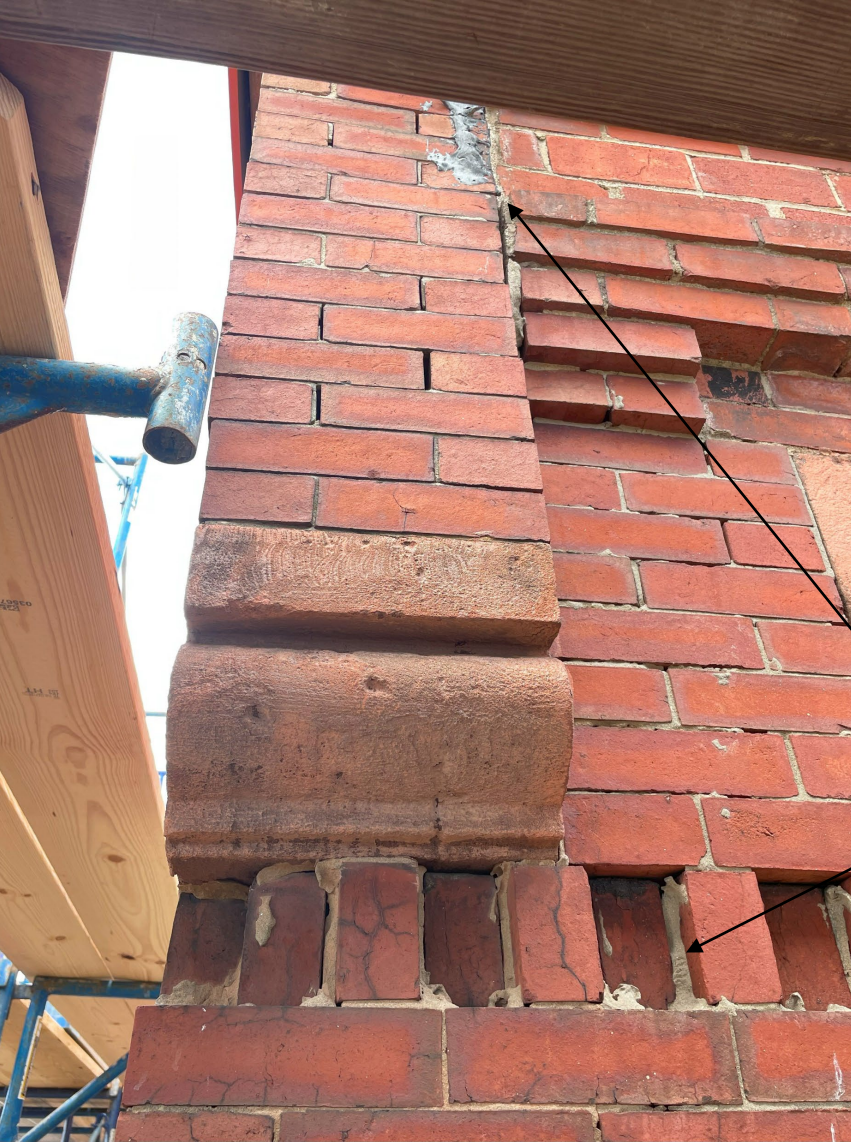
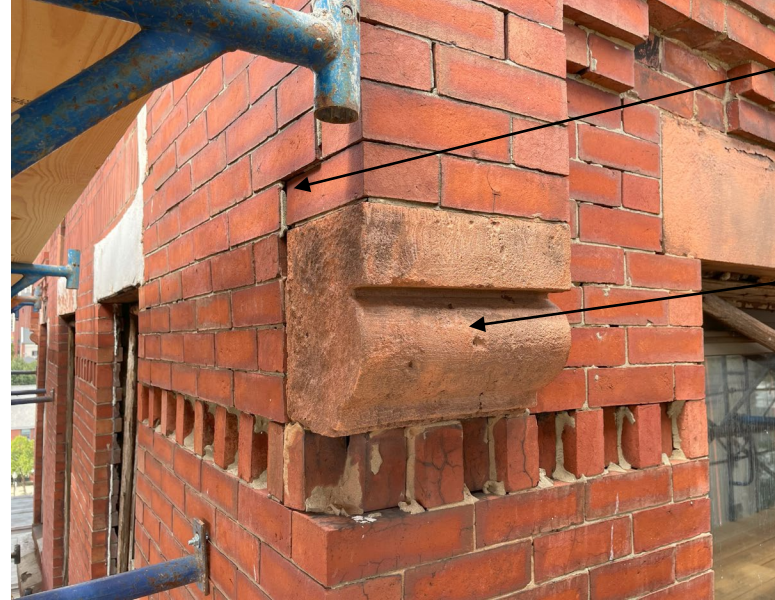
Brick separation around corner on W. Brookline side of building

Yet to be determined how well corner corbel is tied into masonry wall

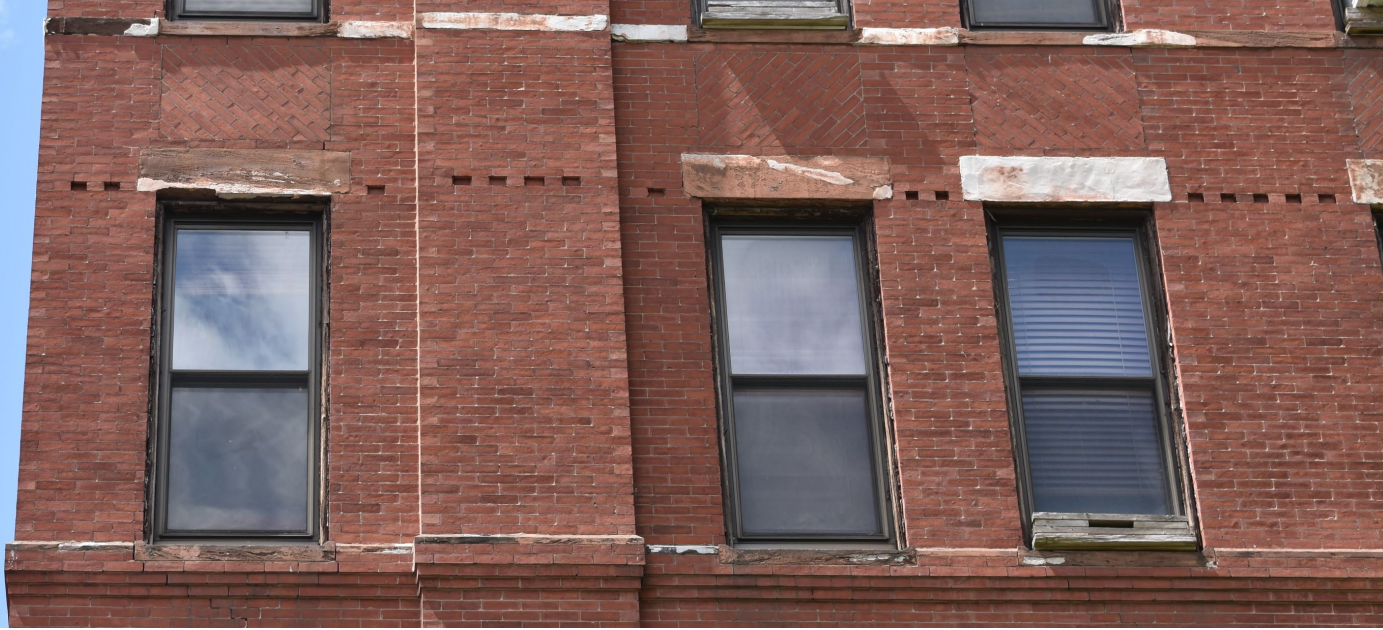
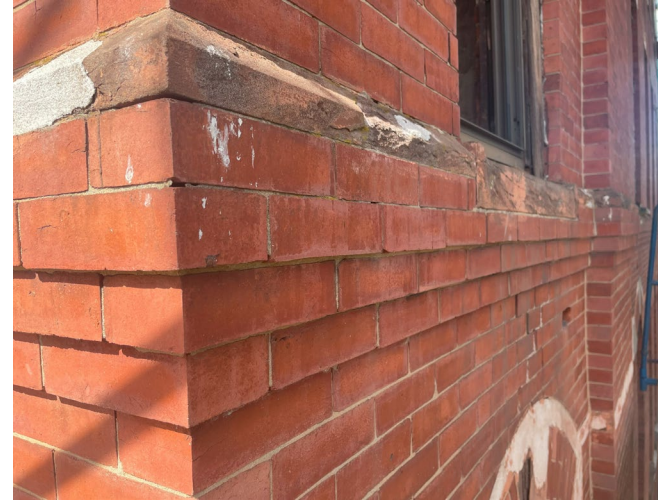
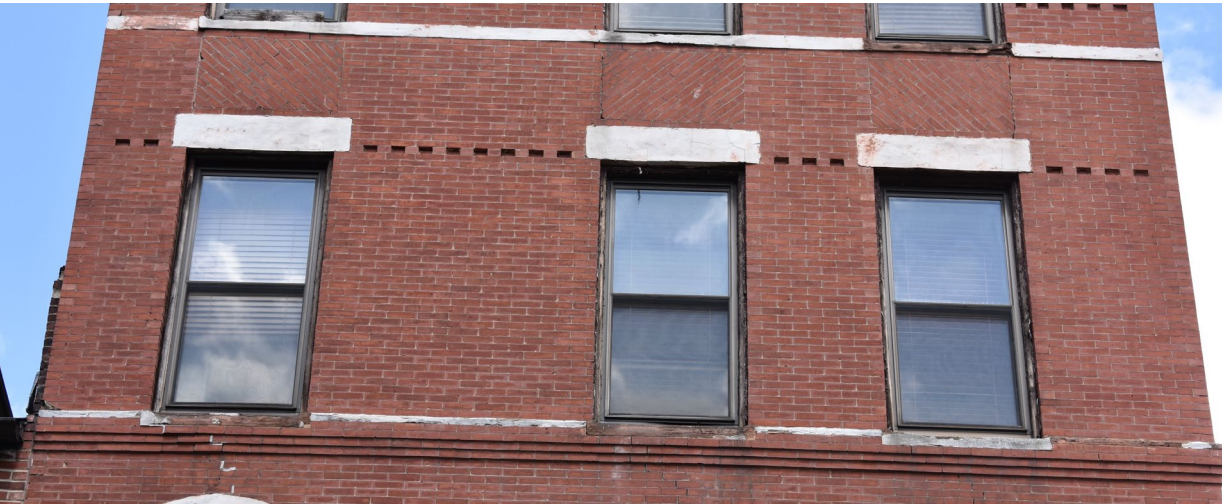
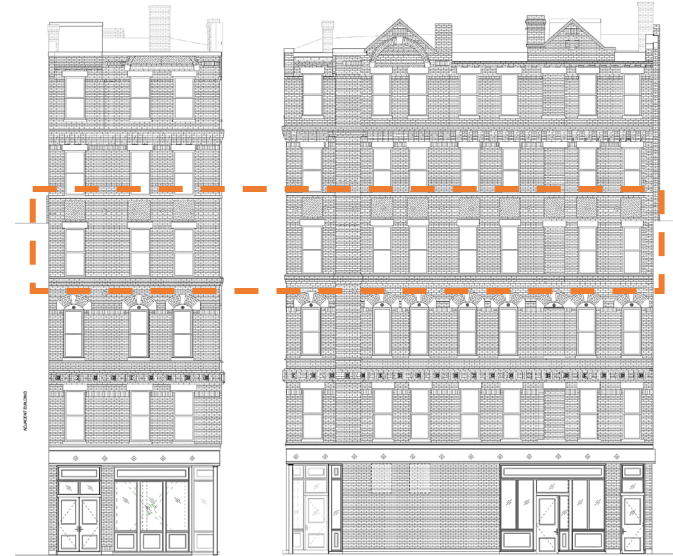
EXISTING CONDITIONS, FLOOR FOUR: SHAWMUT AVE & W. BROOKLINE

Due mostly to water infiltration and exterior wall movement, many sections of the corbel on both sides of the building have separated, lost full masonry units, have deteriorated, show signs of delamination, moved/no longer aligned, and have impacted areas around it, especially window openings.
