Tree Health Assessment – *Ailanthus altissima*

308 Commonwealth Avenue Condominium Association
Attn: Michael Jammen

Date: April 29, 2026

Location: 301 Public Alley 431, Boston, MA

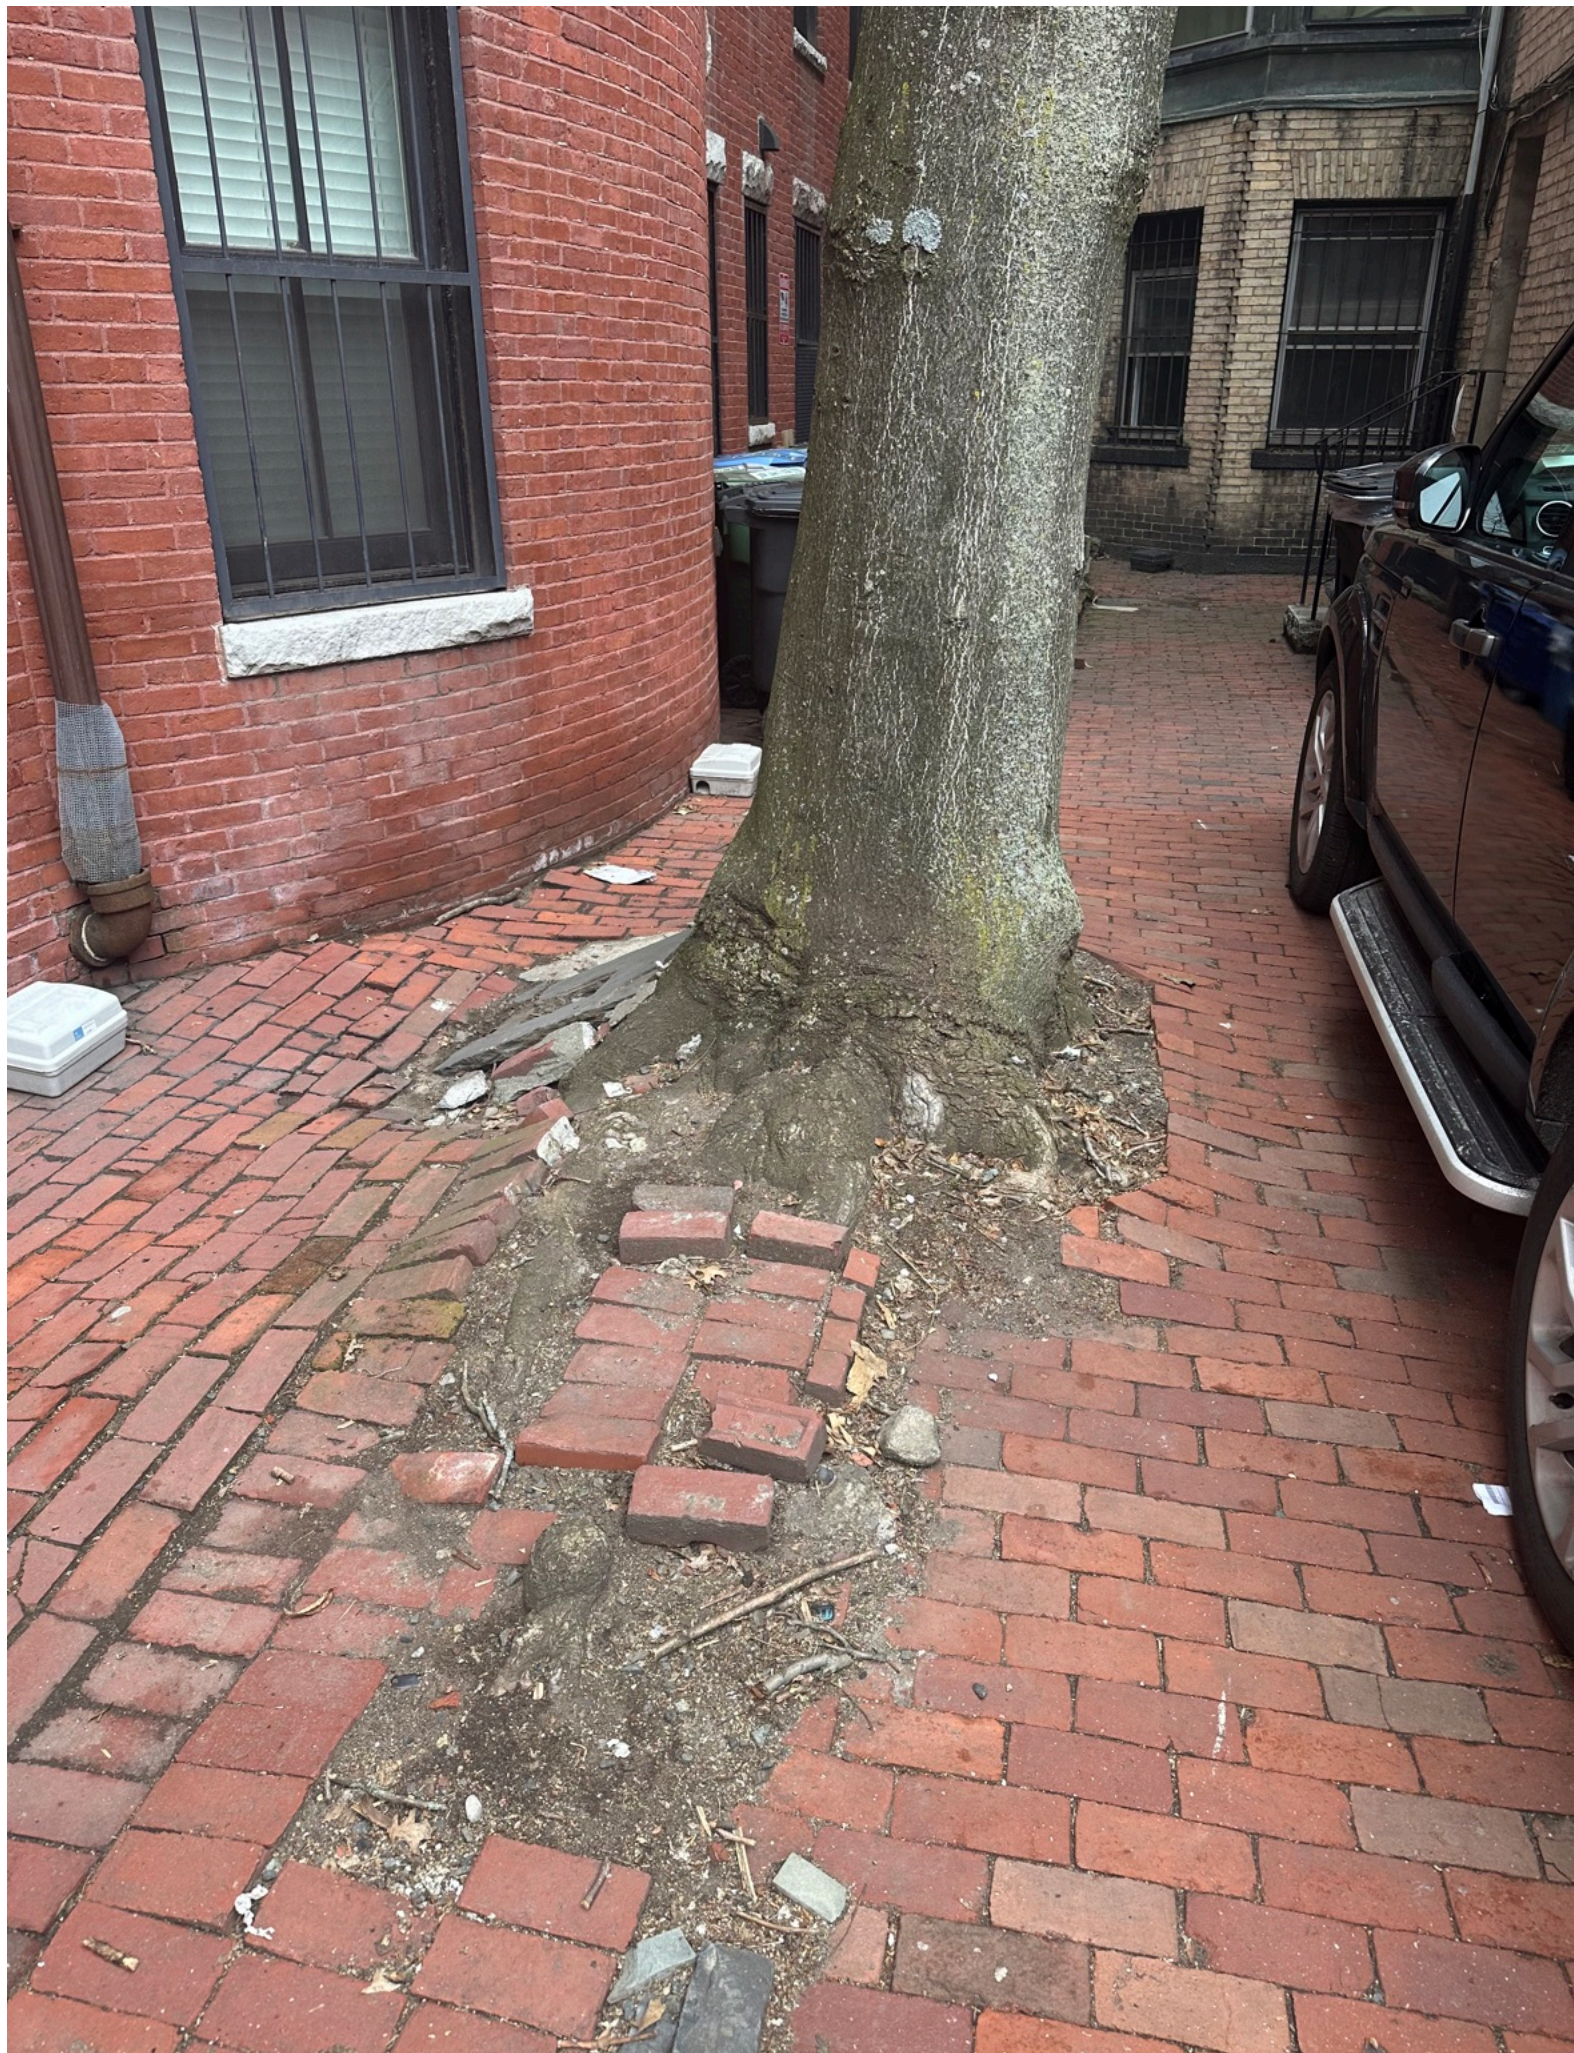
At your request, a visual arboricultural assessment was performed on a mature *Ailanthus altissima* (Tree-of-Heaven) located at 301 Public Alley 431, Boston, Massachusetts. The tree has an approximate diameter at breast height (DBH) of 23 inches, height of approximately 60 feet, and canopy spread of 30 feet. The evaluation was conducted during the spring season and consisted of a ground-based visual inspection only. (Figure 1.)

Based on the observed canopy condition, structural pruning impacts, site constraints, root-zone disturbances, proximity to structures, and the invasive status of the species, removal of the subject tree is recommended.

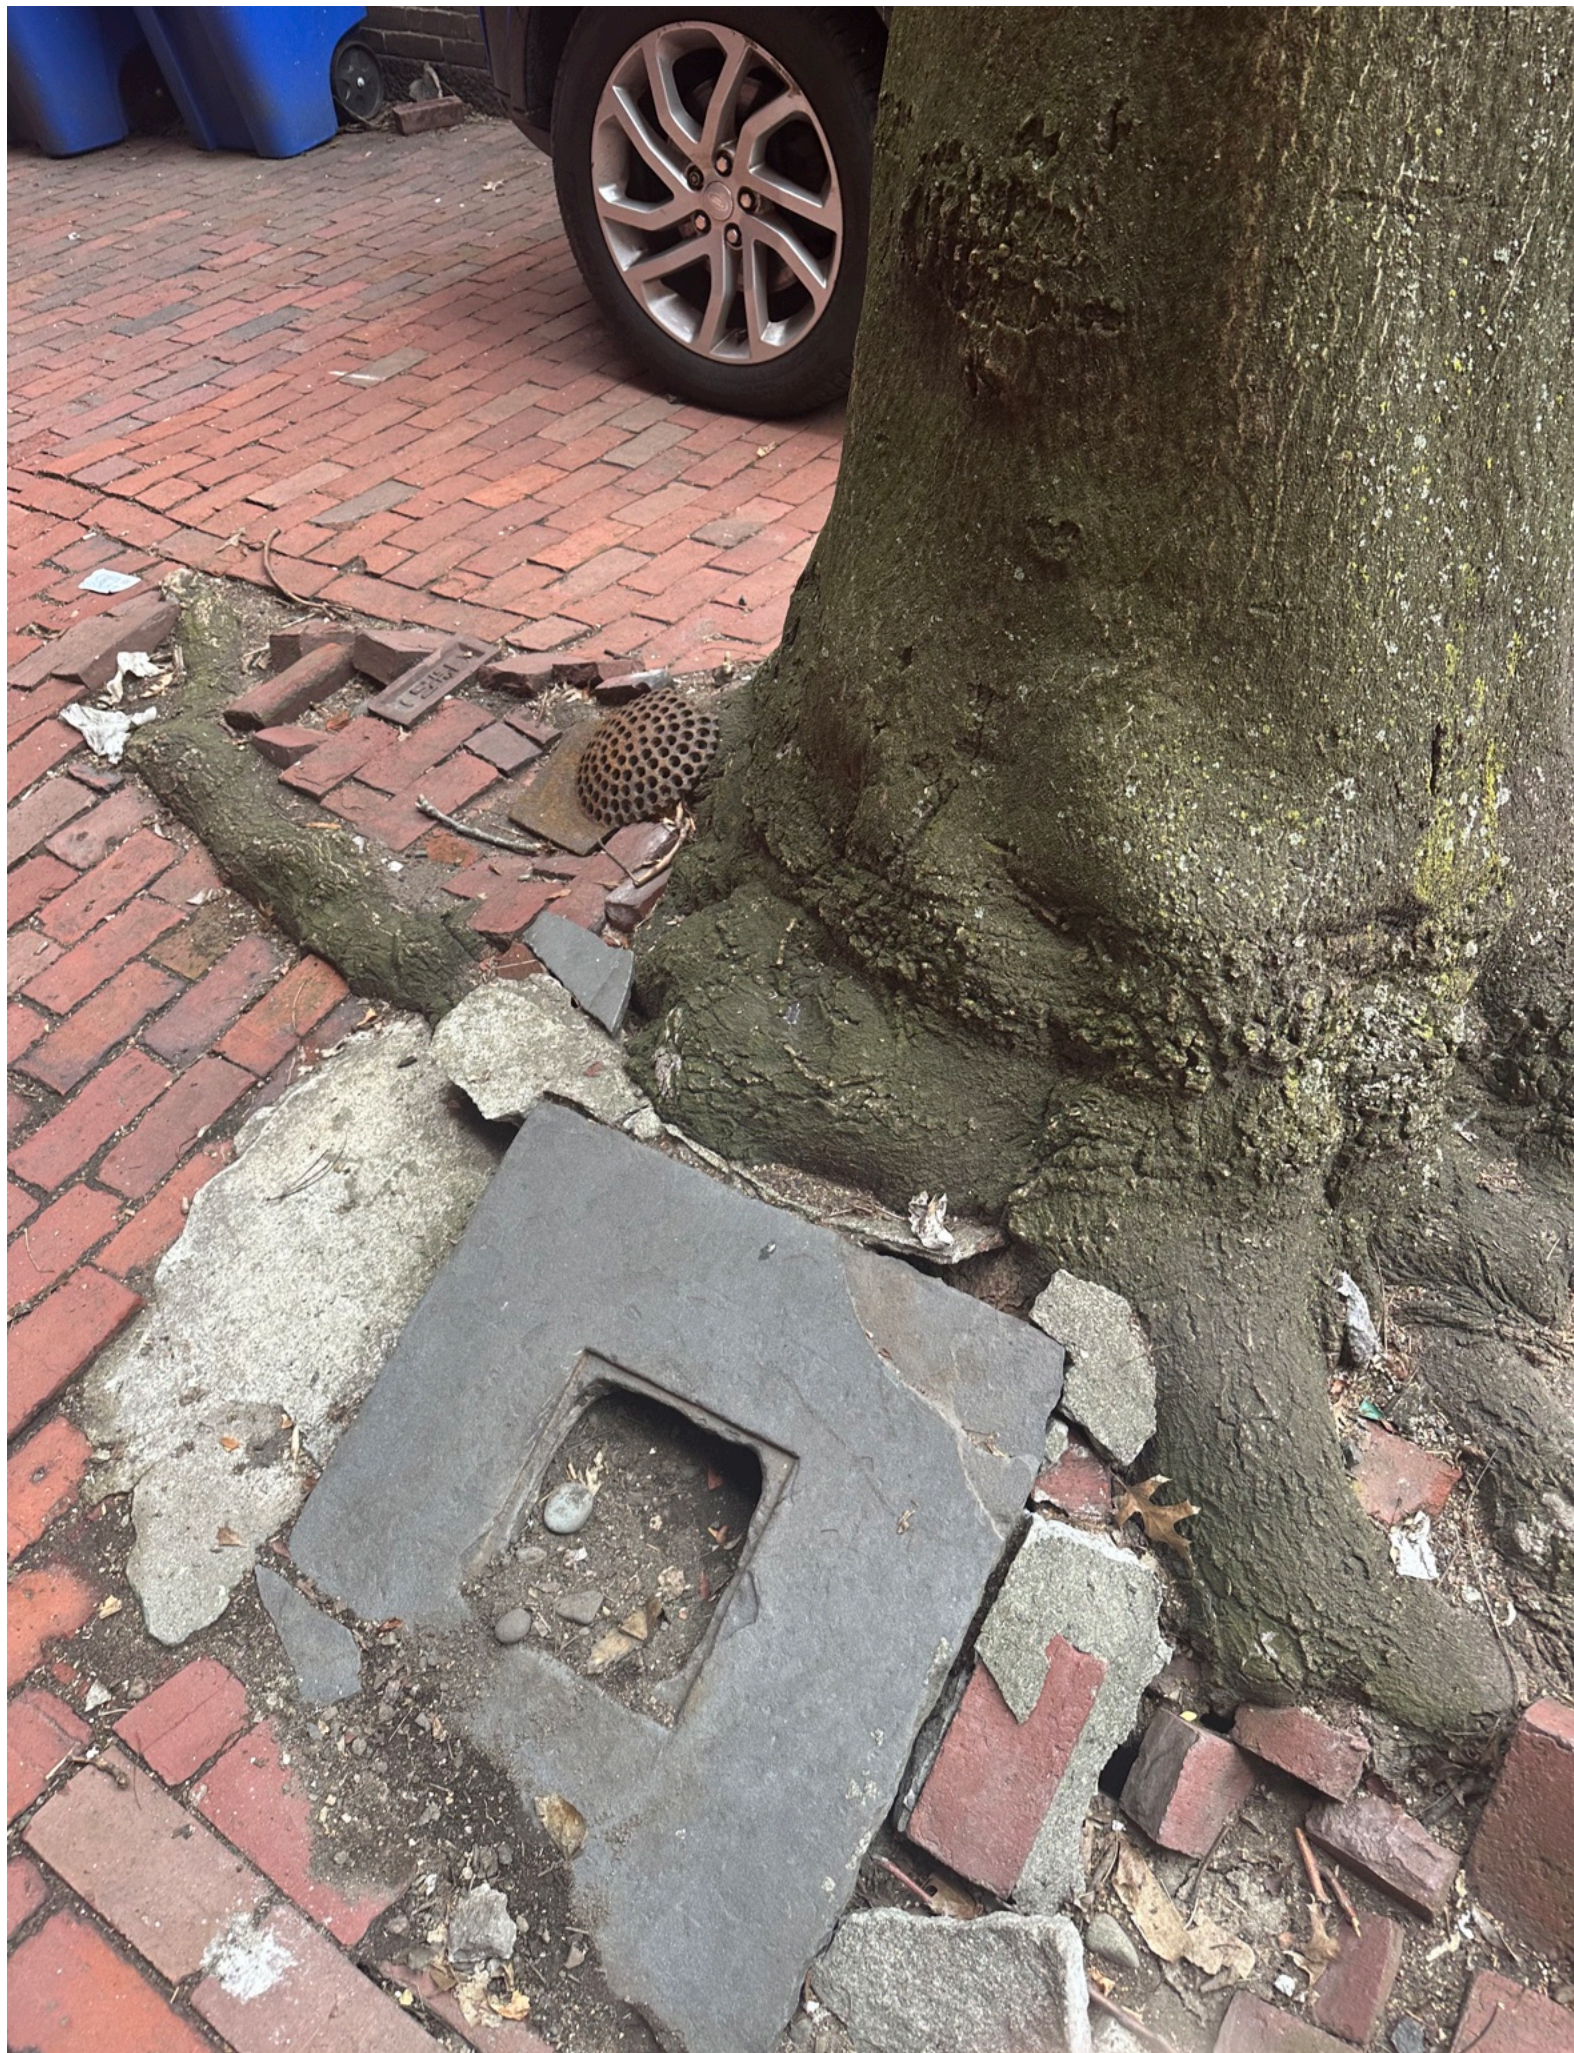
At the time of inspection, the tree was observed to be in fair overall condition. The exterior portions of the canopy exhibited normal bud swell consistent with the current stage of the spring growing season. However, multiple dead branches were noted within the interior of the canopy, indicating reduced vigor and declining interior crown health. (Figure 2.)

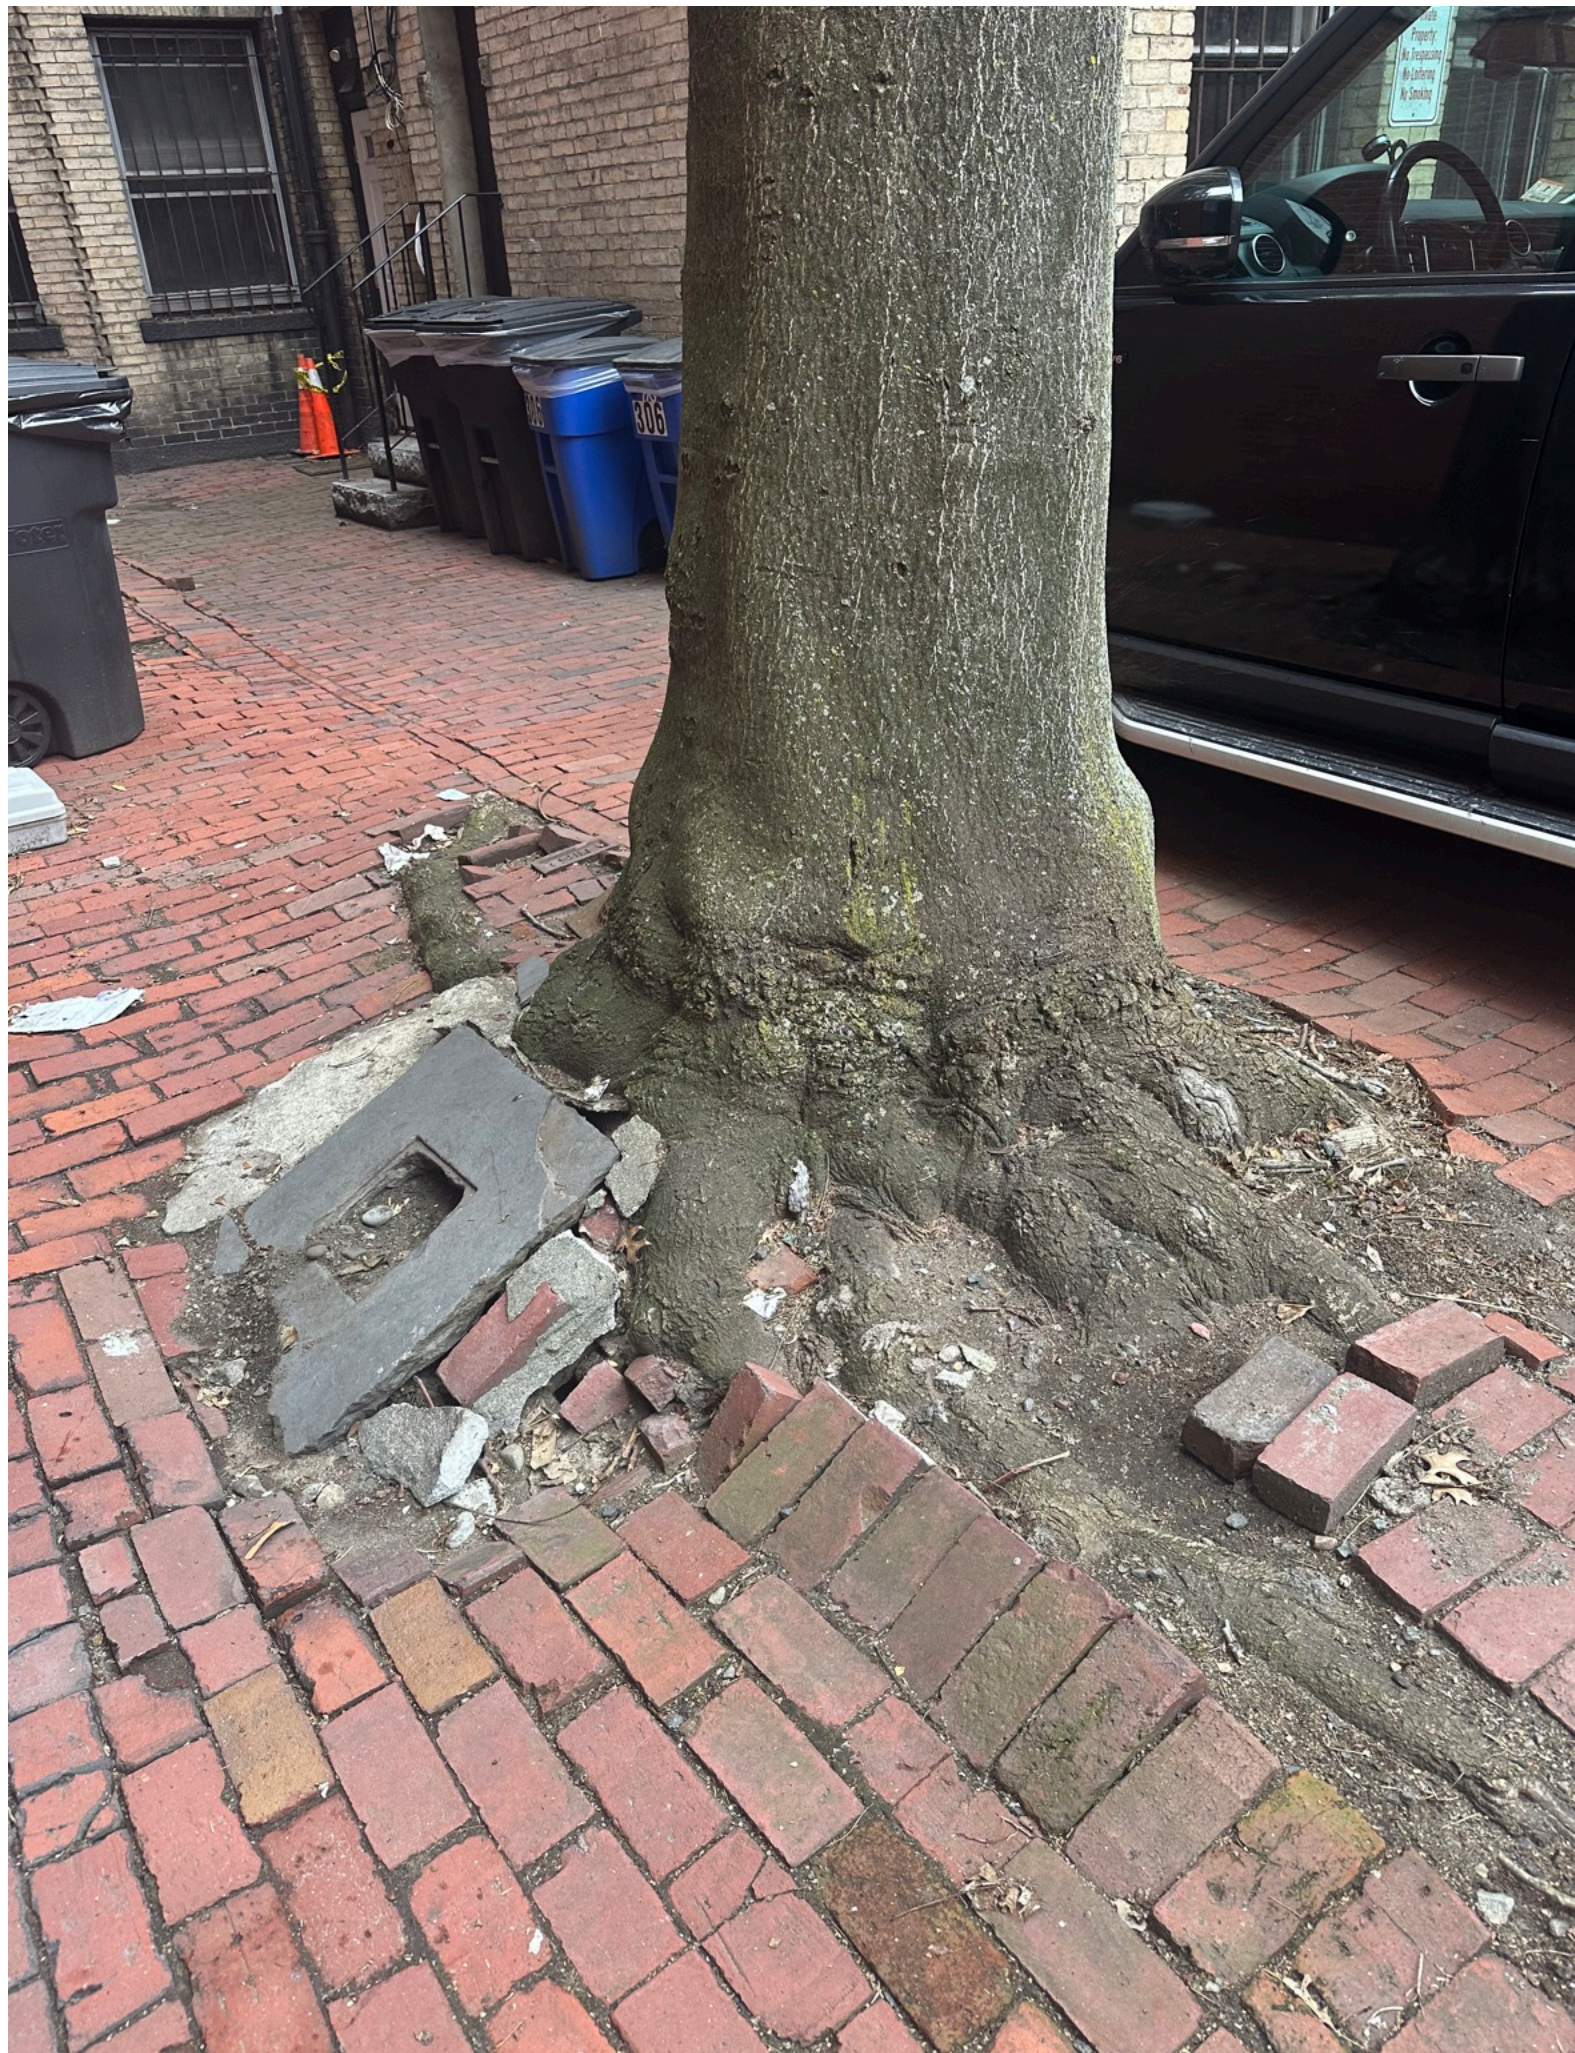
The tree has an observed history of pruning to maintain clearance from adjacent buildings. These repeated clearance cuts have resulted in a lion-tailed canopy structure, characterized by foliage concentrated at the outer ends of branches with sparse interior growth. This condition can reduce branch taper and increase mechanical stress on limbs and leaders, thereby predisposing them to failure during adverse weather conditions. (Figure 3.)
