SCHEMATIC DESIGN
WASHINGTON IRVING MIDDLE SCHOOL
105 CUMMINS HIGHWAY
ROSLINDALE, MA

DRAFT REPORT
OCTOBER 14, 2022

BOSTON PUBLIC SCHOOLS
CITY OF BOSTON
WASHINGTON IRVING SCHOOL RENOVATION/ADDITION PROJECT
ROSLINDALE, MA.

SCHEMATIC DESIGN

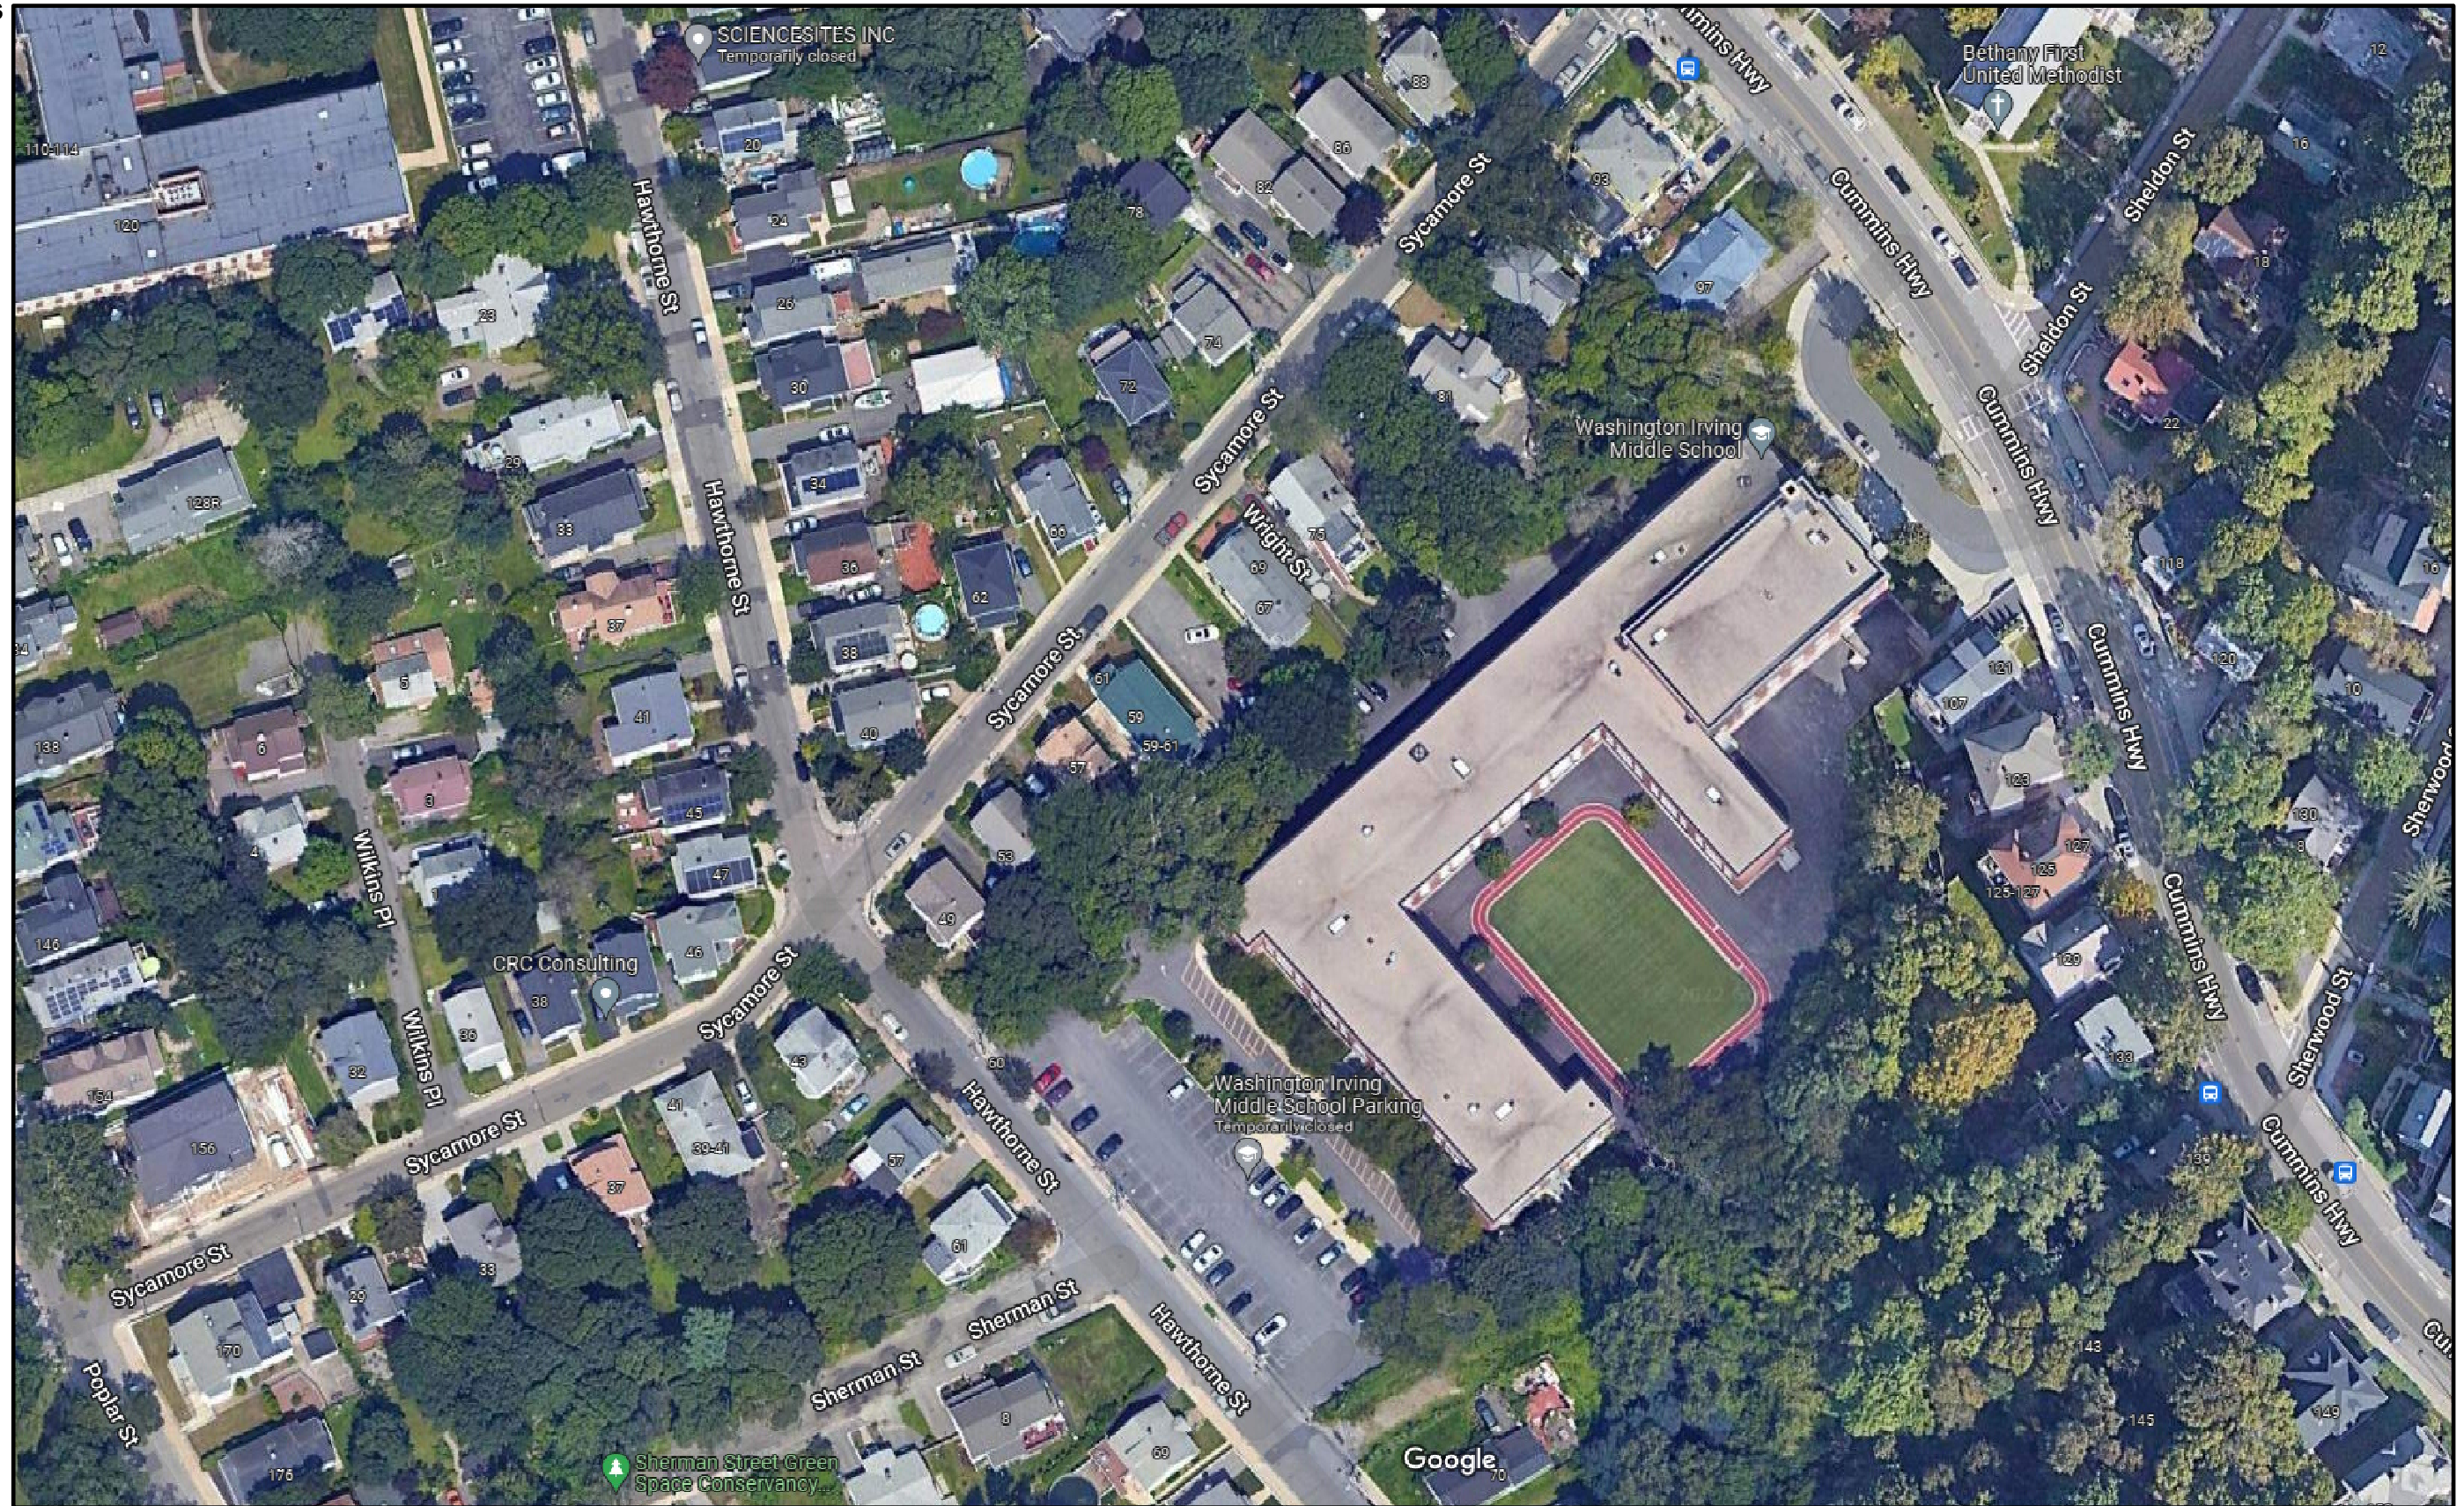
Washington Irving Elementary School Location
Alternative 1, Existing Aerial View
Gr. K-6, 700 Students
Renovation/Addition Construction
114,225 SF

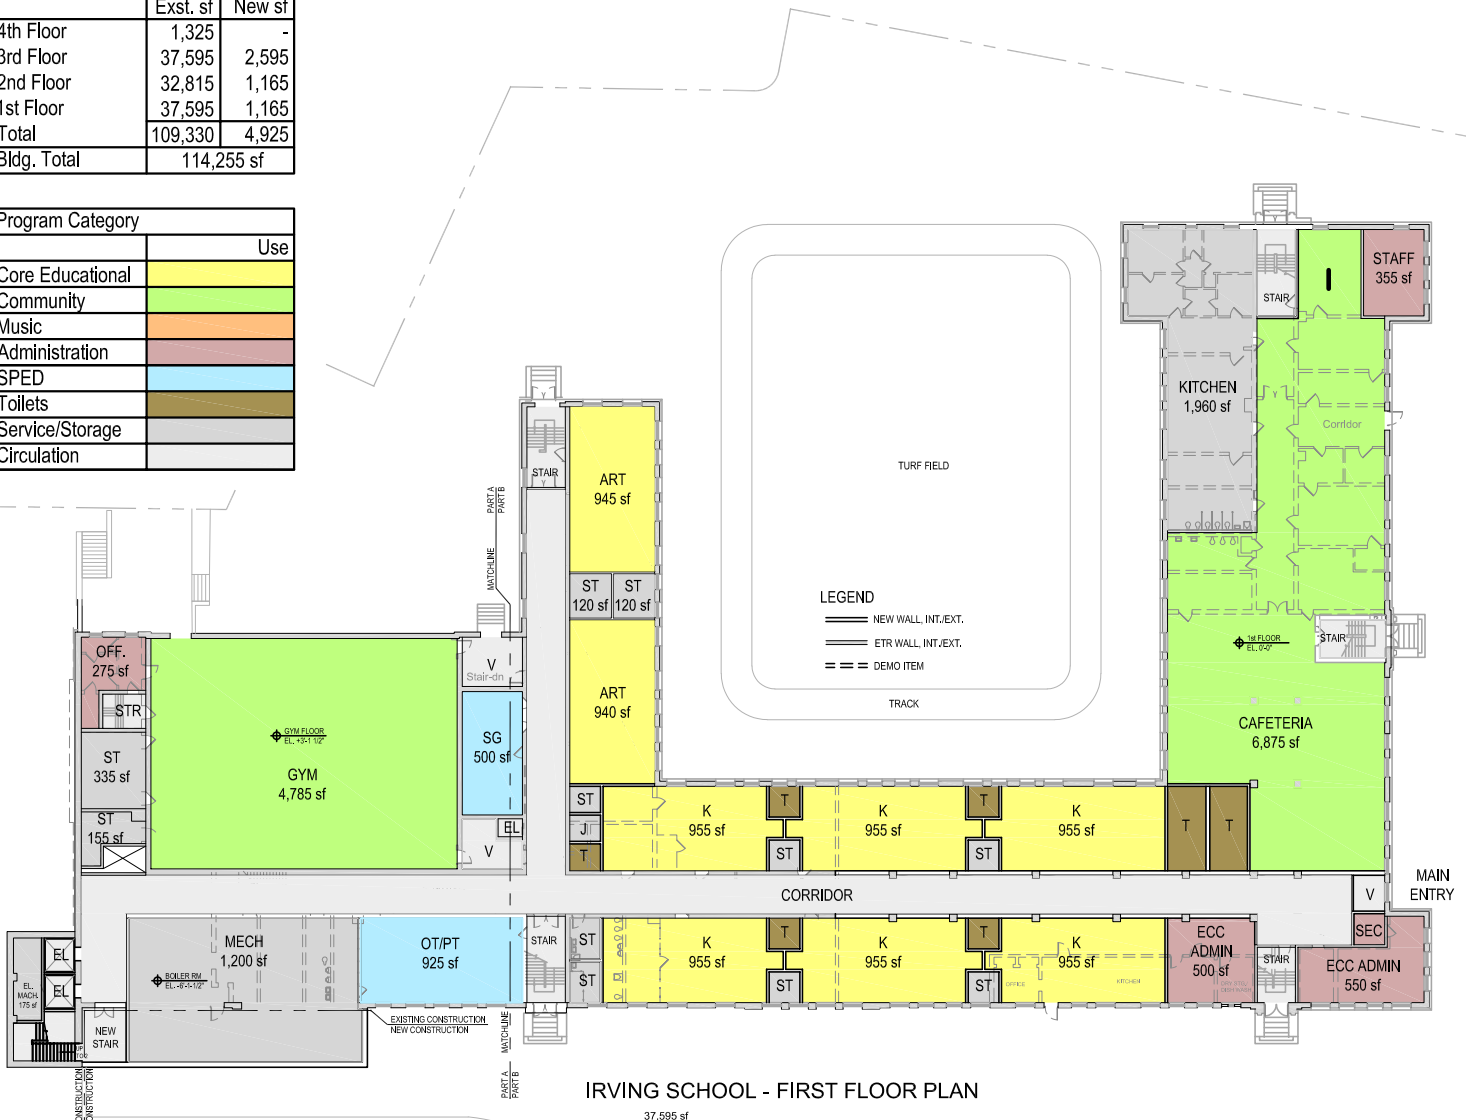
Washington Irving Elementary School Location
Alternative 1, First Floor
Gr. K-6, 700 Students
Renovation/Addition Construction
114,225 SF

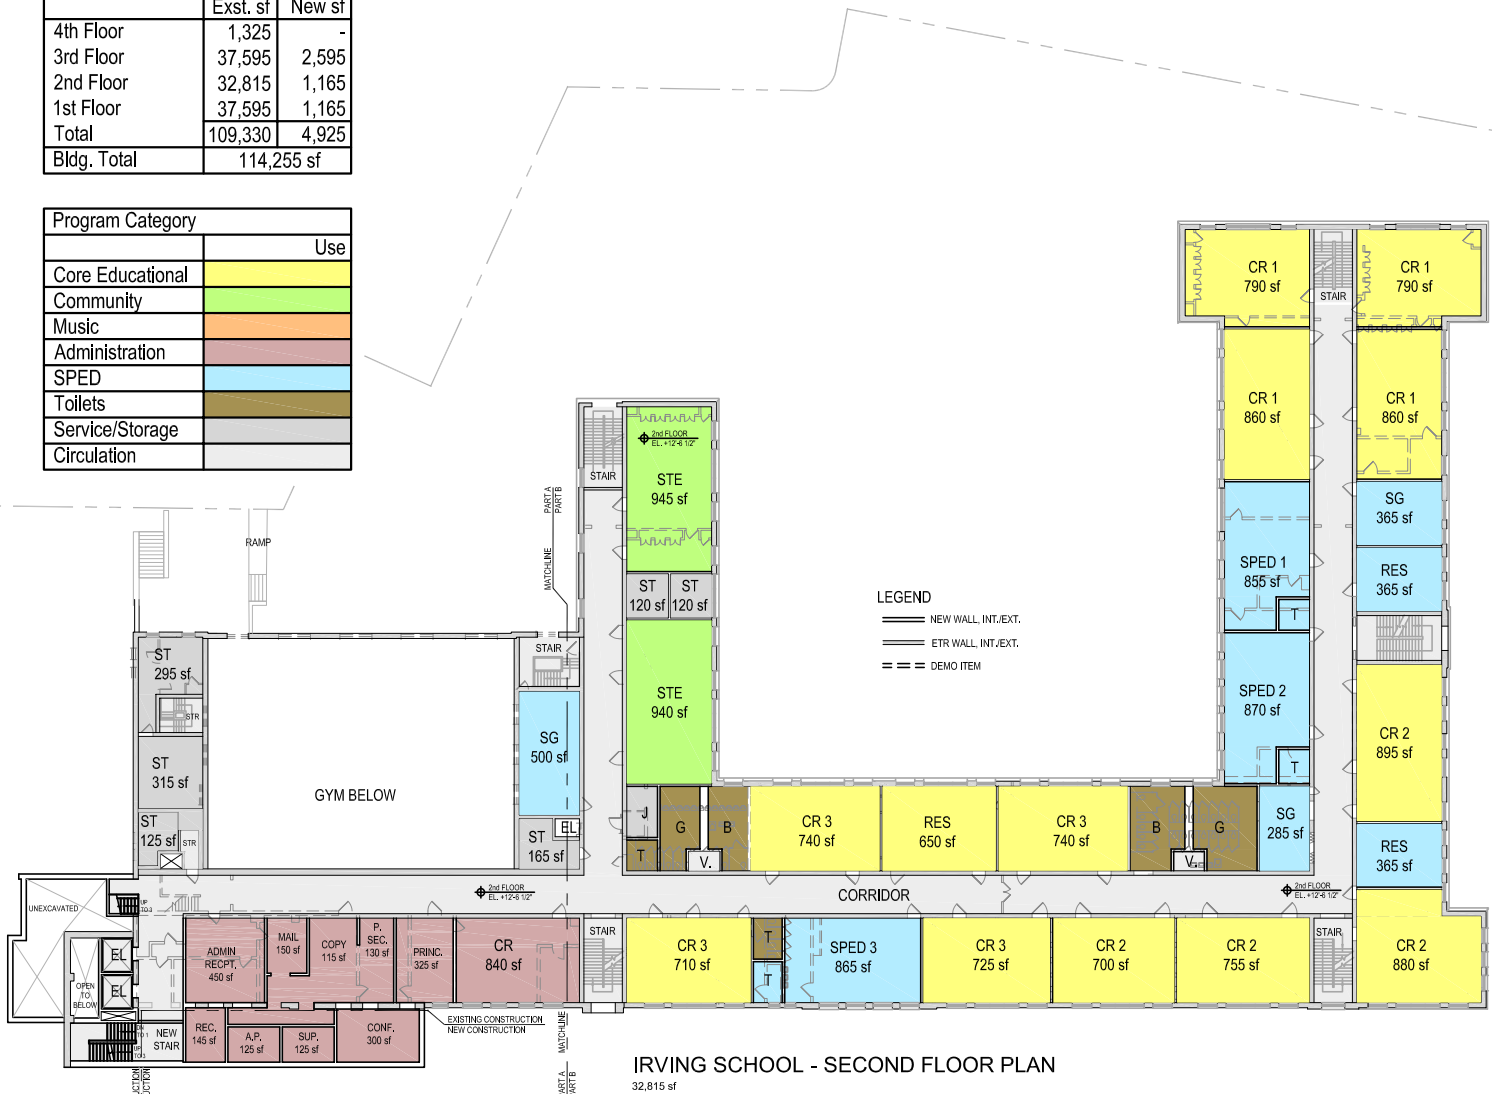
Washington Irving Elementary School Location
Alternative 1, Second Floor
Gr. K-6, 700 Students
Renovation/Addition Construction
114,255 SF

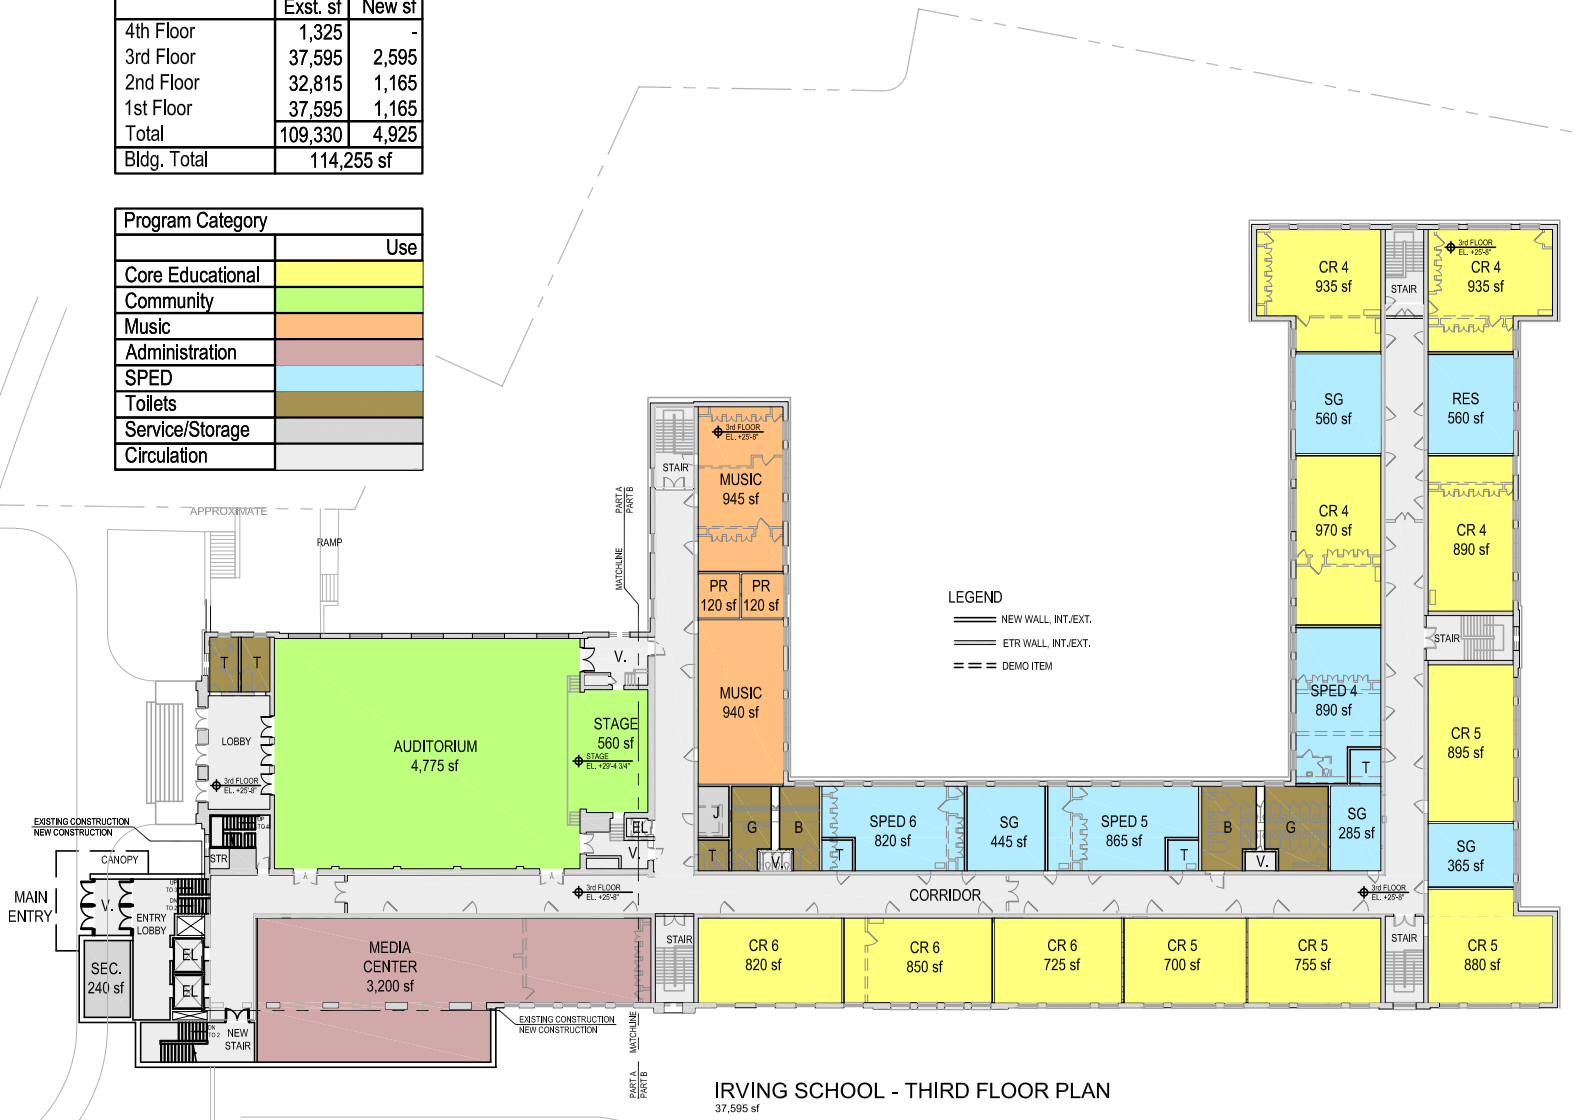
Washington Irving Elementary School Location
Alternative 1, Third Floor
Gr. K-6, 700 Students
Renovation/Addition Construction
114,225 SF

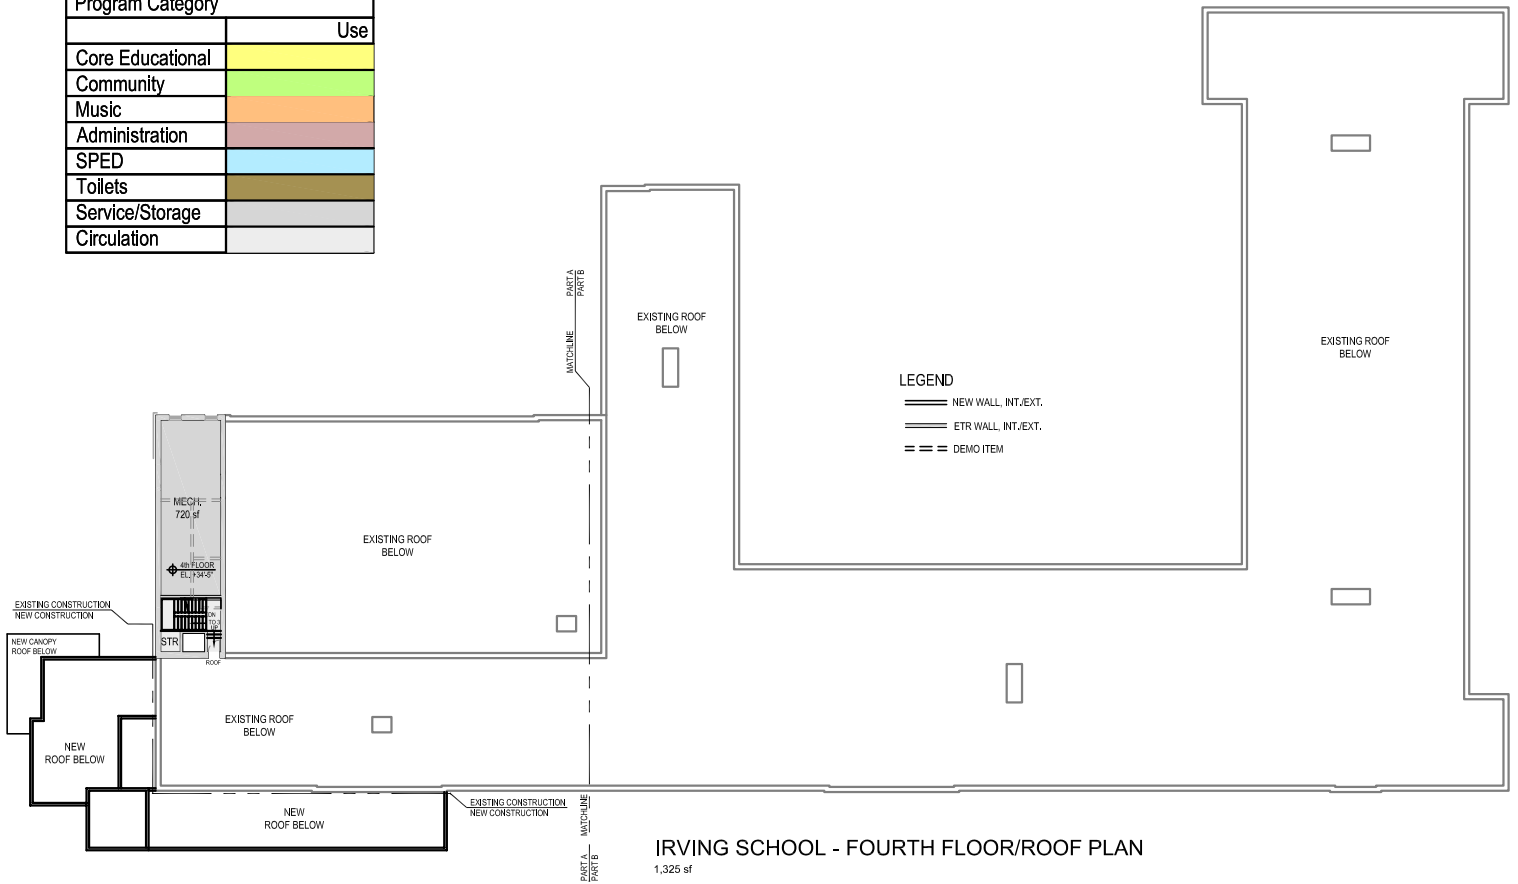
Washington Irving Elementary School Location
Alternative 1, Fourth Floor
Gr. K-6, 700 Students
Renovation/Addition Construction
114,225 SF

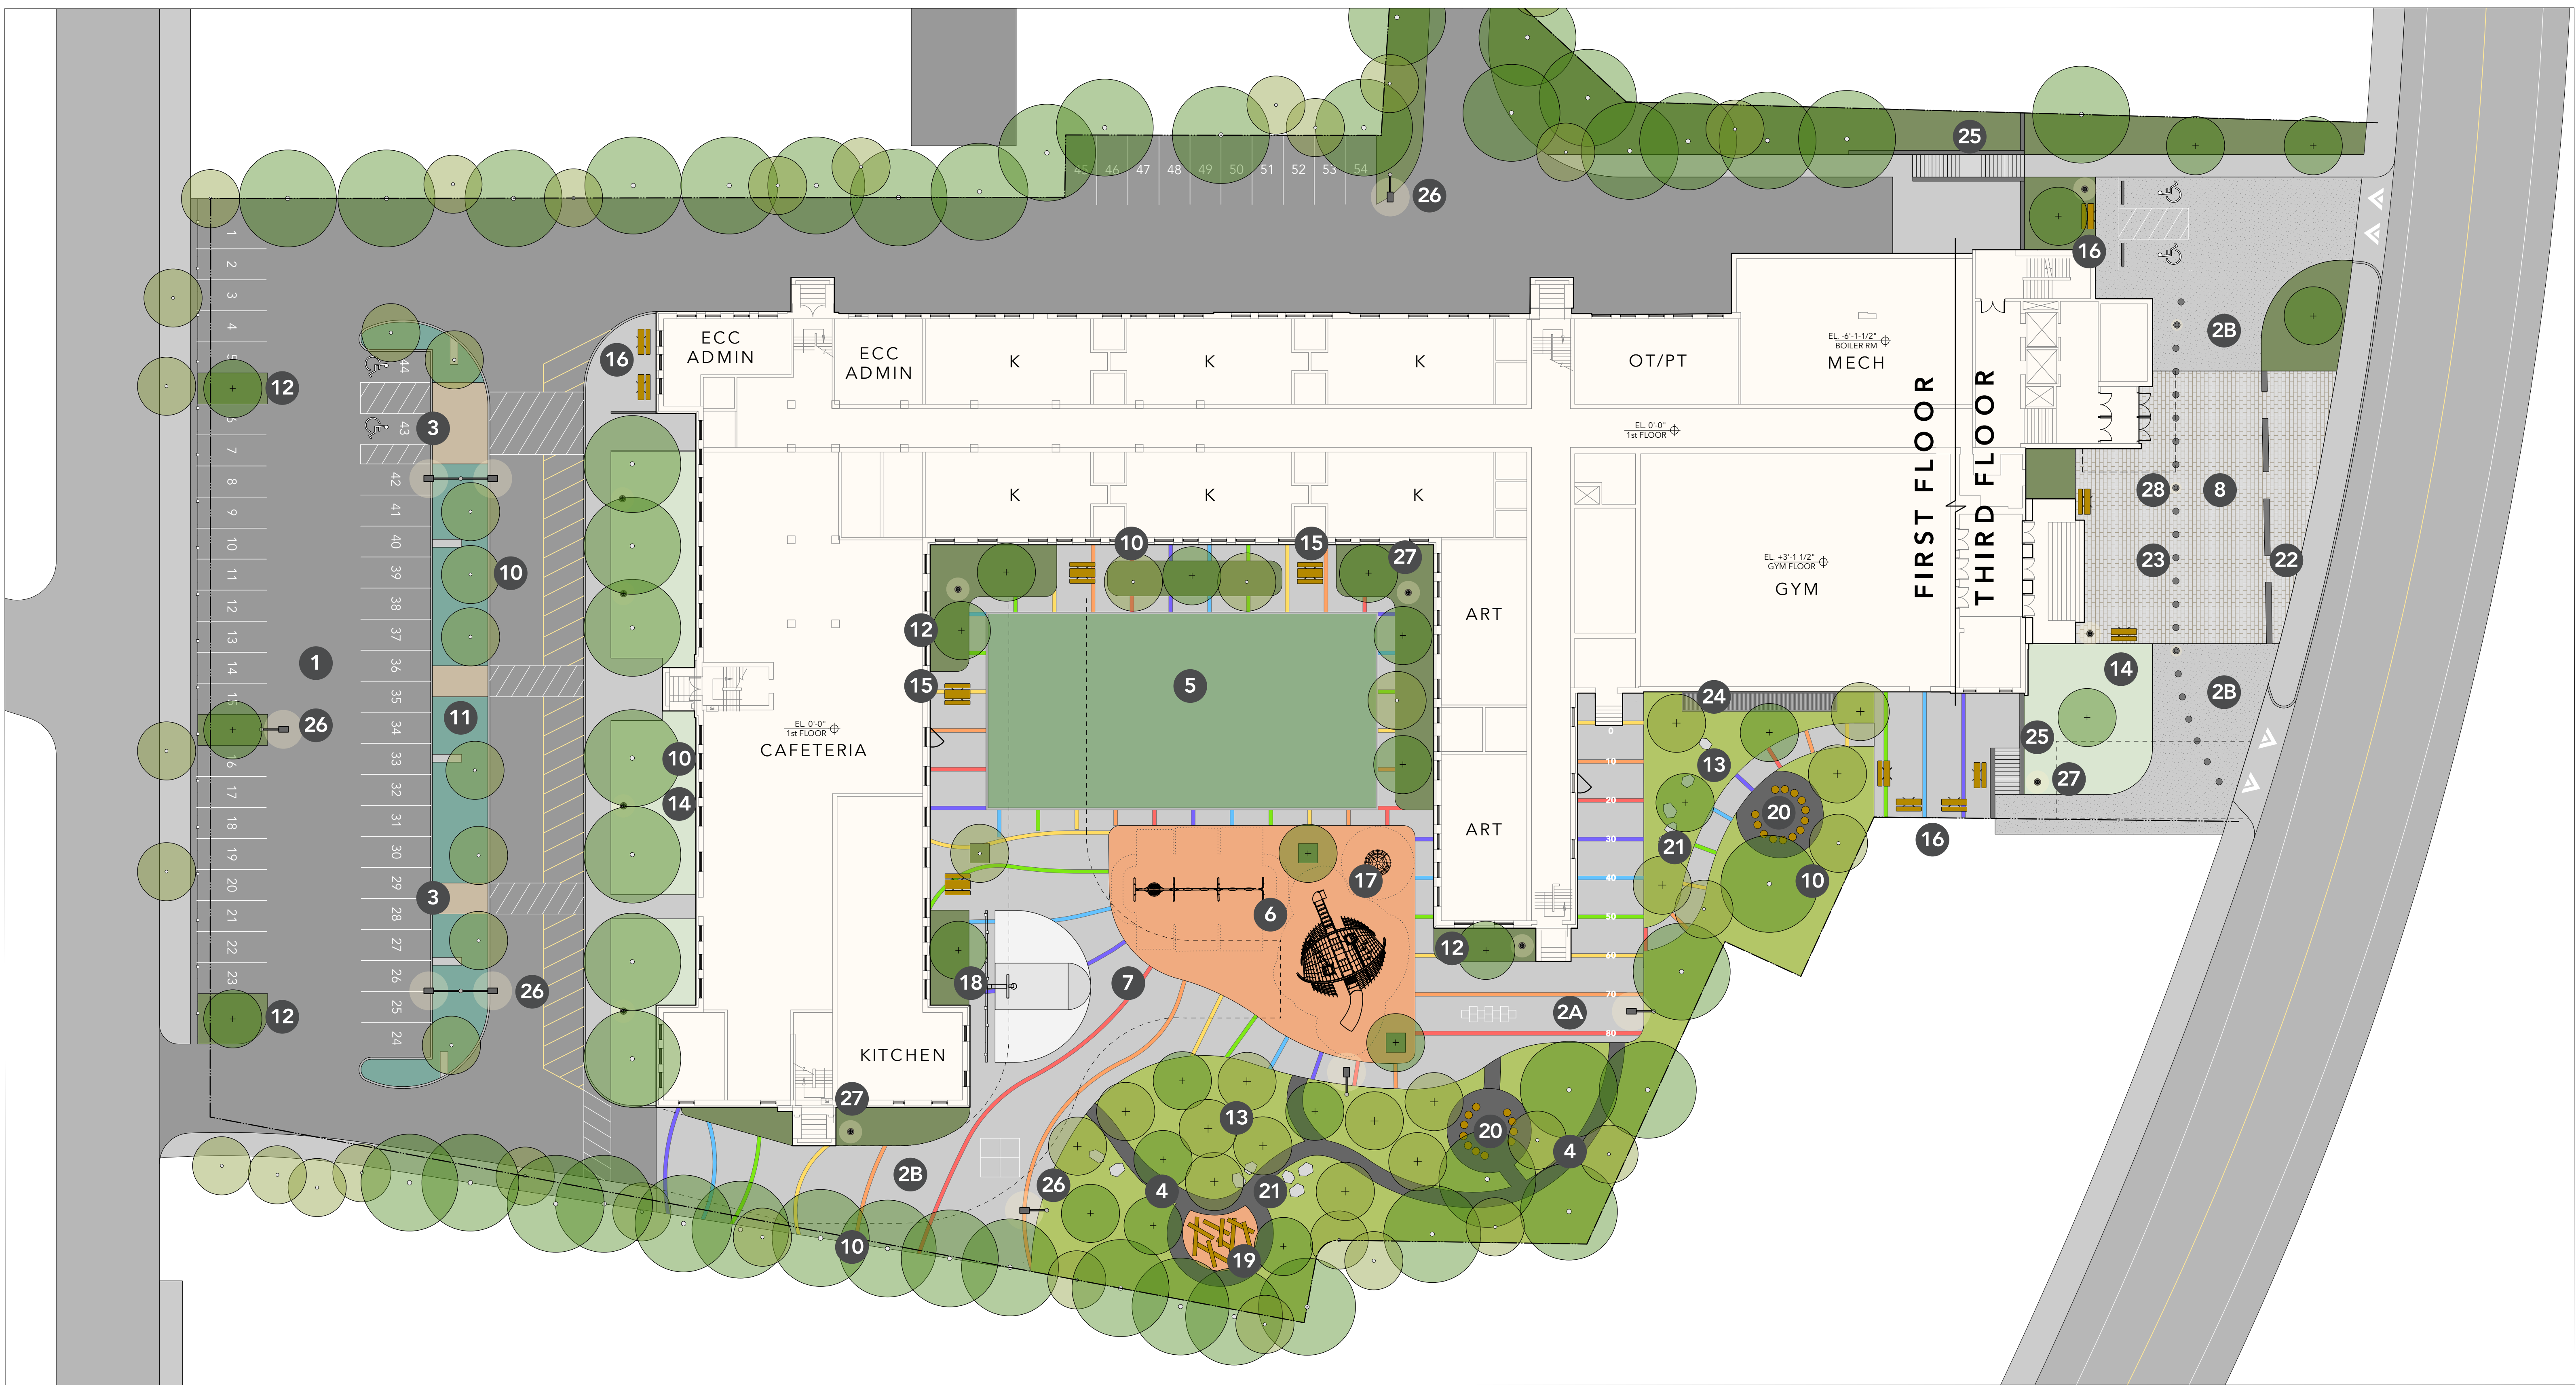
DRAWING NUMBER
L100-1

PAVING / SURFACING

- 1** ASPHALT PARKING LOT
new parking lot top coat and striping
- 2A** PEDESTRIAN CONCRETE PAVING
4" poured concrete on 6" aggregate base
- 2B** VEHICULAR CONCRETE
6" poured concrete on 12" aggregate base
- 3** BOARDWALK
wood boardwalk flush with parking lot to bridge rain garden
- 4** STABILIZED STONEDUST
accessible reinforced stonedust path with steel edging

LIGHTING

- 26** PARKING / FLOOD LIGHT
product TBD.
- 27** PEDESTRIAN LIGHT
product TBD.
- 28** BOLLARD LIGHT
product TBD.

At this entry it is proposed to add two new ADA parking spaces by the new accessible school entry. In addition, the new entry and the auditorium stairs are joined on a shared pedestrian / vehicular plaza. The automobile zone is demarcated by bollards and change in paving color, but is a flush condition. The plaza is bounded by granite blocks that create a low wall, which are broken to allow access to the plaza from the crosswalk on Cummings Highway. Bike racks are located on either side of the building. Removable bollards allow fire access to the back of the building.

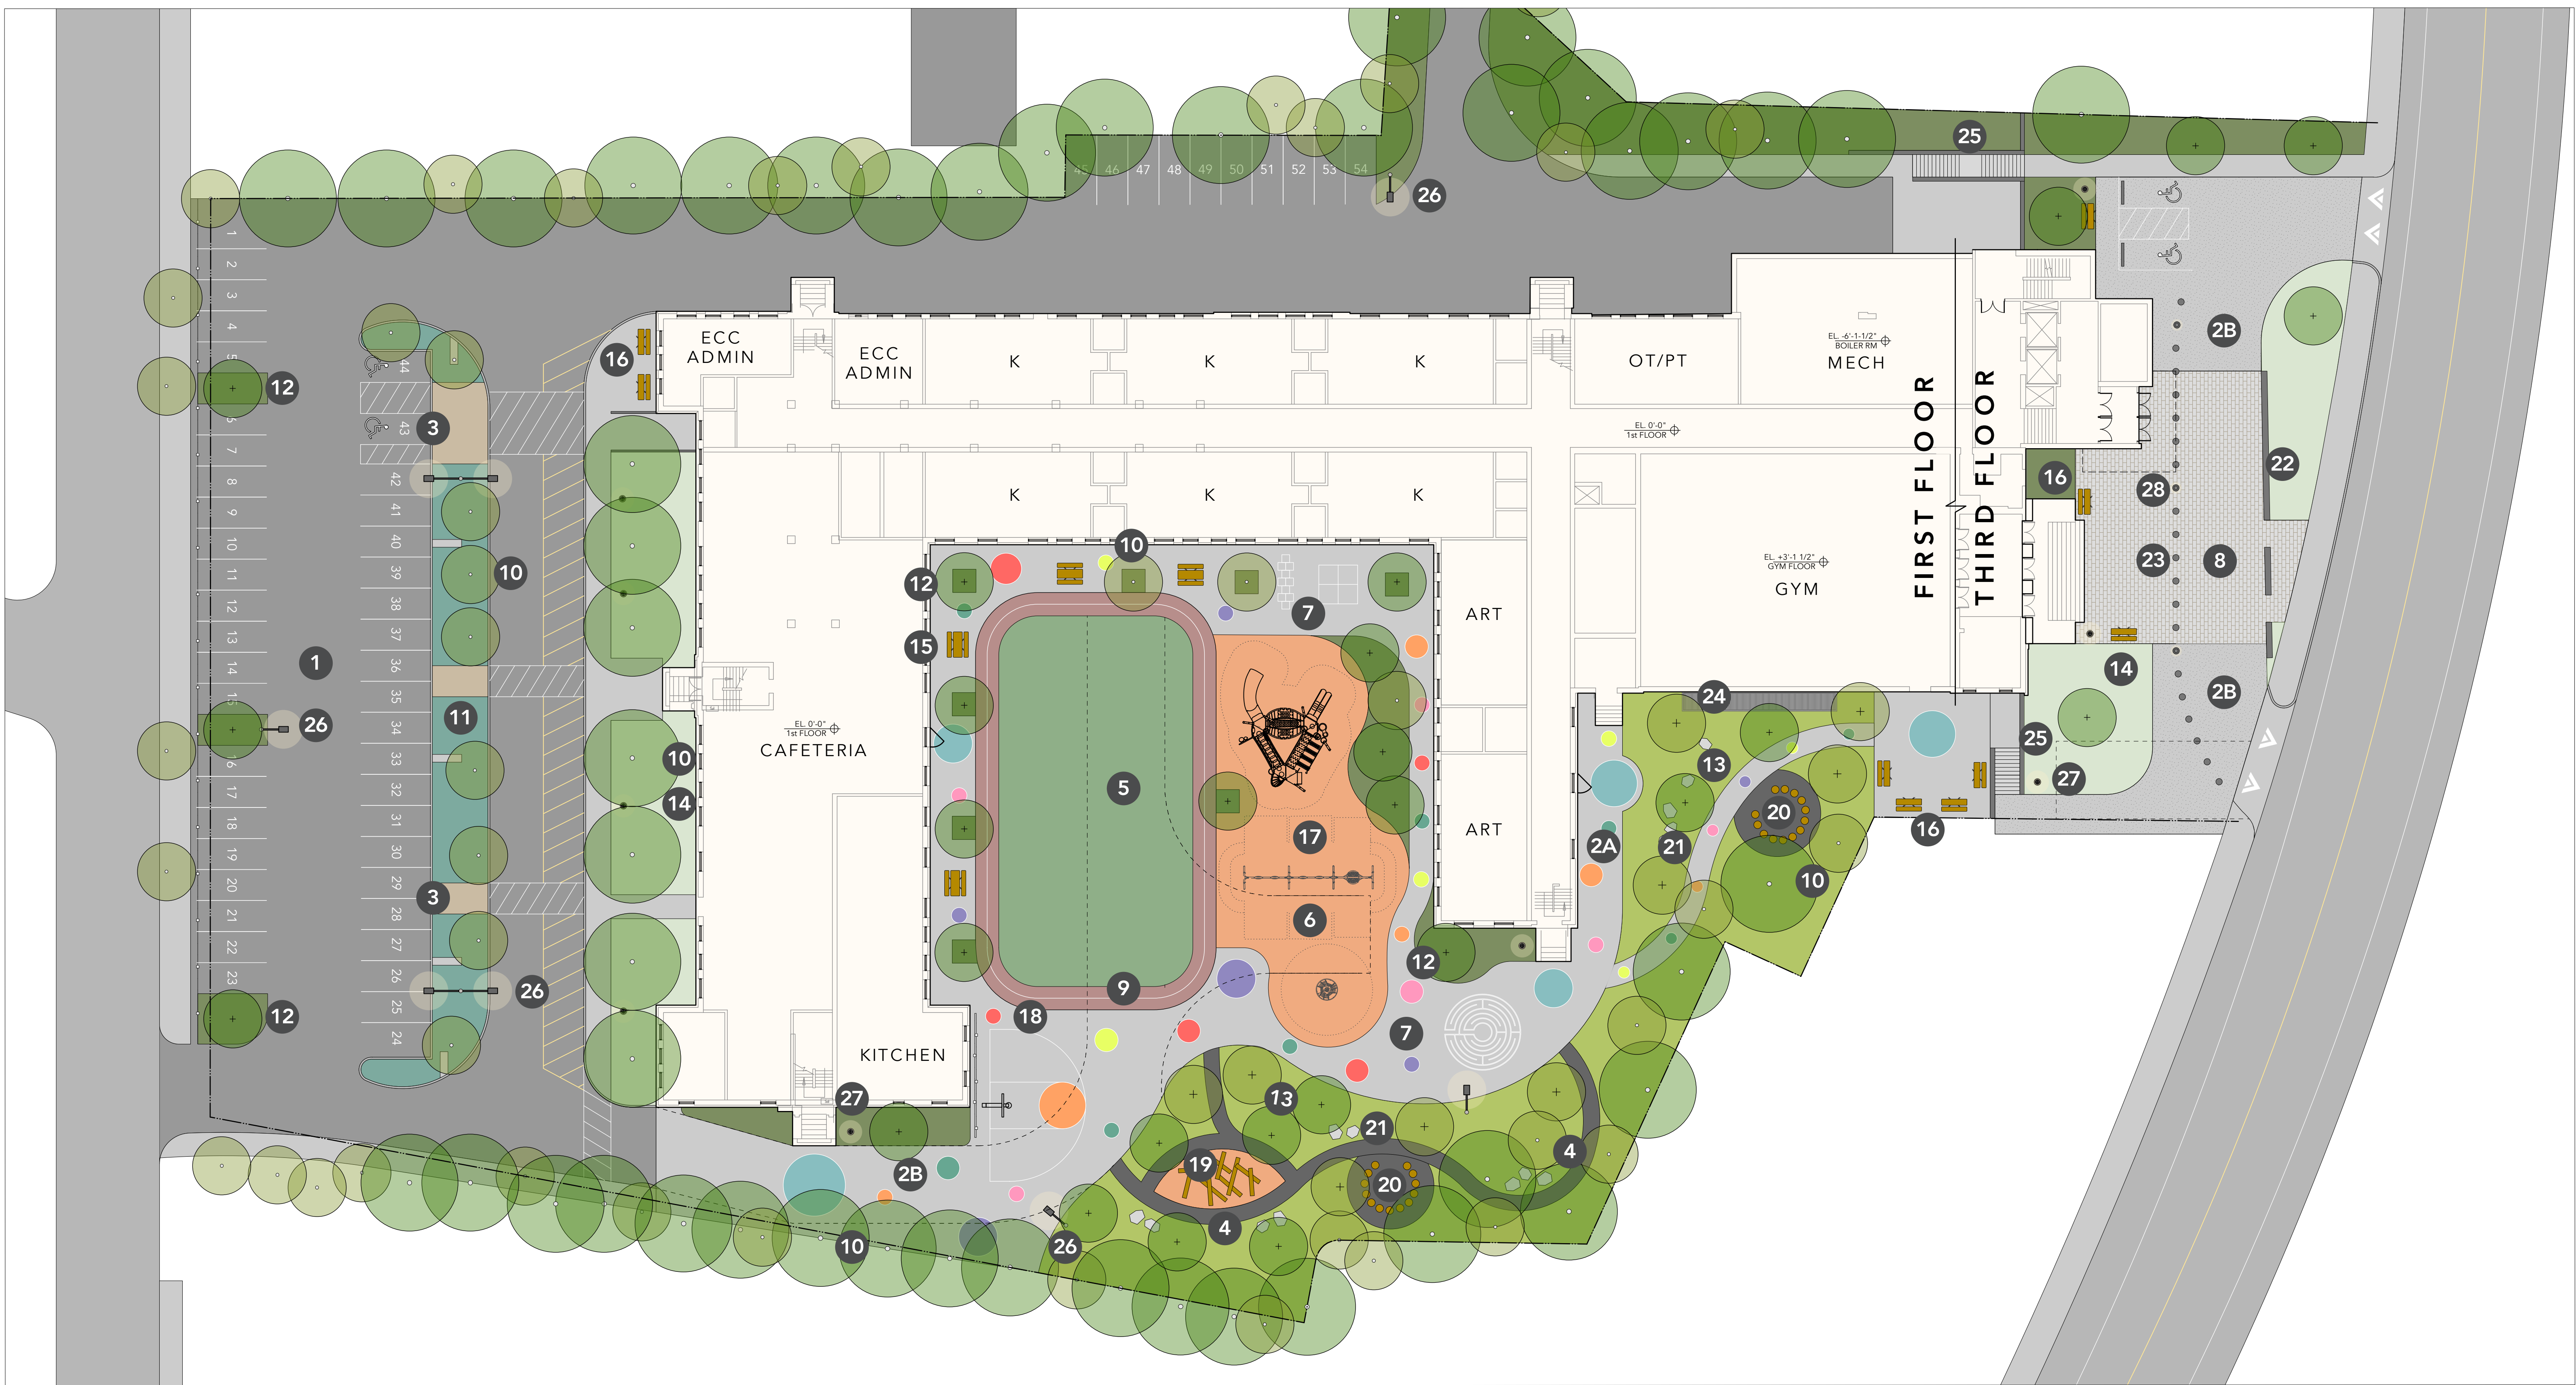
DRAWING NUMBER
L100-3

PAVING / SURFACING

- 1 ASPHALT PARKING LOT**
new parking lot top coat and striping
- 2A PEDESTRIAN CONCRETE PAVING**
4" poured concrete on 6" aggregate base
- 2B VEHICULAR CONCRETE**
6" poured concrete on 12" aggregate base
- 3 BOARDWALK**
wood boardwalk flush with parking lot to bridge rain garden
- 4 STABILIZED STONEDUST**
accessible reinforced stonedust path with steel edging

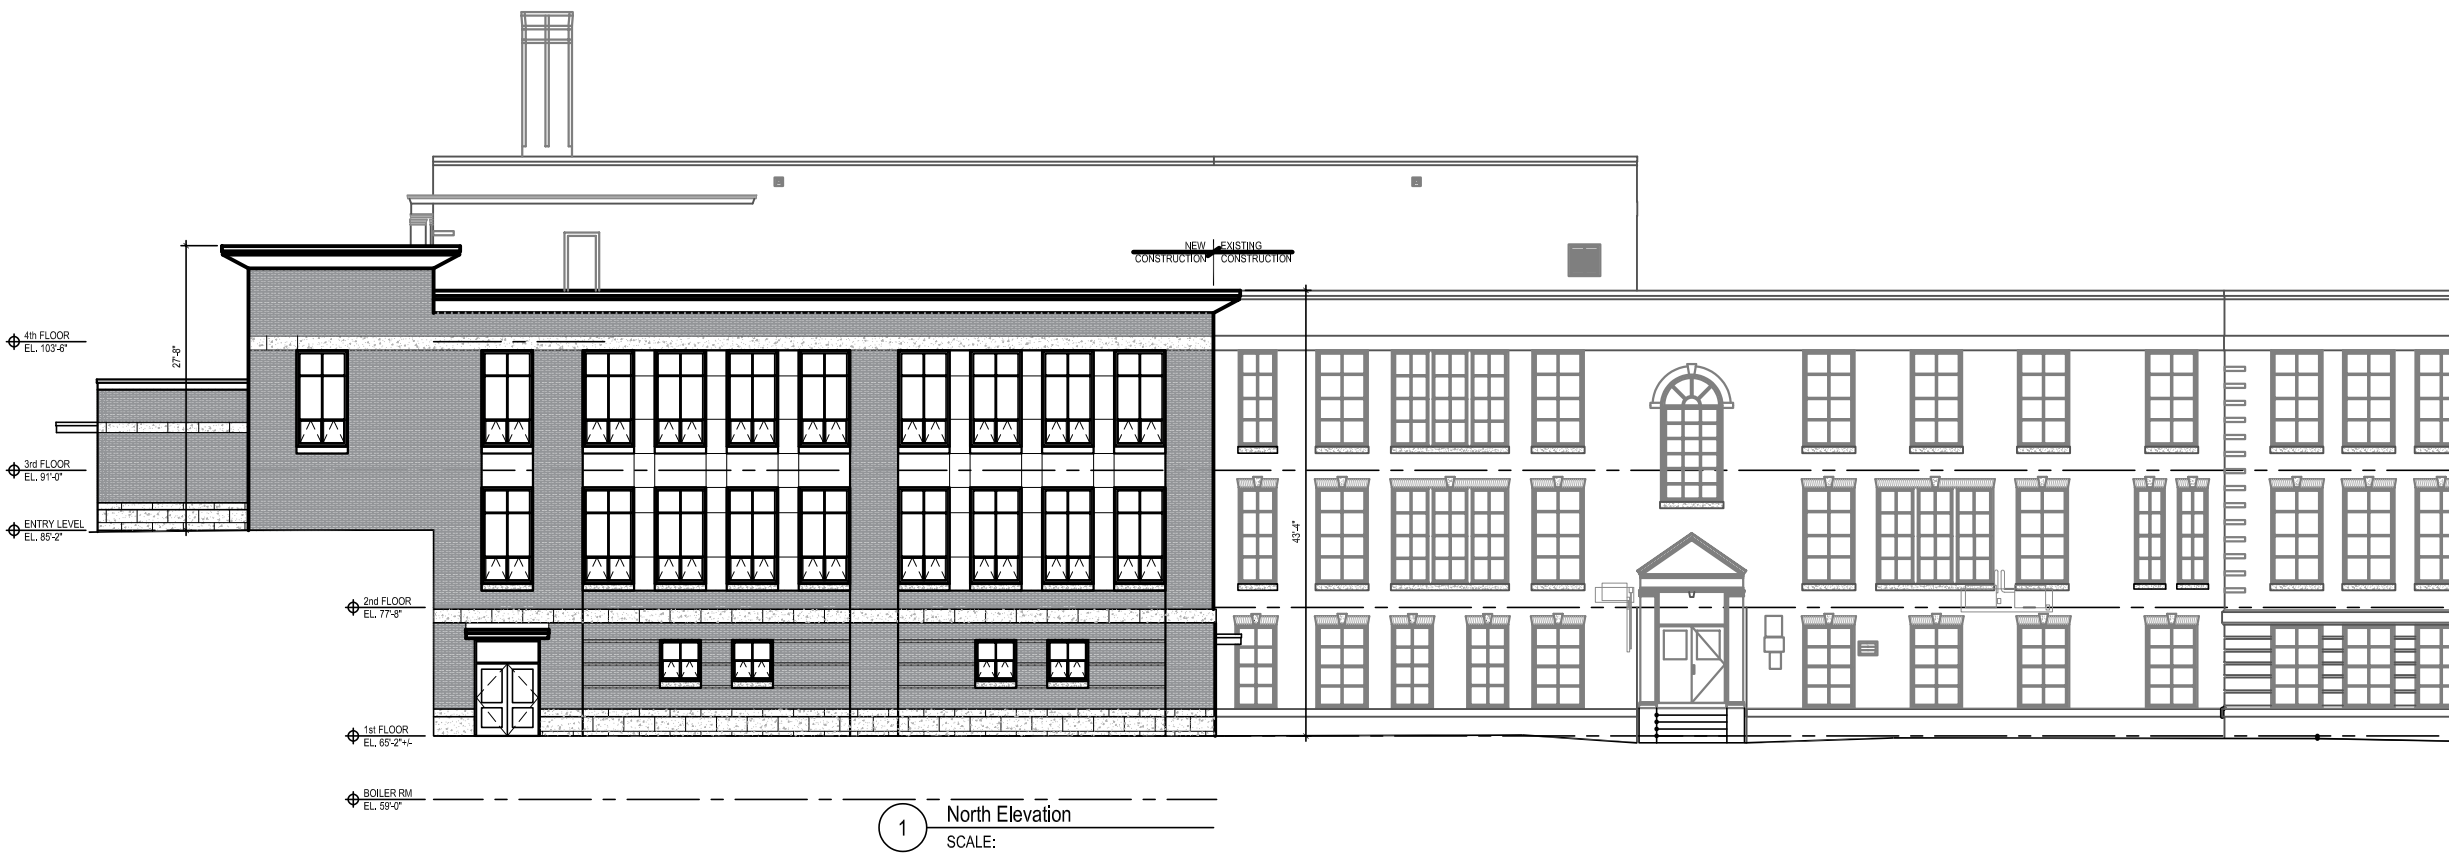
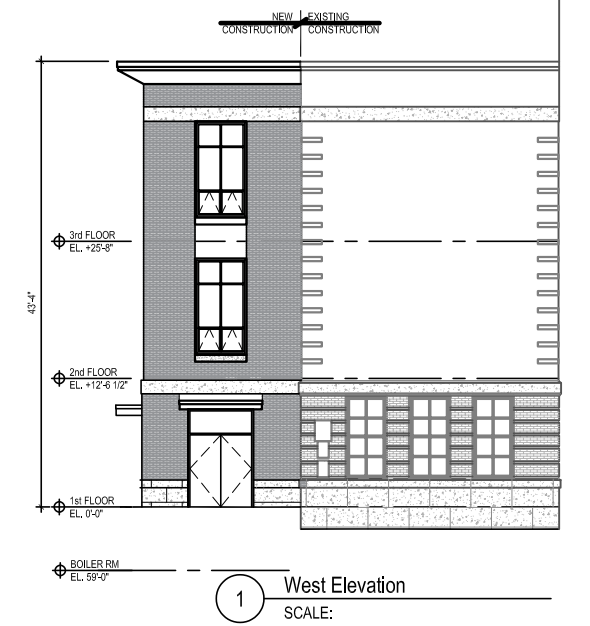
Washington Irving Elementary School Location
Alternative 1, North & West Exterior Elevations @ New Addition
Gr. K-6, 700 Students
Renovation/Addition Construction
114,225 SF

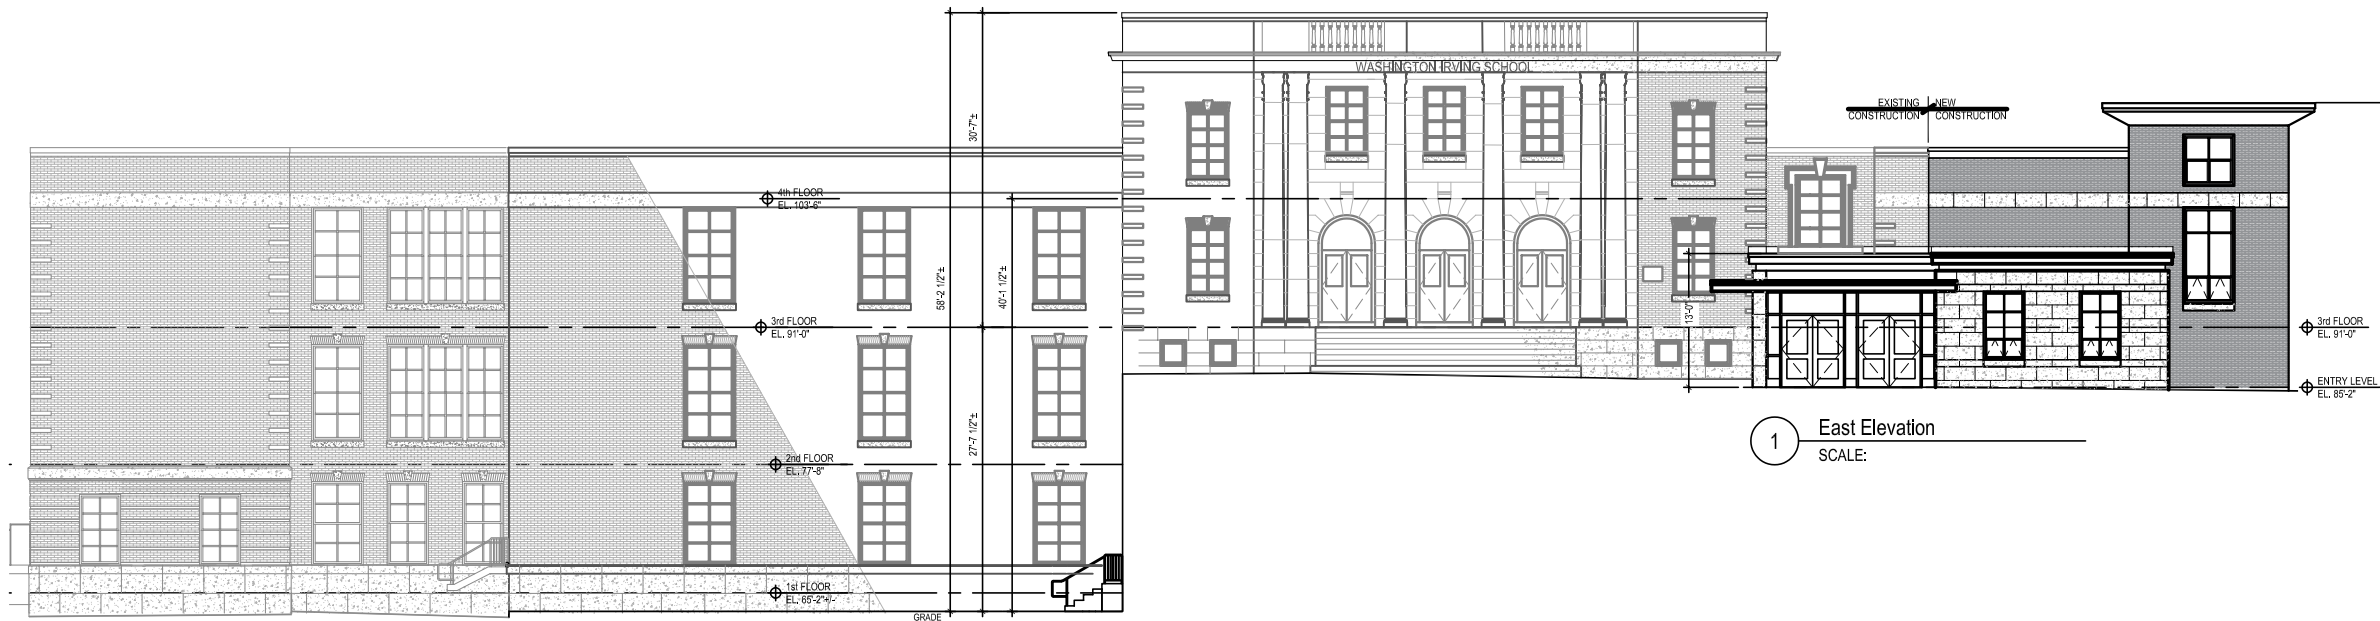
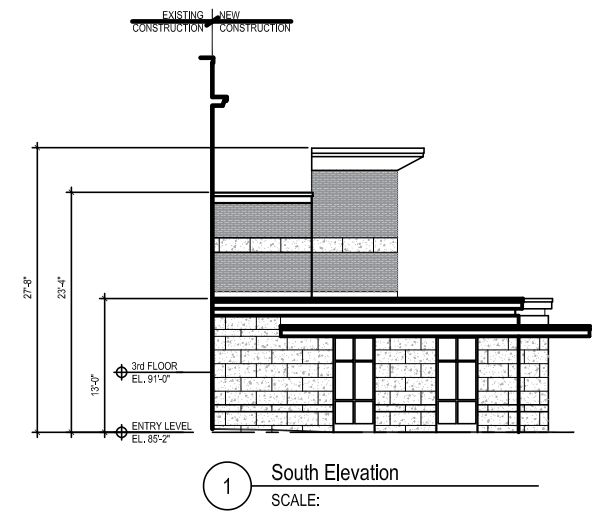
Washington Irving Elementary School Location
Alternative 1, East & South Exterior Elevations @ New Addition
Gr. K-6, 700 Students
Renovation/Addition Construction
114,225 SF
