SCHEMATIC DESIGN
WASHINGTON IRVING MIDDLE SCHOOL
105 CUMMINS HIGHWAY
ROSLINDALE, MA

DRAFT REPORT
OCTOBER 14, 2022

BOSTON PUBLIC SCHOOLS
CITY OF BOSTON
WASHINGTON IRVING SCHOOL RENOVATION/ADDITION PROJECT
ROSLINDALE, MA.

SCHEMATIC DESIGN

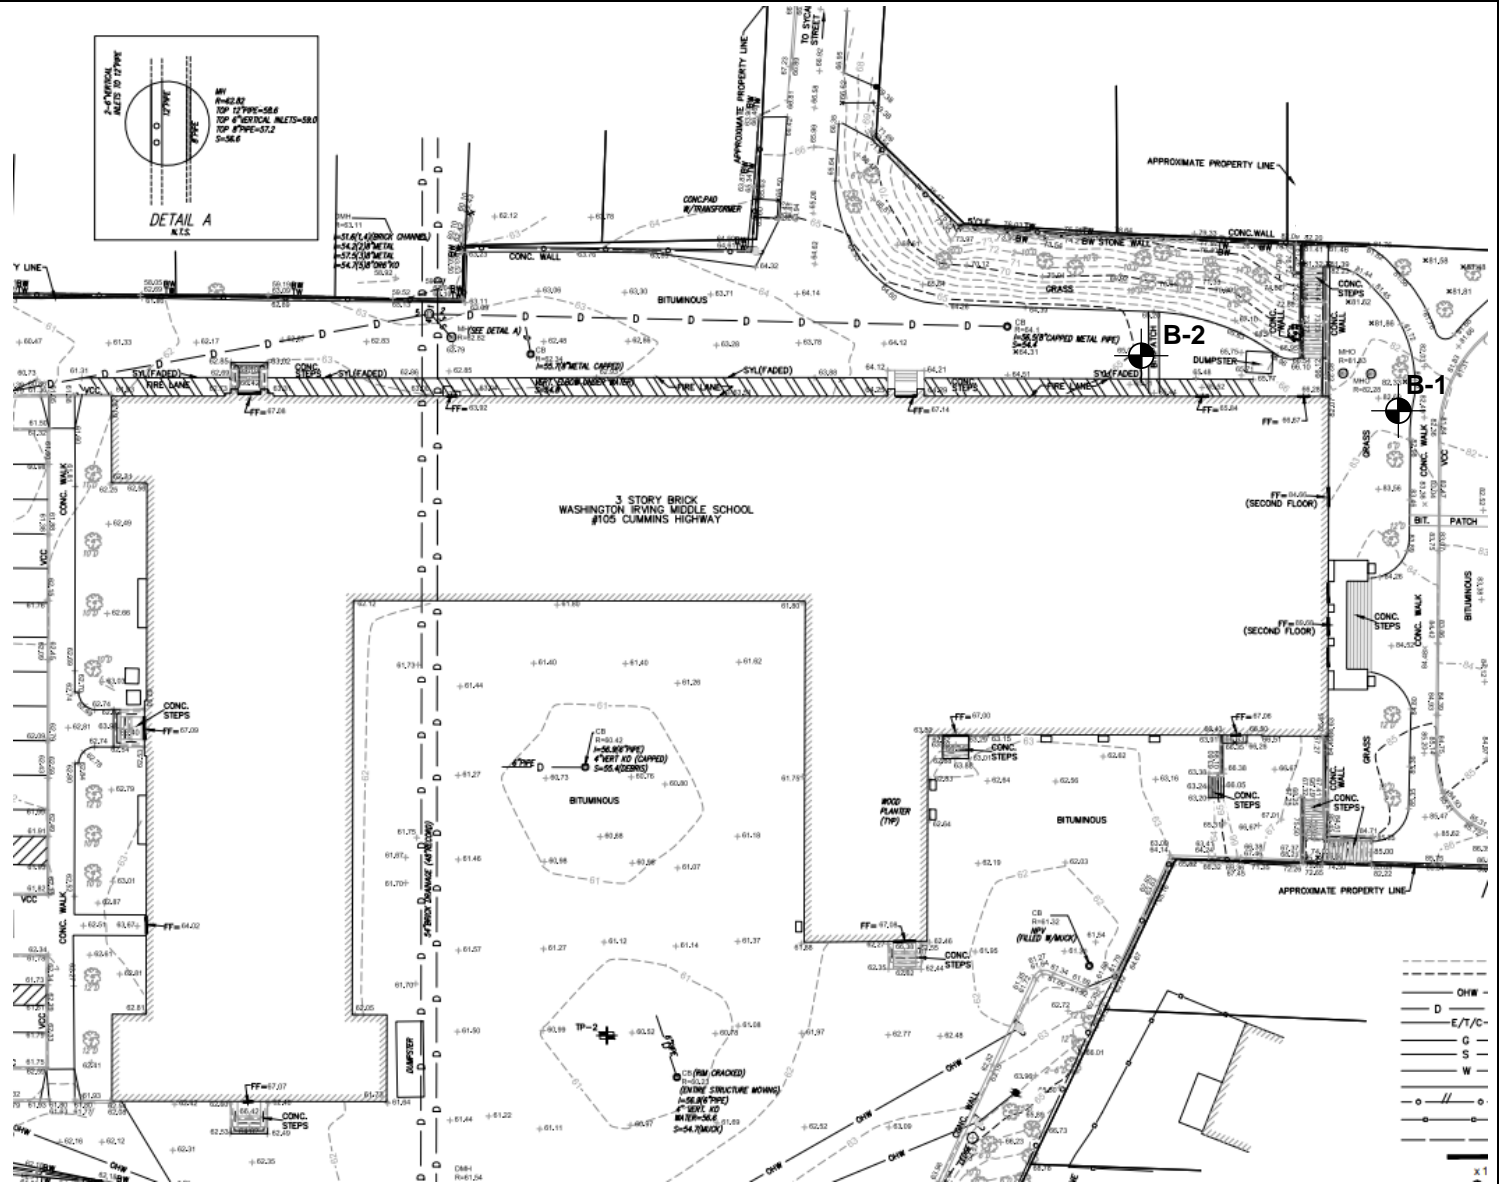
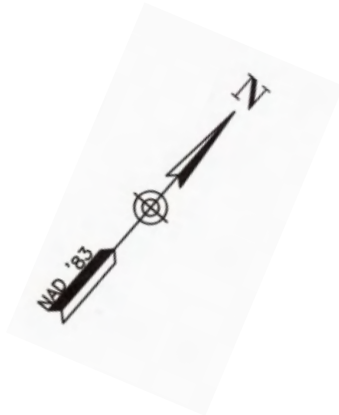
Client: Mount Vernon Group Architects, Inc.	Project: Proposed Additions – Washington Irving Middle School	Figure 3 – Boring Location Plan

Approximate location of borings advanced by Northern Drill Services, Inc. (NDS) of Northborough, MA on October 12, 2022, and observed by Lahlaf Geotechnical Consulting, Inc. (LGCI).

Figure based on drawing titled: "Existing Conditions, Green Infrastructure & Site Improvements at W. Irving School, 105 Cummins Hwy Roslindale, MA," prepared by Bryant Associates, dated May 10, 2016, and provided to LGCI by Mount Vernon Group Architects, Inc. (MVG) via e-mail on October 3, 2022.

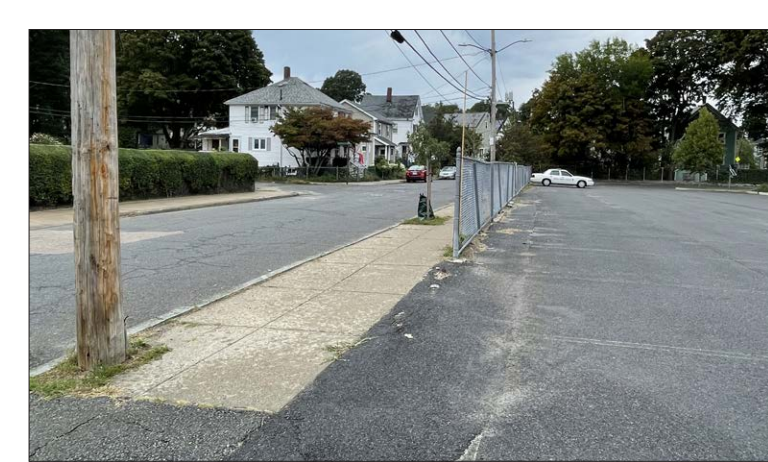
1 ASPHALT PARKING LOT
 all asphalt to get new top coat and parking to be re-stripped. Chainlink fence to be removed and replaced along Hawthorne sidewalk.

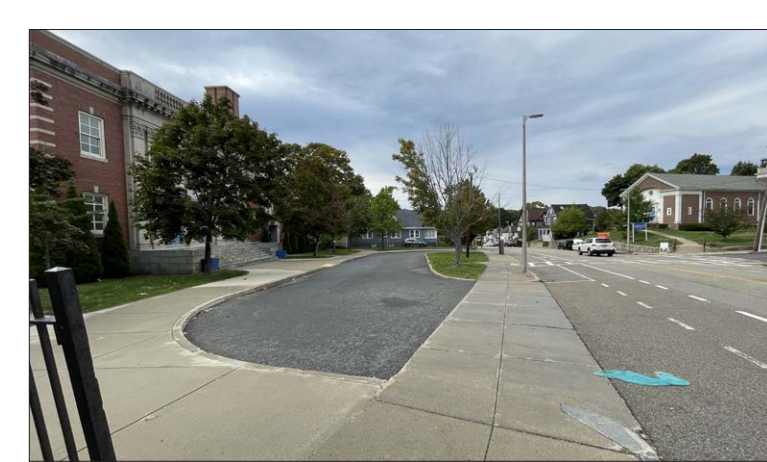
4 CUMMINS HIGHWAY ENTRY
 asphalt and concrete to be removed for accessible entry building addition and future plaza dropoff and parking

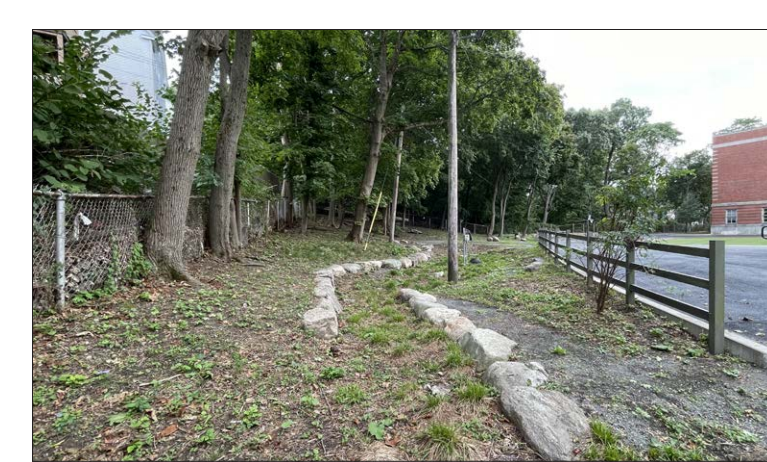
8 PLAY AREA RAIN GARDEN
 existing rain garden to be expanded and improved. Vinyl split rail fence to be removed.

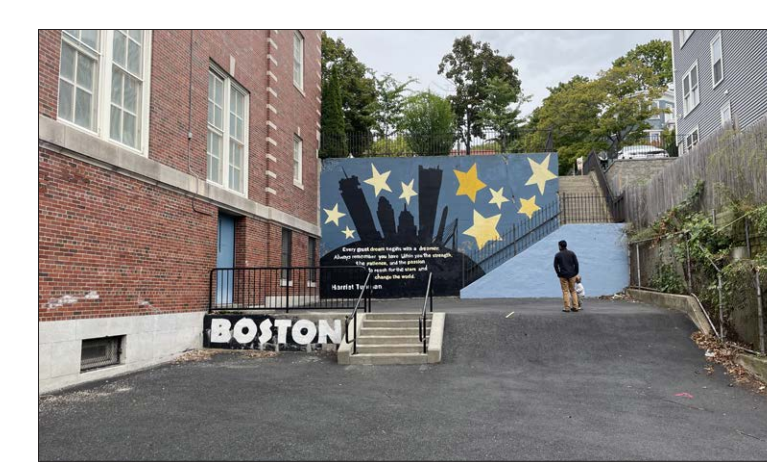
12 CONCRETE STAIRS AND ASPHALT RAMP
 stairs and ramp to be removed and replaced with sloped path through nature play. window well required at building.

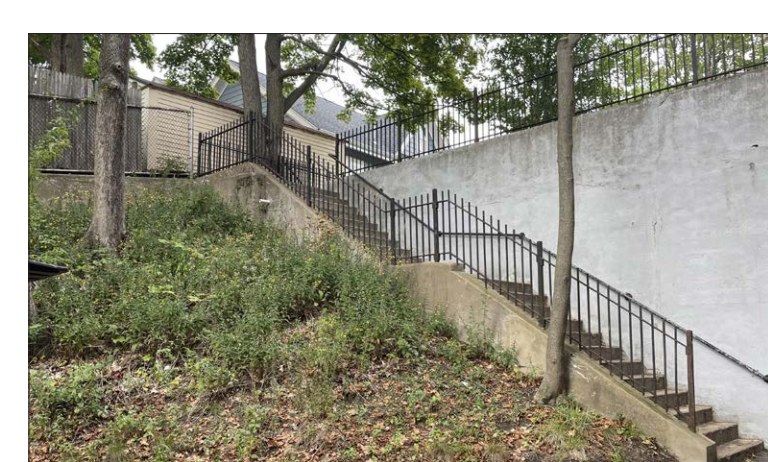
2 CONCRETE STAIRS
 stairs to be demolished and replaced to align parallel with the building. Slope to be removed and retained with a wall following the north property line.

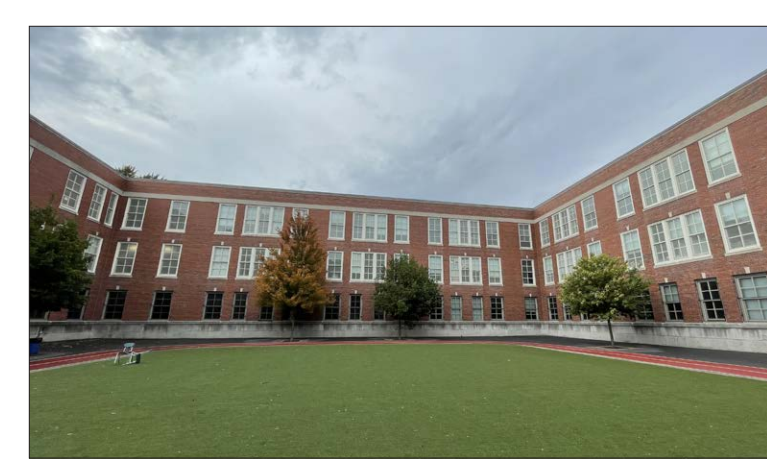
5 TURF FIELD AND RUBBER TRACK
 field and track to be removed and replaced with smaller grass field and playground structures

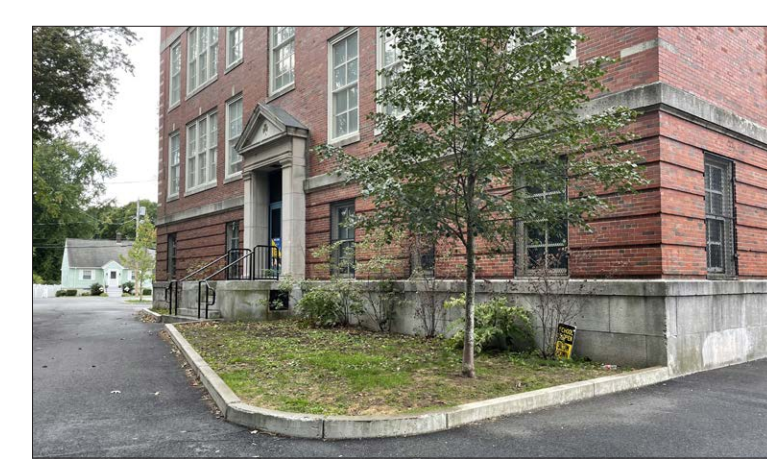
9 CURBED PLANTING
 curbed planter to be adjusted to improve fire access

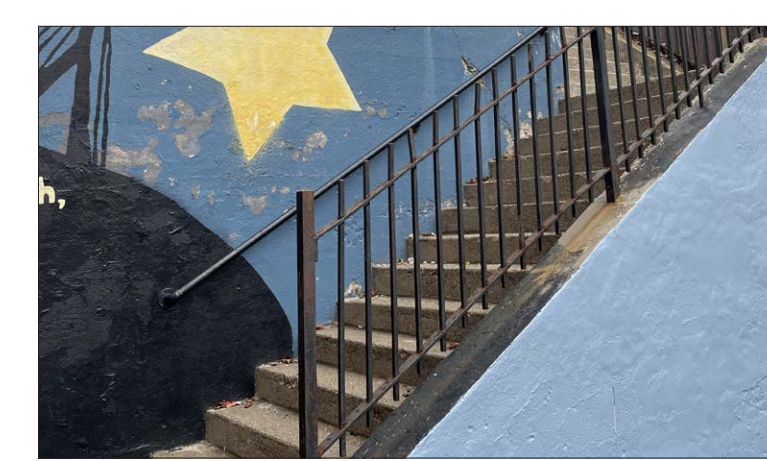
13 CONCRETE STAIRS AND WALLS
 stairs and walls to be structurally assessed and replaced in kind if deemed necessary

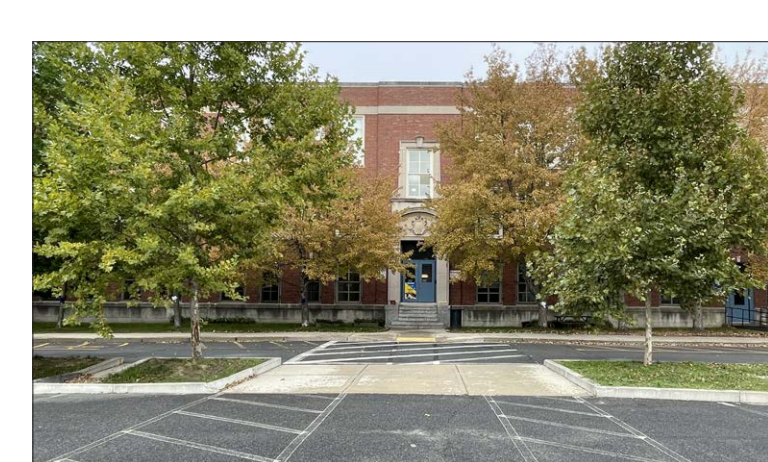
3 1ST FLOOR ENTRY
 concrete paving and accessible entry to be removed and reconfigured to meet new secure entry on NW corner

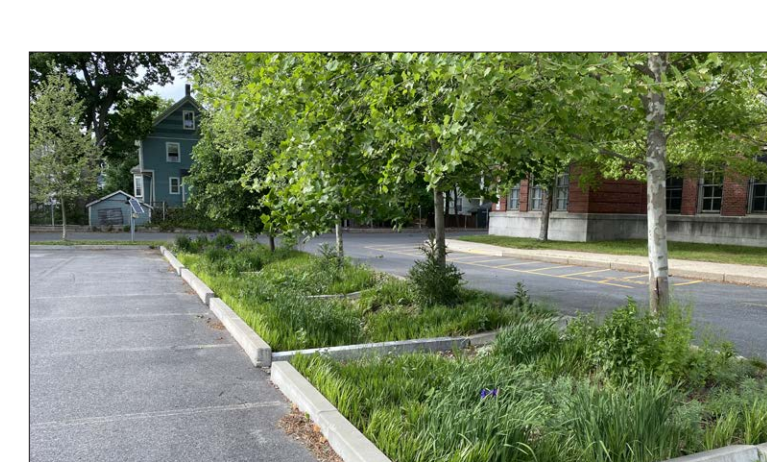
6 PARKING LOT RAIN GARDEN
 rain garden to remain and be extended along entire row of parking and bus drop off

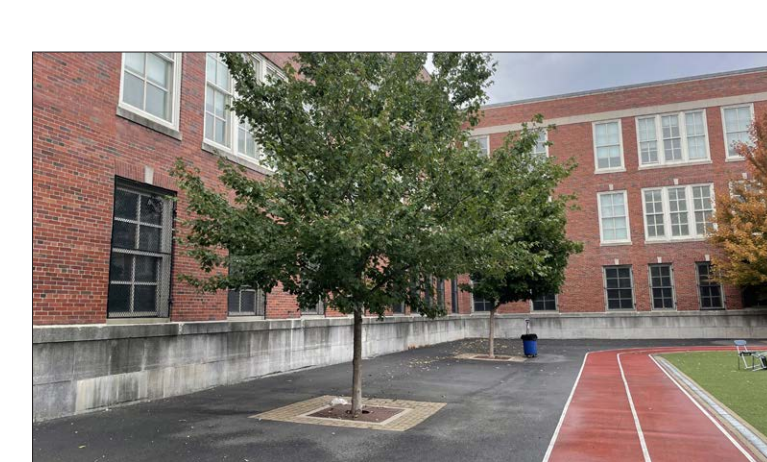
10 SHADE TREES
 deciduous trees to remain when possible in proposed plan

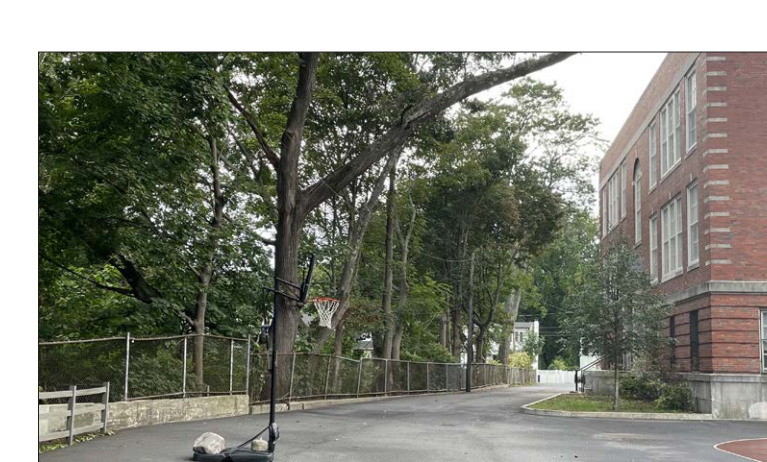
14 BASKETBALL HOOP
 movable hoop to be removed and replaced.

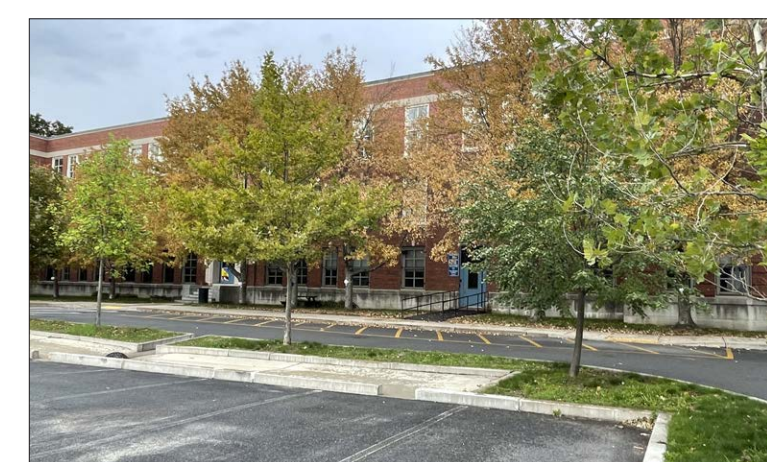
7 CONCRETE DRAINAGE BASIN
 concrete to be removed and replaced with extension of rain garden

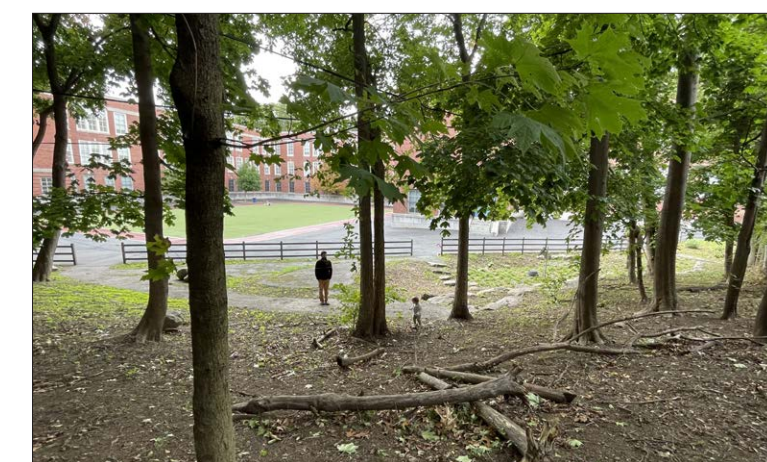
11 WOODED PLAY AREA
 canopy trees to remain and planting to be expanded as nature play area. Abandoned curbs and vinyl split rail fence at boundary to be removed.

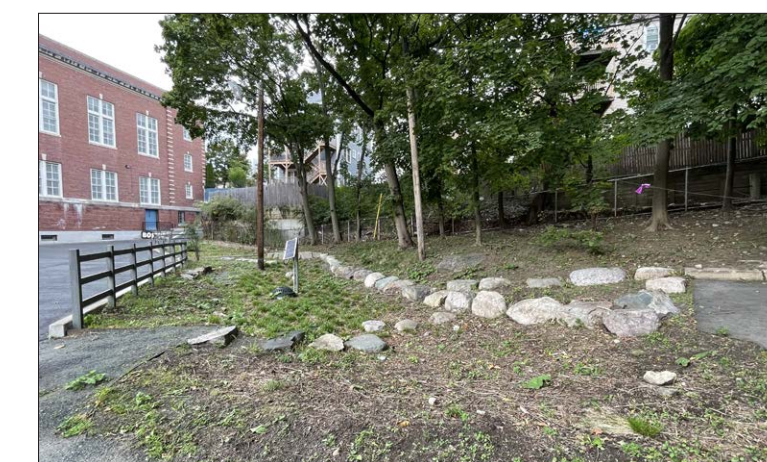
15 TELEPHONE POLES
 existing powerlines to be removed when possible. existing lights to be removed and replaced

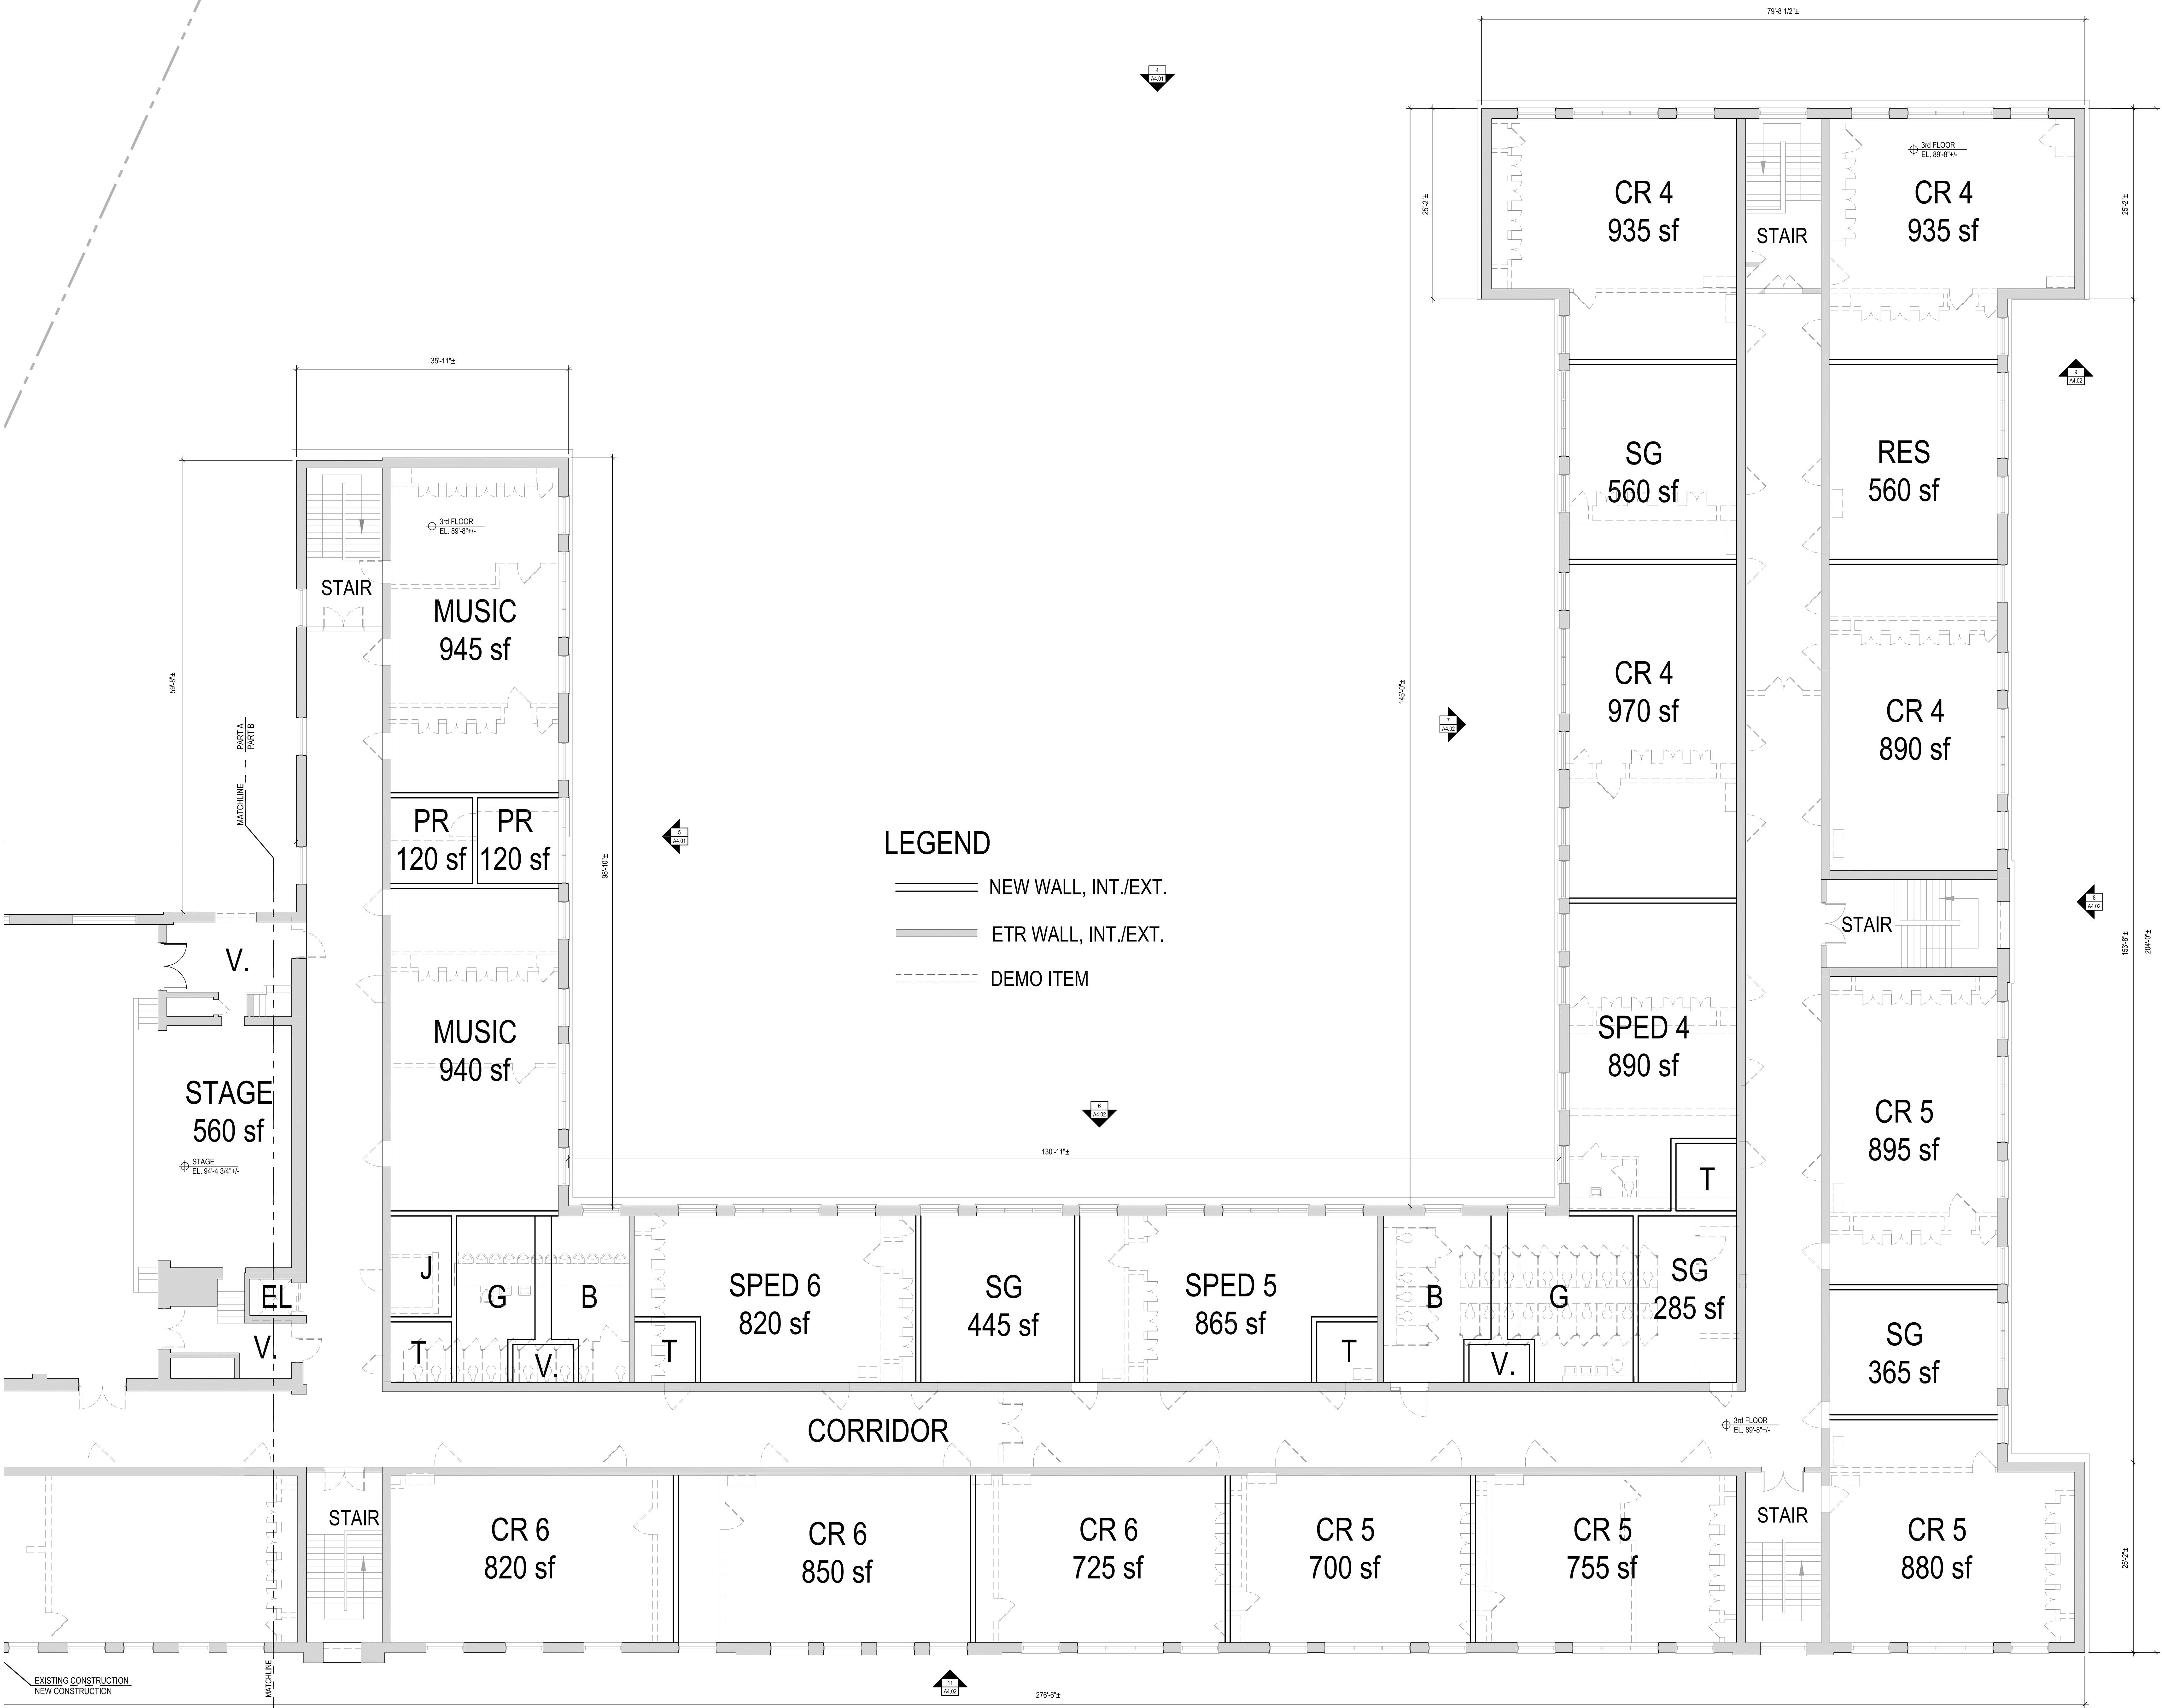
IRVING SCHOOL - THIRD FLOOR PLAN

Program Category	Use
Core Educational	
Community	
Music	
Administration	
SPED	
Toilets	
Service/Storage	
Circulation

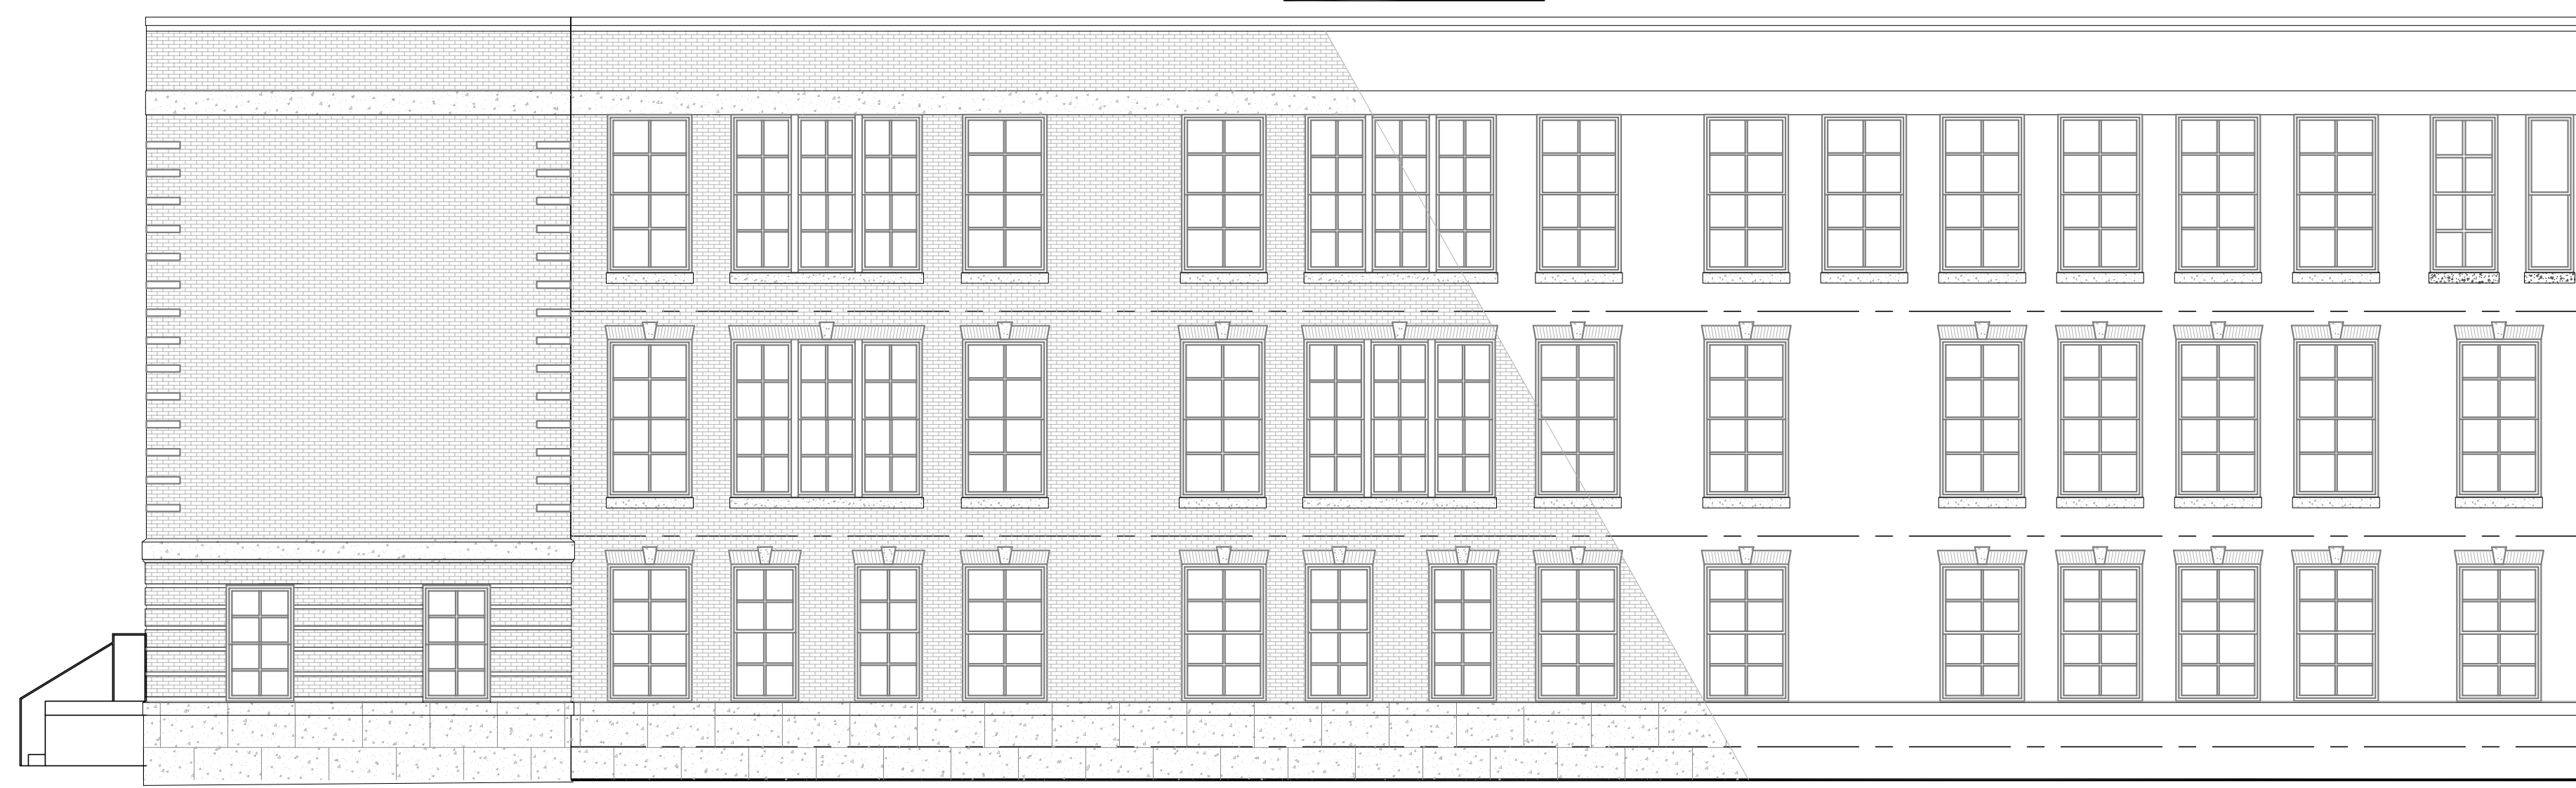
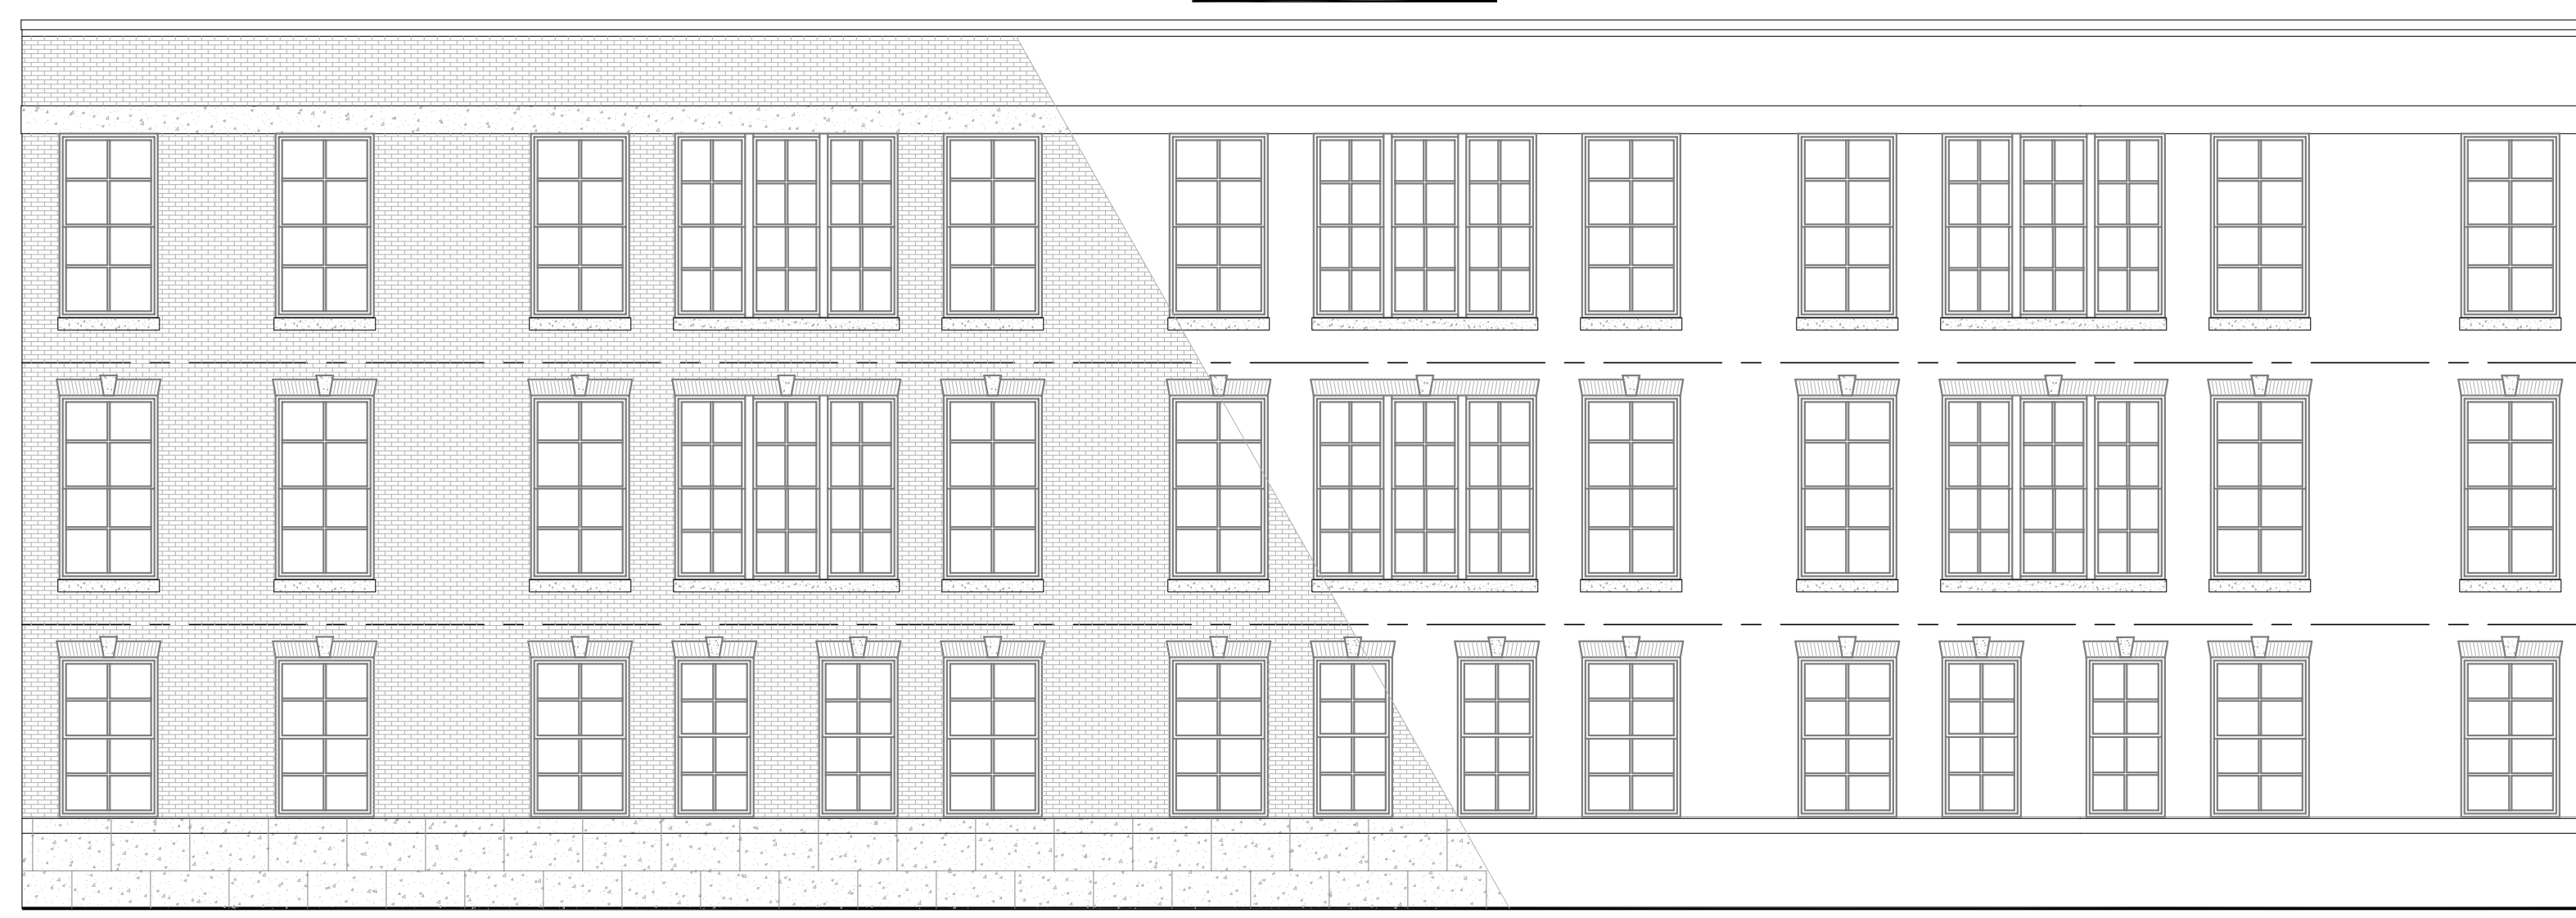
7 EXTERIOR ELEVATION - EAST, PART 'B'
SCALE: 1/8"=1'-0"

6 EXTERIOR ELEVATION - SOUTH, PART 'B'
SCALE: 1/8"=1'-0"

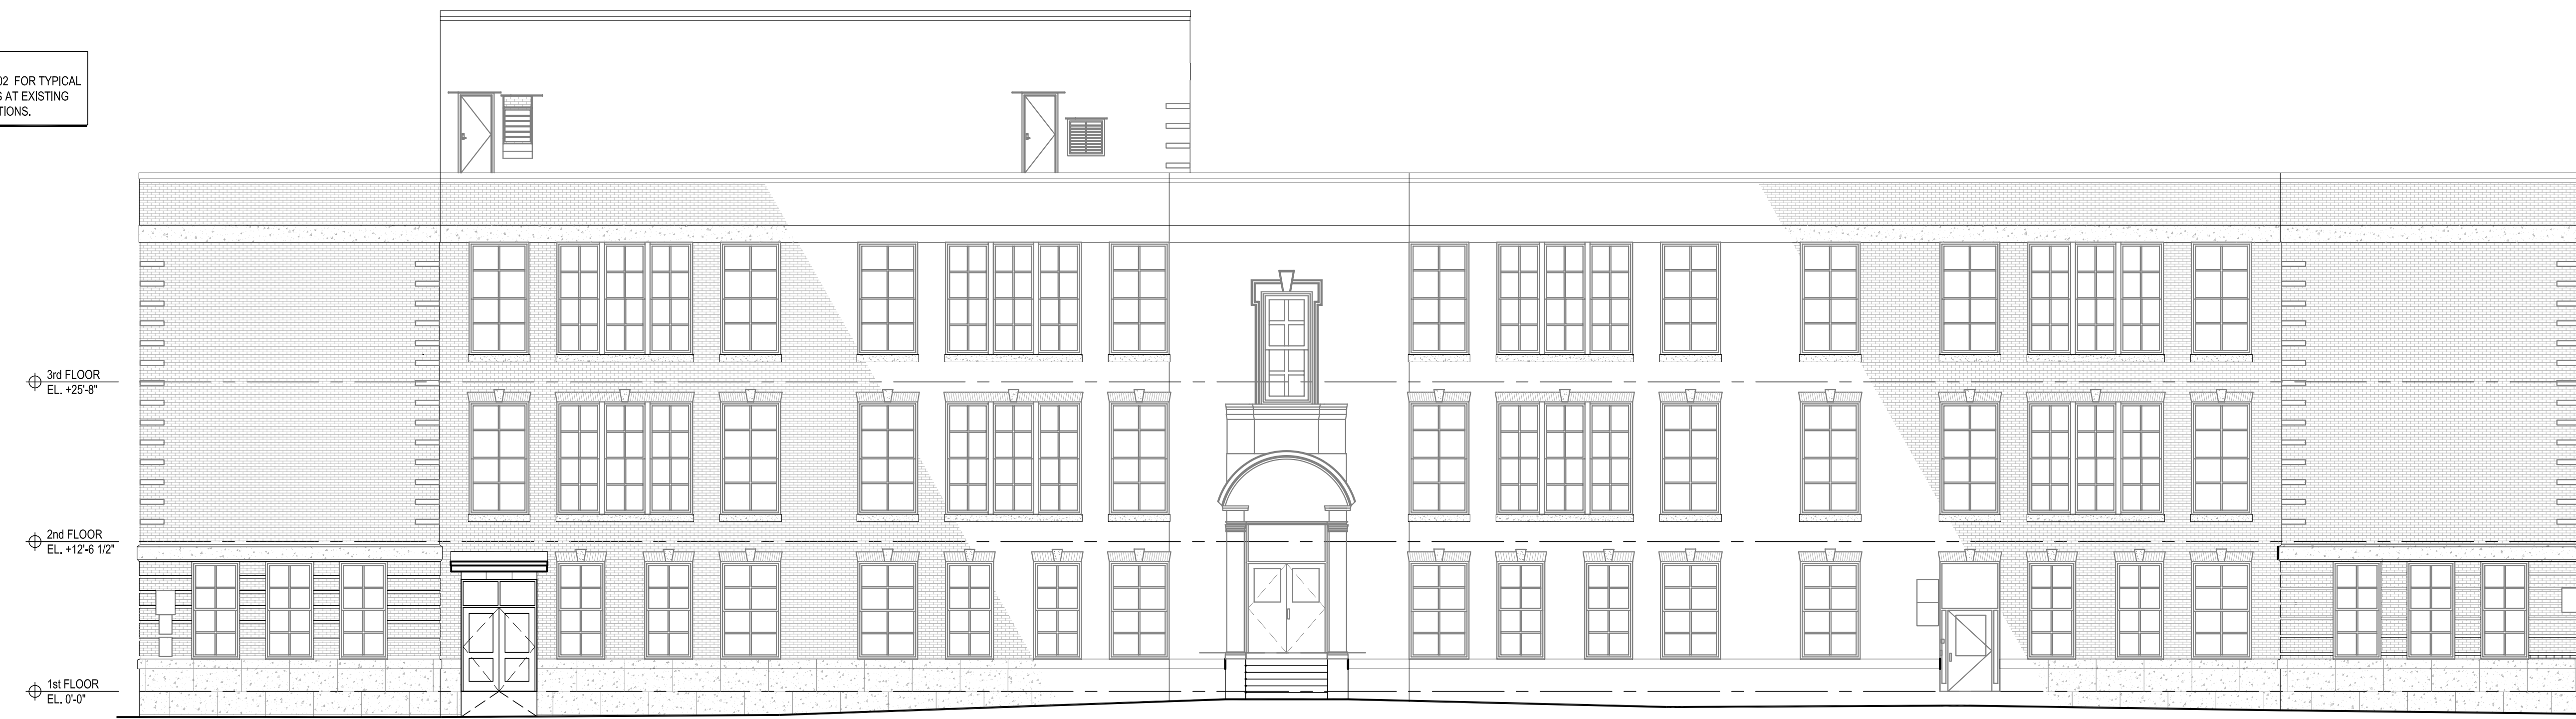
10 EXTERIOR ELEVATION - WEST, PART 'A'
SCALE: 1/8"=1'-0"

9 EXTERIOR ELEVATION - NORTH, PART 'B'
SCALE: 1/8"=1'-0"
