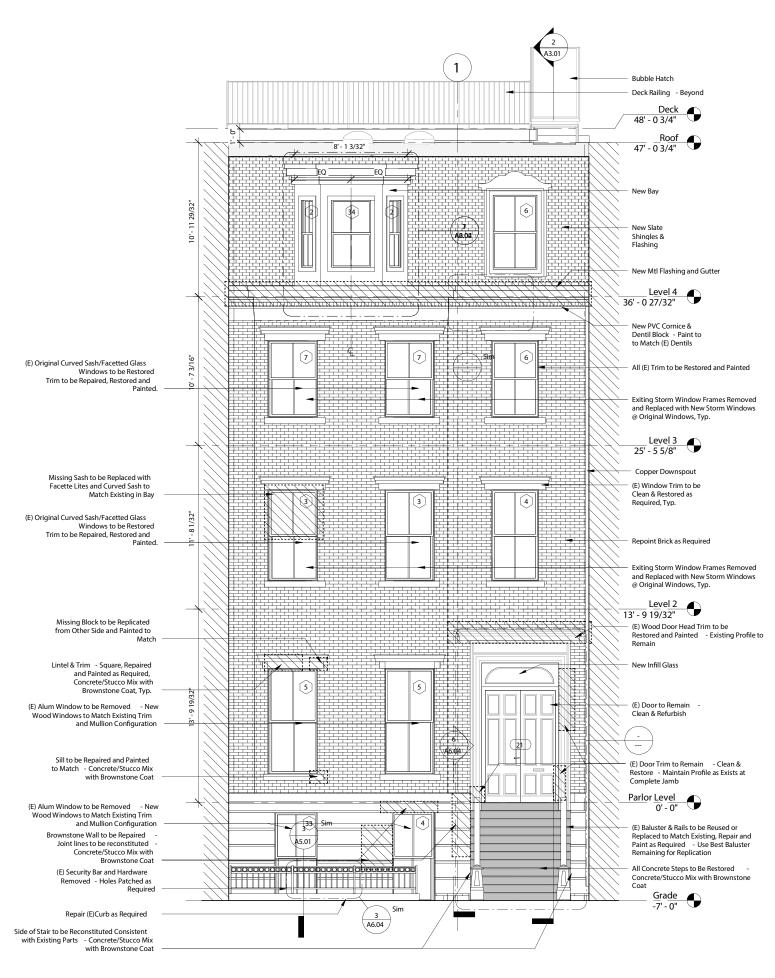
#### Windows:

The windows on level 2 and 3 are original windows with curved sashes w/ factted lites at center mullion. Windows will be restored and a clear storm window will be installed in front in front of existing, with horizontal muntin to alignt with middle sash.

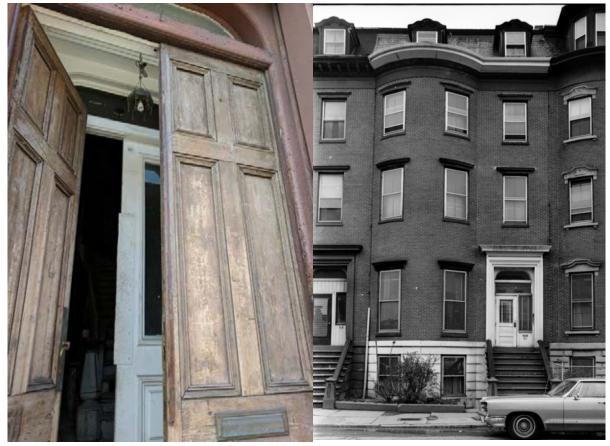
Door:

### Door is not original - We will repair if possible or replace as indicated

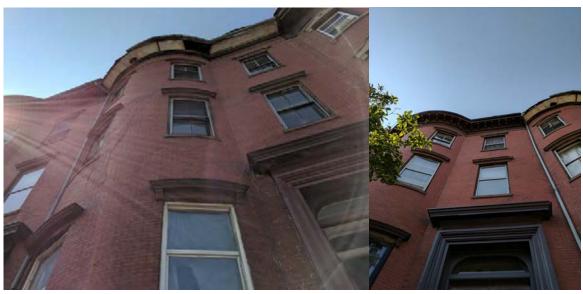
**Existing Cornice Non-existent**

515 Mass Cornice to be Replicated

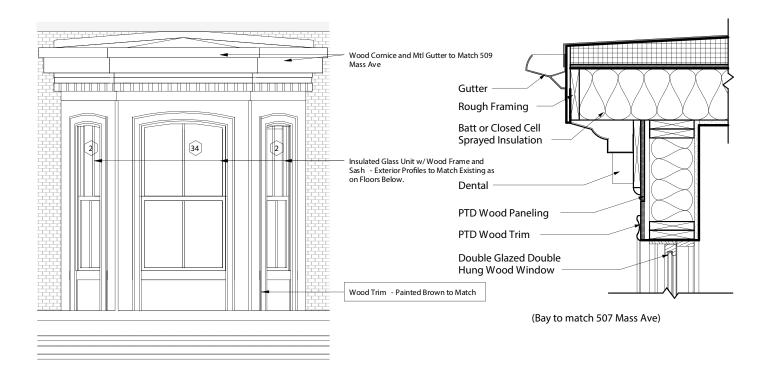
Bay Windows @ 507 Mass Ave - Will Replicate
