SOUTH END LANDMARKS DISTRICT COMMISSION PRESENTATION | 12.7.2021

10 UNION PARK

UNION PARK FAÇADE REPAIR AND REHABILITATION

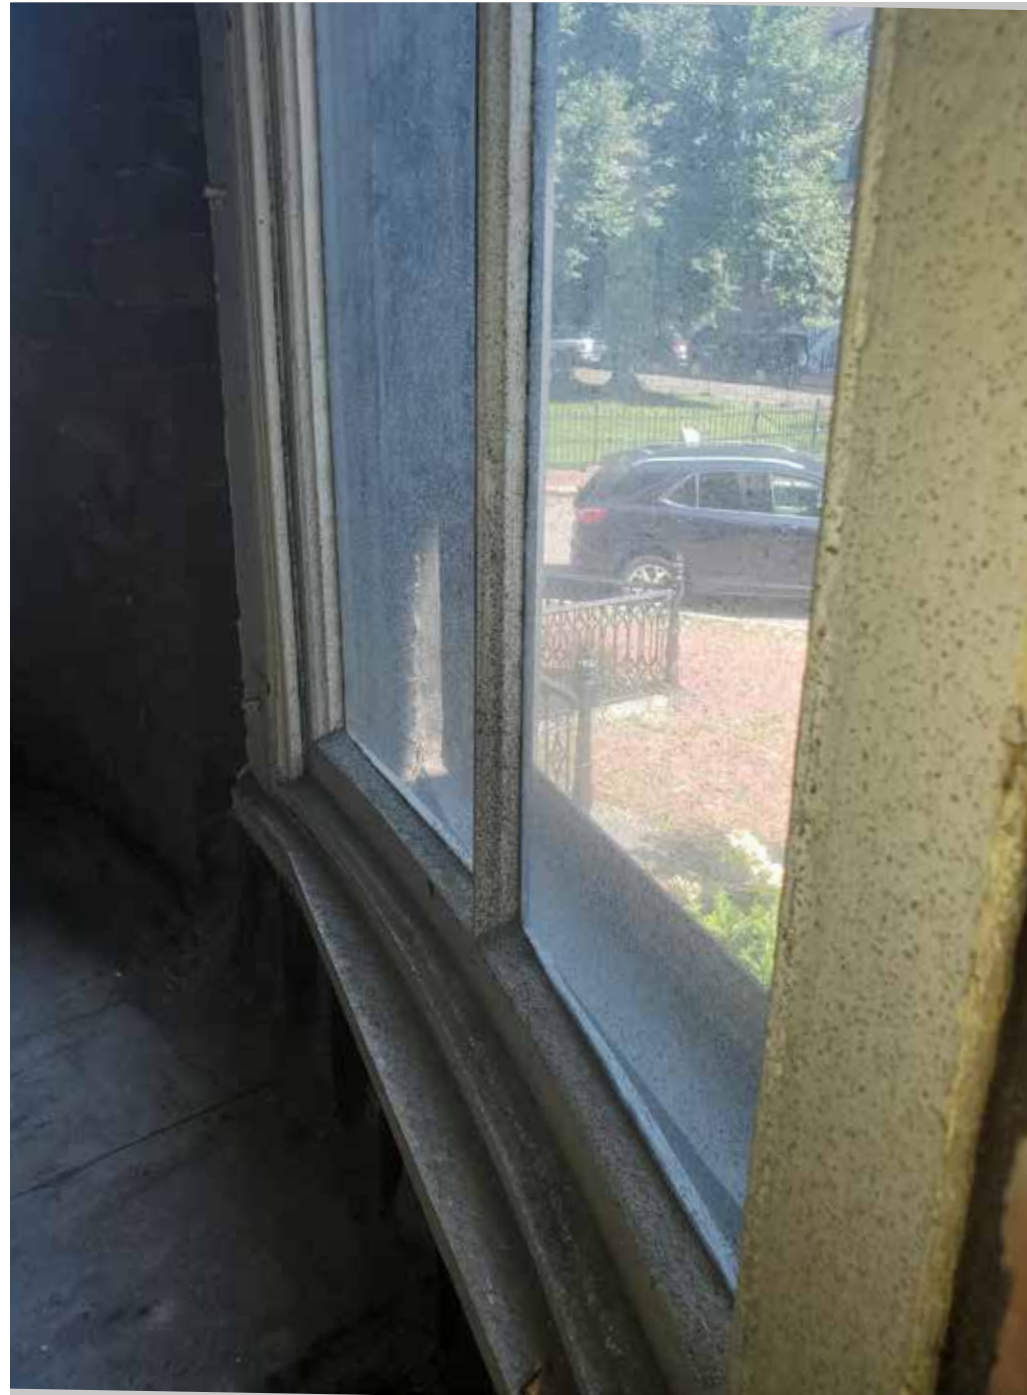
UNION PARK - PARLOR LEVEL WINDOWS

SEPTEMBER 27, 2021 STAFF SITE VISIT
CONFIRMED: **PARLOR LEVEL WINDOWS WITH CURVED SASHES & FLAT GLASS ARE ONLY ORIGINAL WINDOWS IN FRONT FACADE.**

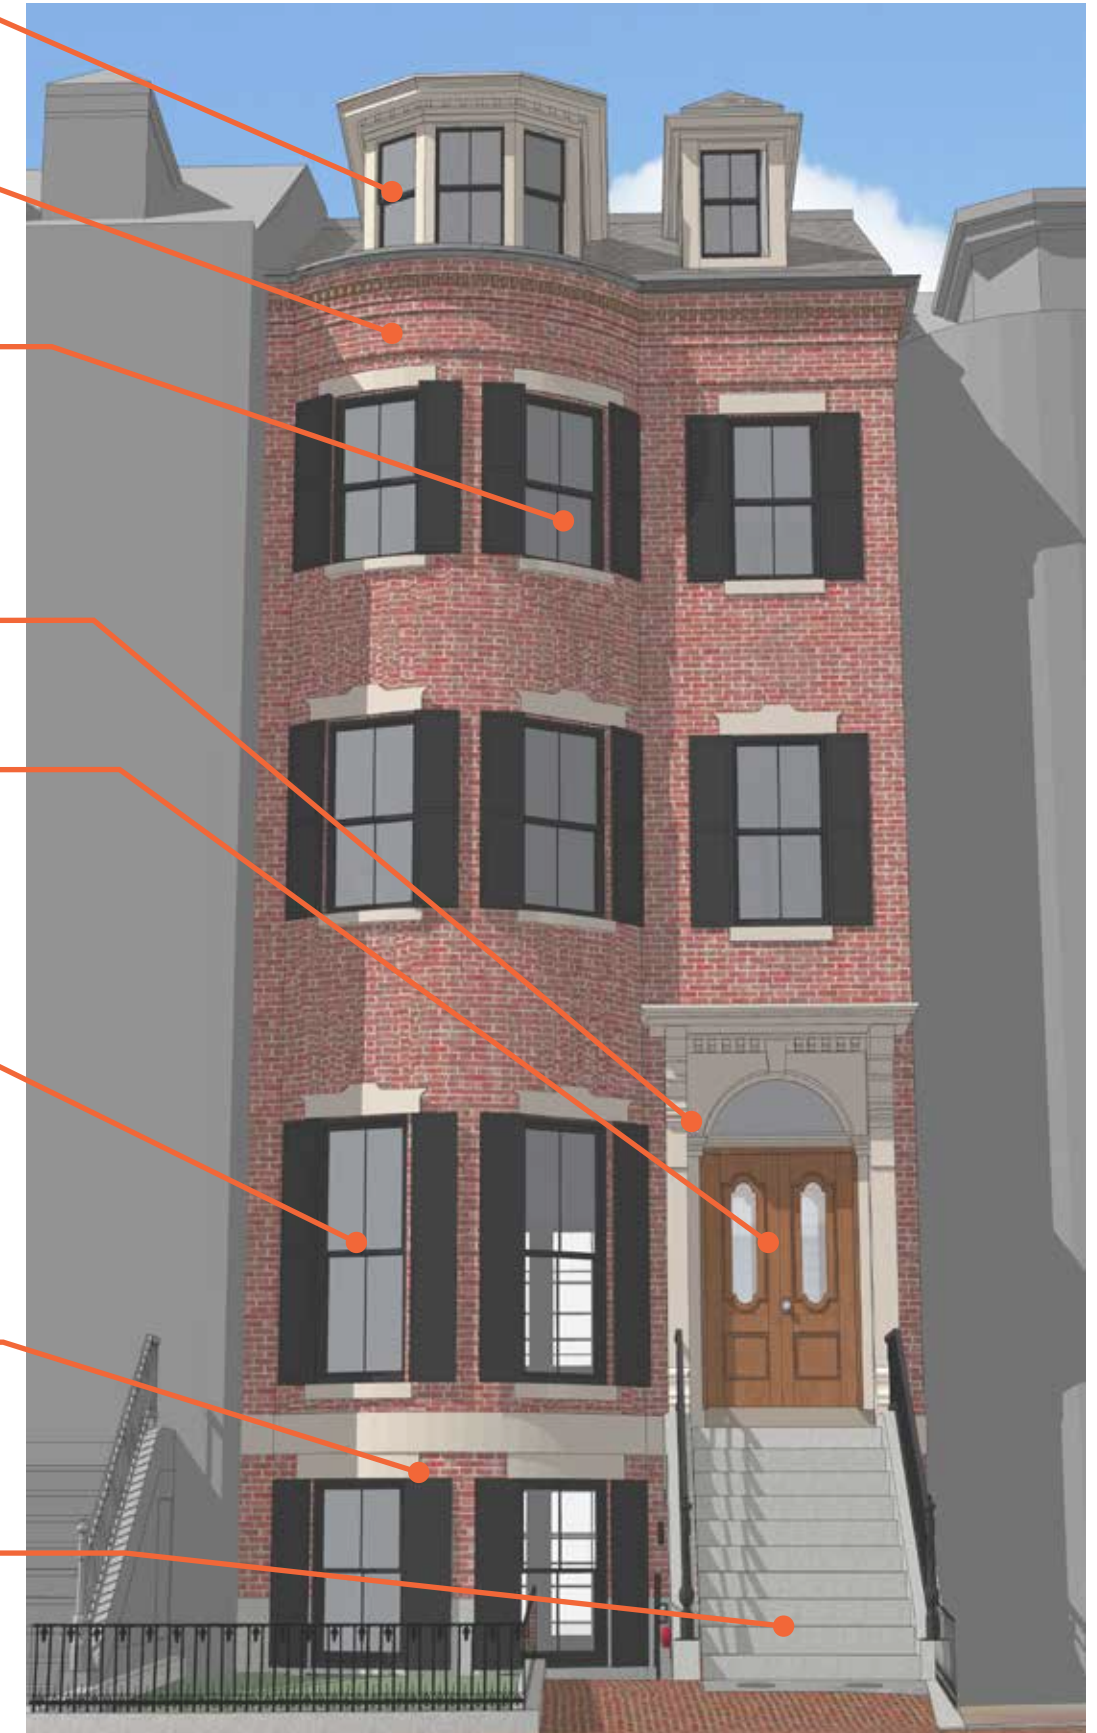
UNION PARK FAÇADE - PROPOSED

ROOF, DORMER, GUTTER REPAIR

BRICK AND STONE REPAIR

NEW HISTORICALLY APPROPRIATE WOOD WINDOWS WITH INSULATED GLAZING - ALL WINDOWS EXCEPT PARLOR LEVEL

NEW BFD STROBE IN EXISTING LOCATION

NEW HISTORICALLY APPROPRIATE ENTRY DOORS AT OUTER DOOR POSITION - TO MATCH EXISTING INNER DOORS

REFURBISH 2 ORIGINAL PARLOR LEVEL BOW WINDOWS - REFURBISH EXTERIOR STORM WINDOWS

NEW SHUTTERS AT STREET LEVEL WINDOWS ON EXISTING PINTLES

CLEAN AND REPAIR EXISTING GRANITE STOOP

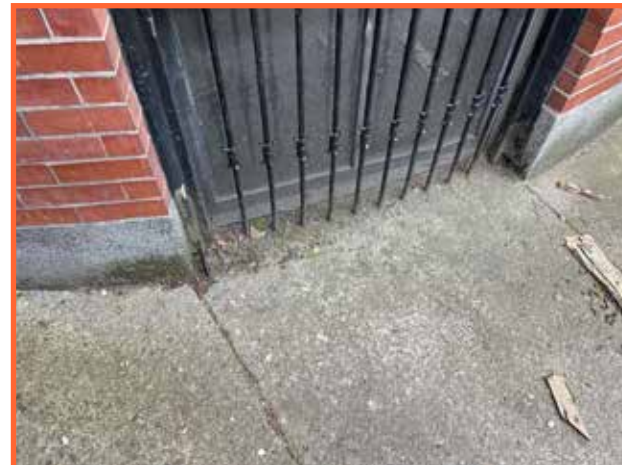
REMOVE SLAB @ BOW

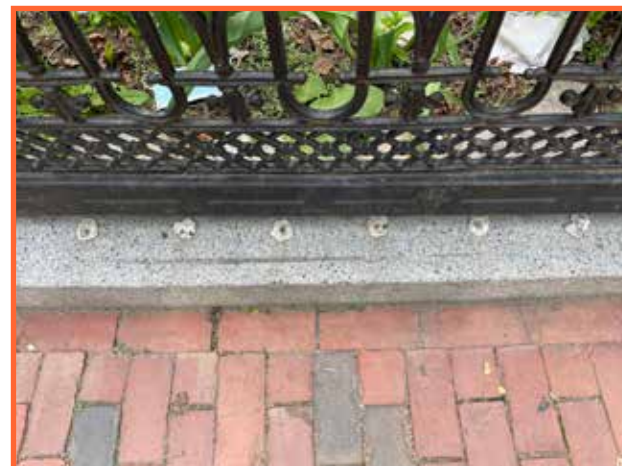
REPAIR HOLES IN GRANITE

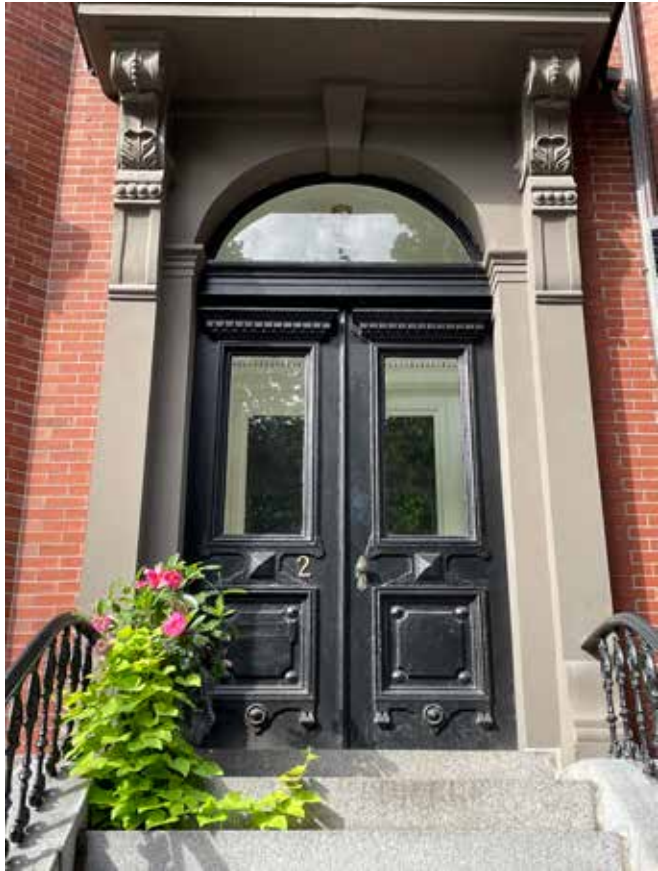
2 UNION PARK

- DOES NOT MATCH 4, 6, 8

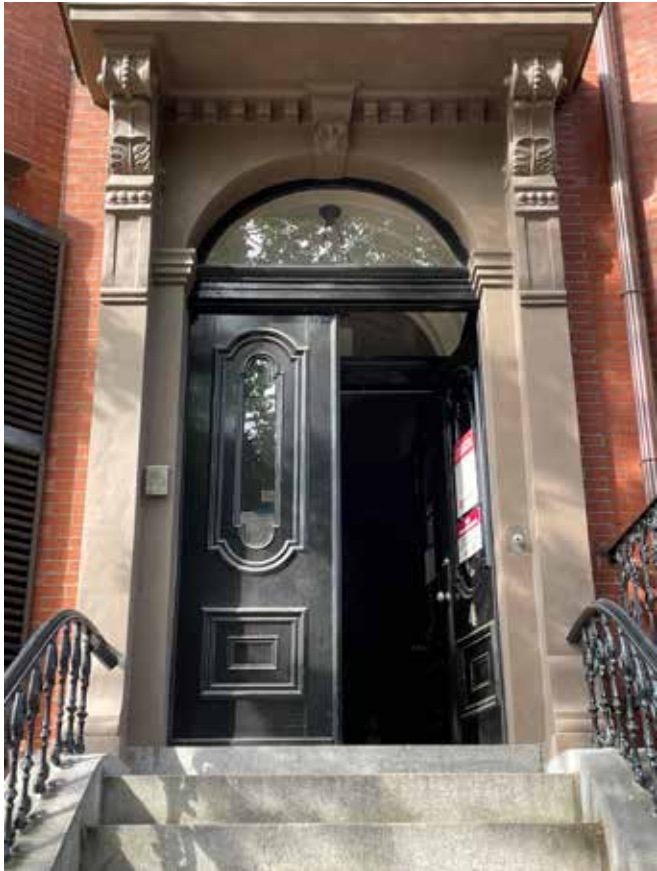
4 UNION PARK

- CLOSEST MATCH TO EXISTING #10 INNER DOORS

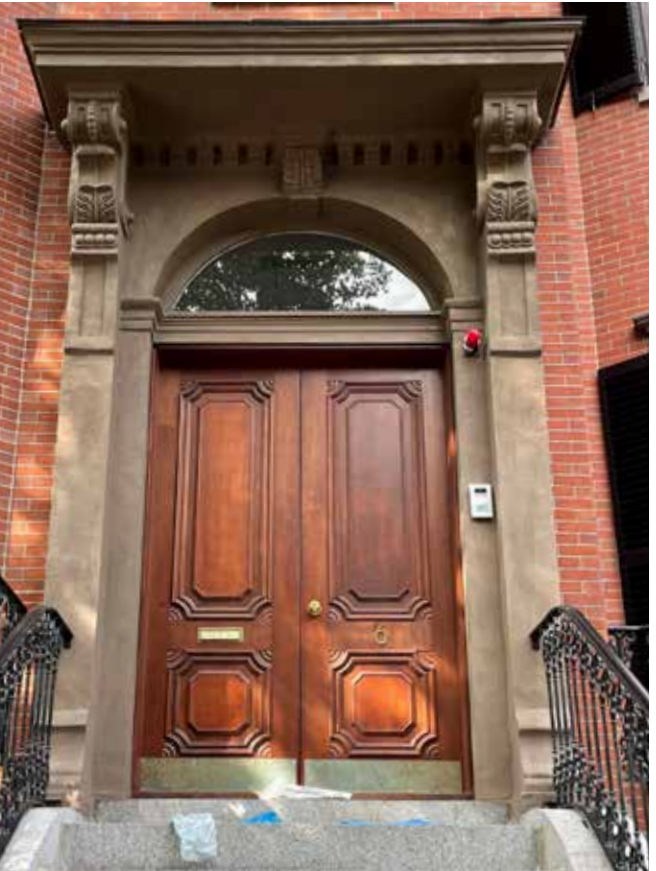
6 UNION PARK

- NO LITE IN DOORS

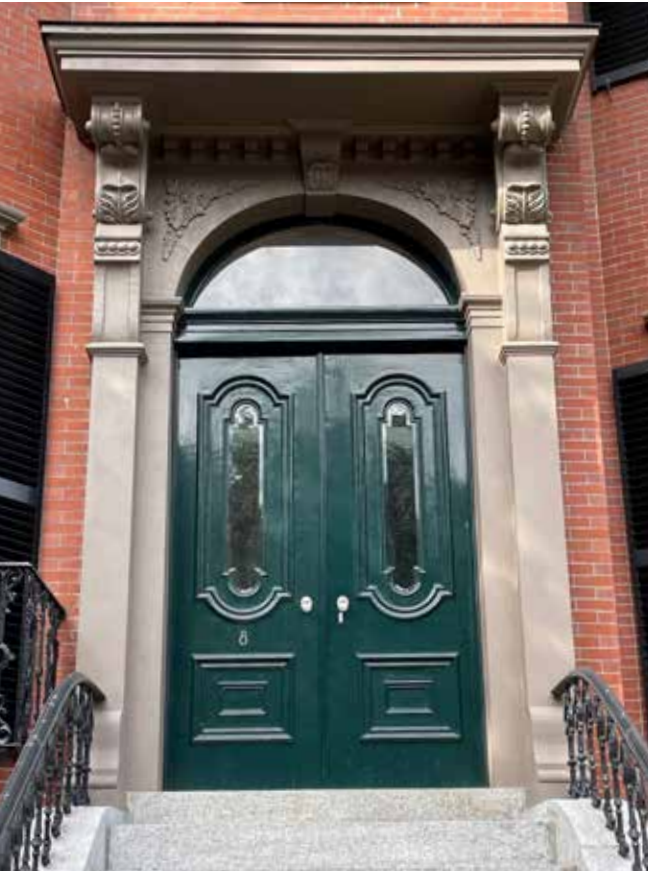
8 UNION PARK

- CLOSE MATCH TO #10 INNER DOORS

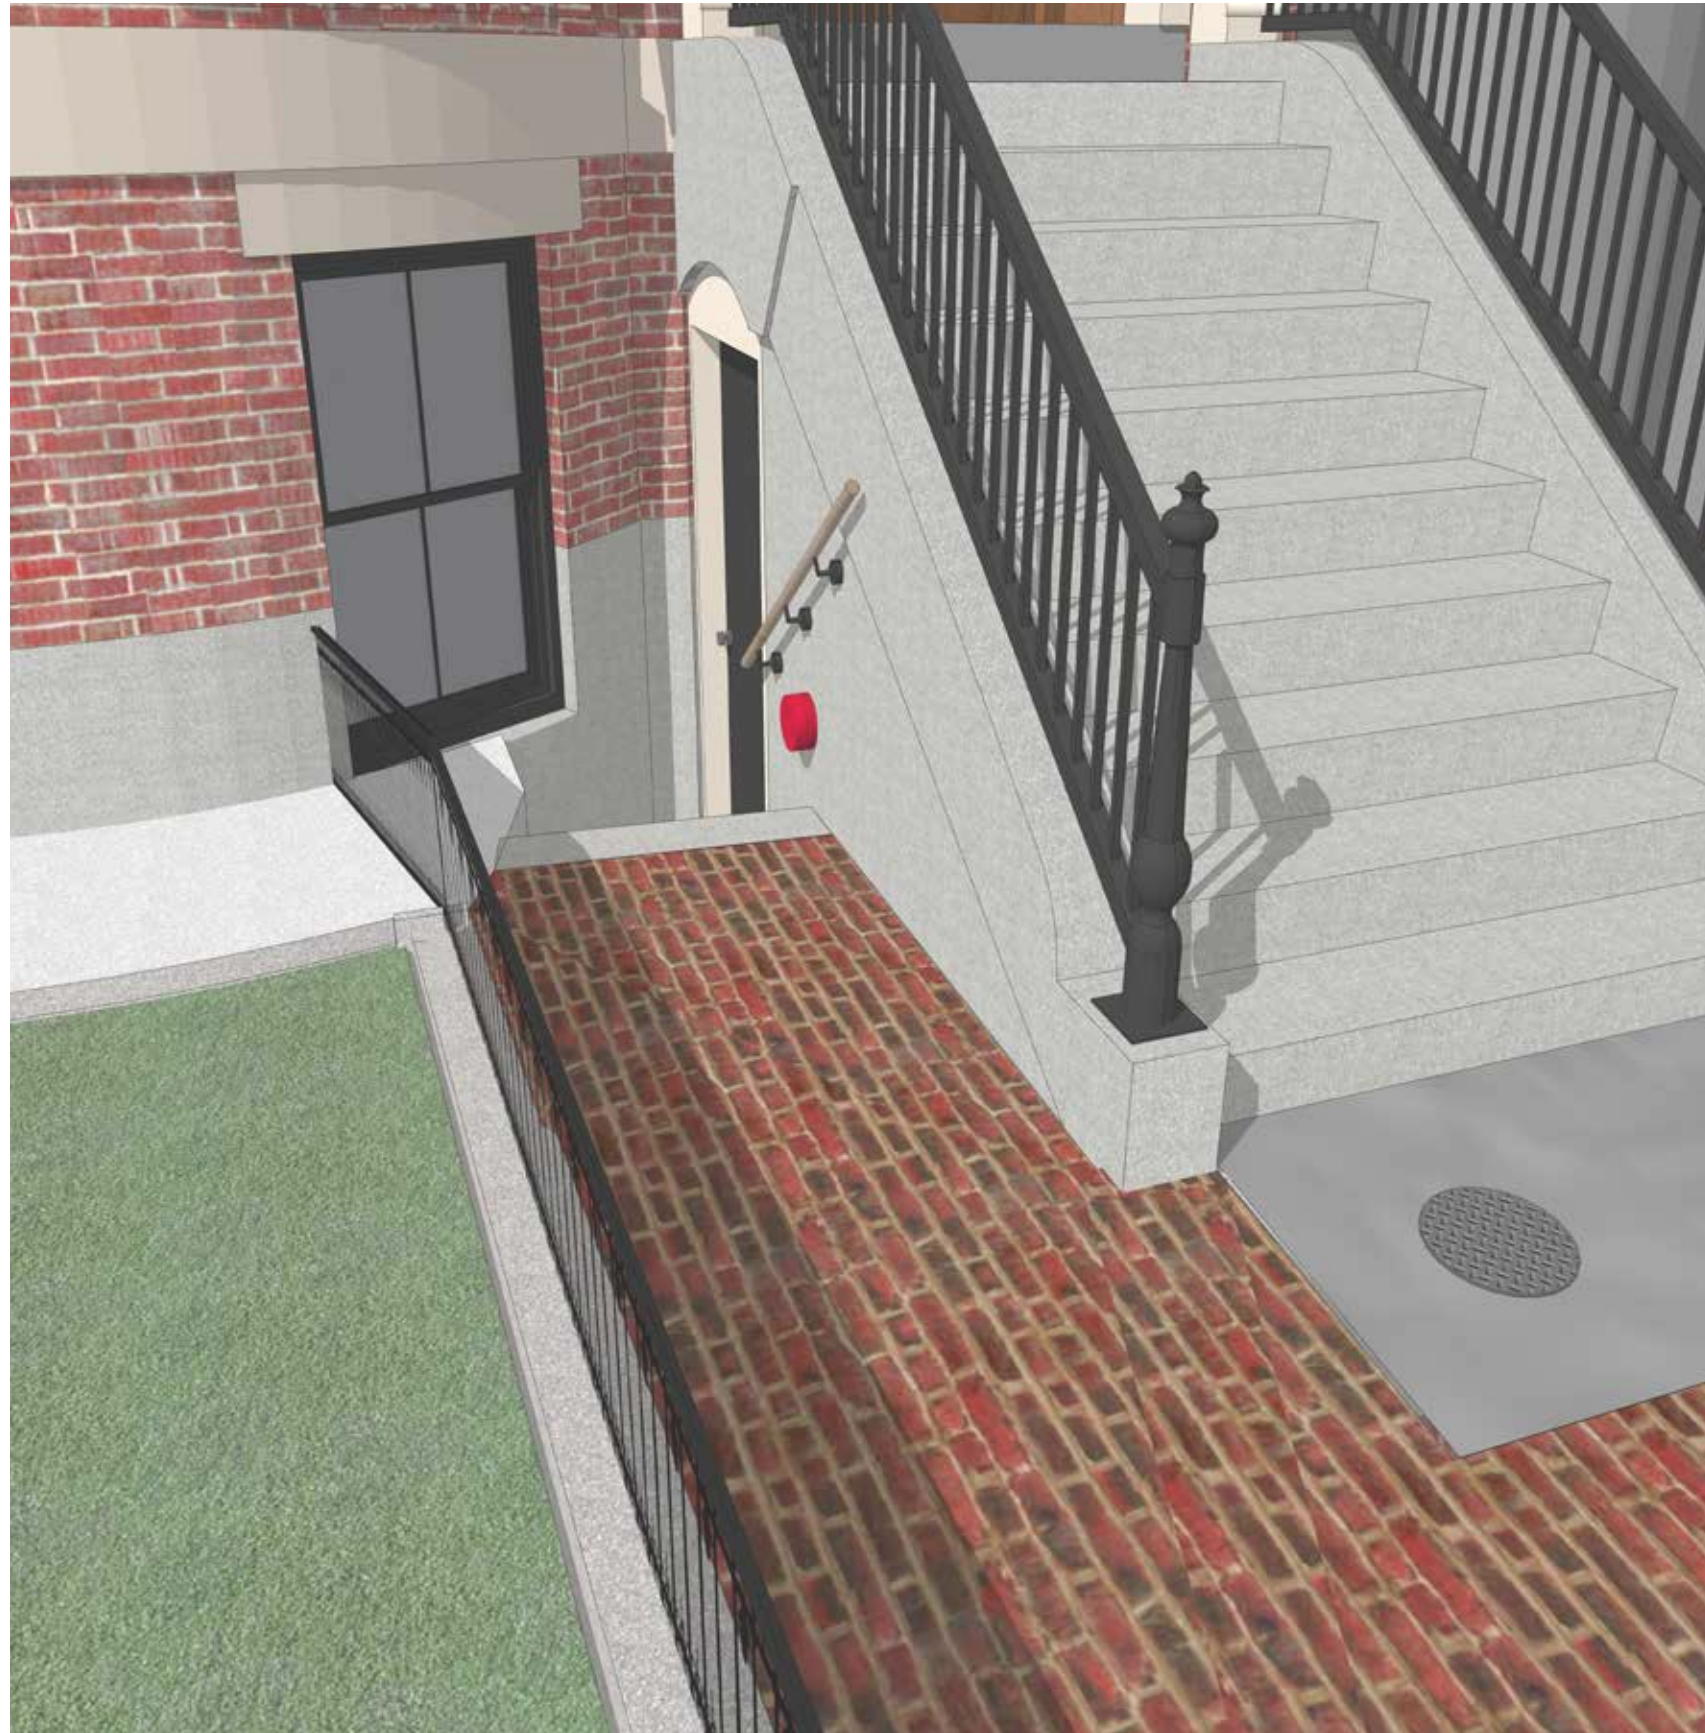
STREET LEVEL STEPS - EXISTING

EXISTING CHALLENGES:

- CONCRETE REDUCES WIDTH
- TINY, IRREGULAR LANDING
- STEEP, IRREGULAR STEPS
- POOR DRAINAGE

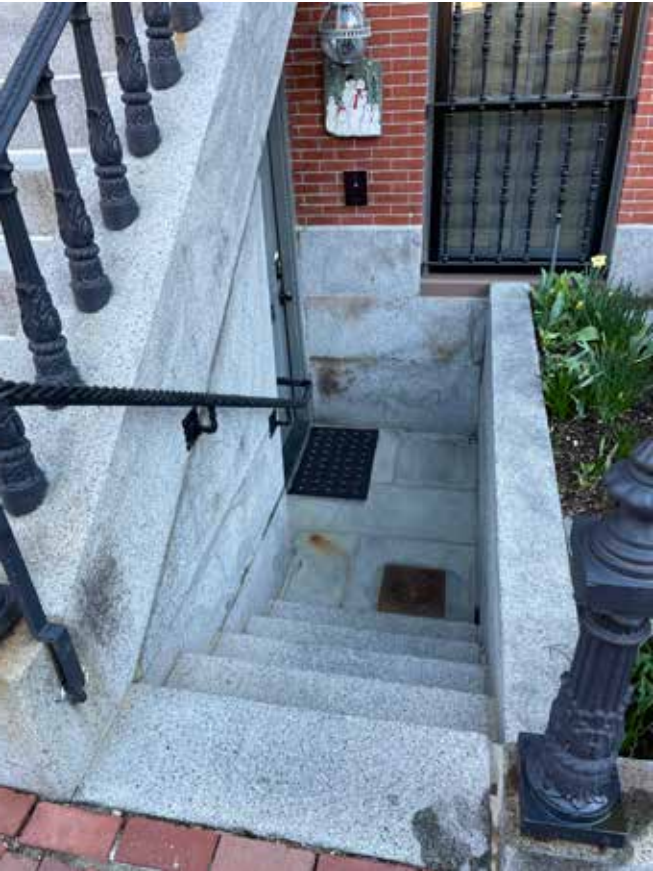
17 UNION PARK

- STEPS ALIGN WITH STOOP GRANITE
- LARGE LANDING AT STREET LEVEL DOOR

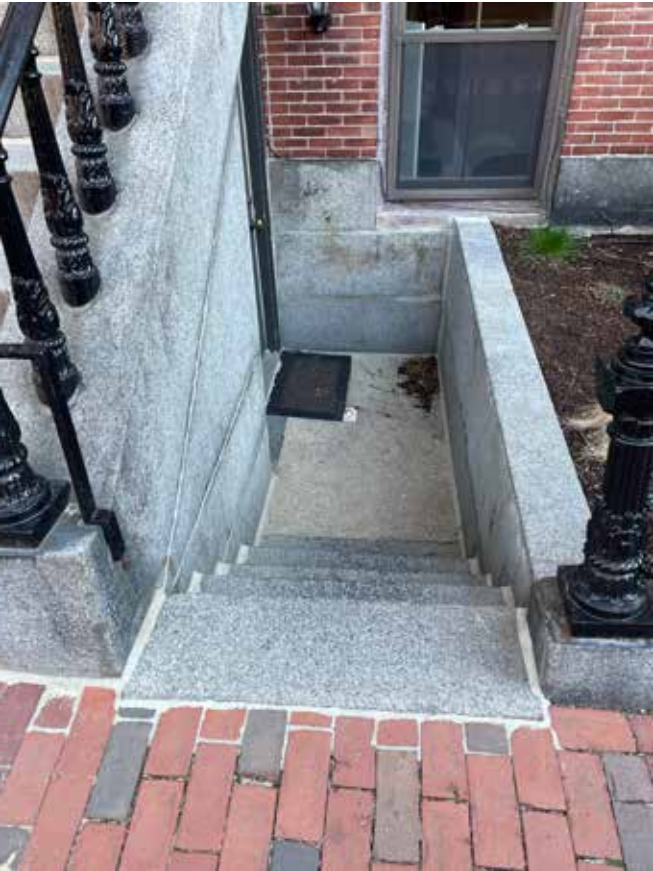
19 UNION PARK

- STEPS ALIGN WITH STOOP GRANITE
- LARGE LANDING AT STREET LEVEL DOOR

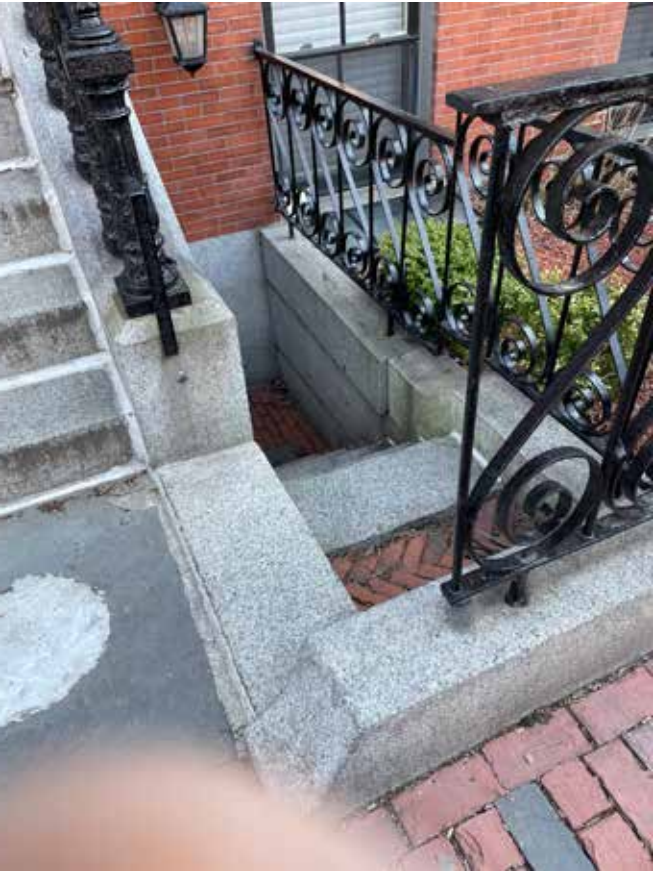
21 UNION PARK

- STEPS ALIGN WITH STOOP STREET LANDING
- LANDING AT TOP OF STEPS

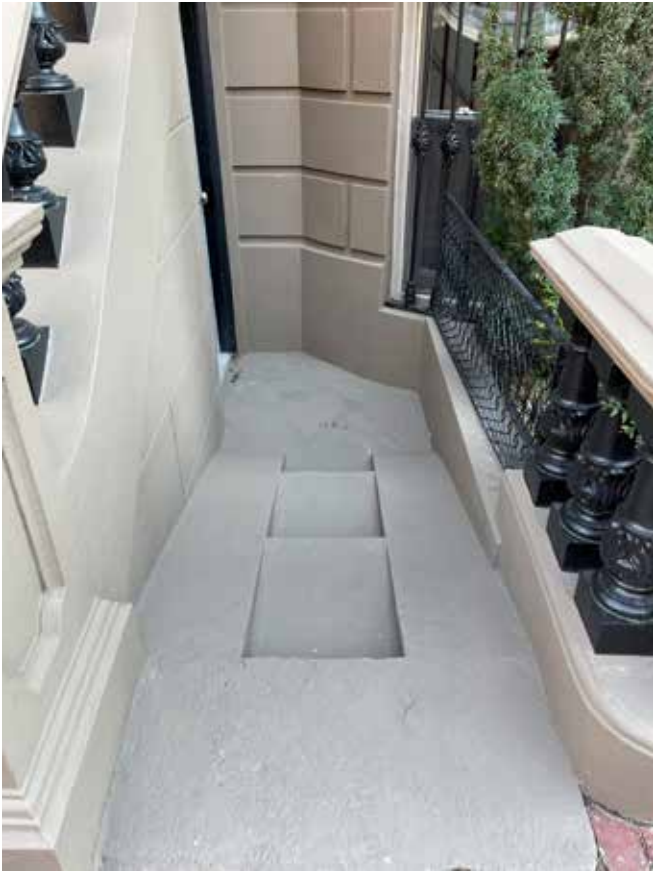
37 UNION PARK

- STEPS ALIGN WITH STOOP GRANITE
- INTEGRATED RAMP
- LARGE LANDING AT STREET LEVEL DOOR

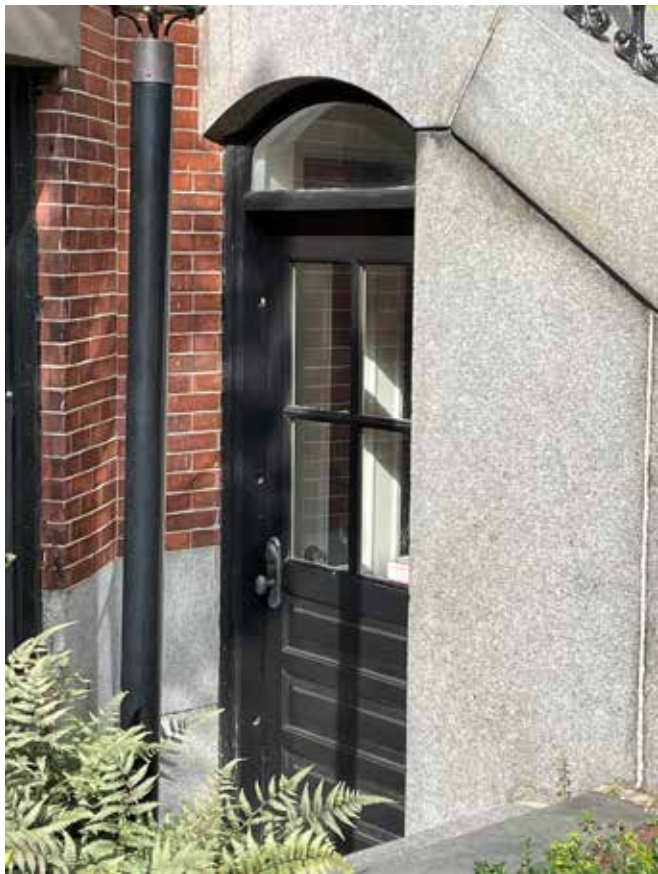
2 UNION PARK

- GLAZED TRANSOM

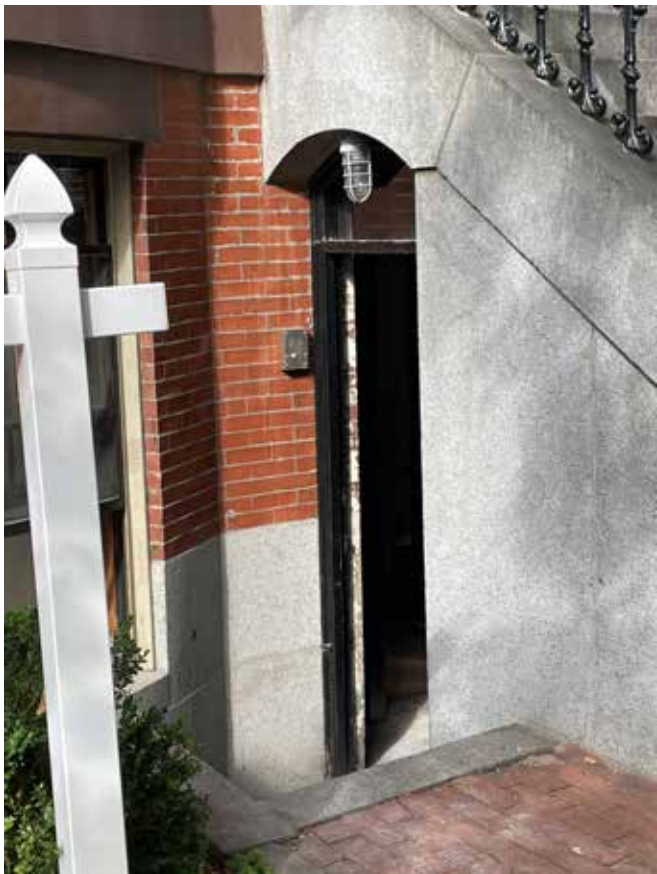
4 UNION PARK

- GLAZED TRANSOM

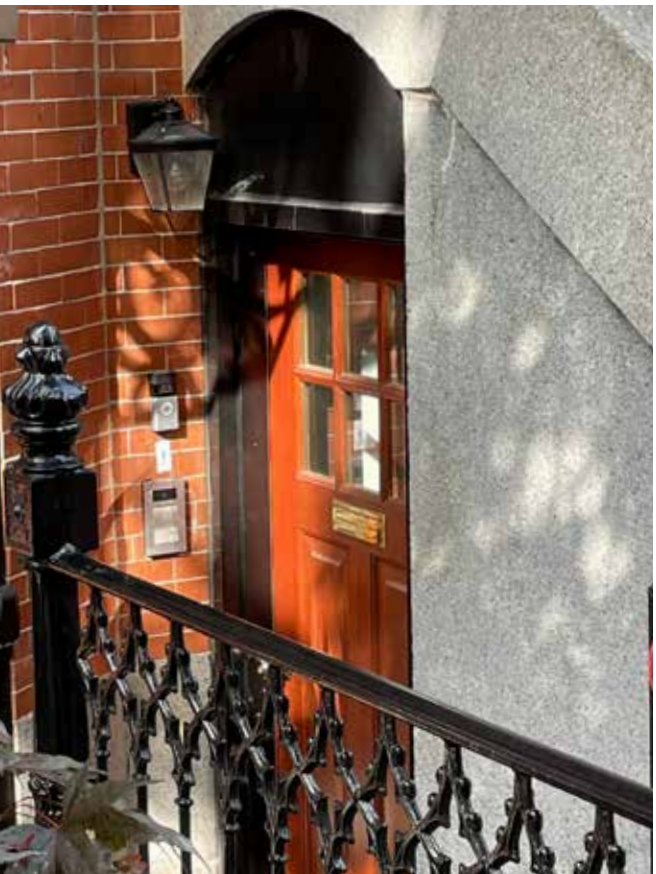
6 UNION PARK

- PRECEDENT FOR LIGHT AND ENTRY KEYPAD LOCATION

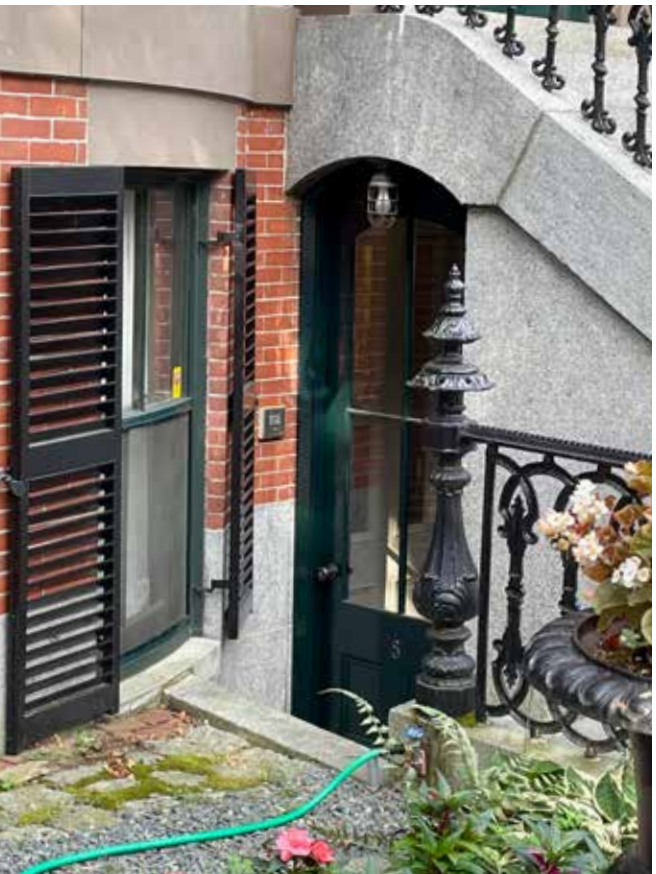
8 UNION PARK

- GLAZED, BOWTOP DOOR

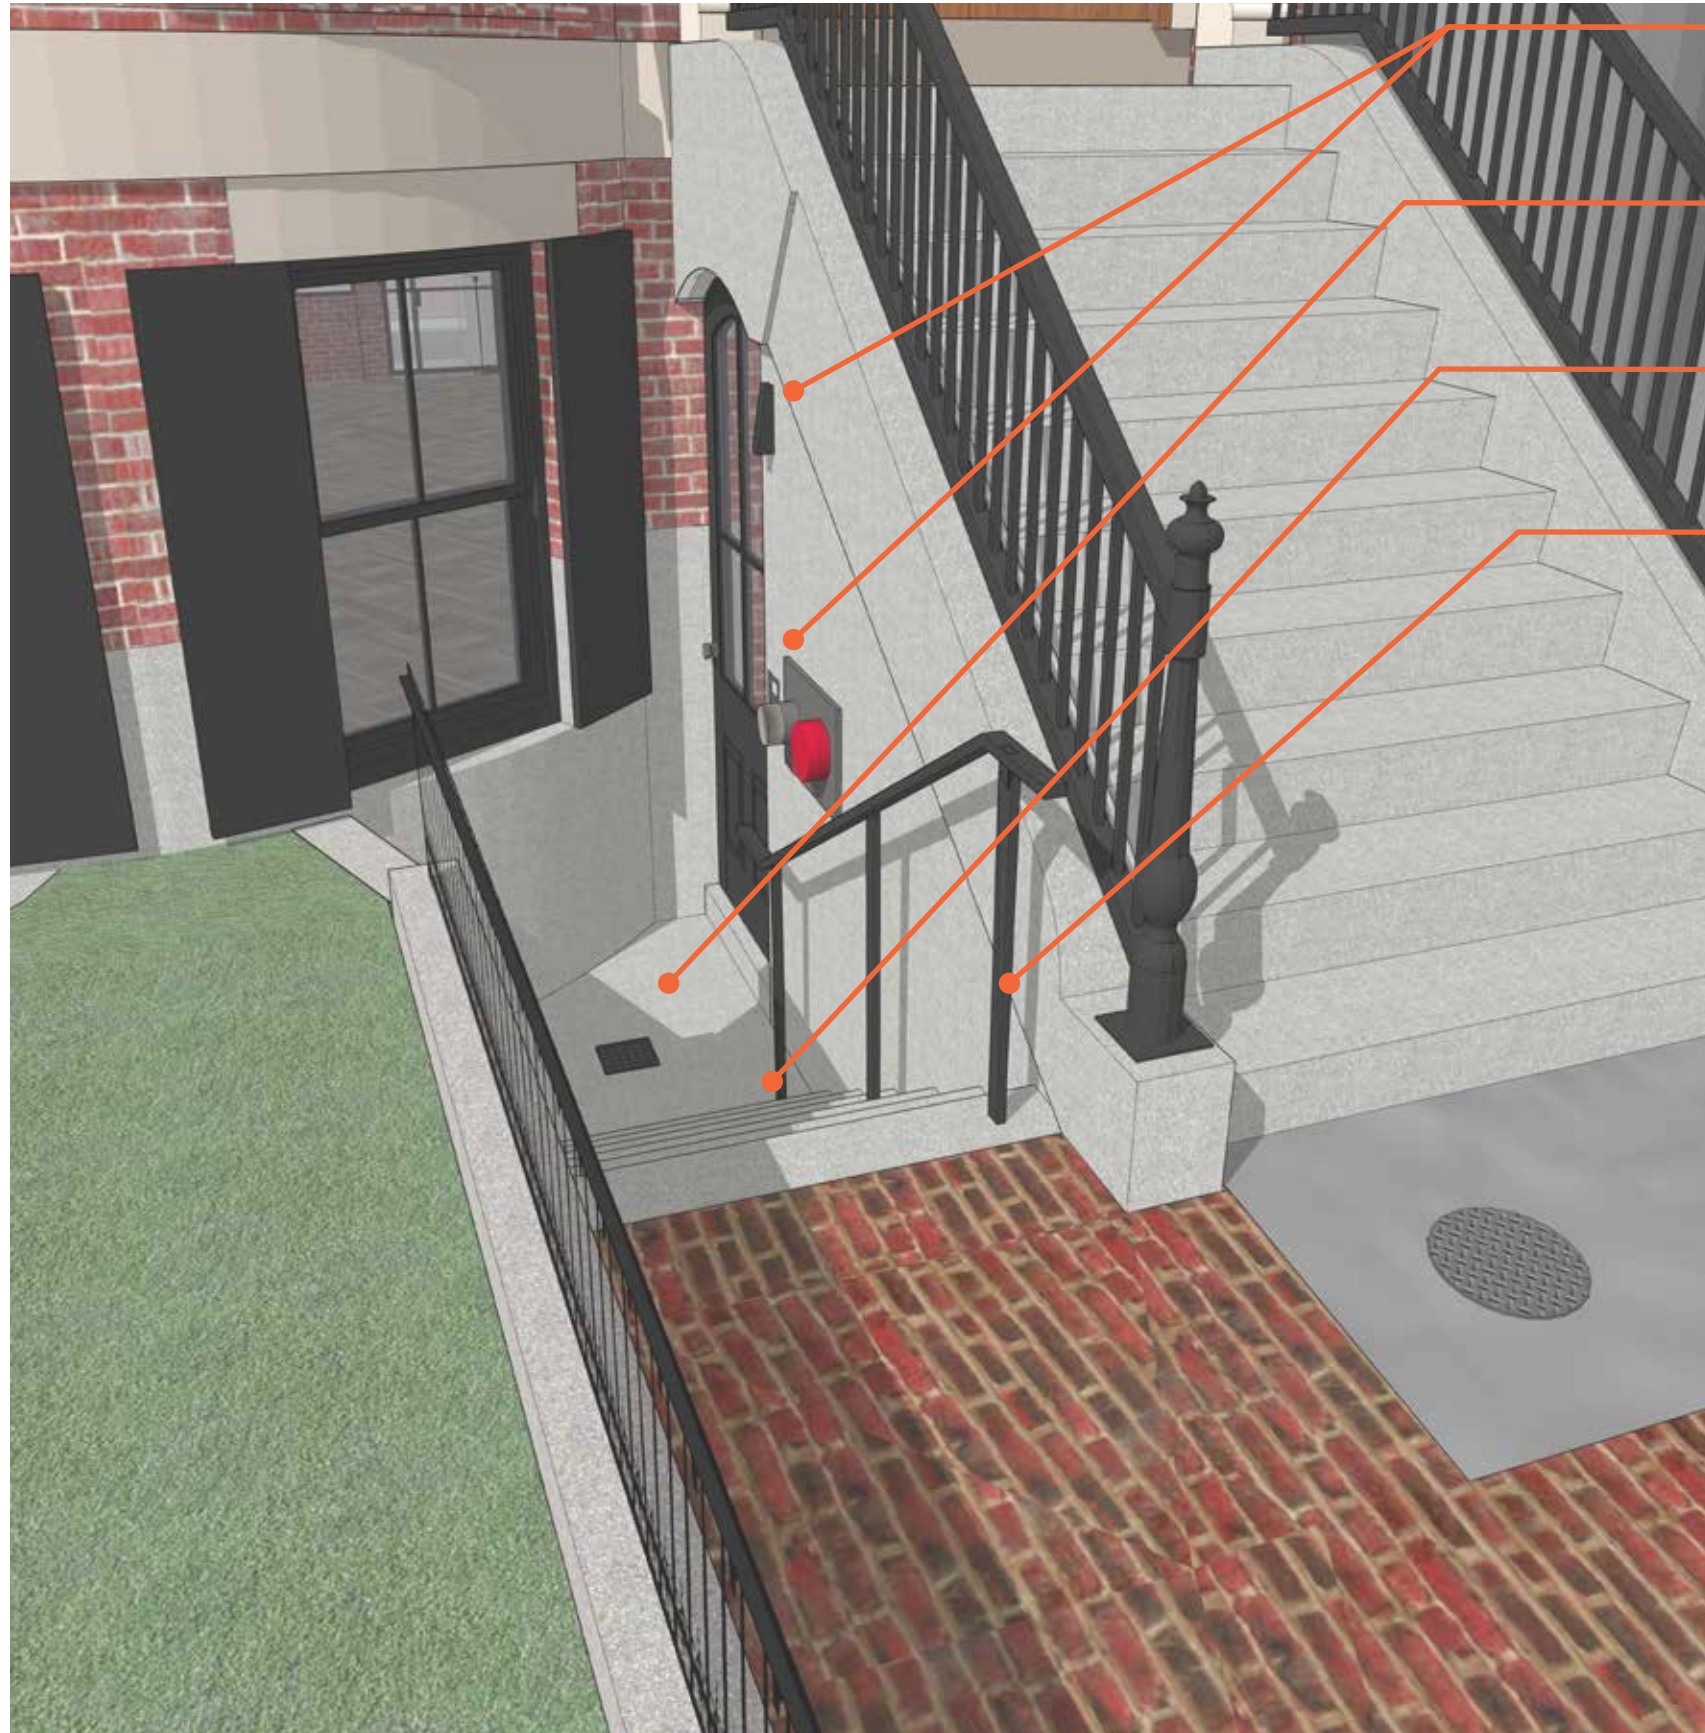
STREET LEVEL STEPS - PROPOSED

NEW LIGHT FIXTURE AND ALARM ENTRY KEYPAD

LARGER LANDING WITH NEW DRAINAGE SYSTEM

NEW GRANITE STEPS AT SHALLOWER RISE/RUN RATIO.

NEW MINIMAL HANDRAIL - RELATES TO HISTORIC IRONWORK MATERIALS, BUT SEPARATED

DUE TO LARGE LOT DEPTH - EXISTING AND PROPOSED STEPS ARE HIDDEN FROM PUBLIC WAY VIEW

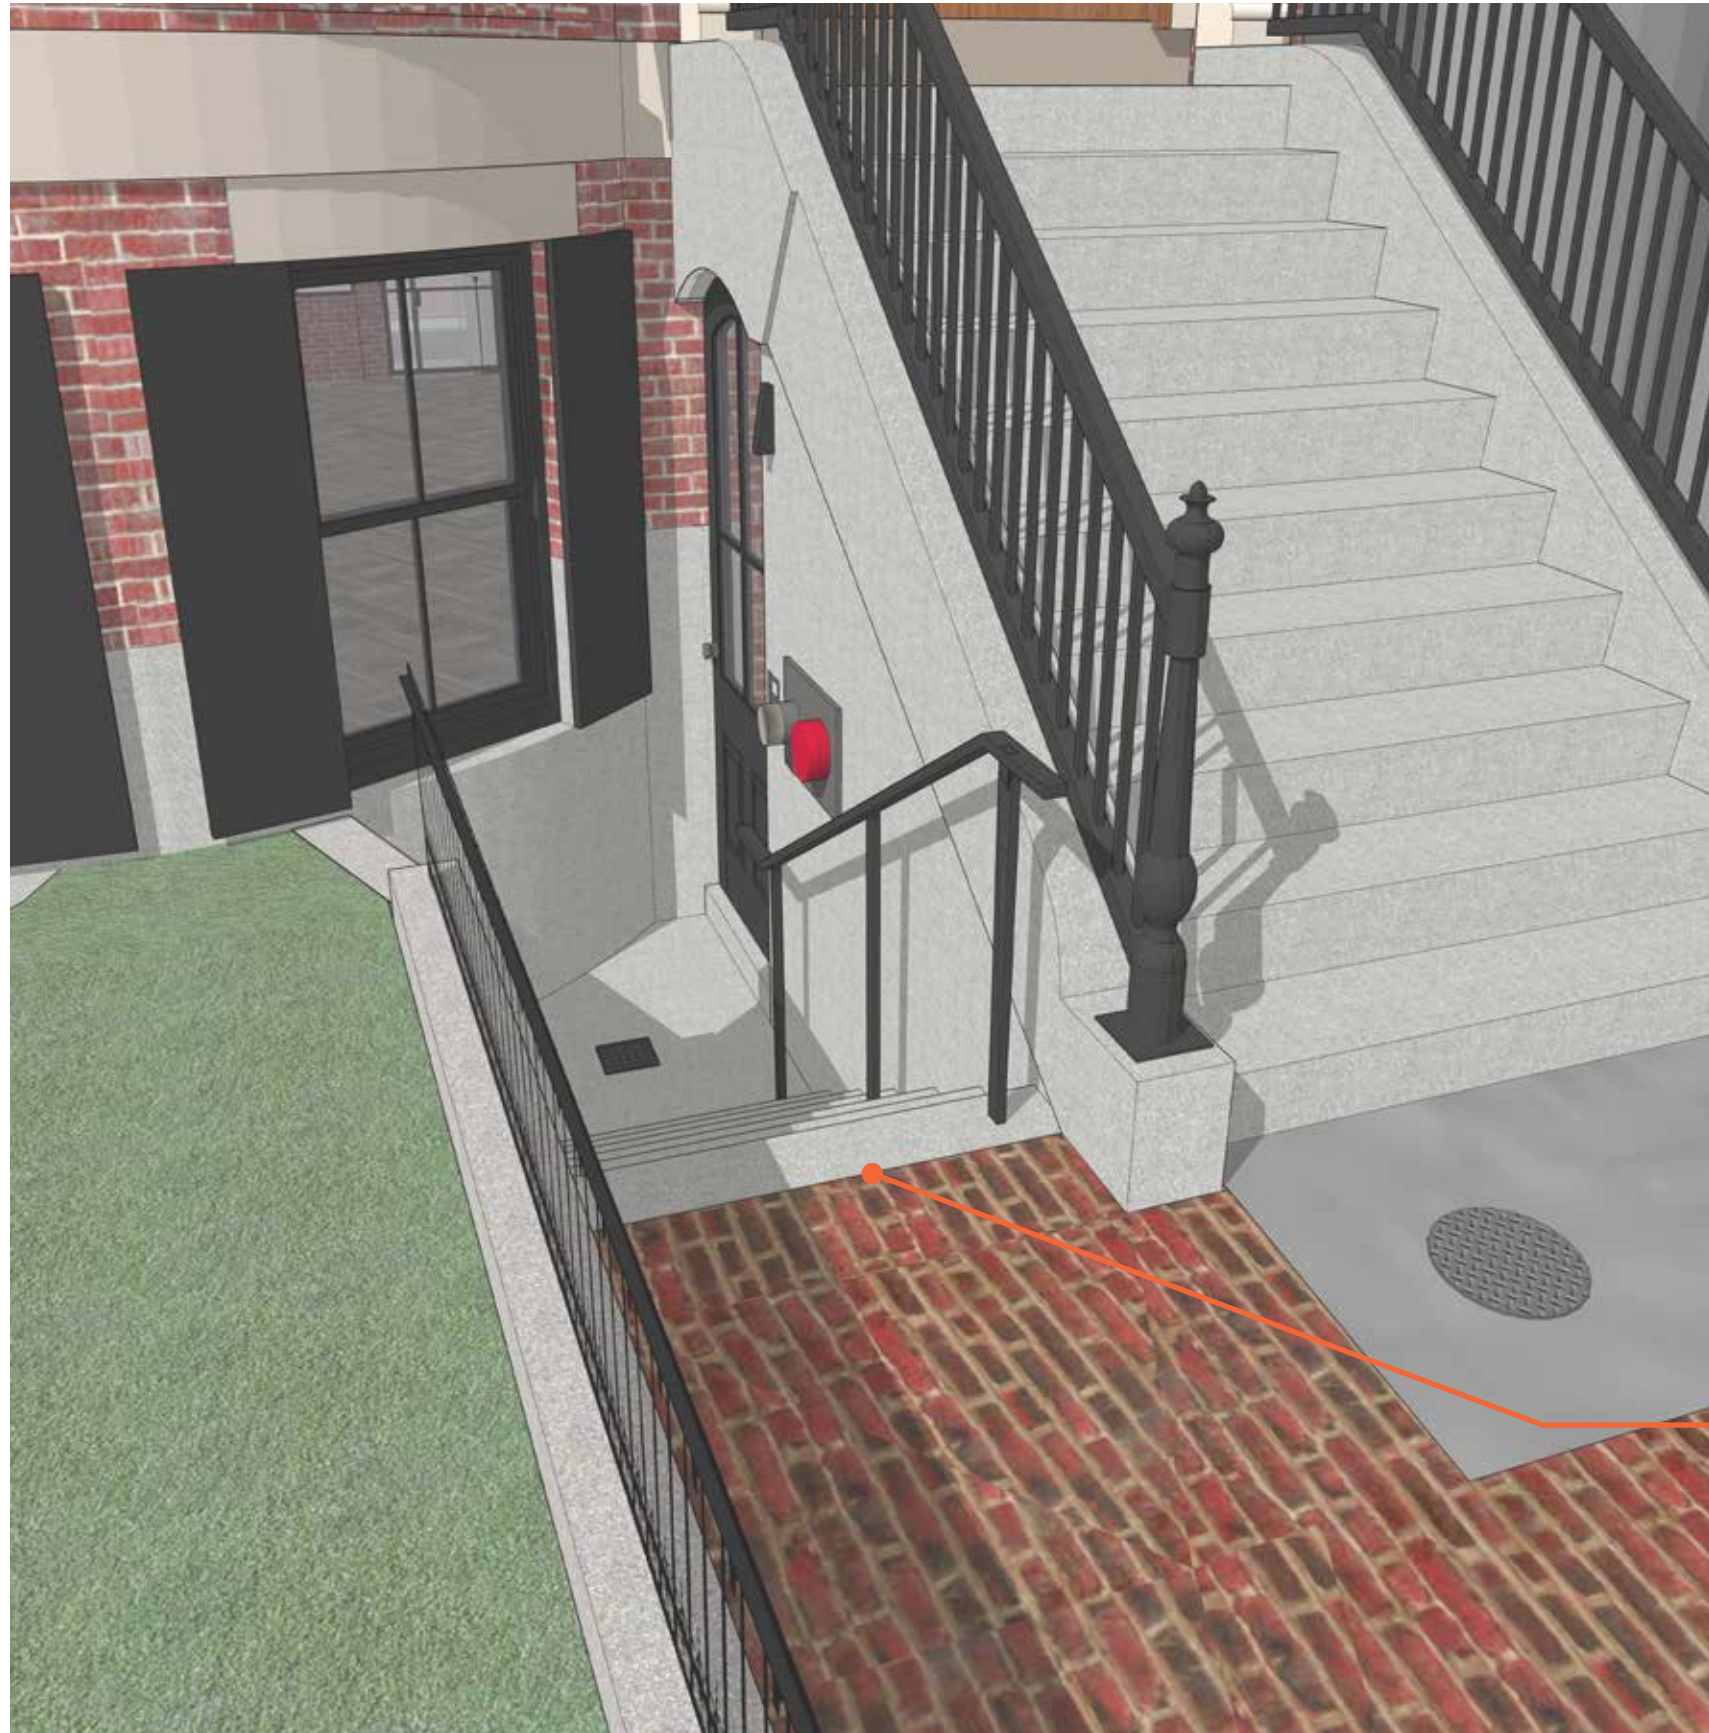
CURRENT PROPOSAL

TOP OF STEPS PUSHED
BACK FROM FRONT
EDGE OF STOOP, PER
SUGGESTIONS OF
COMMISSIONERS
