SOUTH END LANDMARKS DISTRICT COMMISSION PRESENTATION | 12.7.2021

10 UNION PARK

UNION PARK FAÇADE REPAIR AND REHABILITATION

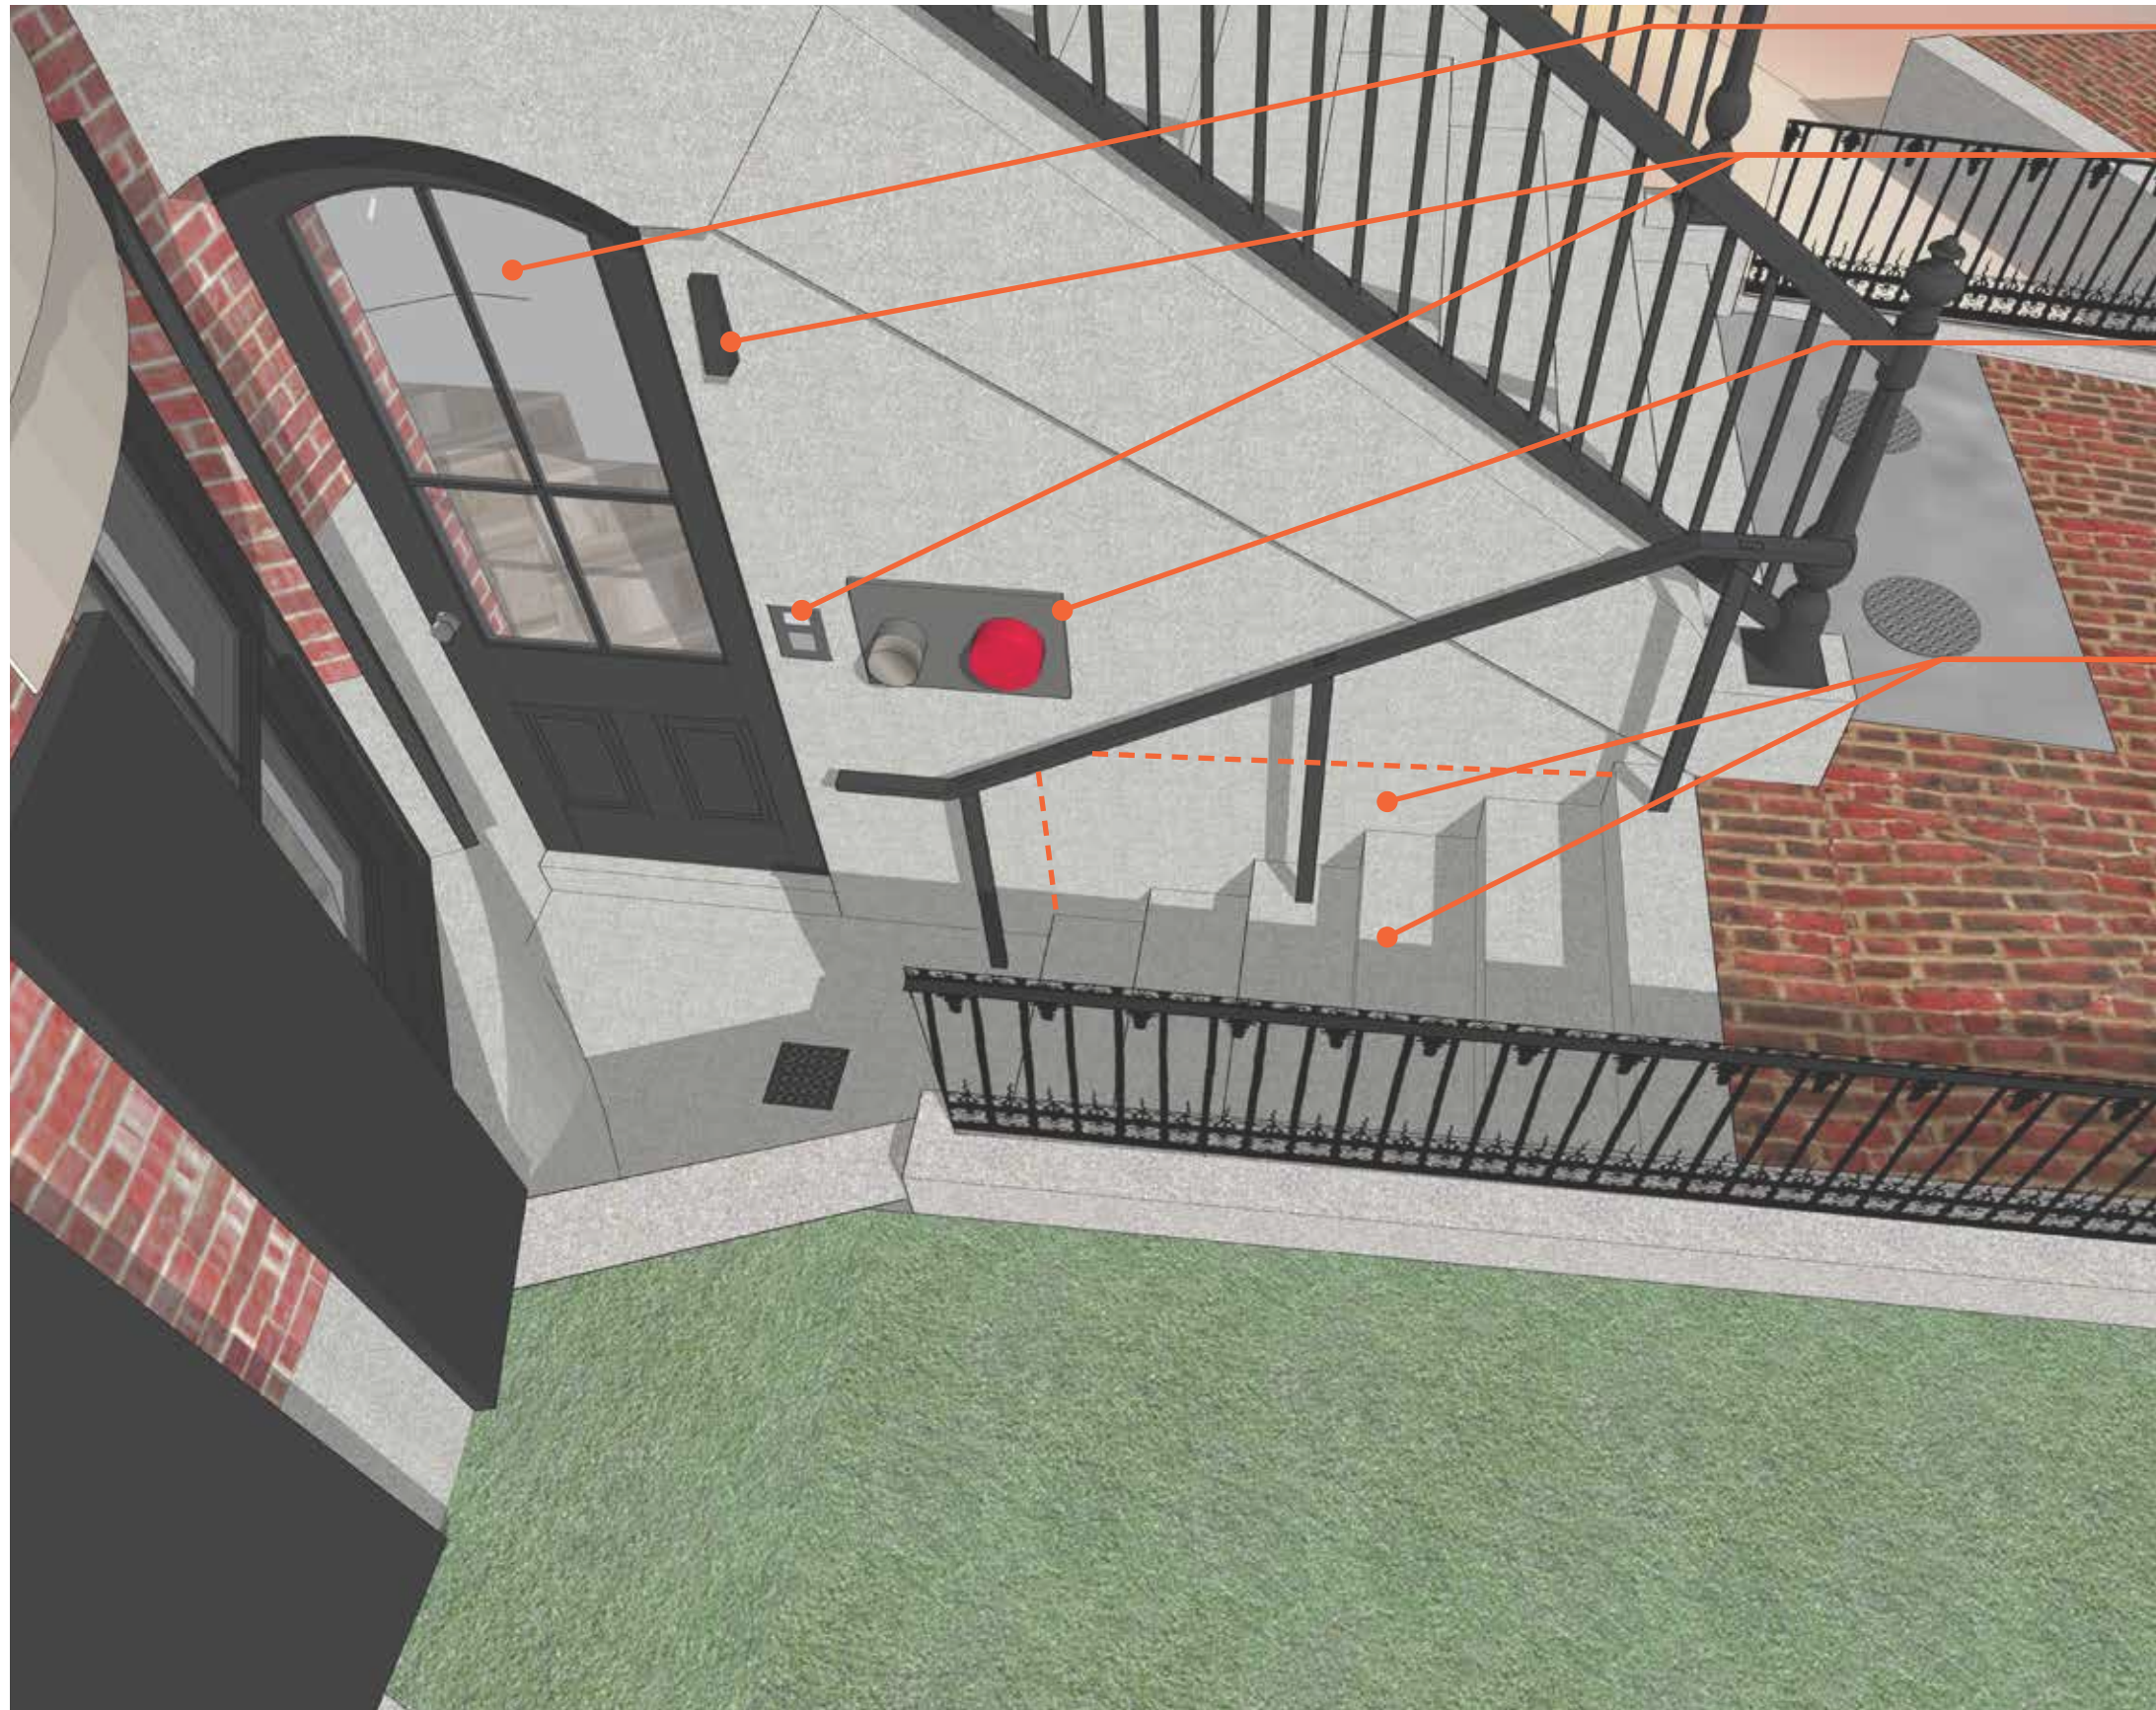
PROPOSED VIEW

NEW DOOR TO STREET LEVEL

NEW LIGHTING AND ENTRY KEYPAD

NEW FIRE ALARM BELL IN EXISTING LOCATION, NEW FIRE DEPARTMENT CONNECTION

NEW GRANITE STEPS AND NEW GRANITE INFILL AT SIDE OF STOOP TO MATCH EXISTING GRANITE

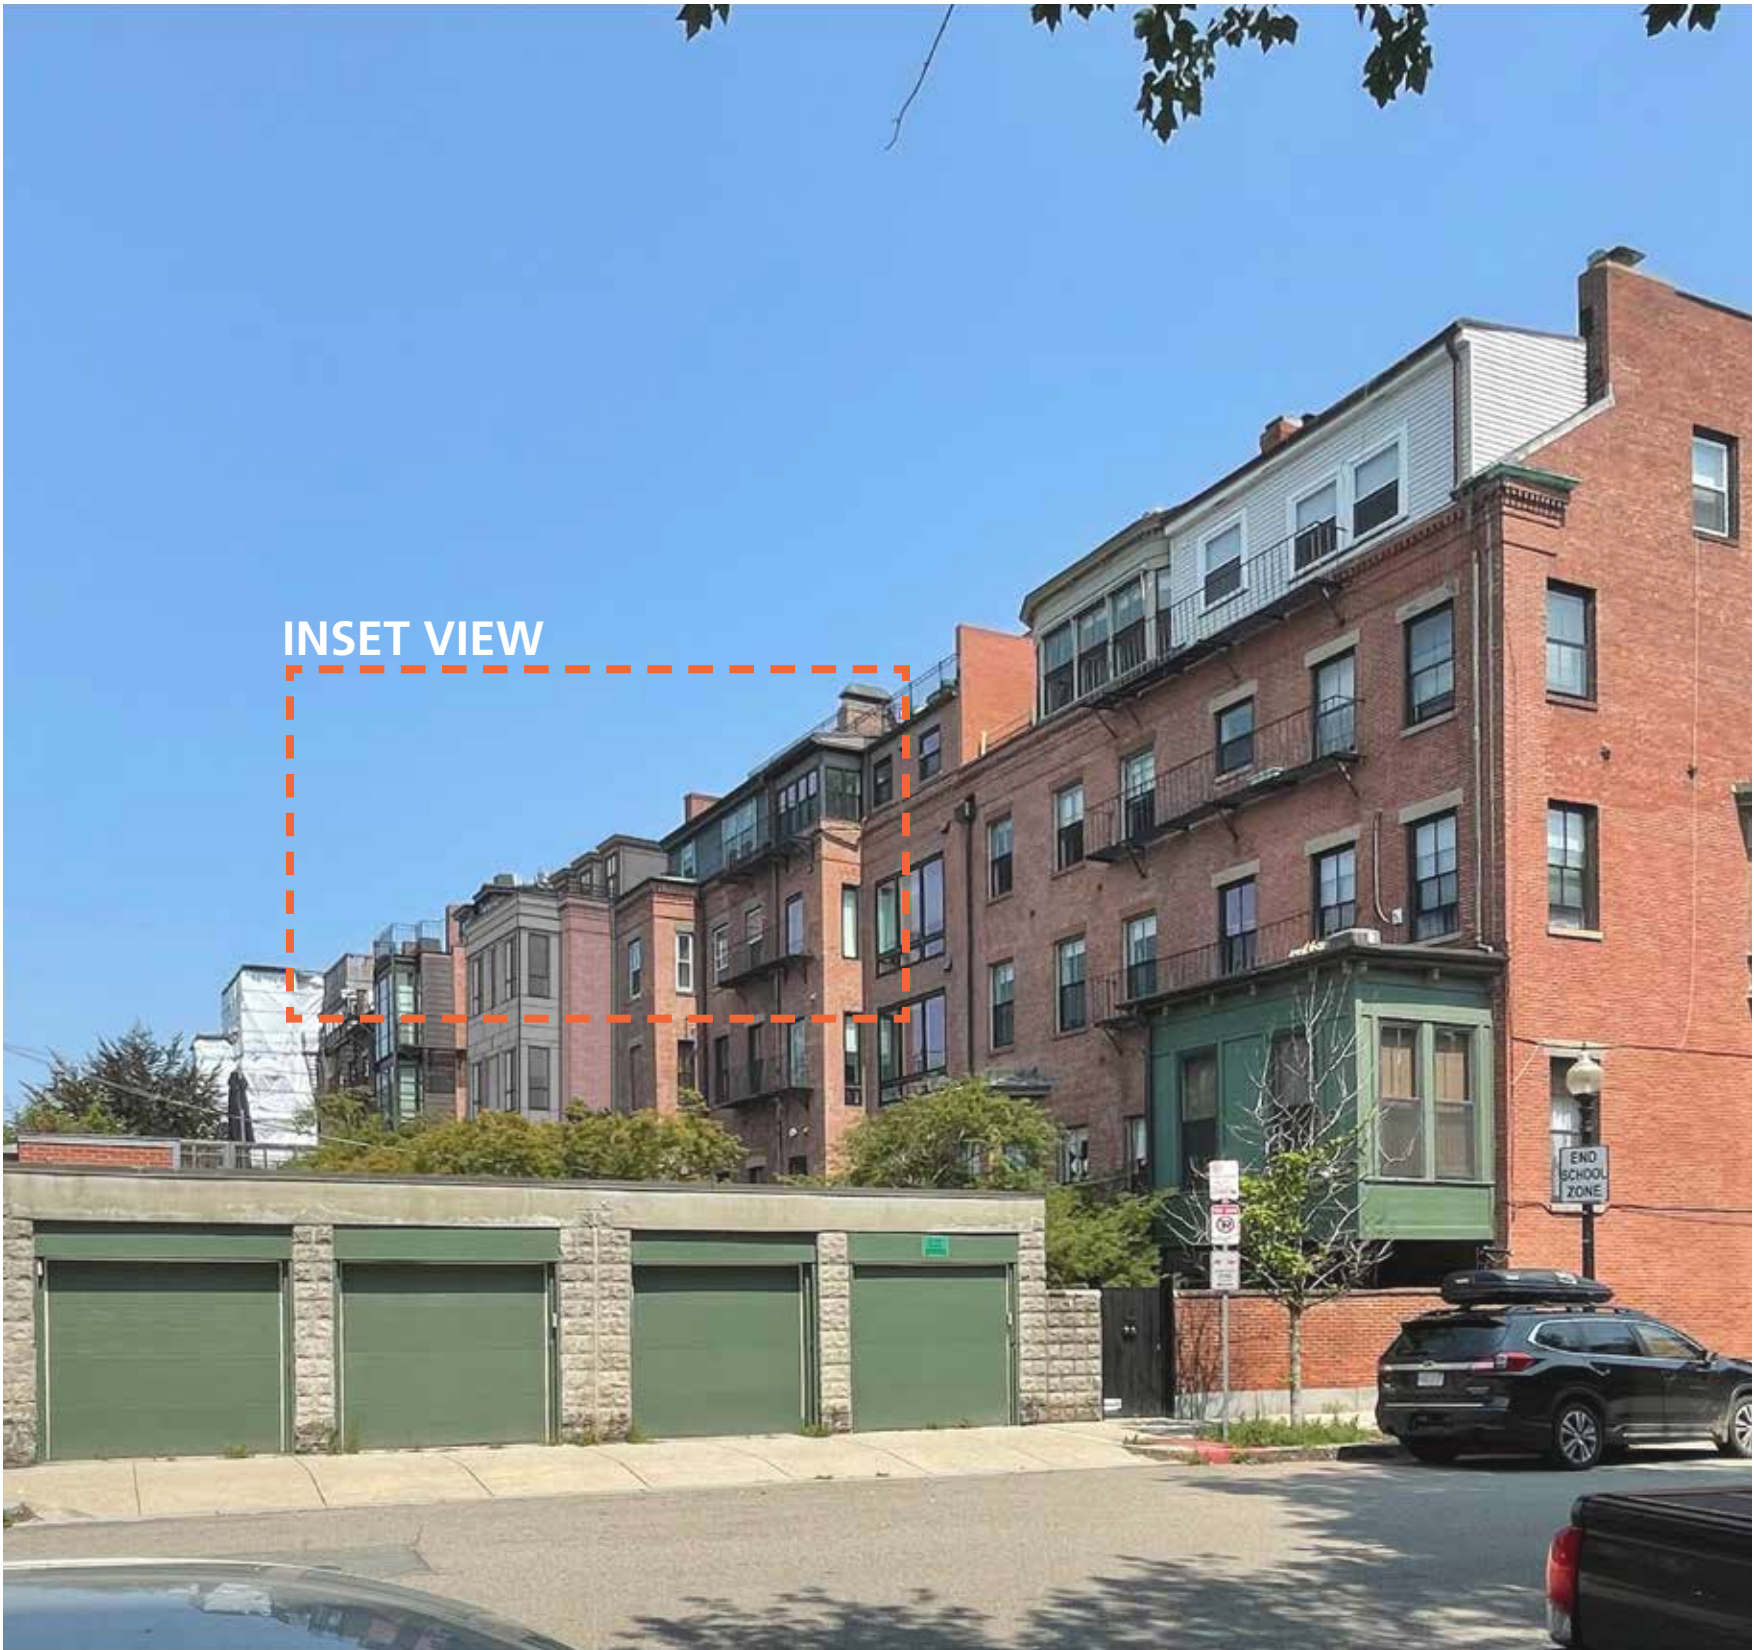
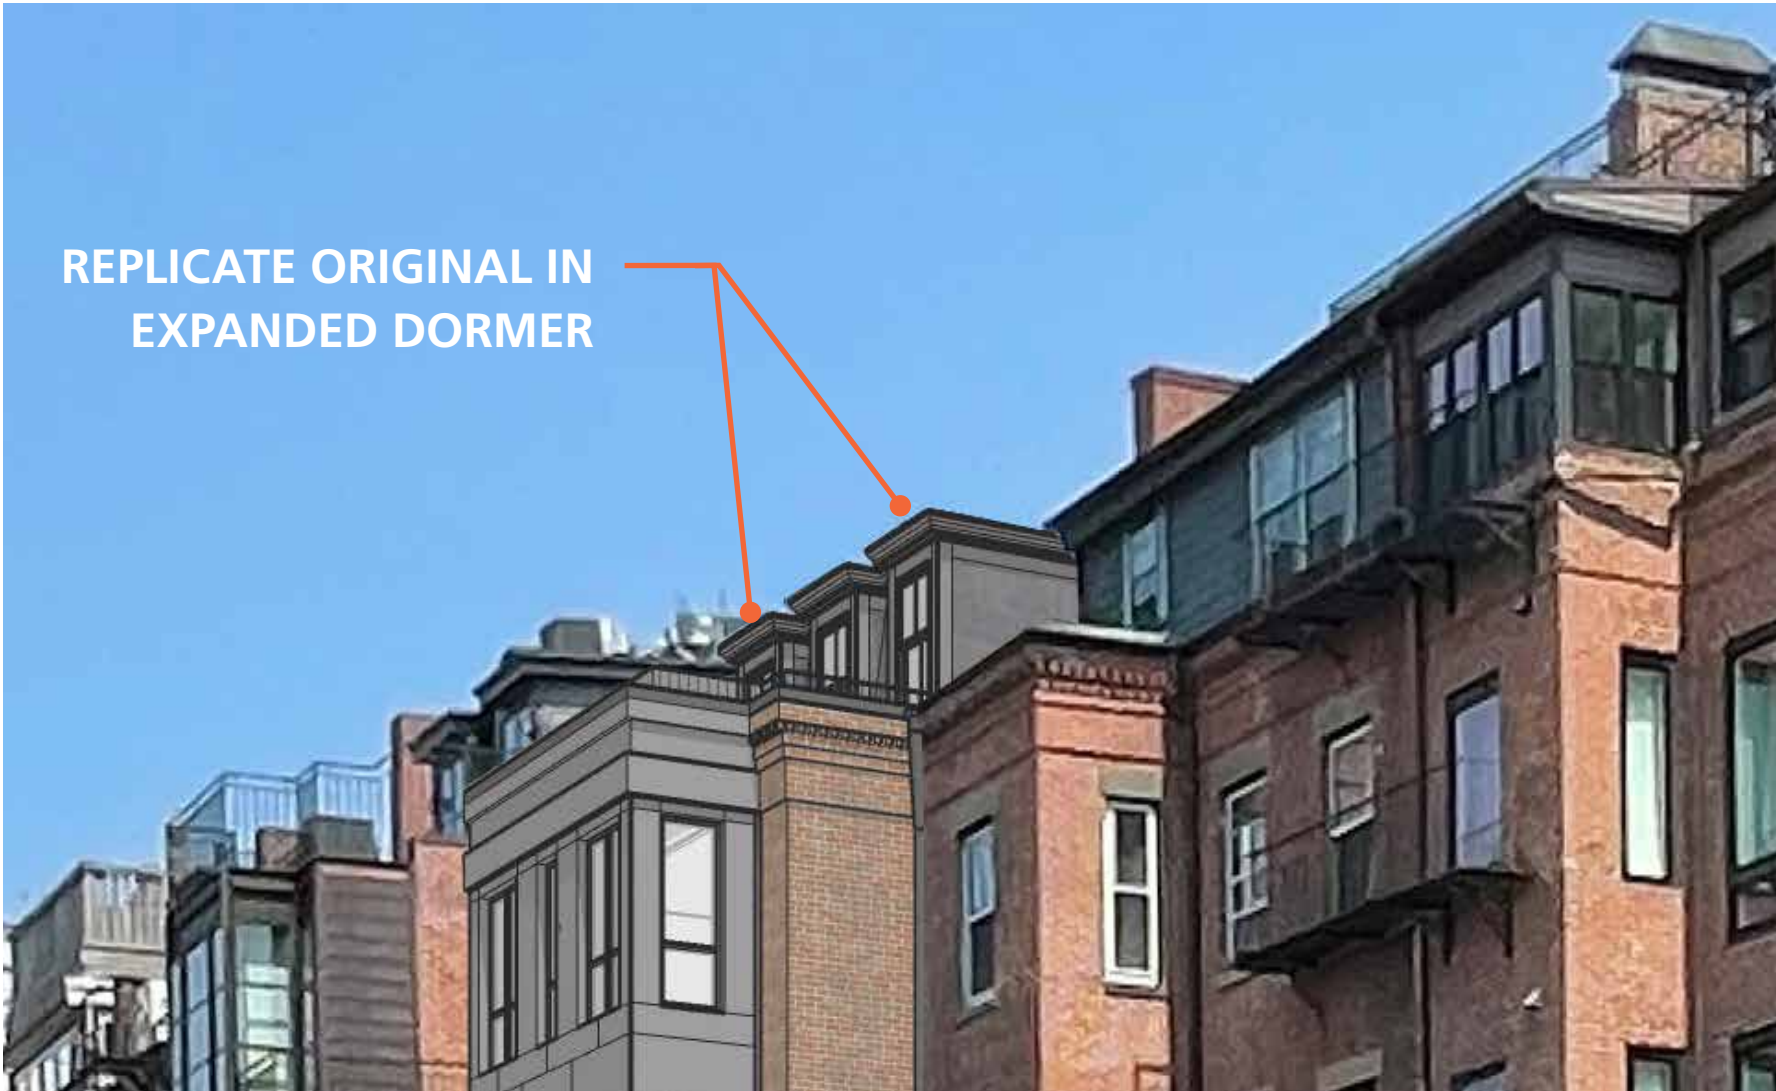
RESPONSE BASED ON FEEDBACK:

- EXPANDED DORMER SET BACK AND REDESIGNED TO ALIGN WITH AND REPLICATE EXISTING HISTORIC DORMER
- ROOF DECK ELIMINATED
- HISTORICALLY APPROPRIATE METAL RAILING AT 5TH FLOOR DECK, ABOVE BRICK CORNICE

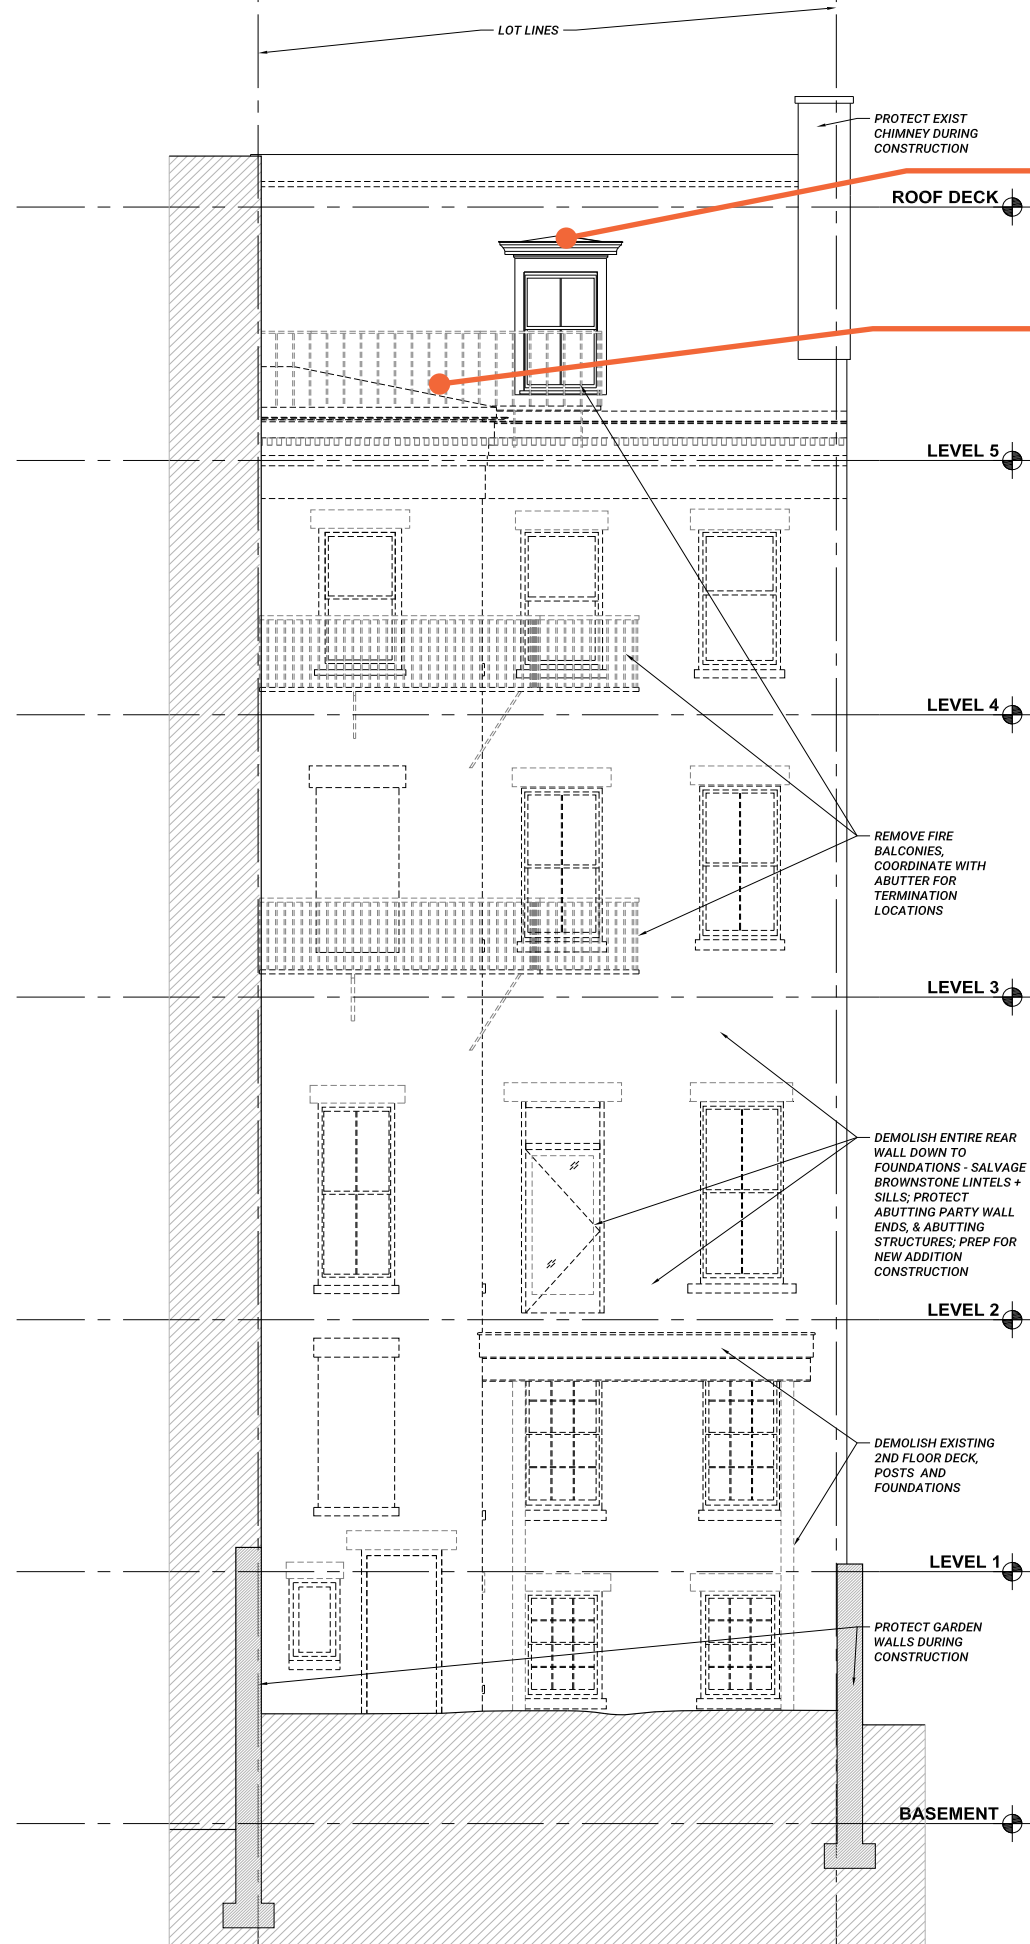
EXISTING CONDITIONS

ORIGINAL DORMER

EXISTING FIRE BALCONIES TO BE REMOVED

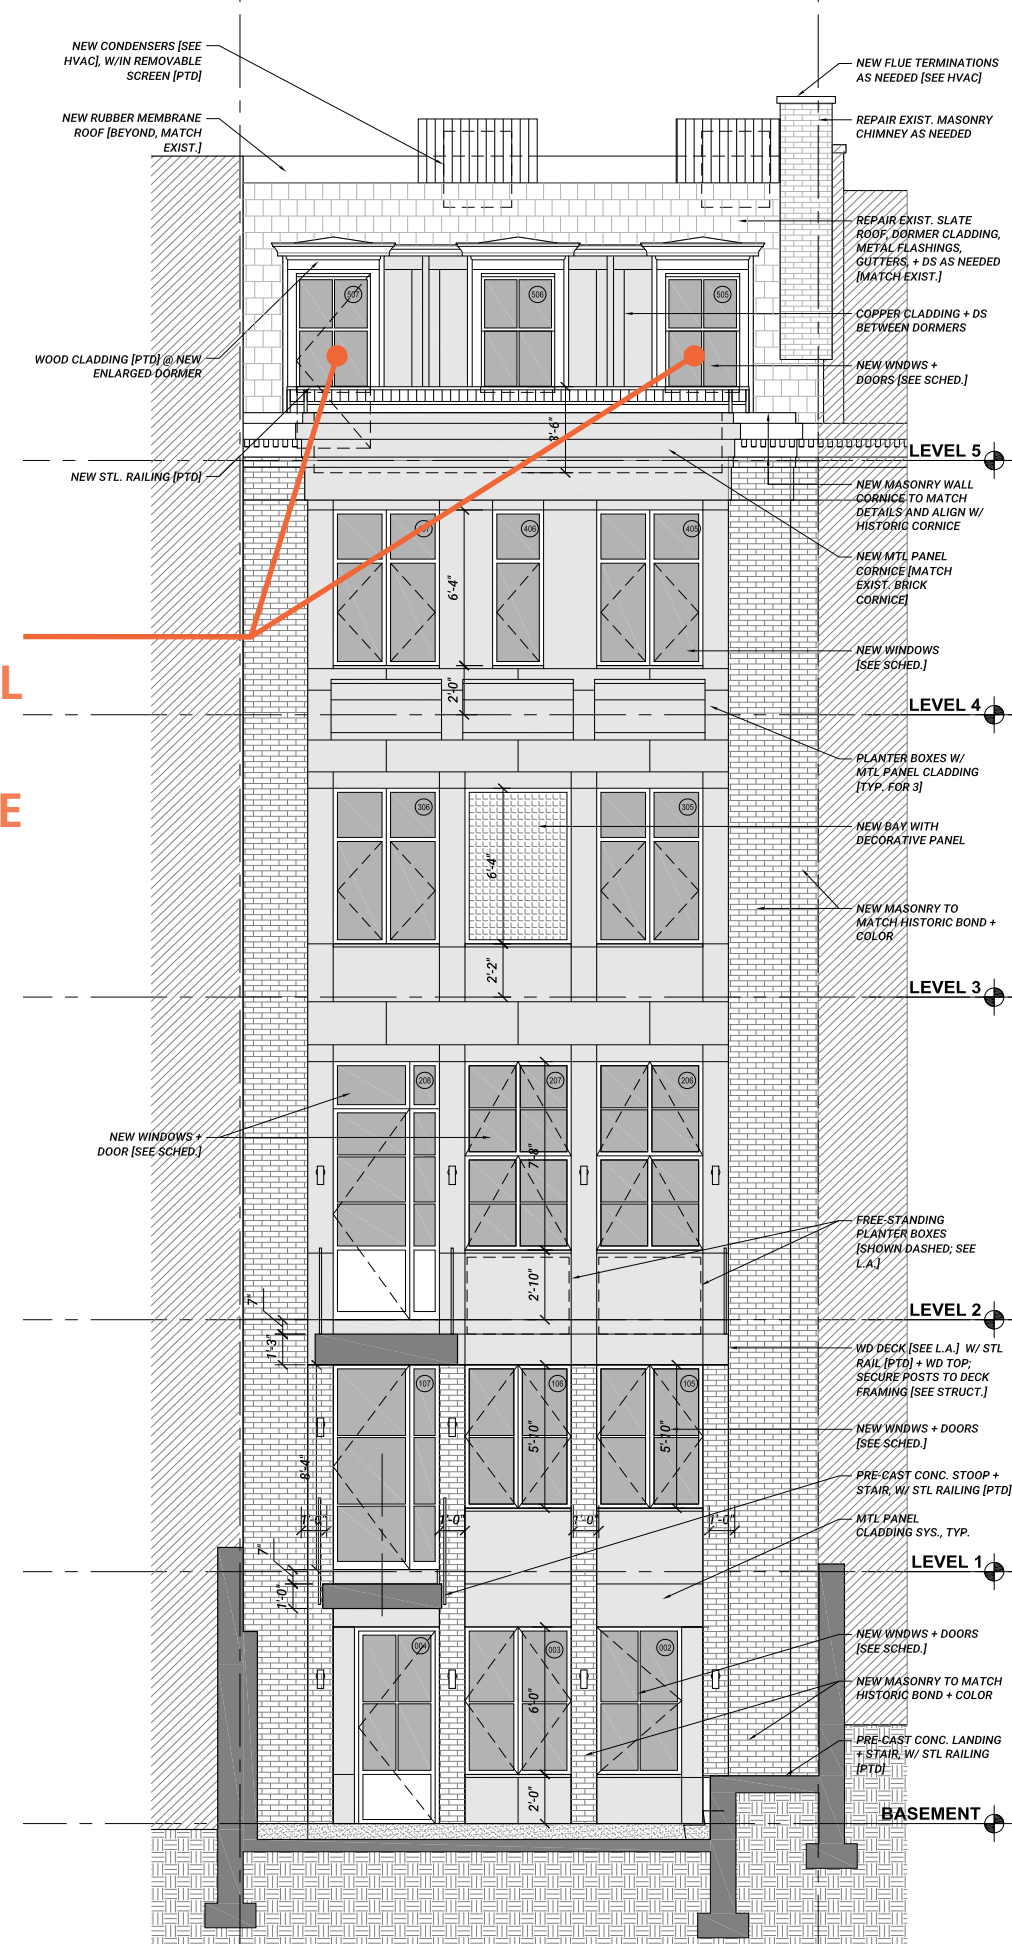
PROPOSED CONDITIONS

EXPANDED DORMER REPLICATES ORIGINAL DORMER DESIGN AT EACH SIDE TO CREATE HISTORICALLY APPROPRIATE CONFIGURATION
