507 MASSACHUSETTS AVENUE
SITE LOCATION & SITE PLAN

DESCRIPTION OF PROPOSED WORK

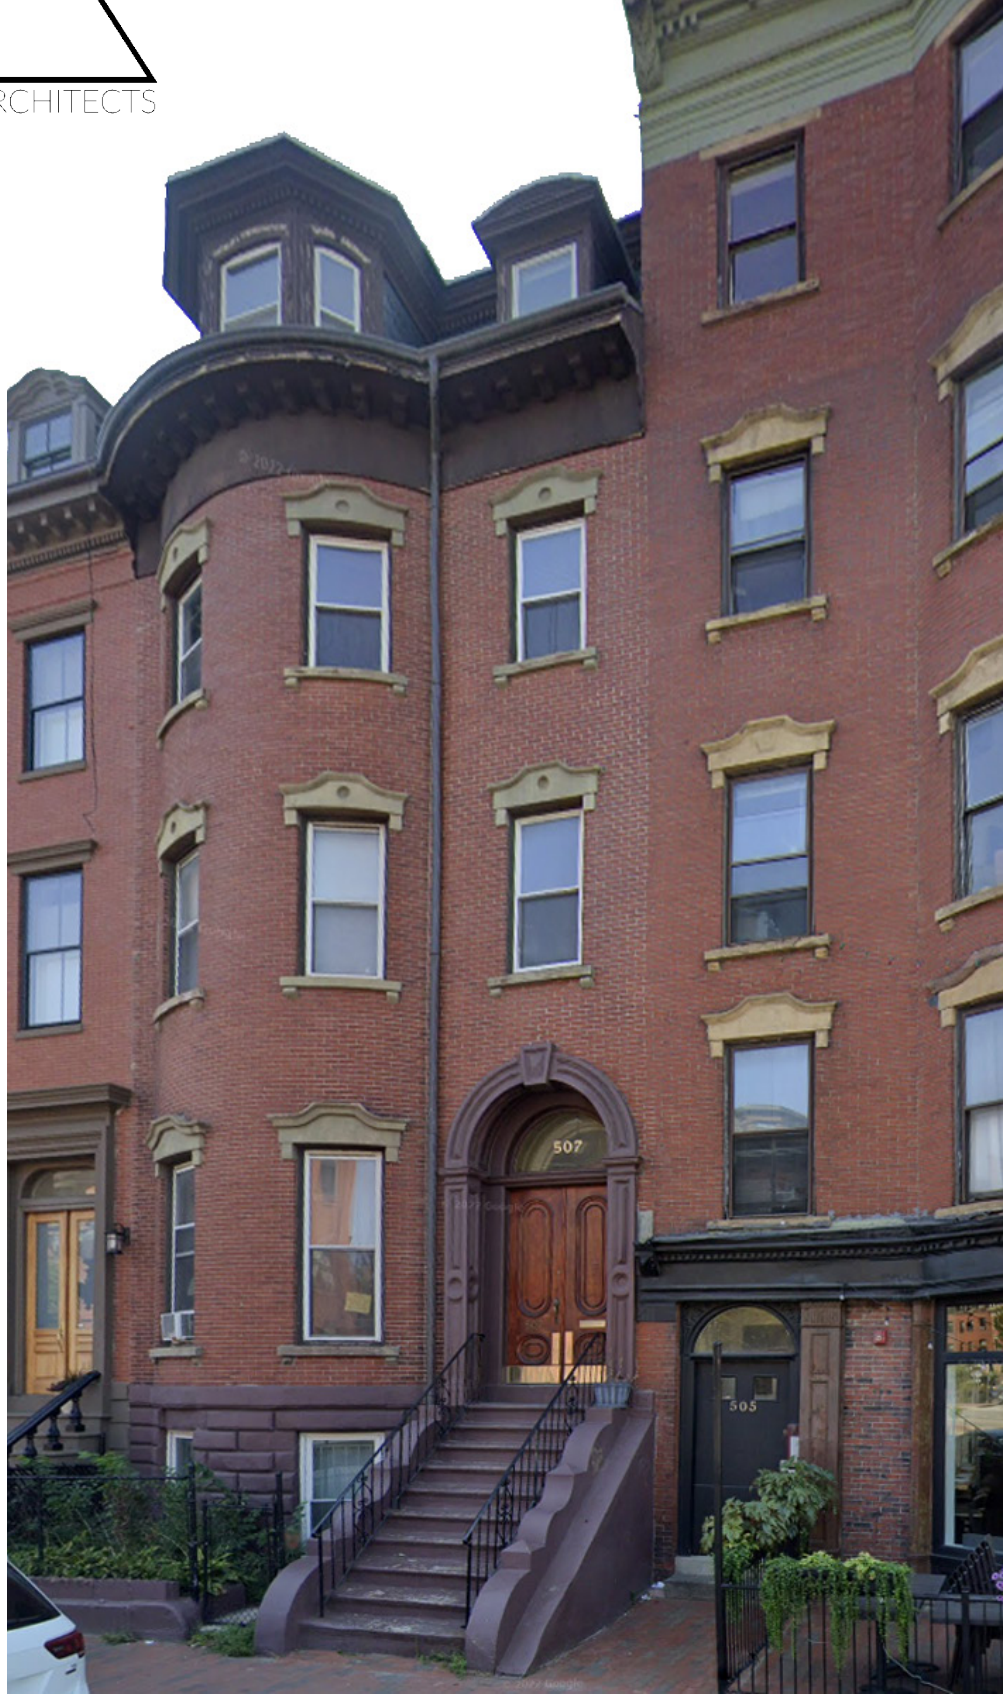
507 MASSACHUSETTS AVE.

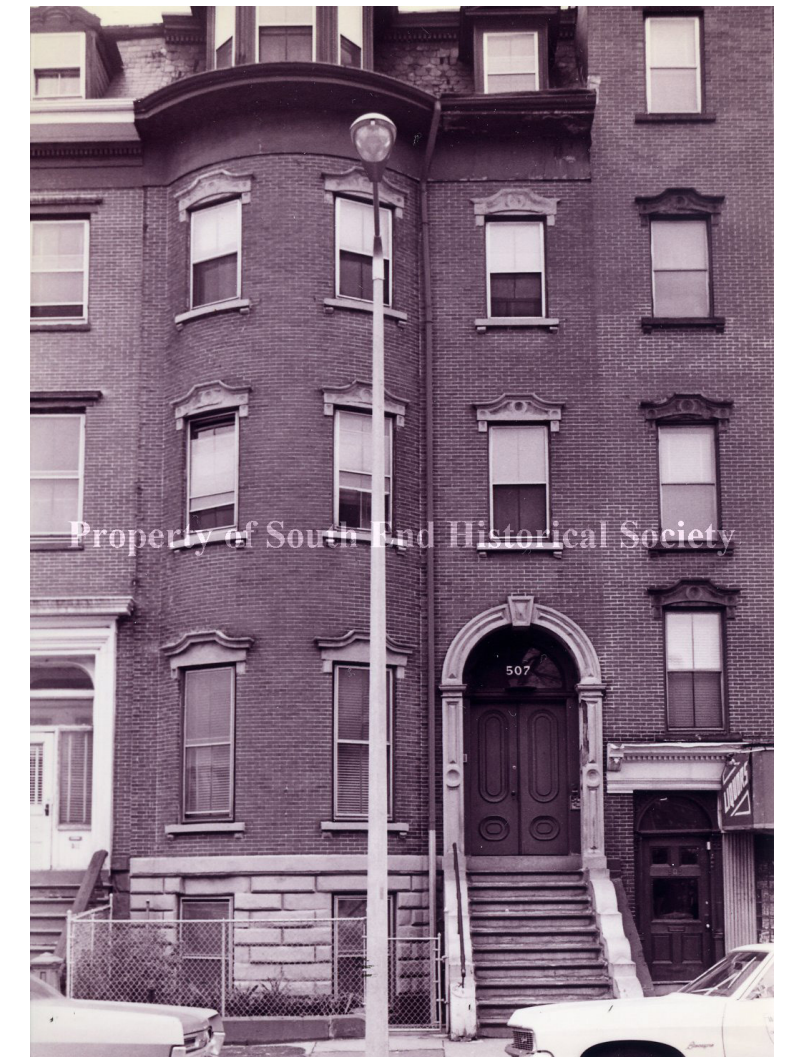
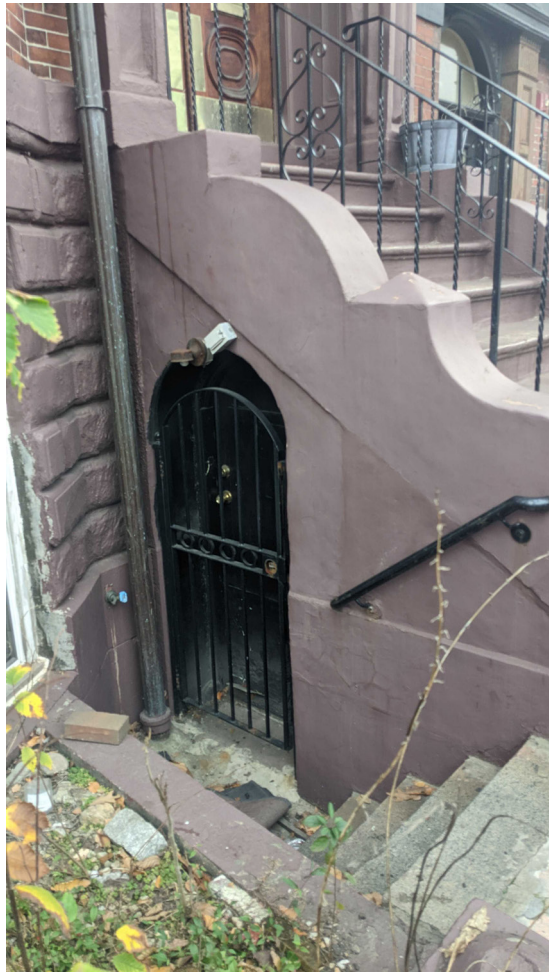
EXISTING STOOP SIDE ENTRY

- EXISTING MISFITTING GATE TO BE REMOVED
- EXISTING SIDE ENTRY DOOR TO BE RESTORED

8. Repair and restore existing side entry door at stoop as required. Refer to attached drawings.
9. Replace (e) vinyl windows w/ new '2 over 2' wood window in existing window locations. Refer to attached drawings.

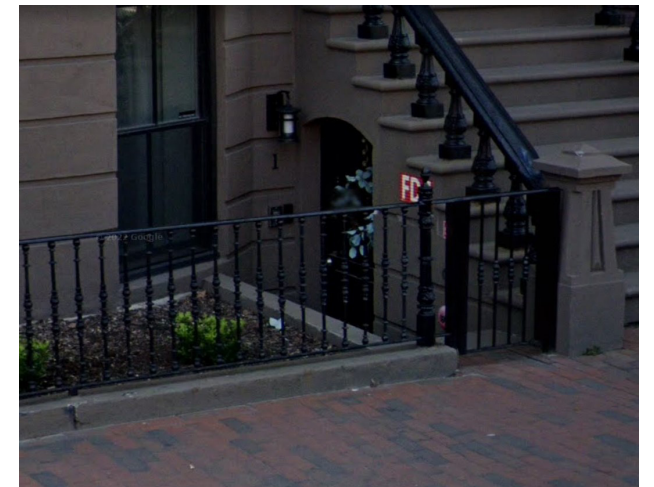
TO MATCH
 FRONT GARDEN FENCE
 AT 511 MASS. AVE.

10. Repair and restore existing trim at doors and windows.
11. Replace existing gutter and downspouts. Color to match existing.
12. Replace existing chain-link fence w/ black iron fence to match context. Refer to attached drawings.
