Boston City Hall Plaza + Restoration 4th Floor Terrace + South Plaza Overview

Phase 02 - Landmarks Advisory Meeting
27 May 2025

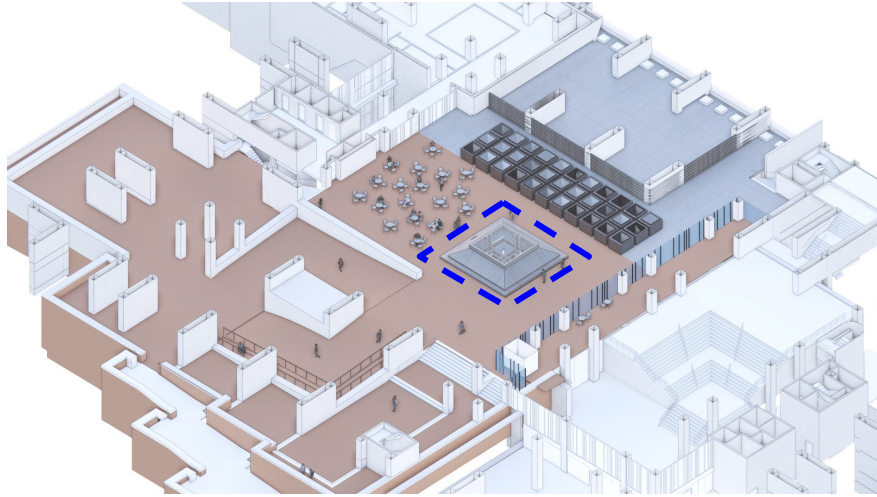
1: Central Skylight

Existing Condition + Proposed Modification

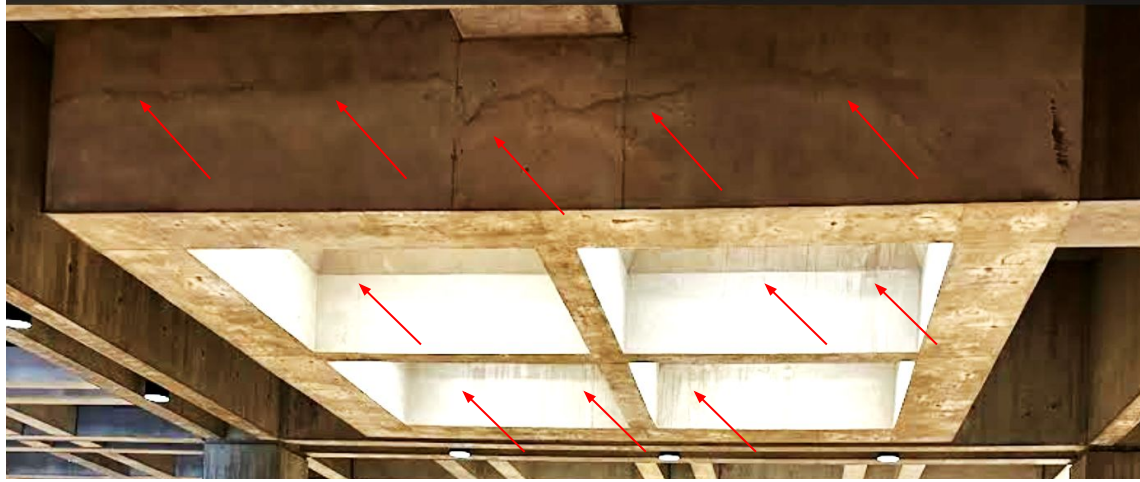
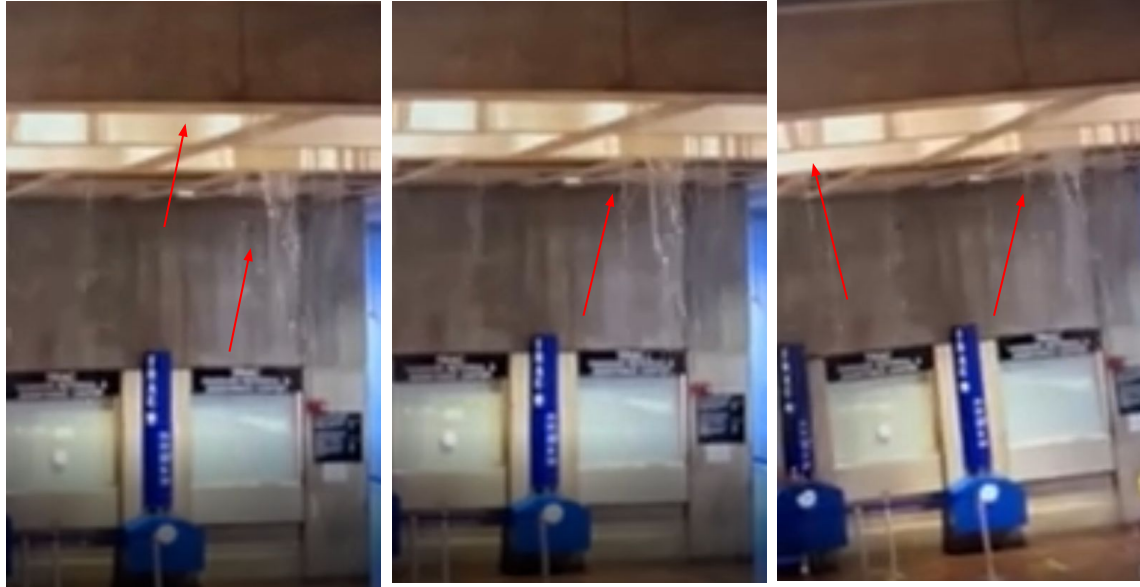
Existing Issues

- Photo illustrates extensive areas of water penetration and damage at outer edge of skylight frame and inner light-wells
- Video stills indicate active water infiltration during a storm event with water cascading down through inner troughs

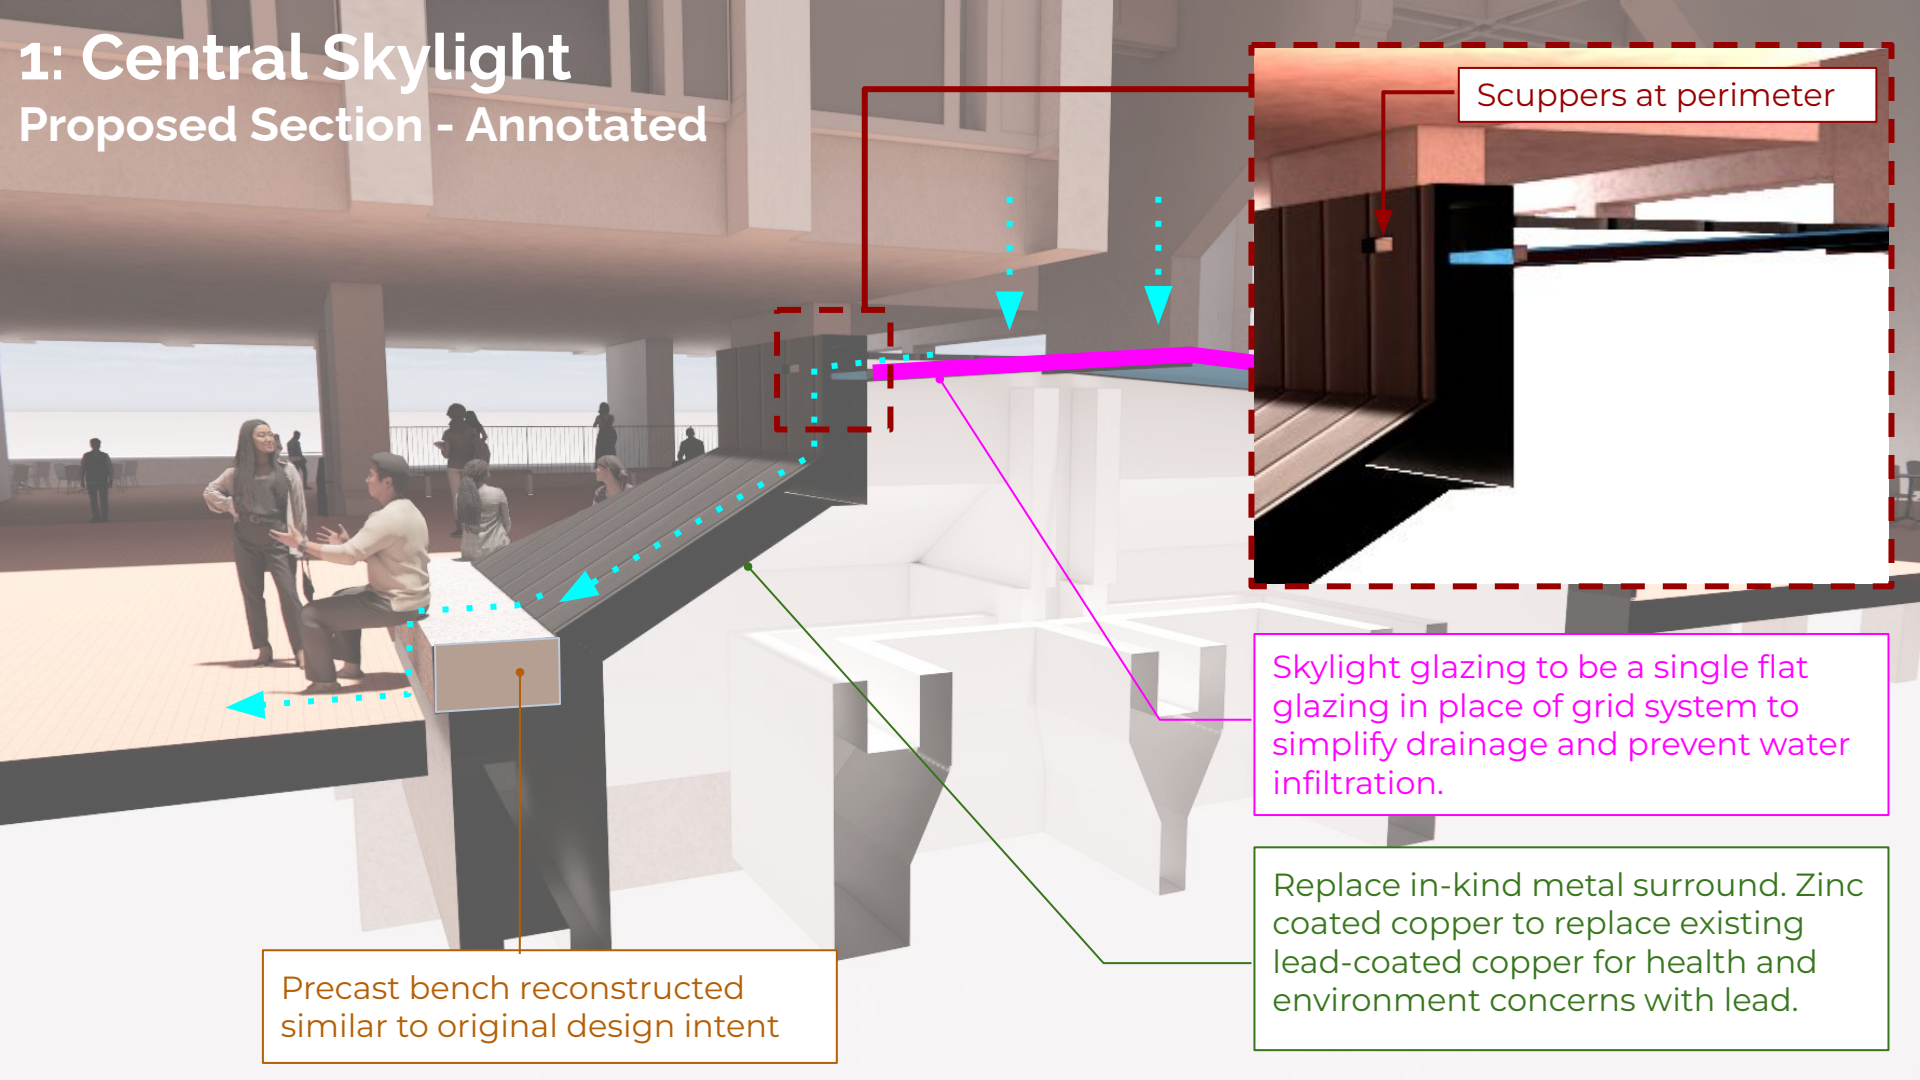
Proposed Section - Annotated

Scuppers at perimeter

Skylight glazing to be a single flat glazing in place of grid system to simplify drainage and prevent water infiltration.

Replace in-kind metal surround. Zinc coated copper to replace existing lead-coated copper for health and environment concerns with lead.

Precast bench reconstructed similar to original design intent

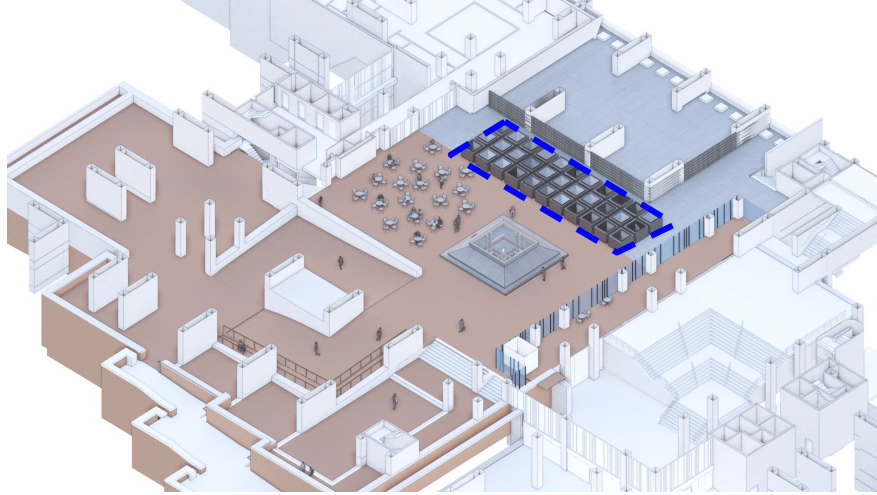
2: Gridded Skylight

Existing Condition + Proposed Modification

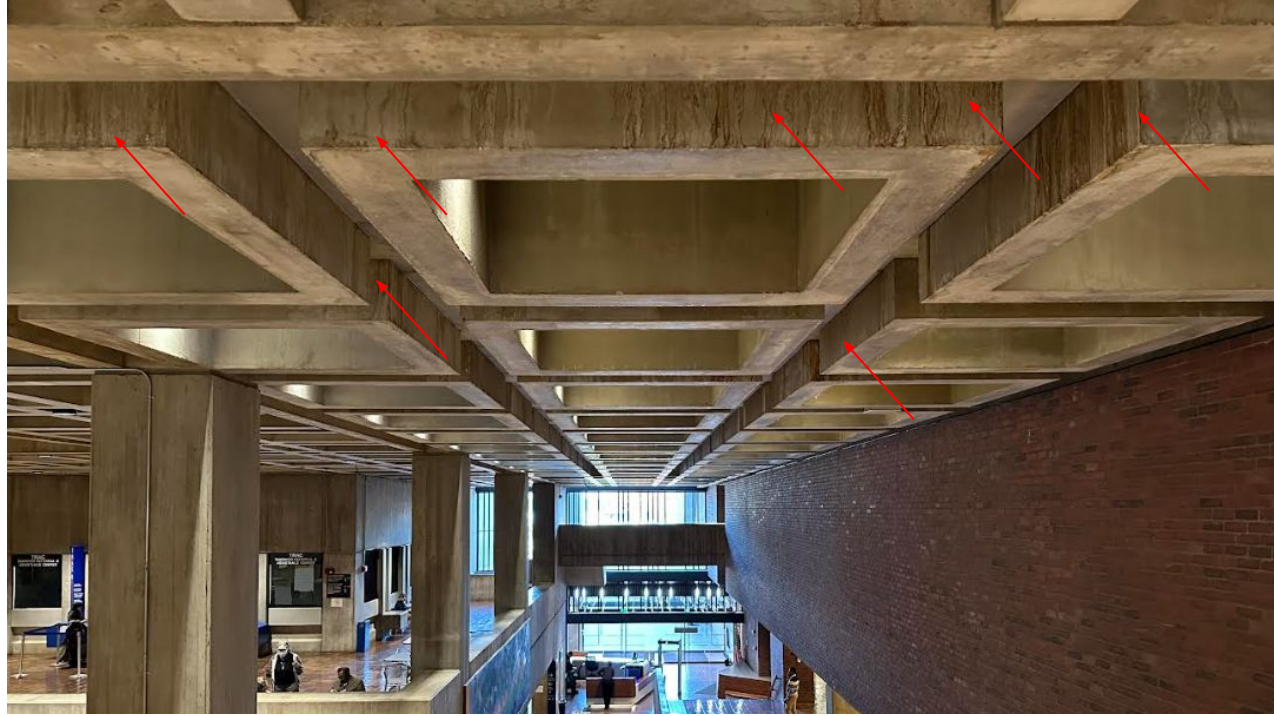
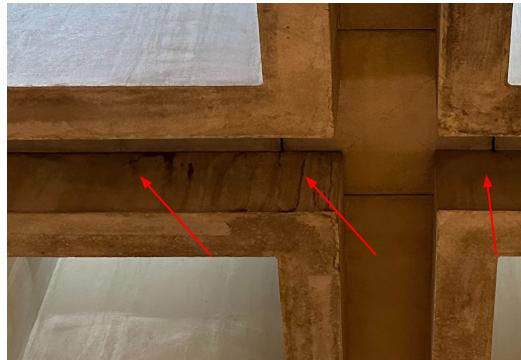
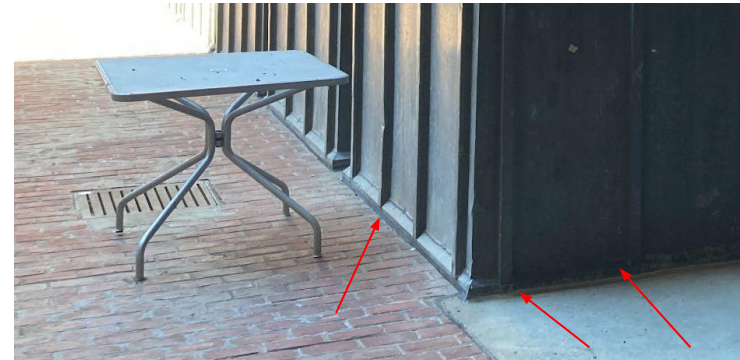
Existing Issues

- Extensive areas of water penetration and damage particularly at outer perimeter of gridded skylights
- Staining and water damage visible at most inner and outer edges of individual light-well precast elements

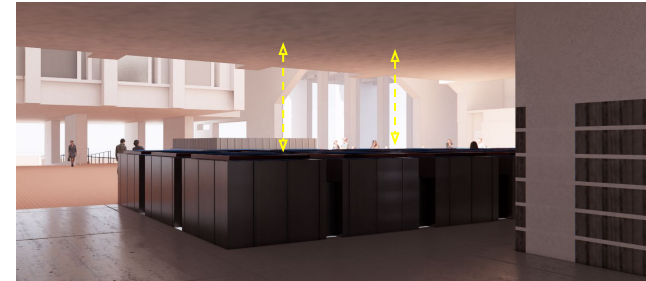
Modified Skylight - Section

Flat Walkable Skylight

- Improves original intent of interior daylighting.
- Addresses water infiltration

Removal of precast and cladding

- Eliminates potential climbing and trip hazards
- Provides more space for circulation and visibility

Light Fixture

- Original design intent to be restored

Precast tubes

- Interior ceiling & skylight design intent maintained

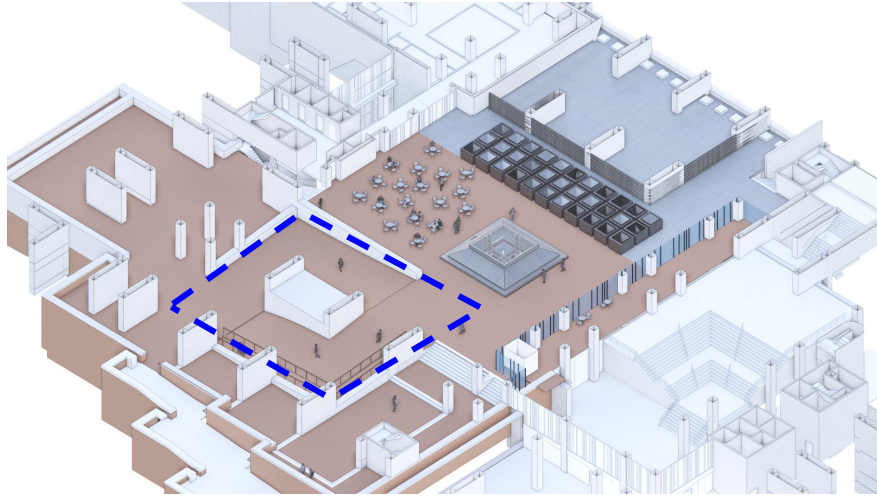
3: Ramps

Existing Condition + Proposed Modification

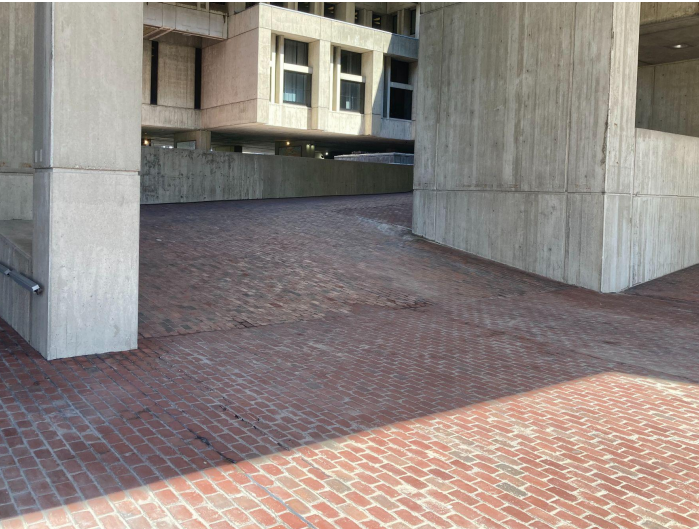
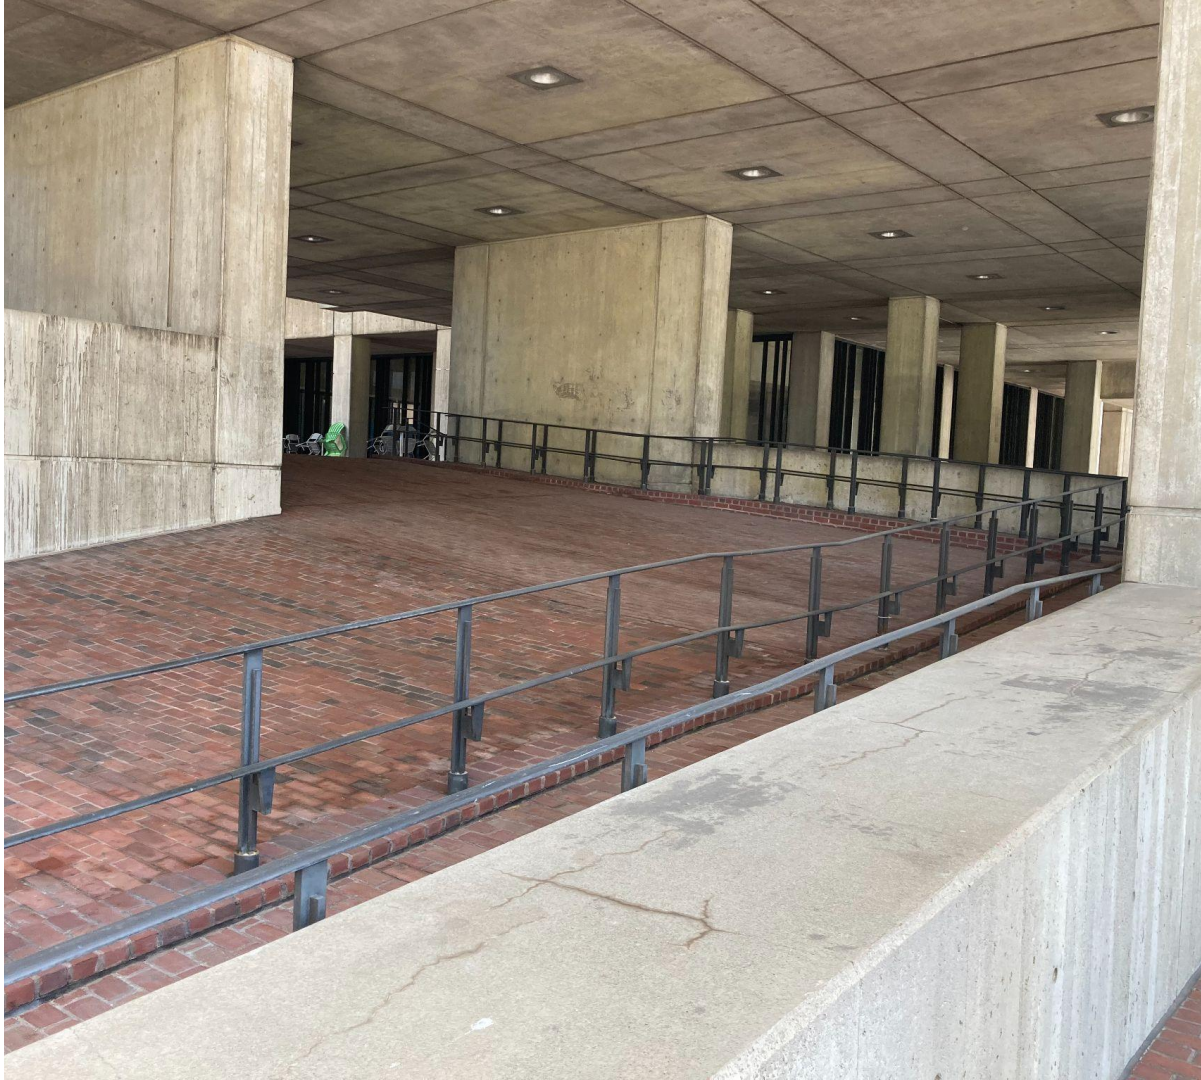
Existing Conditions Photos

3: Ramps

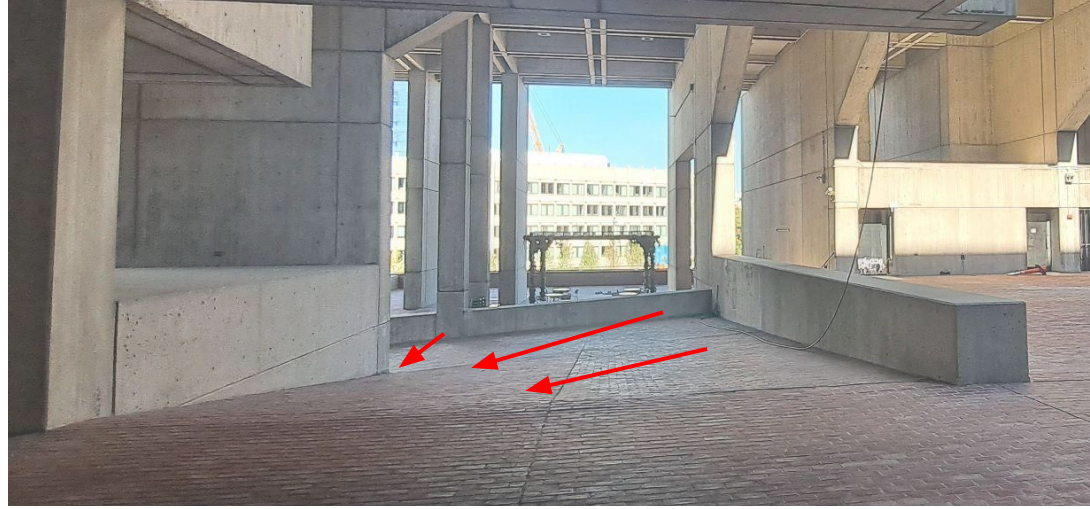
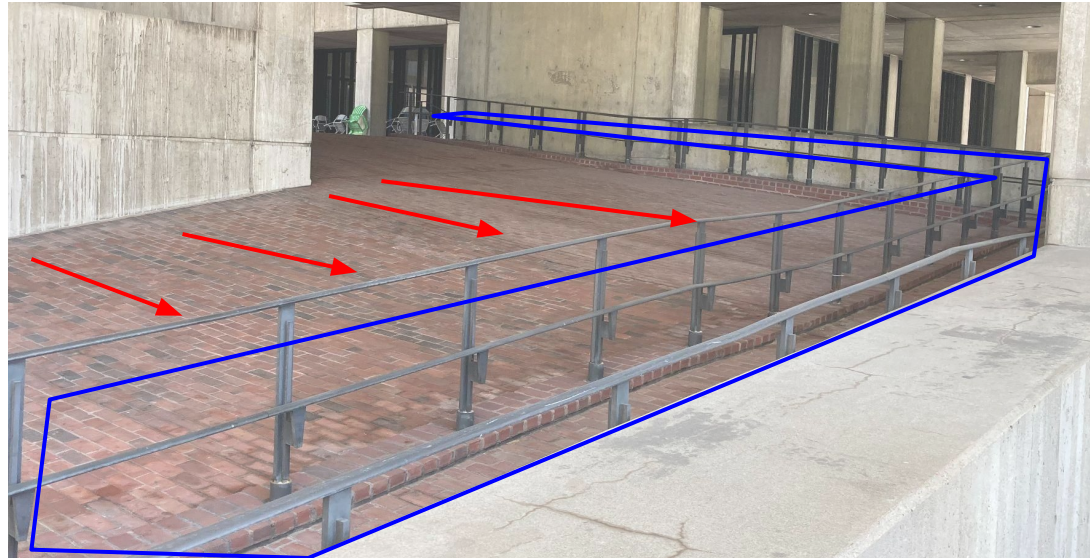
Existing Conditions Issues

- Existing cross slopes of existing ramps significantly exceed ADA requirements and create hazardous conditions for all people (slipping, challenging)
- Existing wheelchair ramp is non-conforming requiring modification and update but not feasible within existing conditions

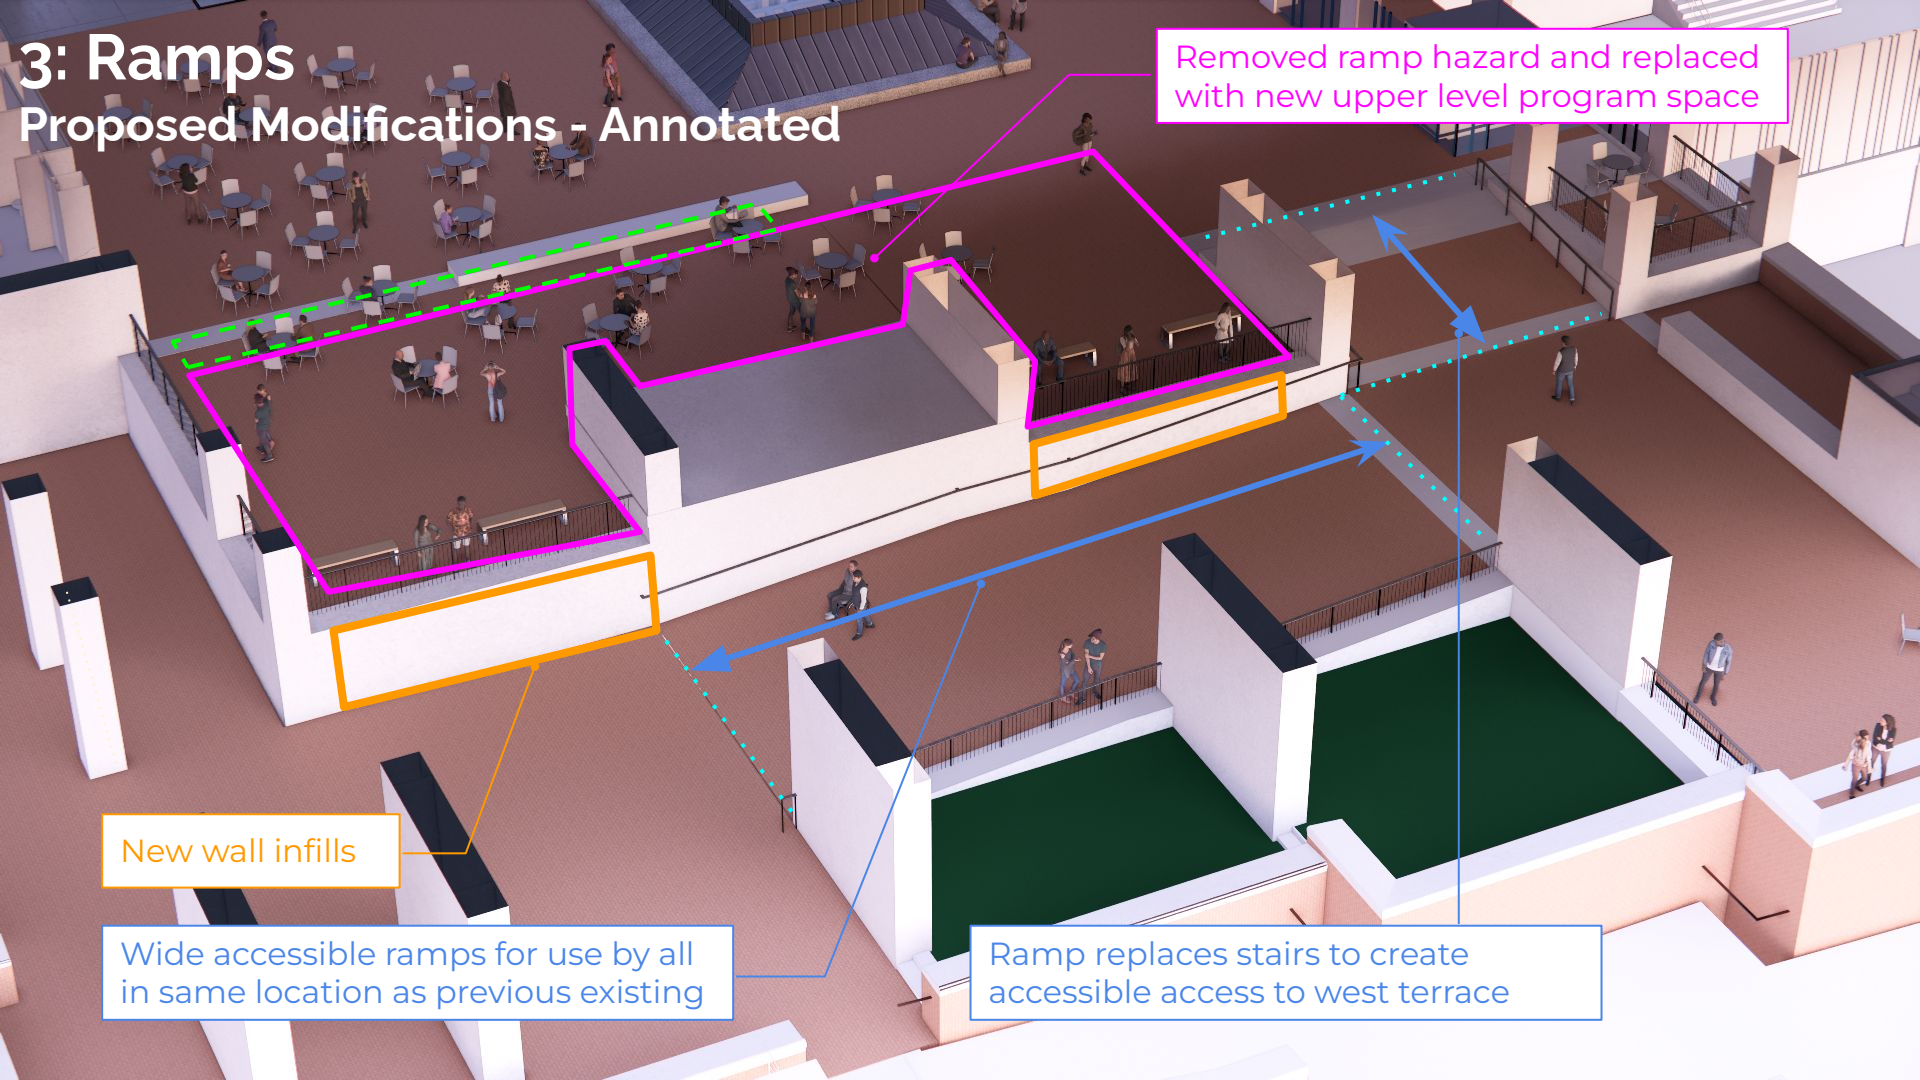
Proposed Modifications - Annotated

Removed ramp hazard and replaced with new upper level program space

New wall infills

Wide accessible ramps for use by all in same location as previous existing

Ramp replaces stairs to create accessible access to west terrace

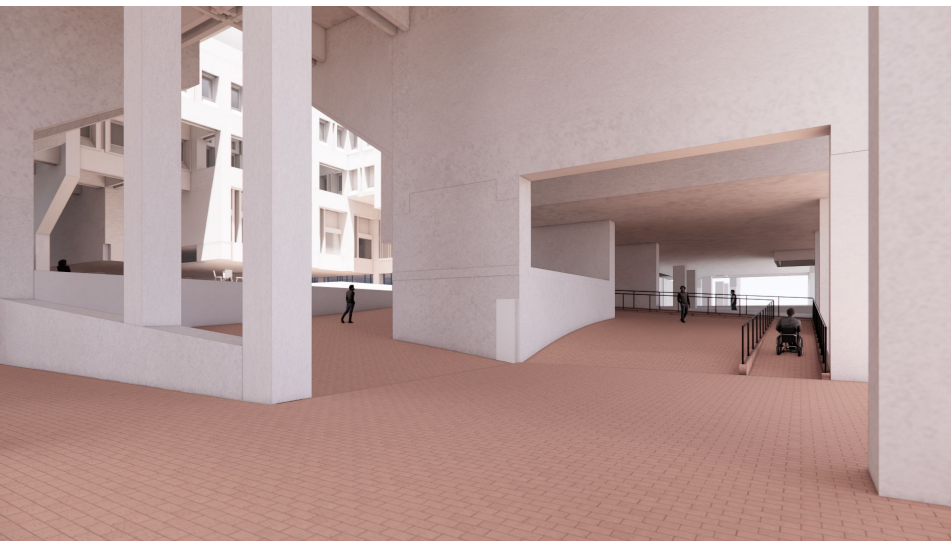
Existing Conditions

View from lower terrace

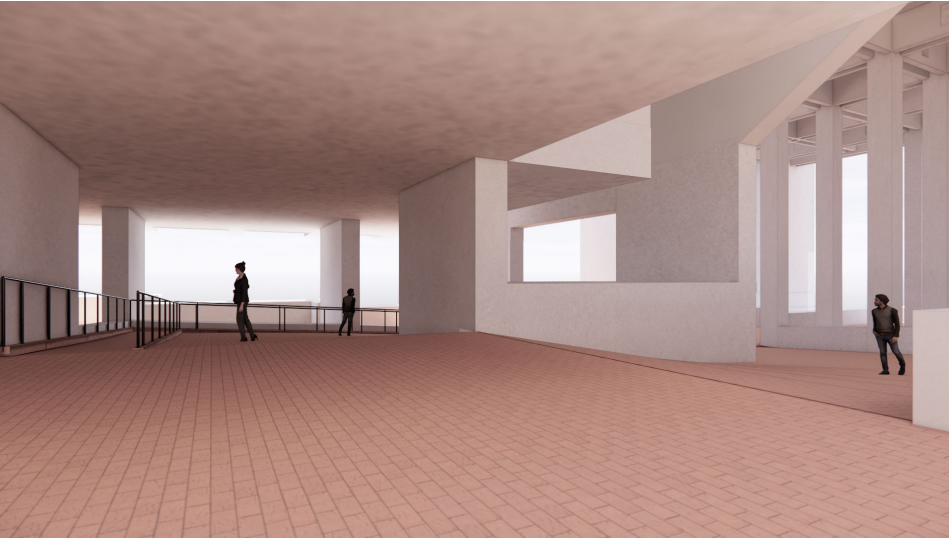
Existing Conditions

View from atop ramps

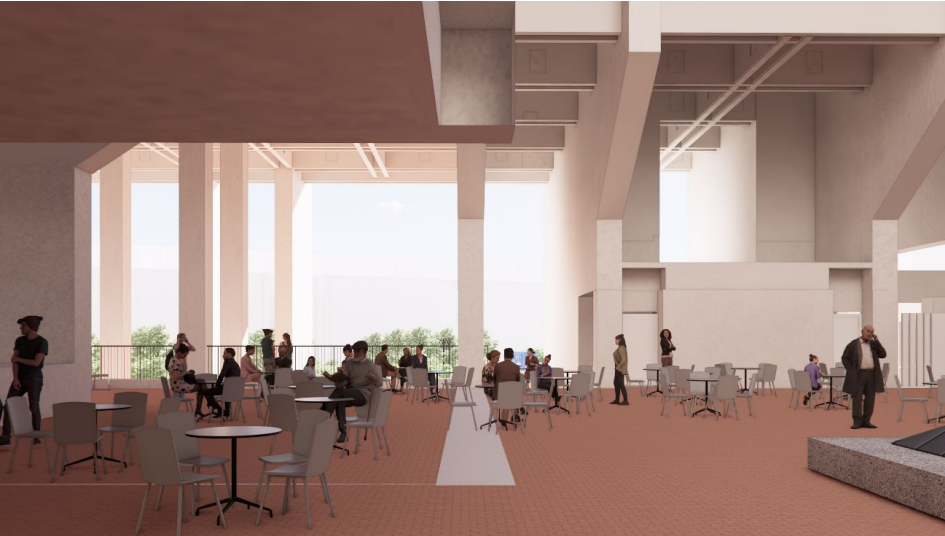
Flush Paving to Reference Old Barrier Wall

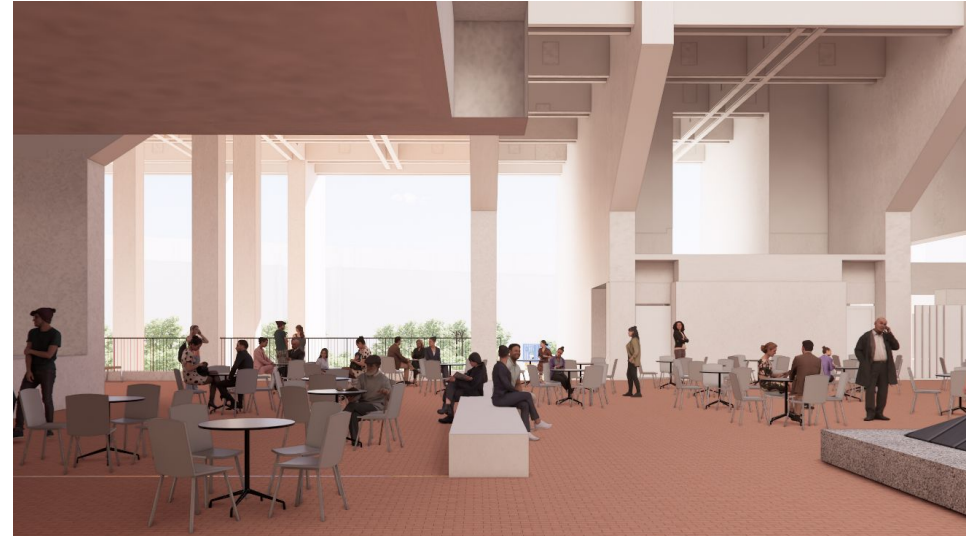
Reconstructed Bench to Reference Old Barrier Wall

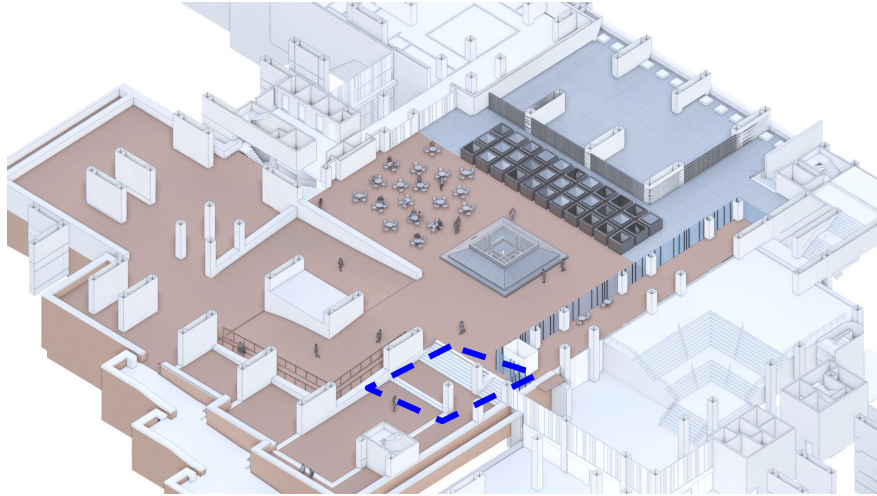
Existing Condition + Proposed Modification

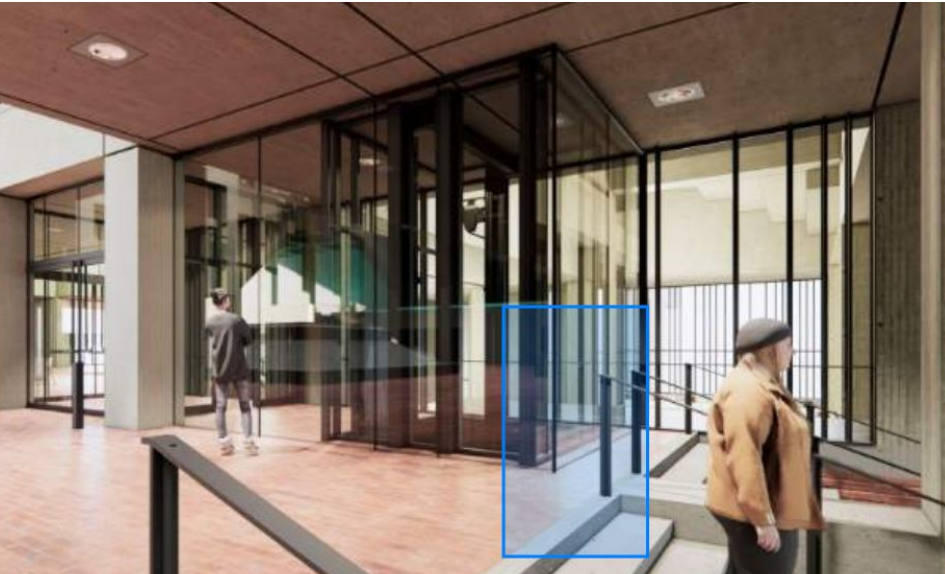
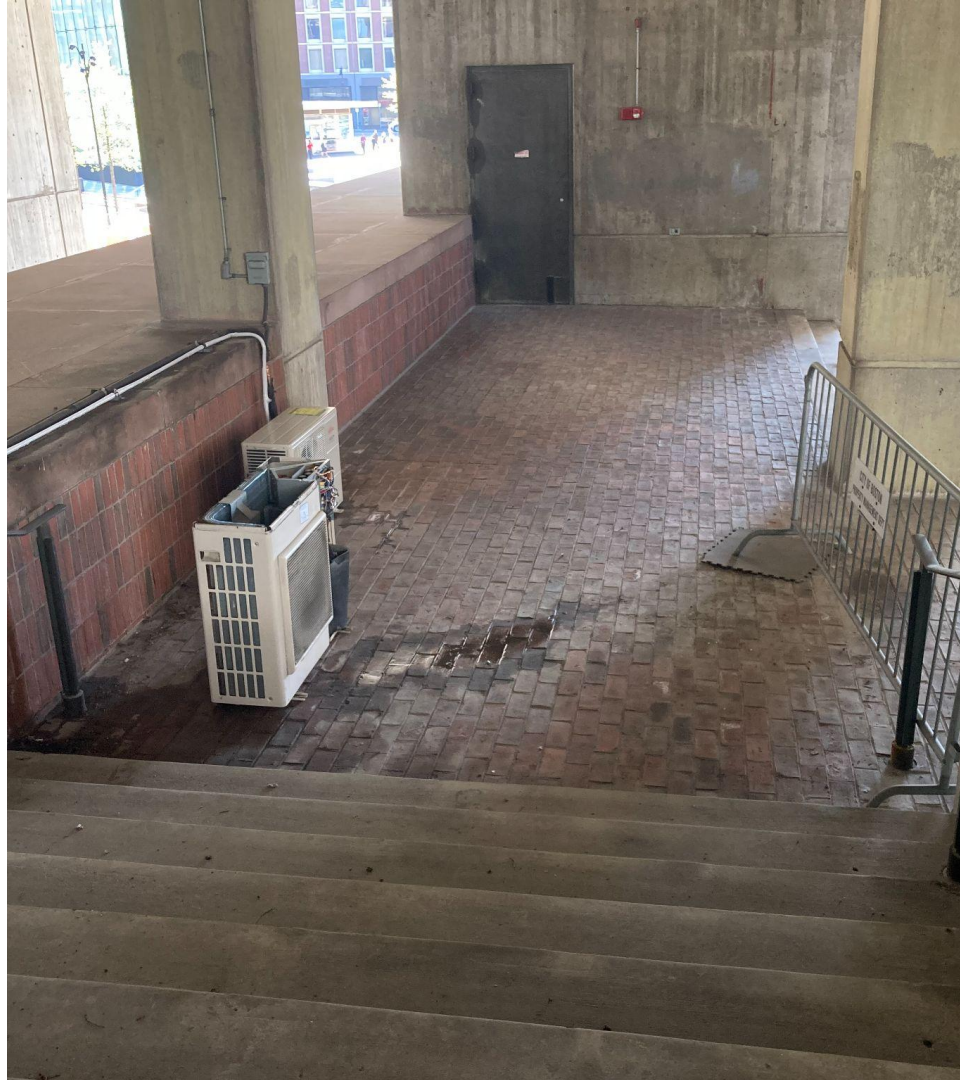
Existing Issues

- New Mezzanine project at top of existing stairs precludes access
- Existing Steps would lead to inaccessible lower space

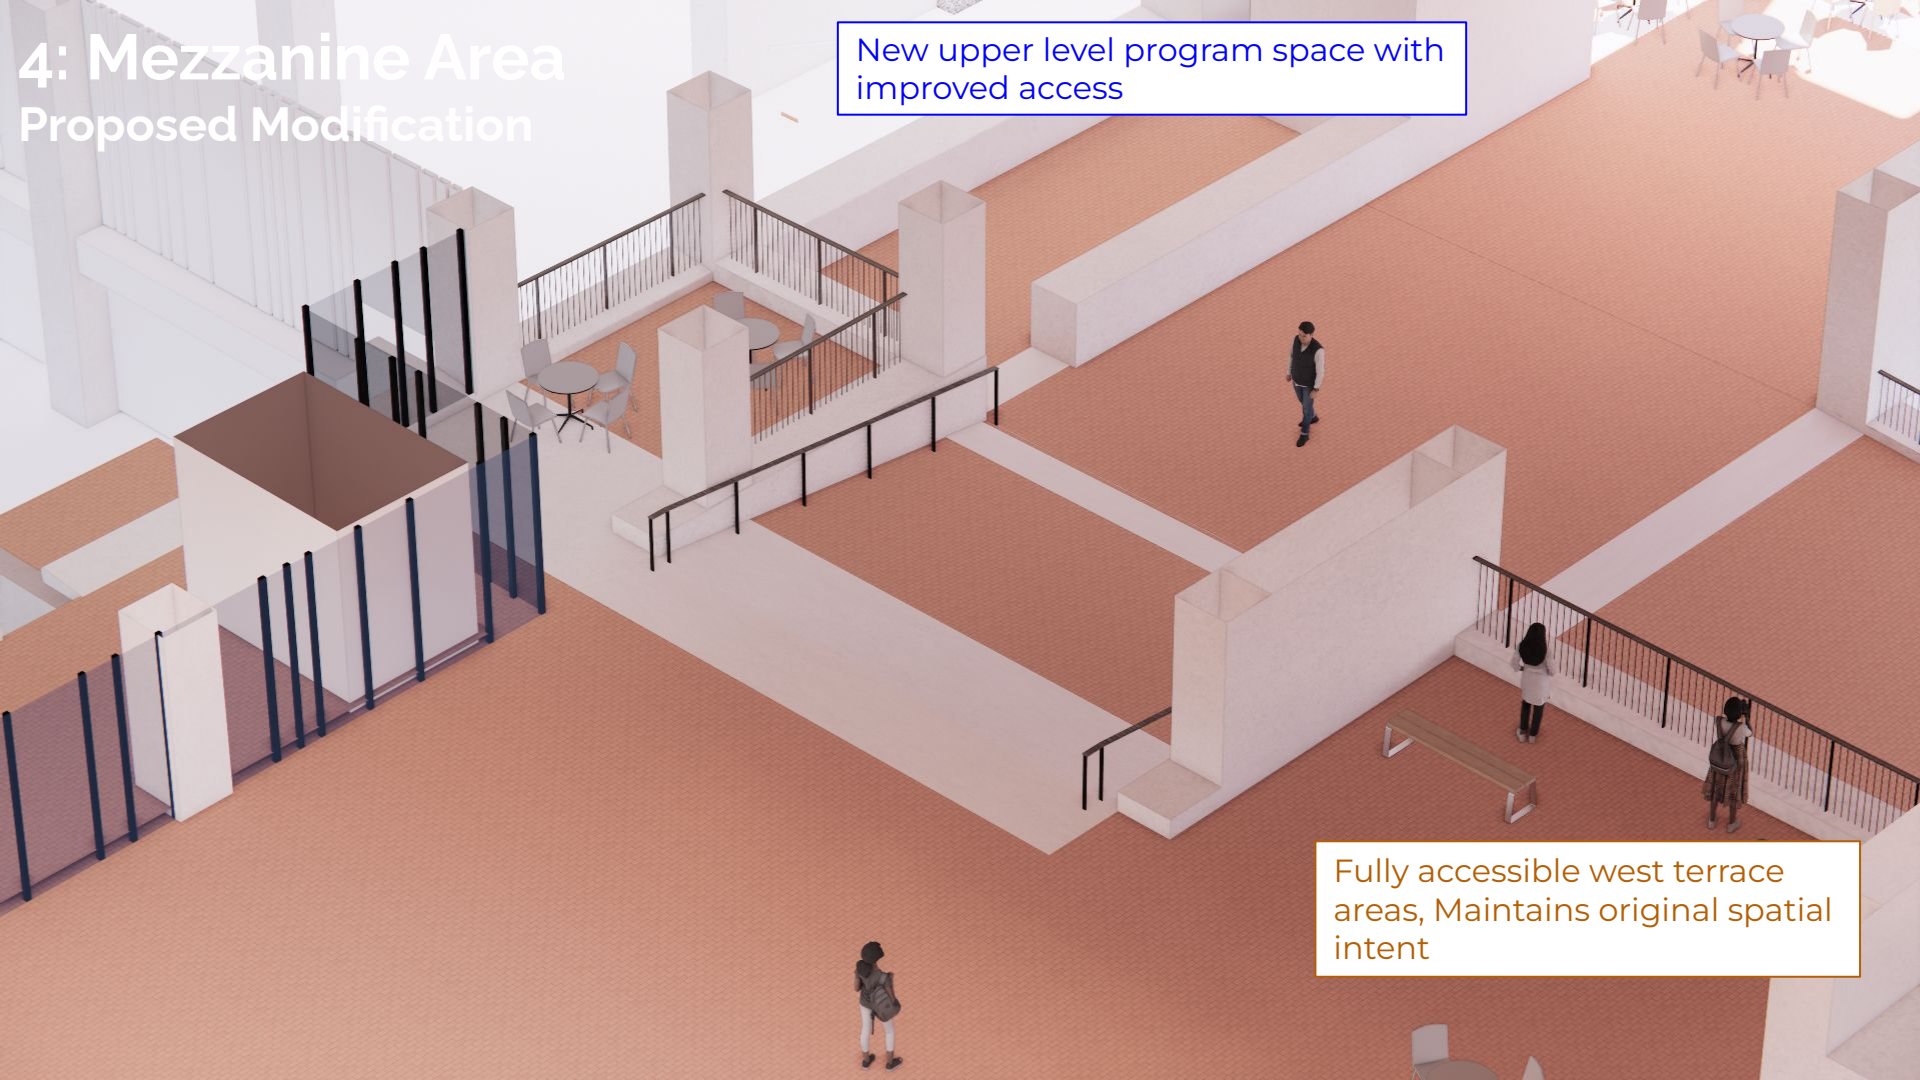
Proposed Modification

New upper level program space with improved access

Fully accessible west terrace areas, Maintains original spatial intent

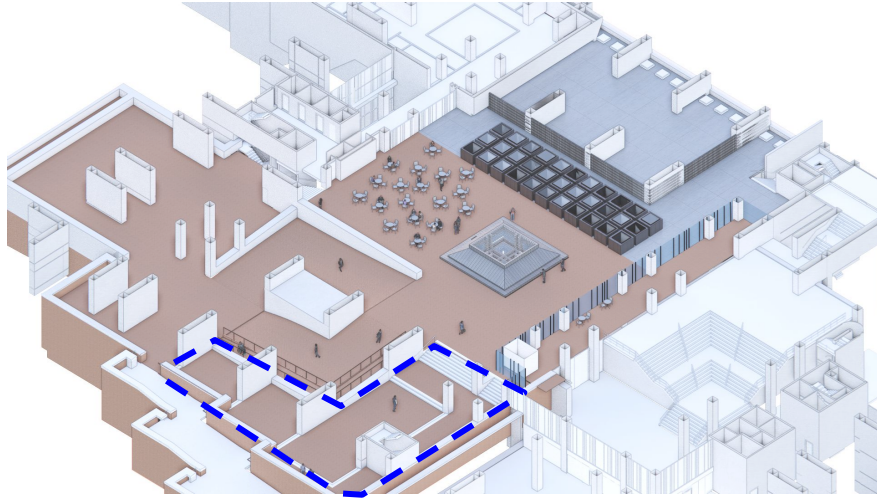
Existing Condition + Proposed Modification

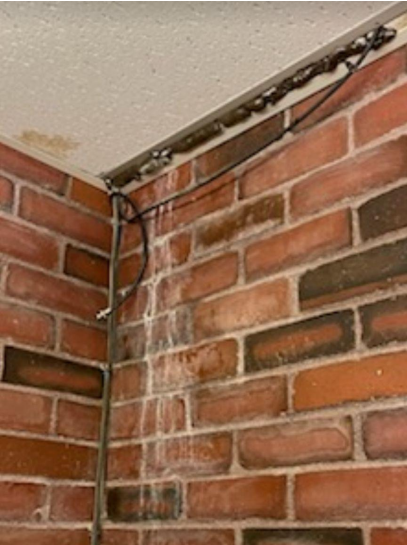
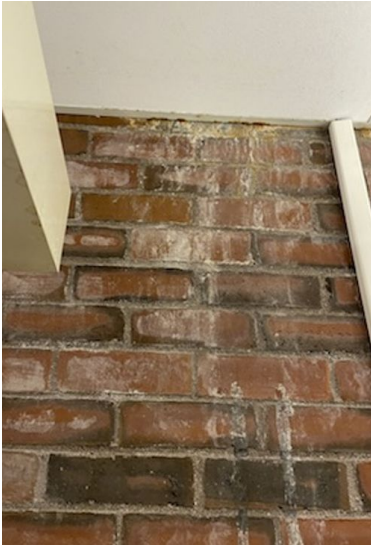
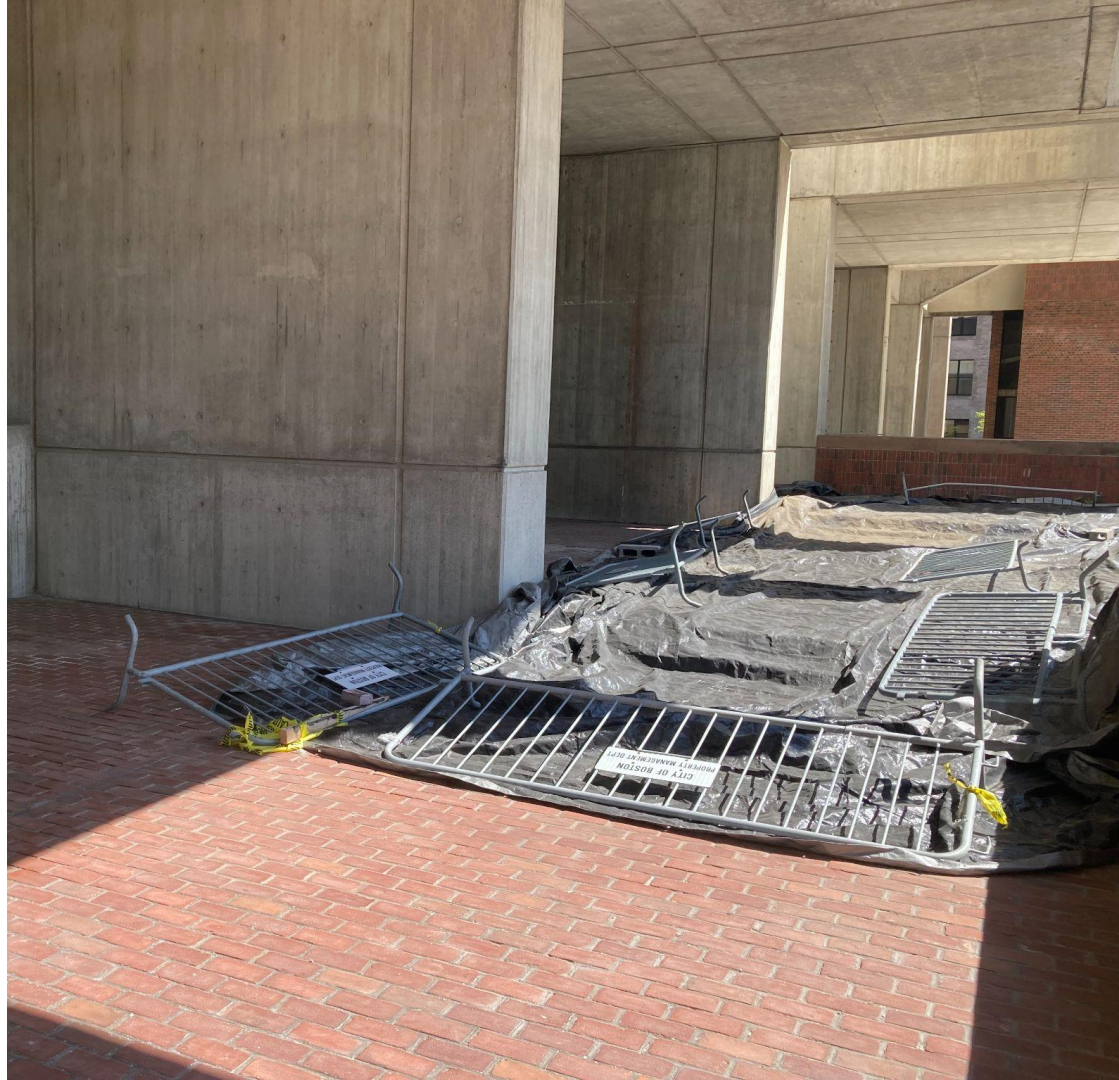
Existing Issues

- Significant leakage and roof drainage blockages over Treasury Department area
- Water damages within office spaces below 4th Floor

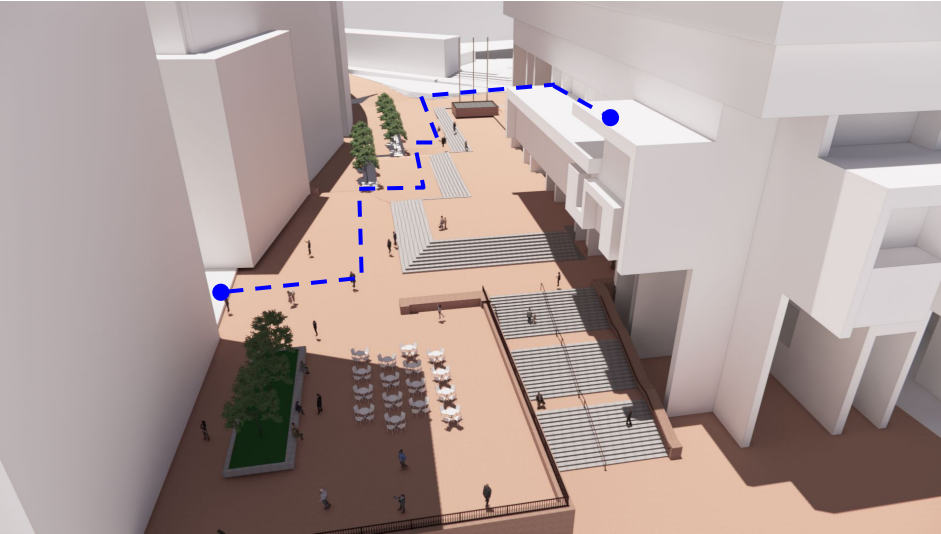
Existing Conditions

ADA/Stroller Route to Main Entrance: **730 ft**

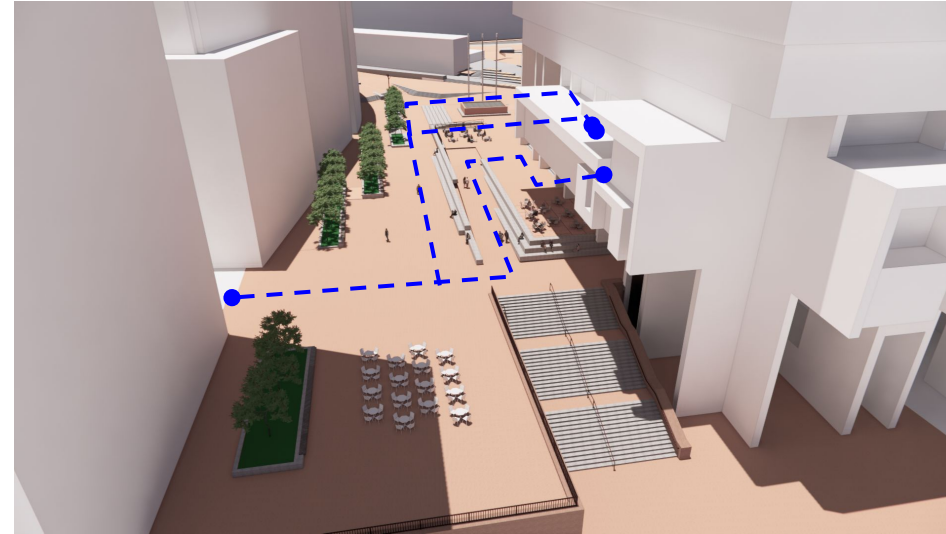
Proposed Conditions

ADA/Stroller Route to Main Entrance: **360 ft**
(approx -180 sec or **-3 min less time**)
