The Boston Children's Museum | 308 Congress Street, Boston, MA Building-level Flood Resilience Assessment

3. Building Level Threat and Resilience Approach

5. Preferred Strategy Evaluation – Design Approach

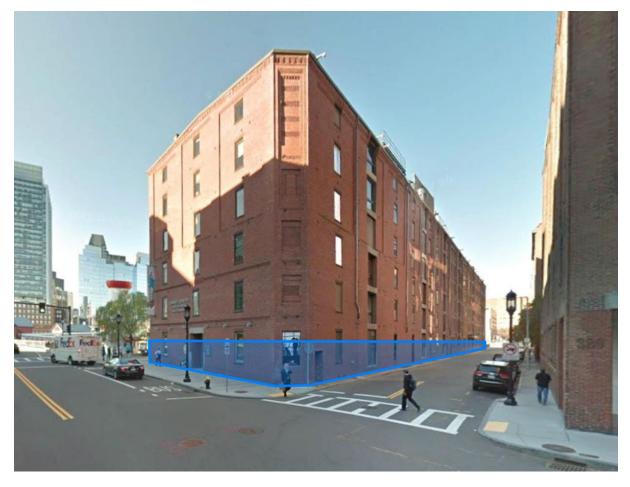
Proposed Strategy – Extents of Treatment

Congress St Towards Atrium

Corner of Congress and Sleeper St

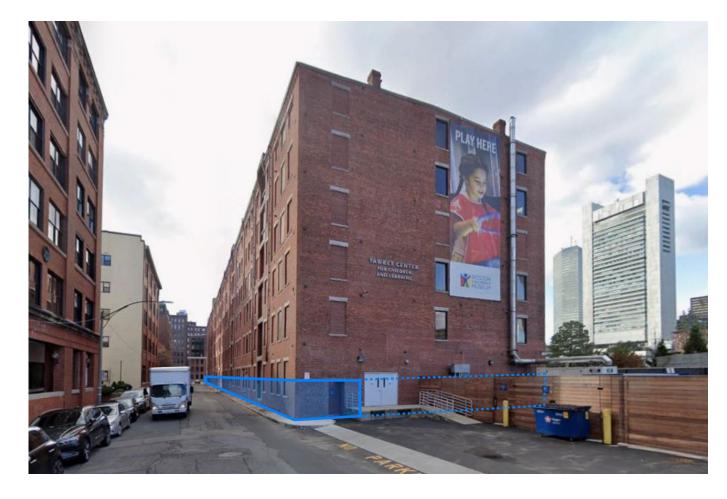
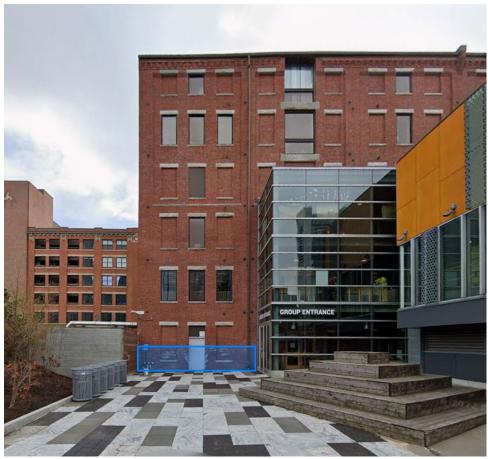
Proposed Strategy – Extents of Treatment

Sleeper St at Loading Dock

Boardwalk Side at Group Entry

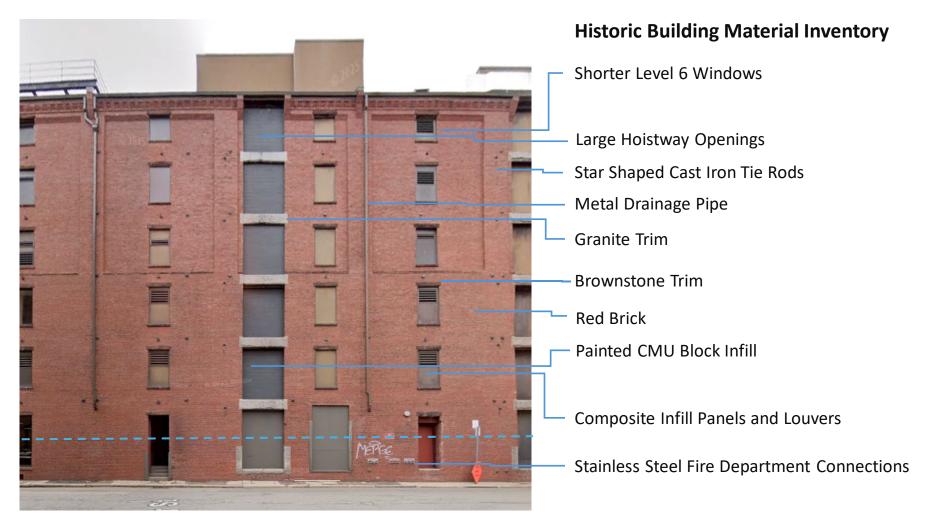
Existing Wall Analysis – Material Inventory

Sleeper Steet Façade

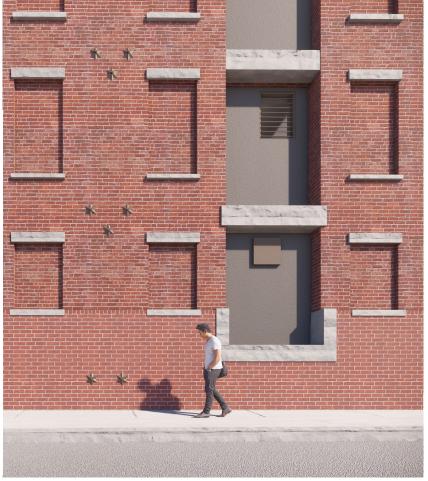
Cladding Strategy

Single Wythe Brick

Conceptual Axonometric

Conceptual Section

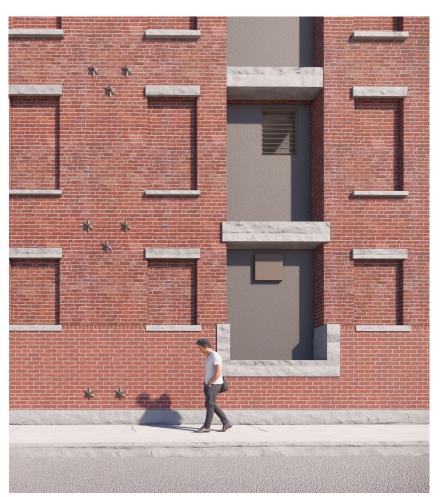
Cladding Strategy

Single Wythe with Granite Watercourse (Preferred)

Rendered Elevational View

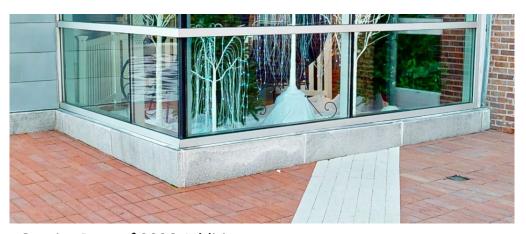
Granite Base of 2006 Addition

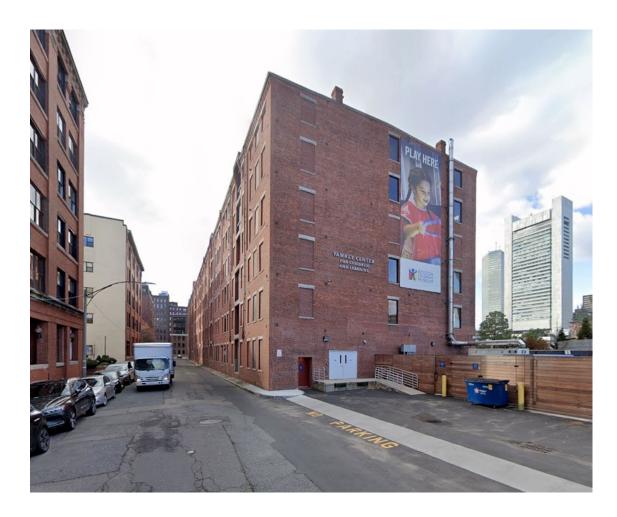
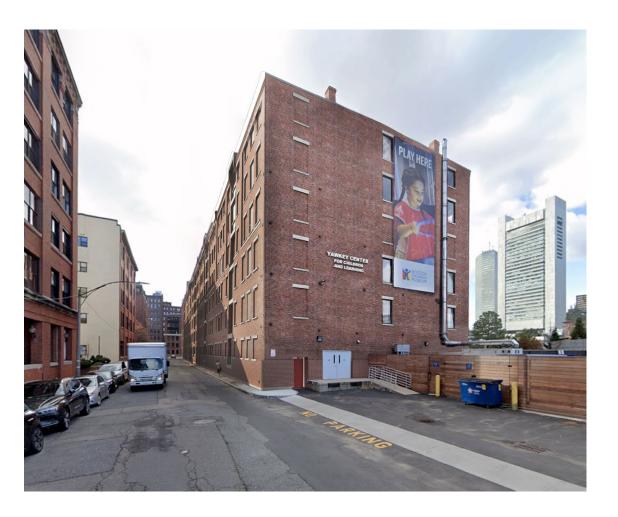
Proposed Strategy – View From Sleeper St Toward Loading Area

Existing Proposed

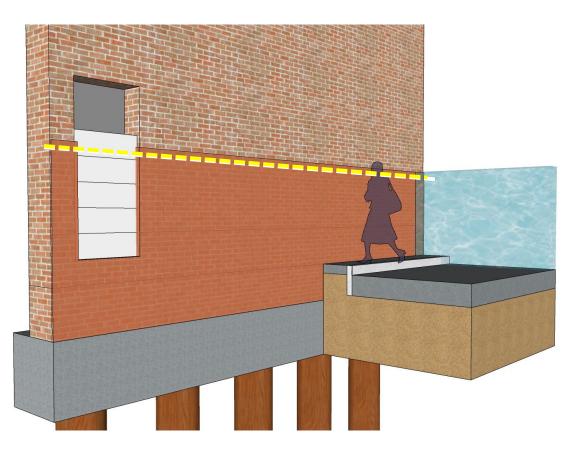
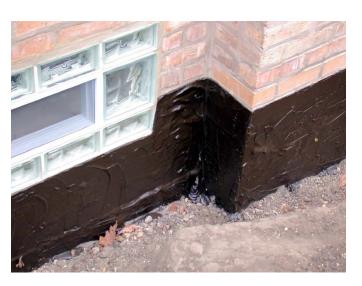
Protecting the historic walls Dismissed Strategy 1

Strategy 1

- Apply opaque/semi-opaque fluid-applied waterproofing to face of exterior brick up to DFE.
- Provide fittings for stop logs at openings.

- Significant detriment to appearance
- Loss of natural brick expression at street level
- Membrane left exposed and subject to damage

Strategy 1 – waterproofing applied to face of exterior brick.

- Least invasive
- Least effective
- Changes character
- Shorter maintenance cycle

Determined to be an inadequate solution due to the **poor external appearance** coupled with **durability** and **performance concerns** from leaving the membrane exposed

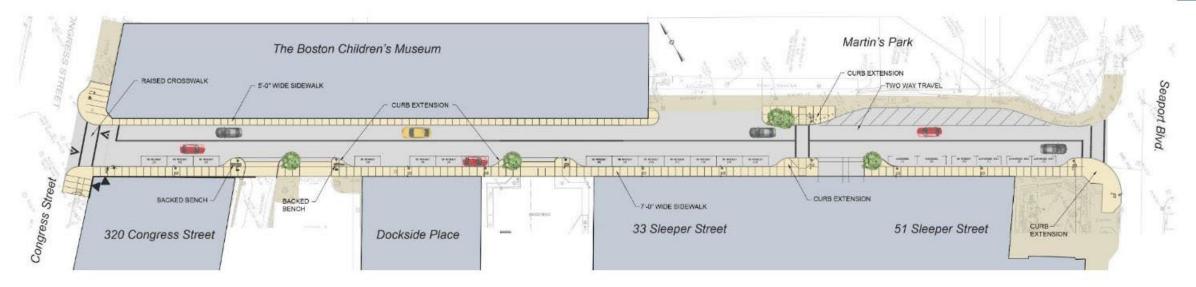
SLEEPER STREET DESIGN COMPARISON

PREVIOUS DESIGN

- RAISED CROSSWALKS
- **SPEED HUMPS**
- **BIKE LANE WIDTH**

SIDEWALK WIDTH

- **ON-STREET PARKING SPACES**
- **CIRCULATION PATTERN**

- 5 feet on west side, 7 feet on east side
- 2 provided
- 3 provided
- No bike lane provided
- 20 provided
- Two-way
