## 226 Beacon Street

### *Applicaton for Design Review to the Back Bay Architectural District Commission*

Prepared By:  
Carpenter & MacNeille Architects and Builders  
106 Western Ave, Essex, MA 01929

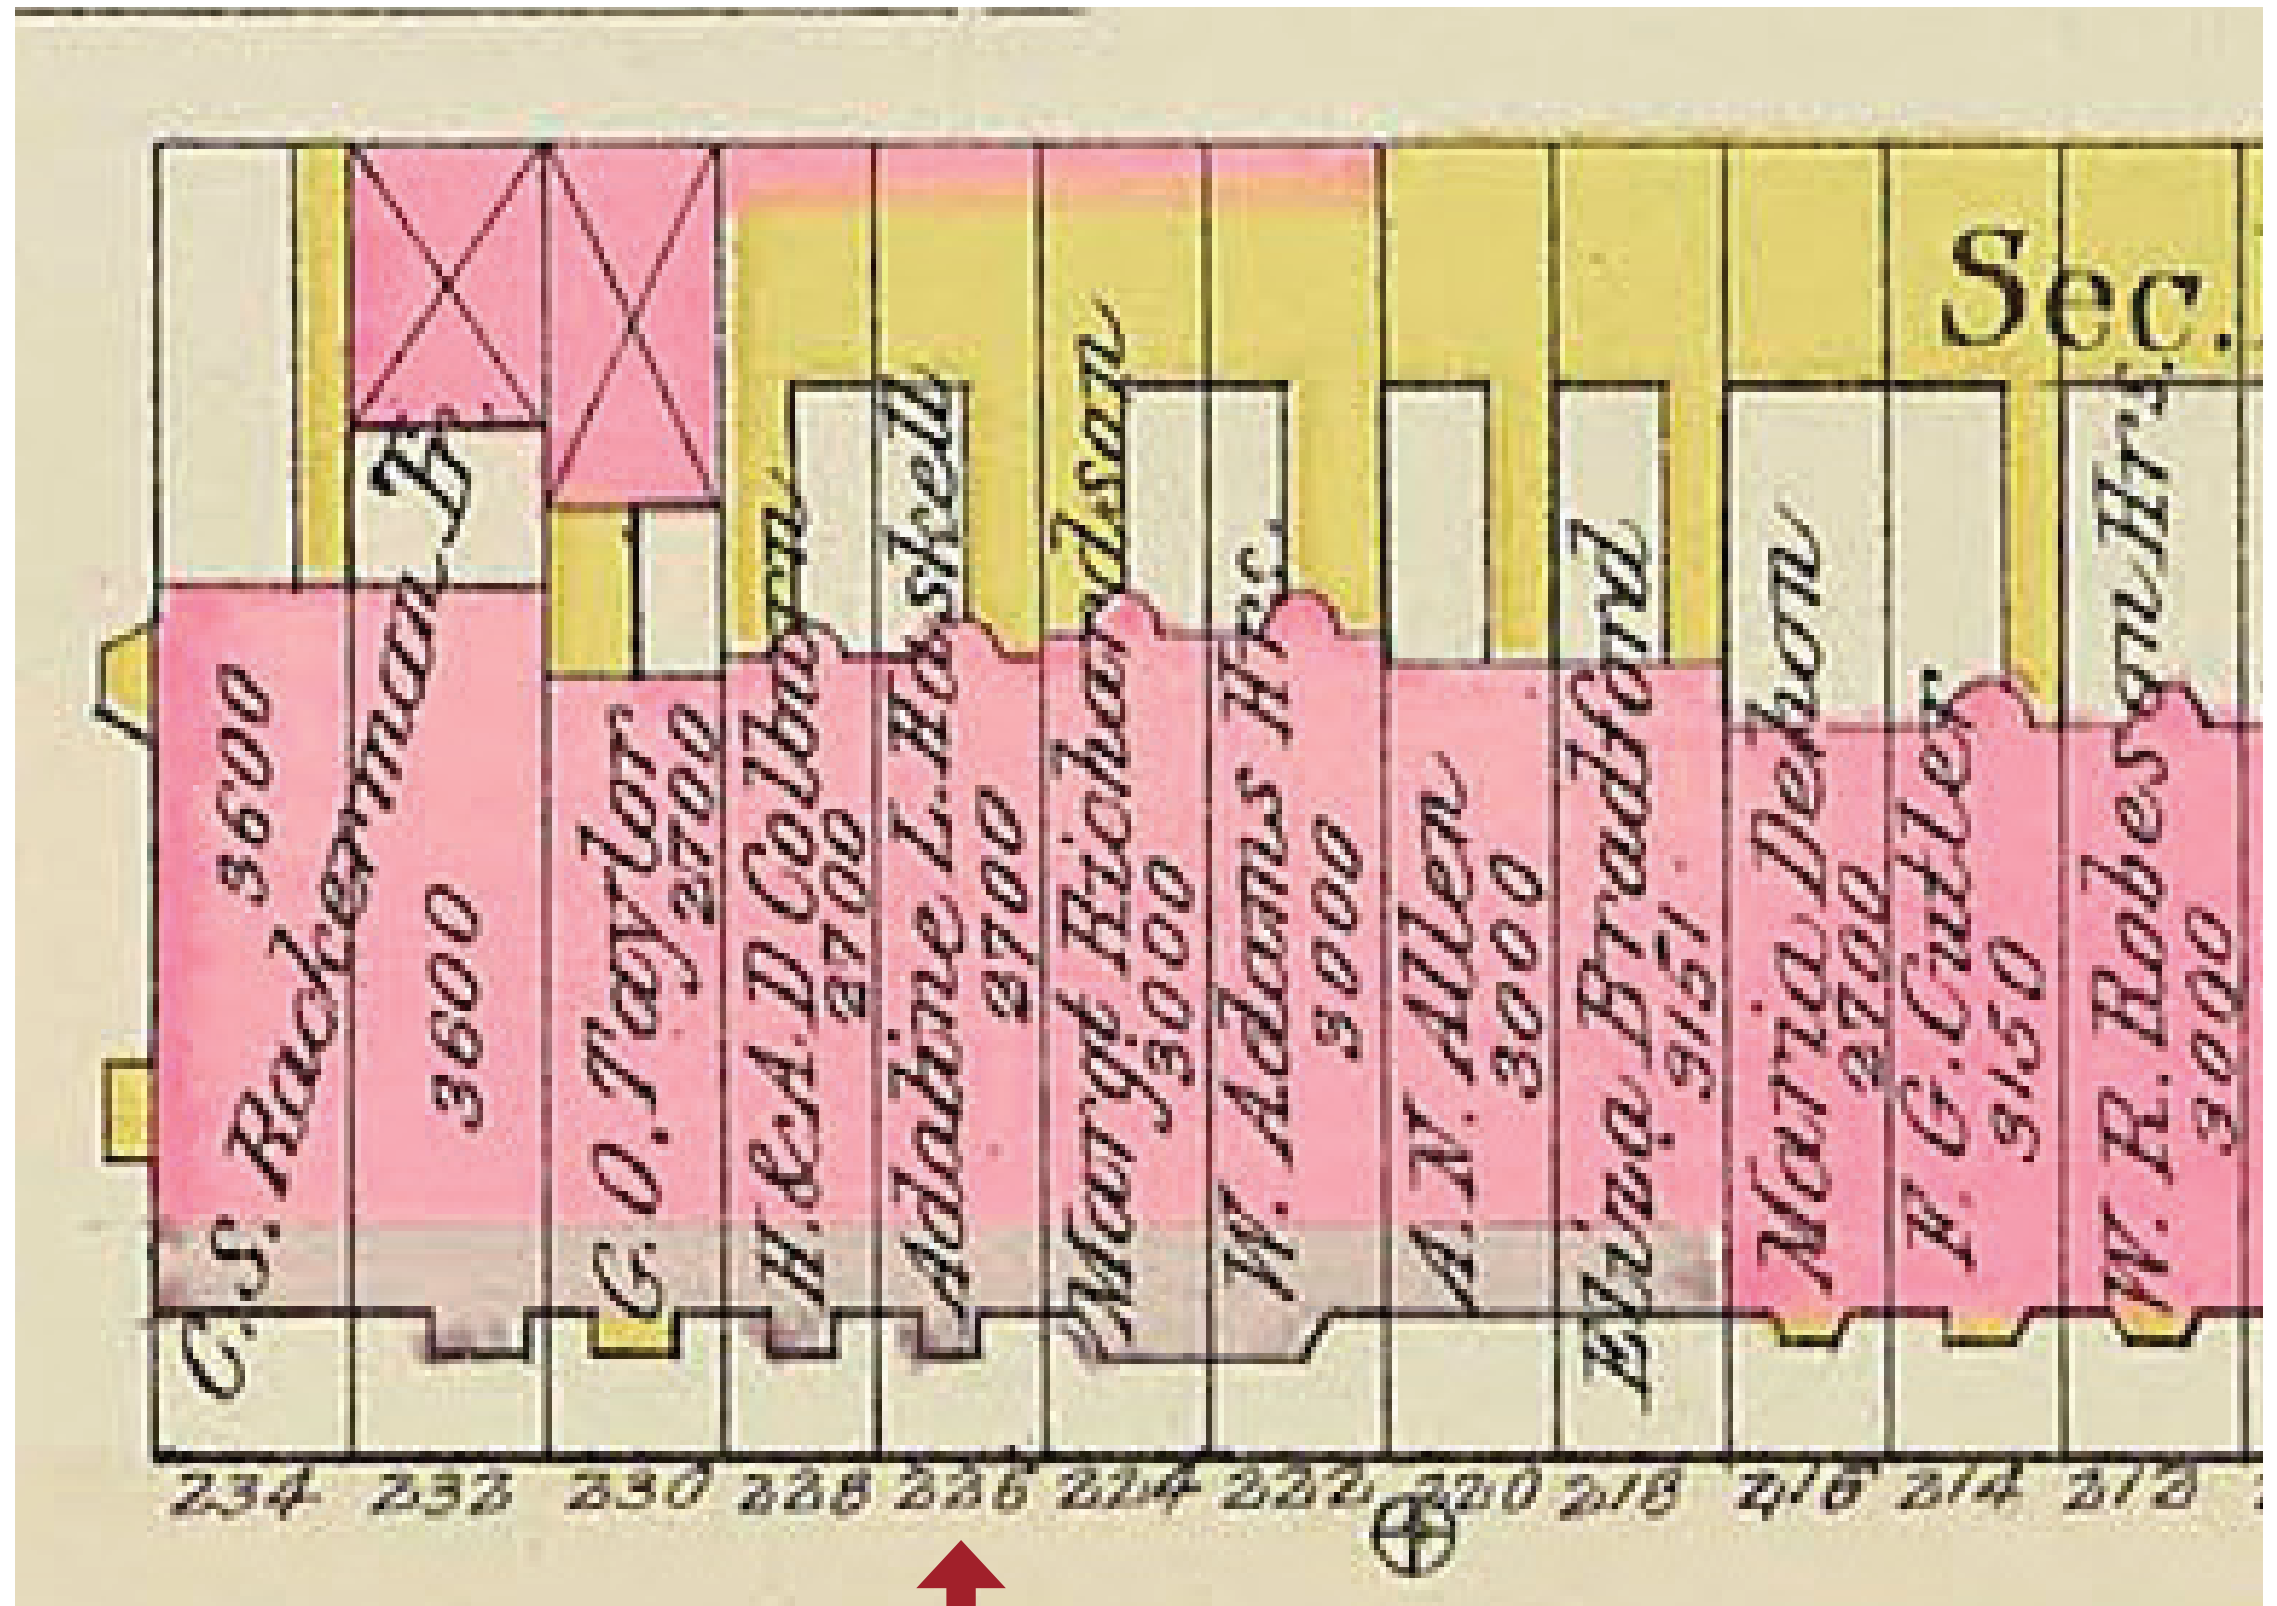
Enlargement from Plate 8,  
Bromley Atlas (1895)

1895 Atlas indicating historic footprint of portico at #226 Beacon Street

Portico depth was congruent with neighboring projections at #228, #230 and #232 which are no longer extant

Map indicates portico depth was almost aligned with the angled bay at #224/22 which still stands today.

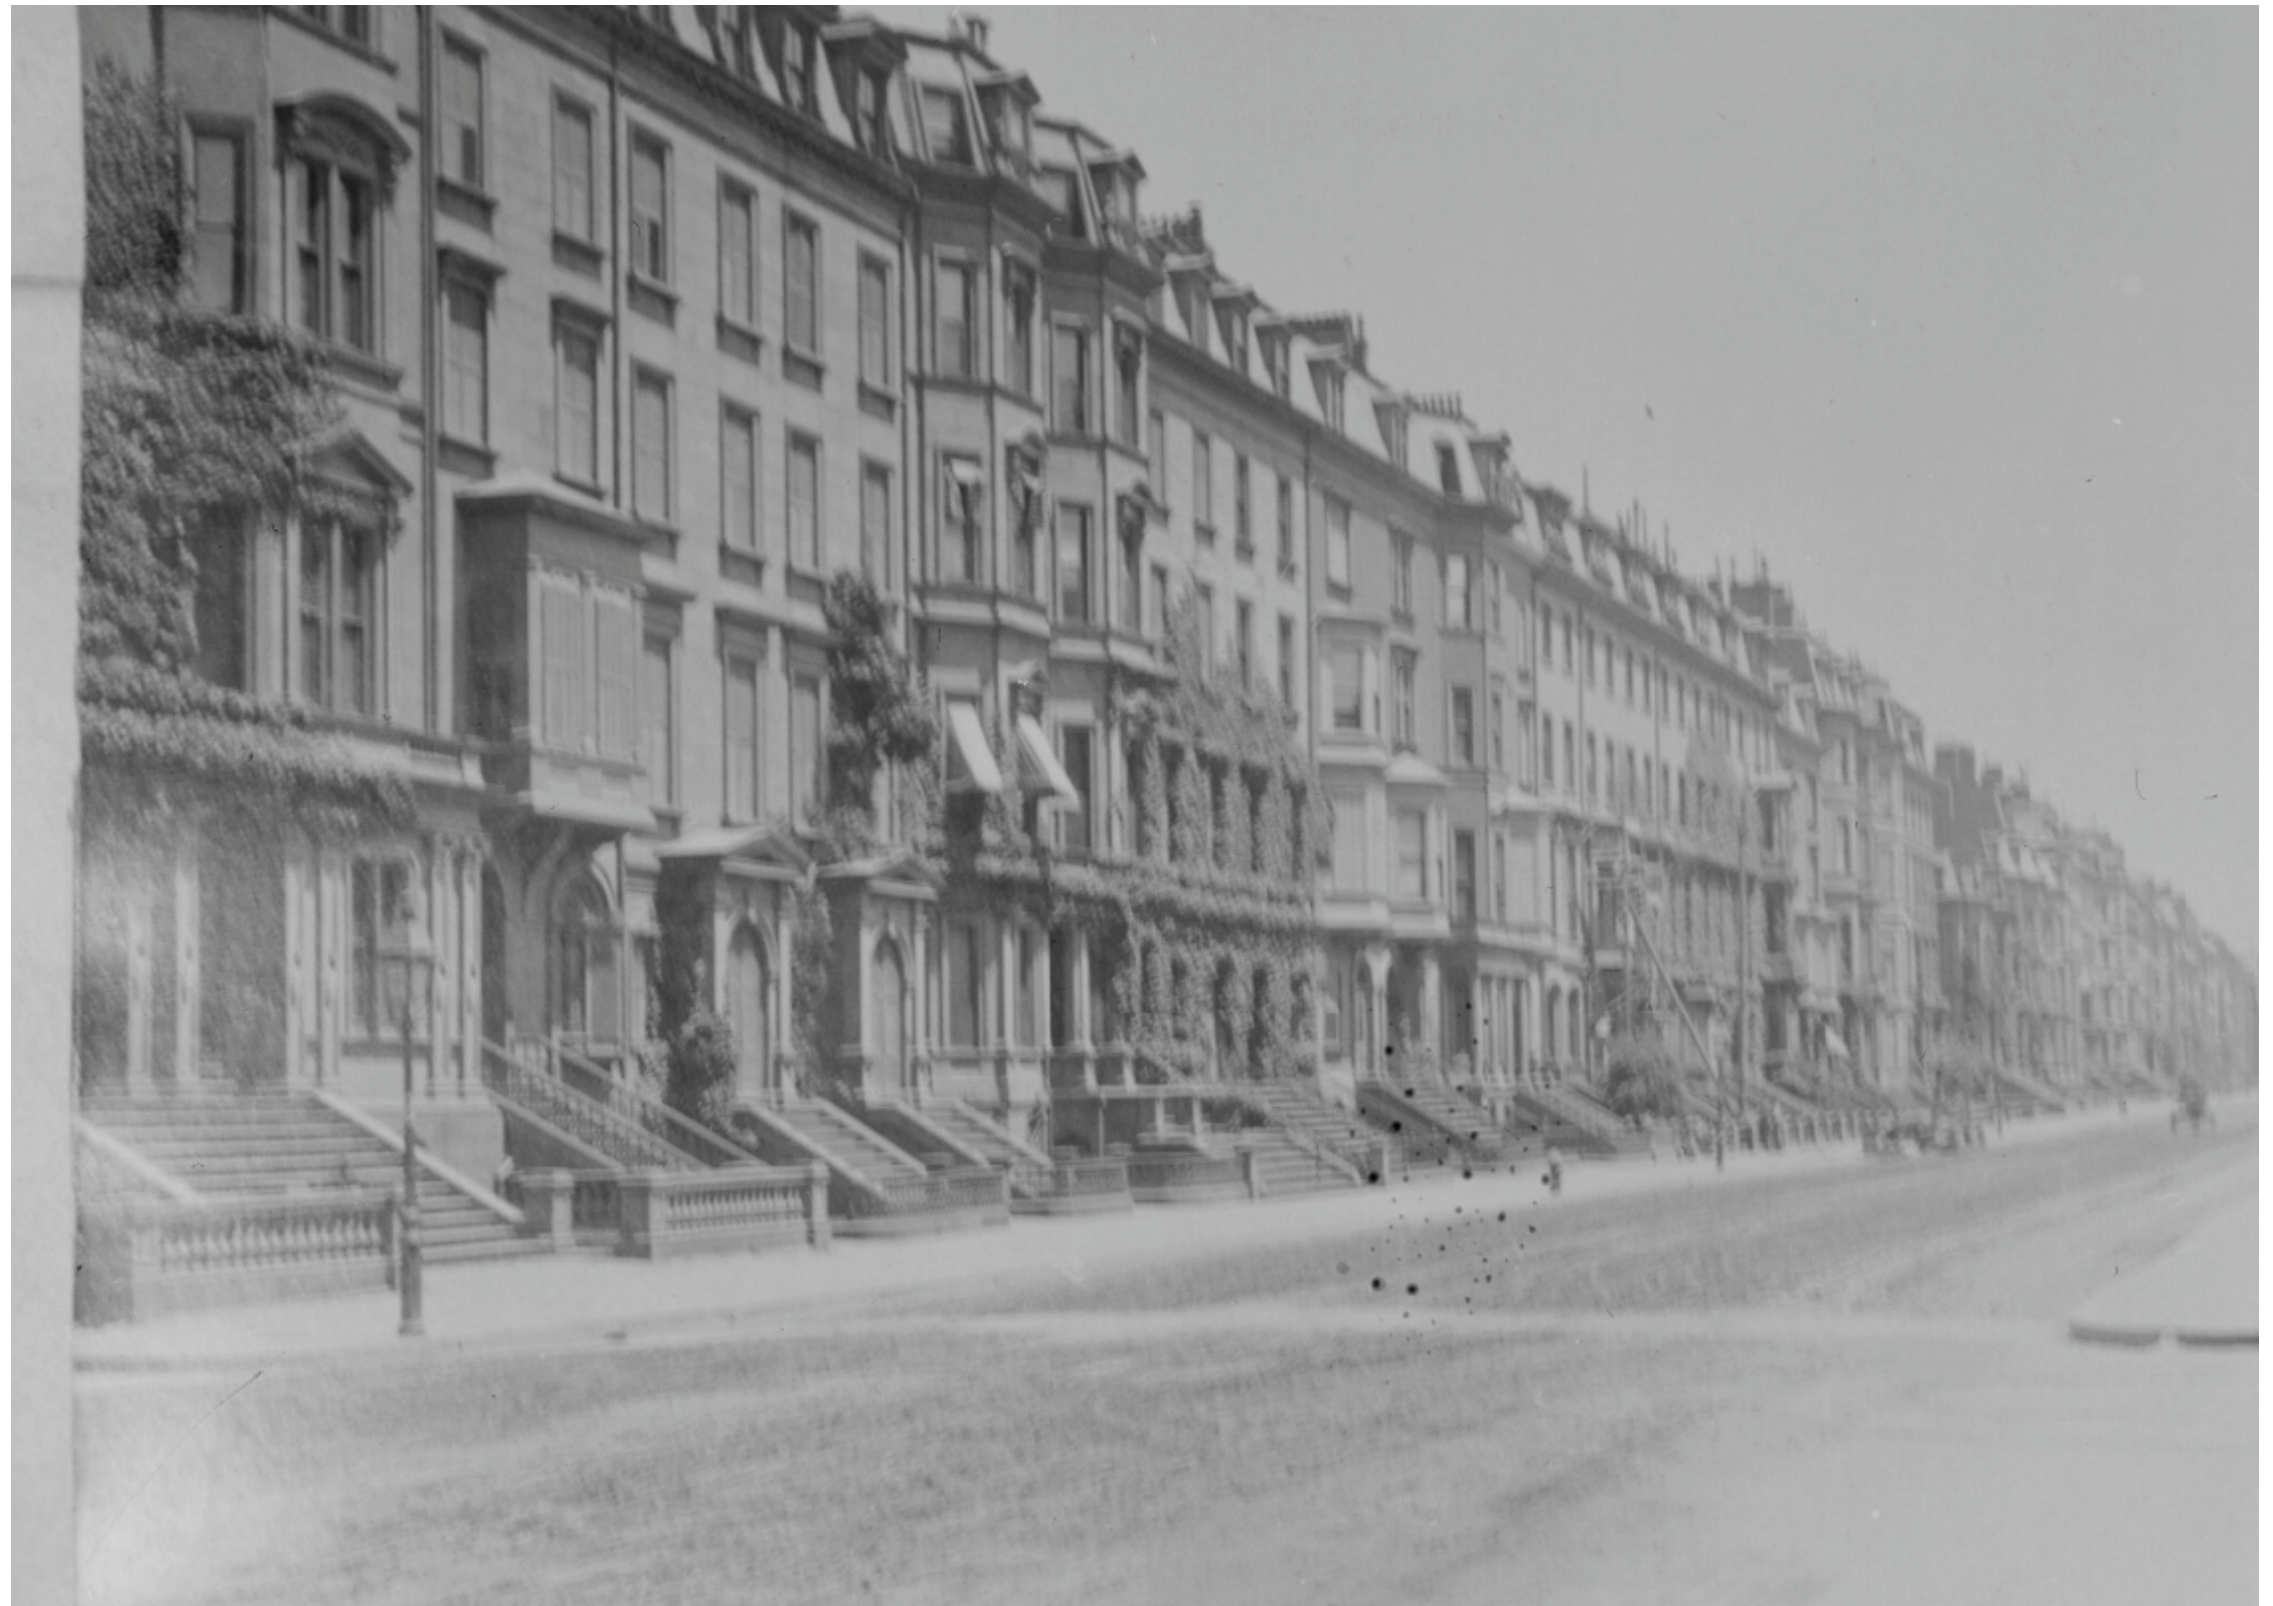
*Ca. 1885  
View along Beacon Street from  
Dartmouth Street*

Ca. 1885 view looking  
down Beacon Street  
from Dartmouth Street

Historic portico at #226  
(look for it's twin!) as  
part of the historic  
streetscape

Note the language of elevated  
entrances, stoops, and steps  
present along the historic  
streetscape, much of which is  
still present today

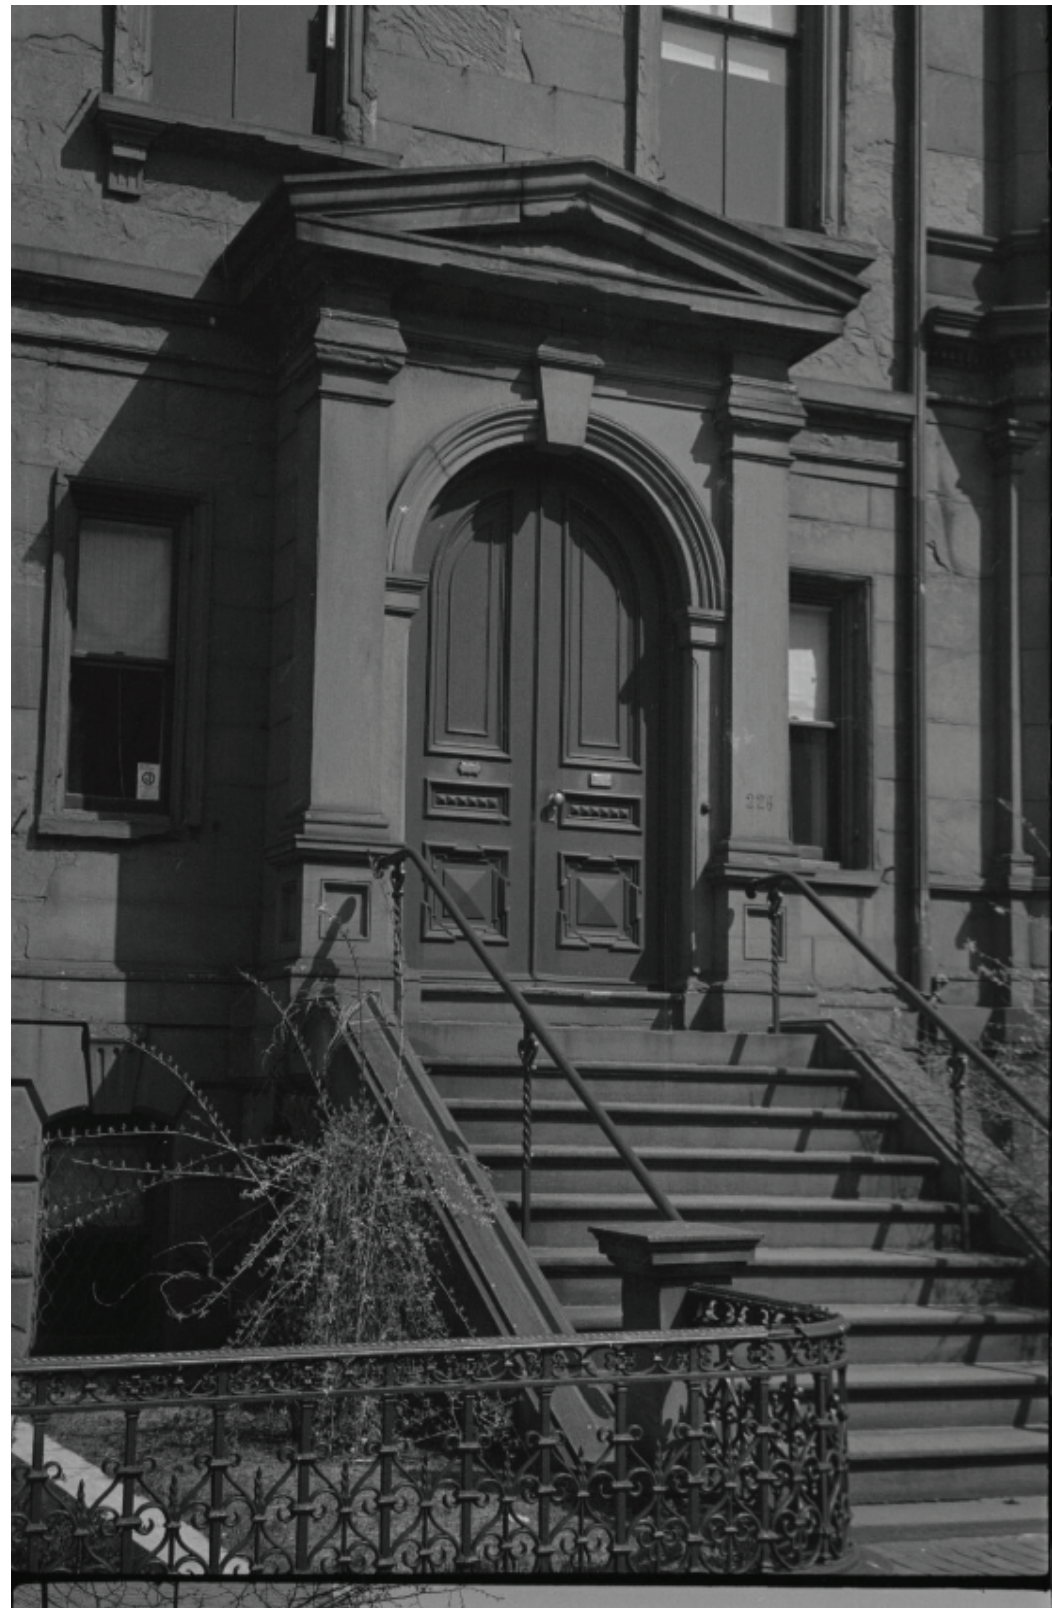
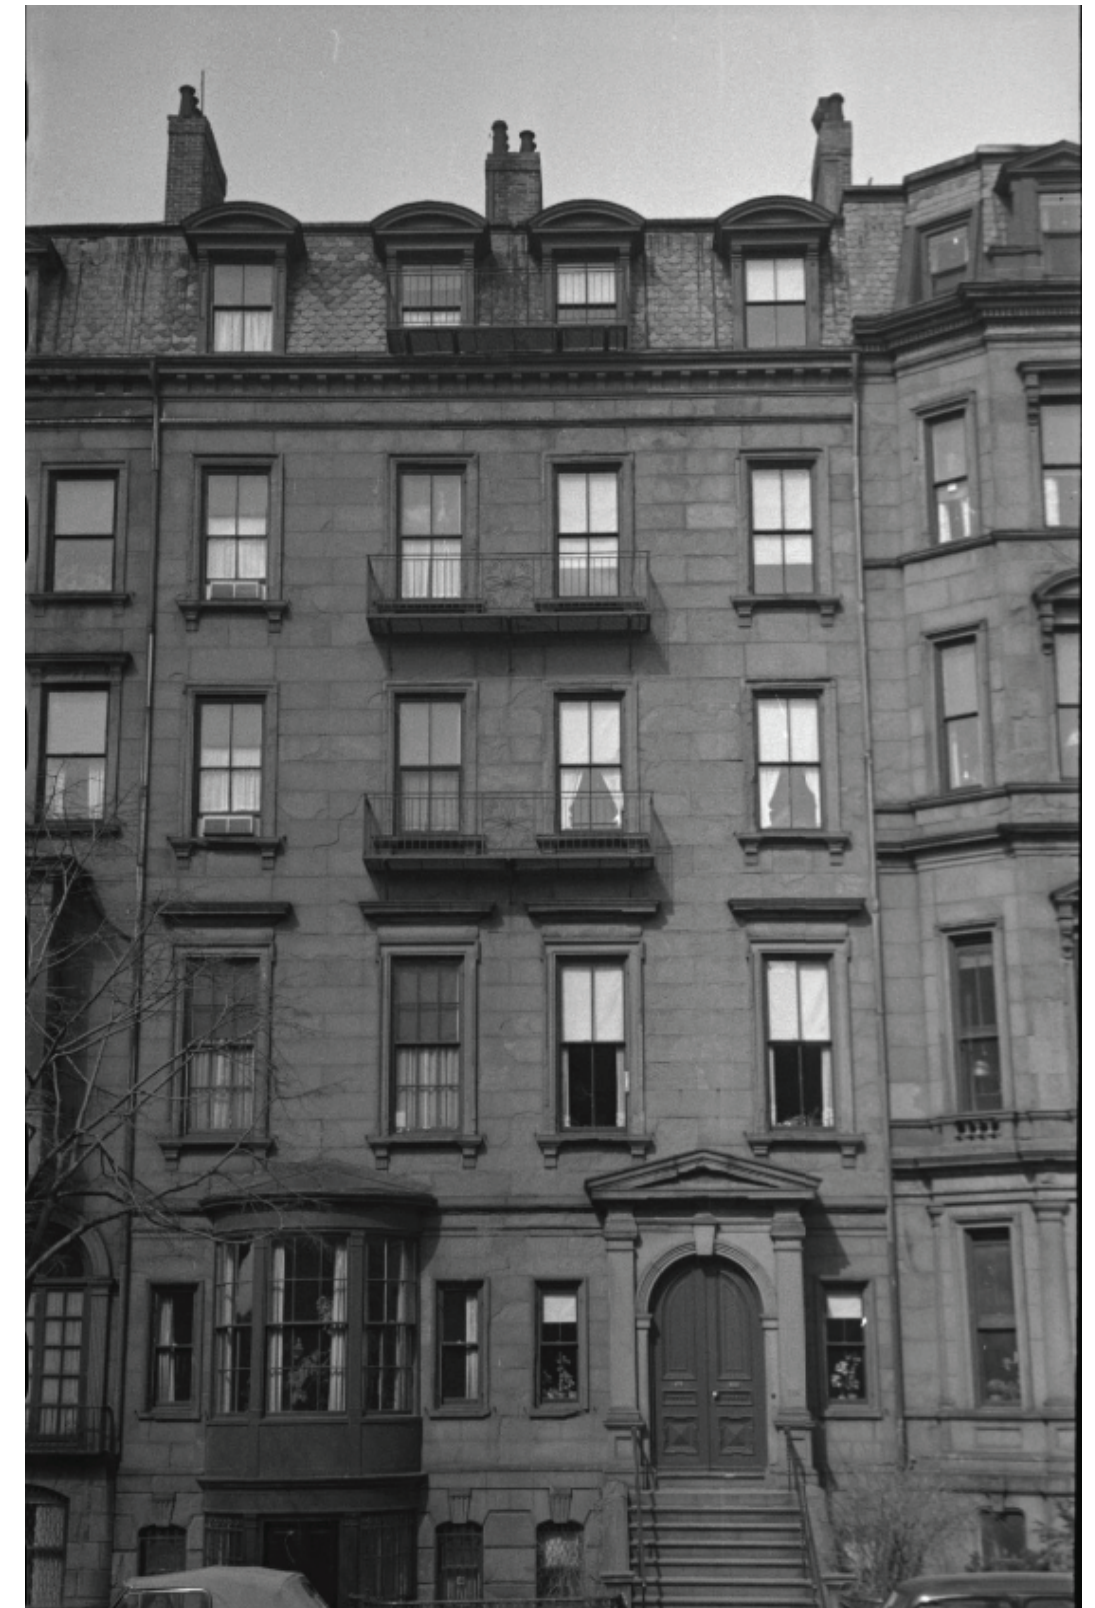
Ca. 1941  
*Views of Original Portico*

1941 photograph of original portico

Angled view (left) highlighting the historic portico's projection from the facade

The restoration of the historic portico would restore an arrangement very similar to that shown in the 1941 photograph (right) including restored portico, steps, rusticated stone base, arched windows, and decorative street fence

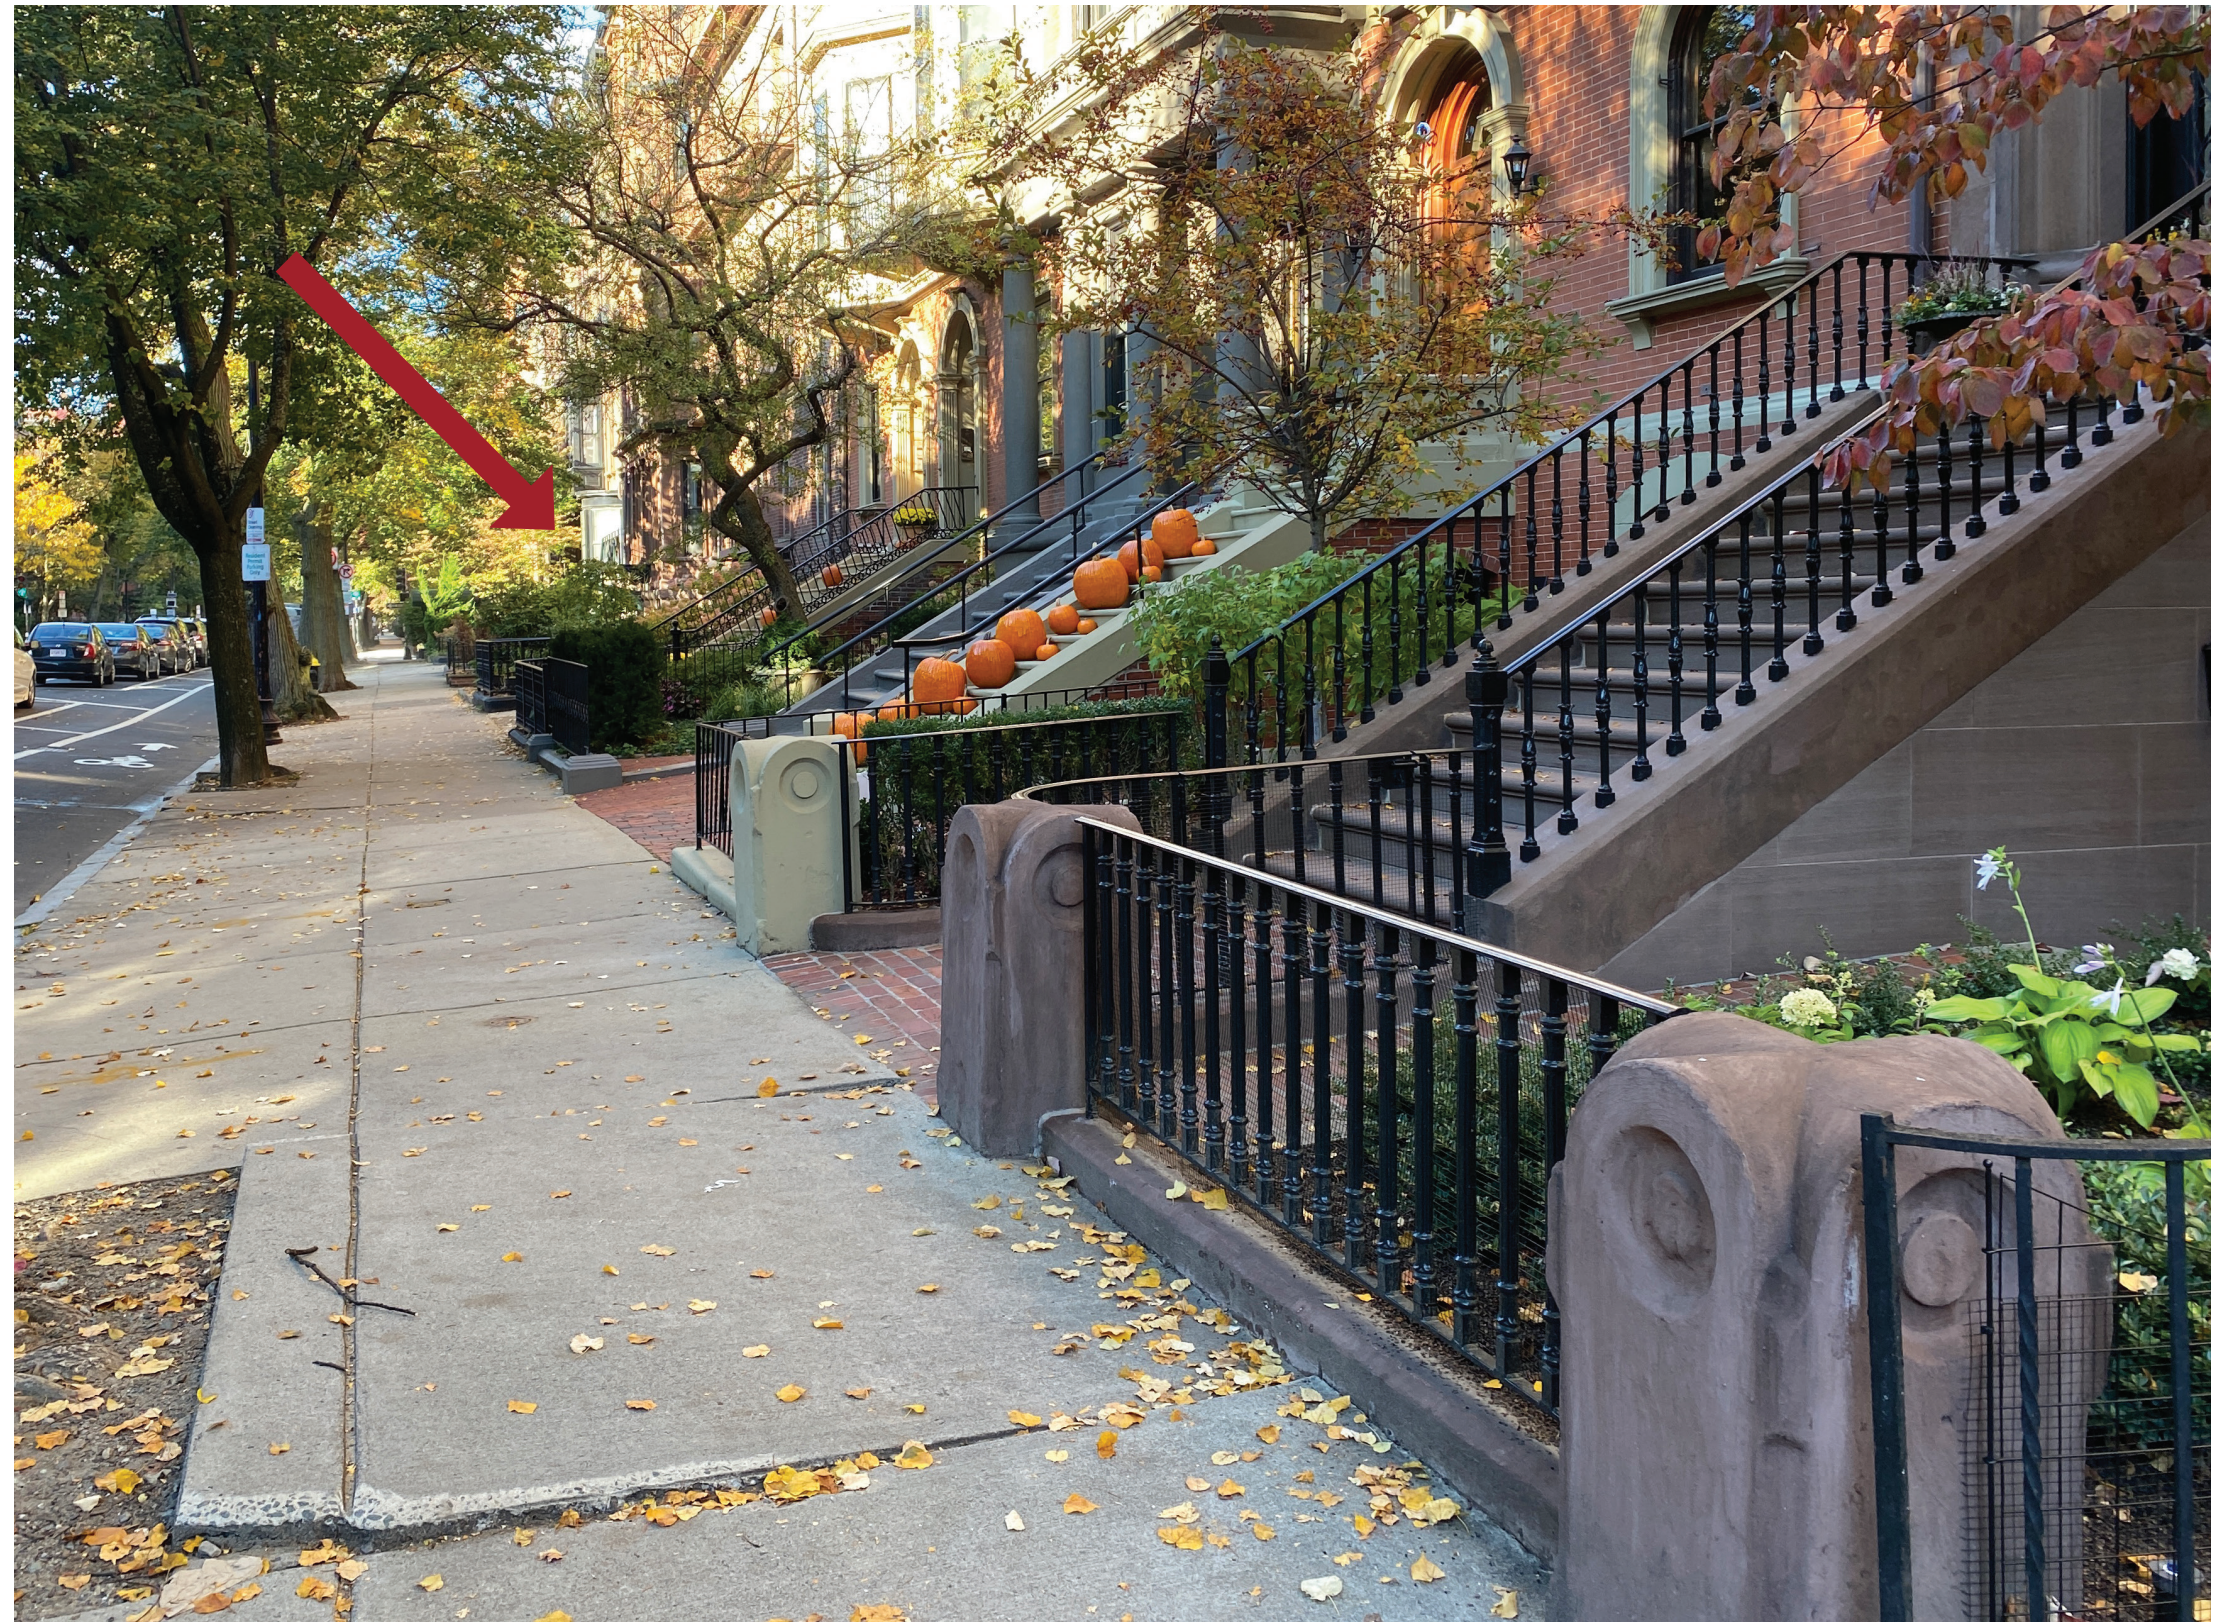
Beacon Street looking towards  
Dartmouth Street  
October 2025

The existing streetscape retains the language of elevated entrances, stoops, and steps

The existing entrance at #226 breaks this rhythm (indicated by red arrow)

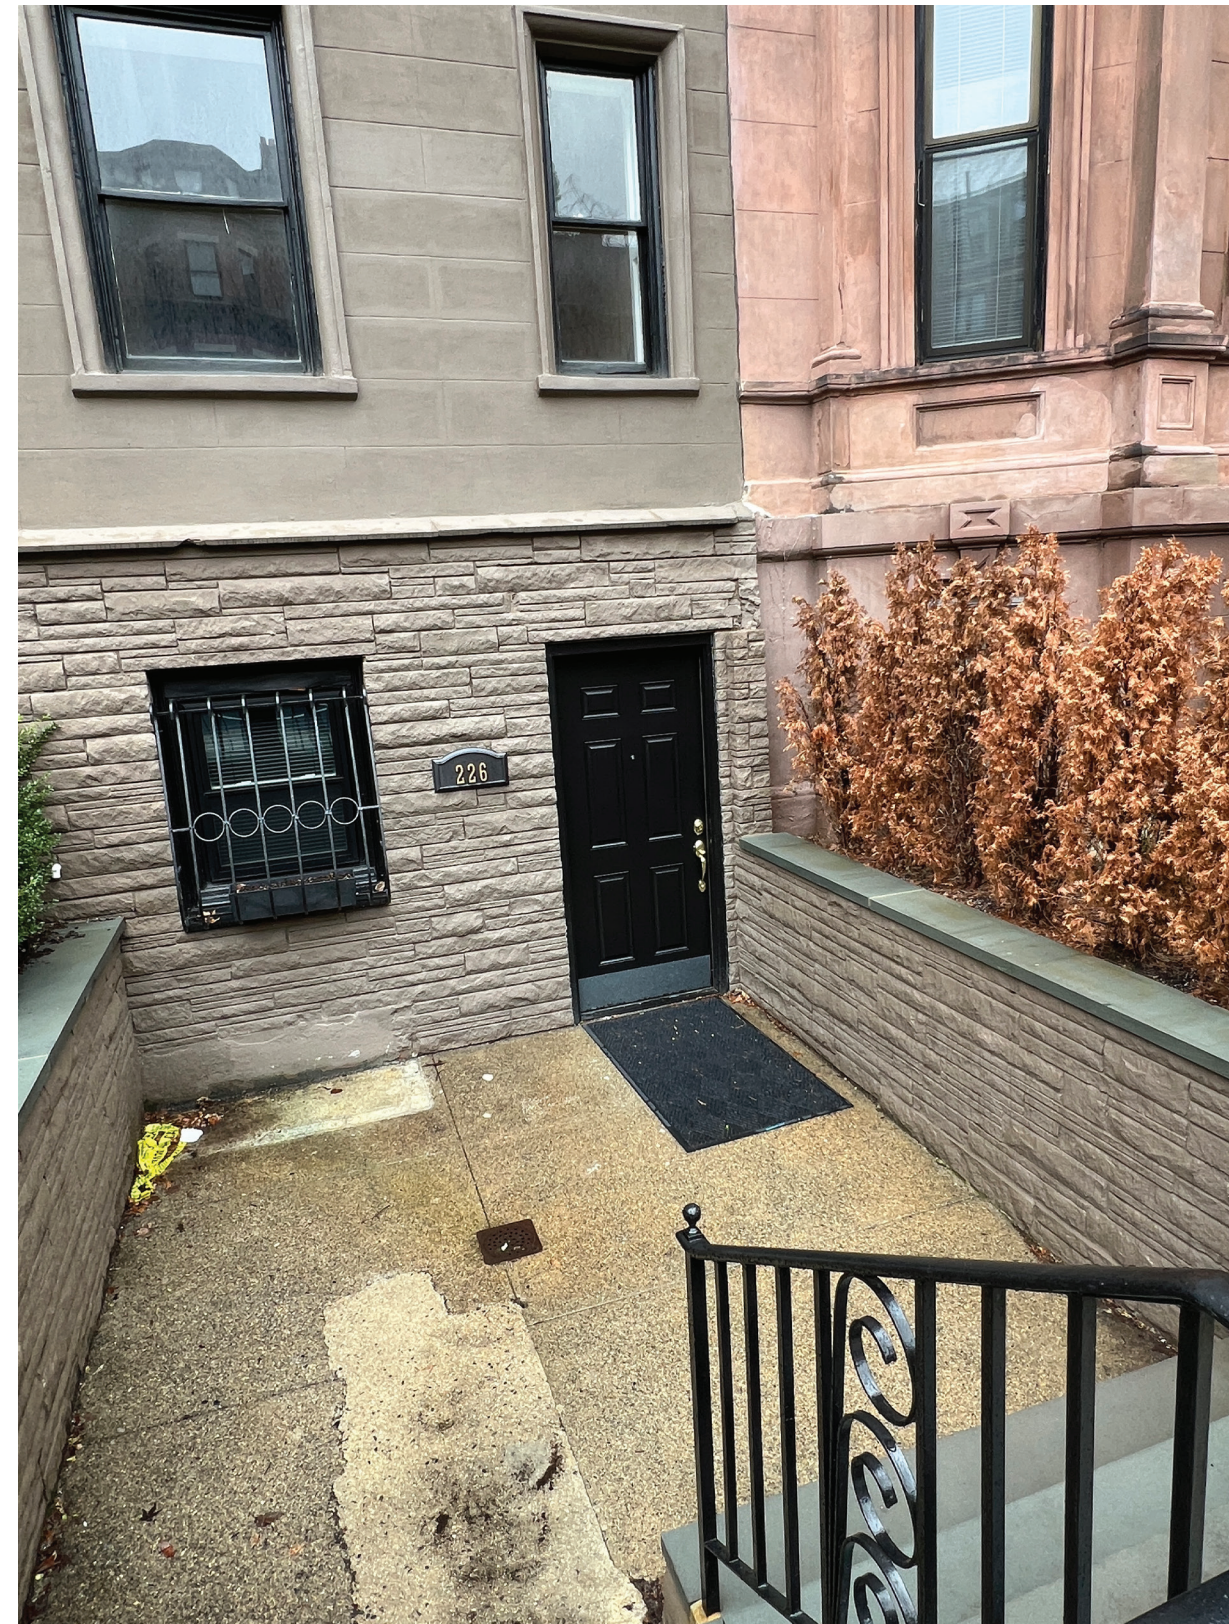
Existing Sunken Courtyard and Basement Entrance

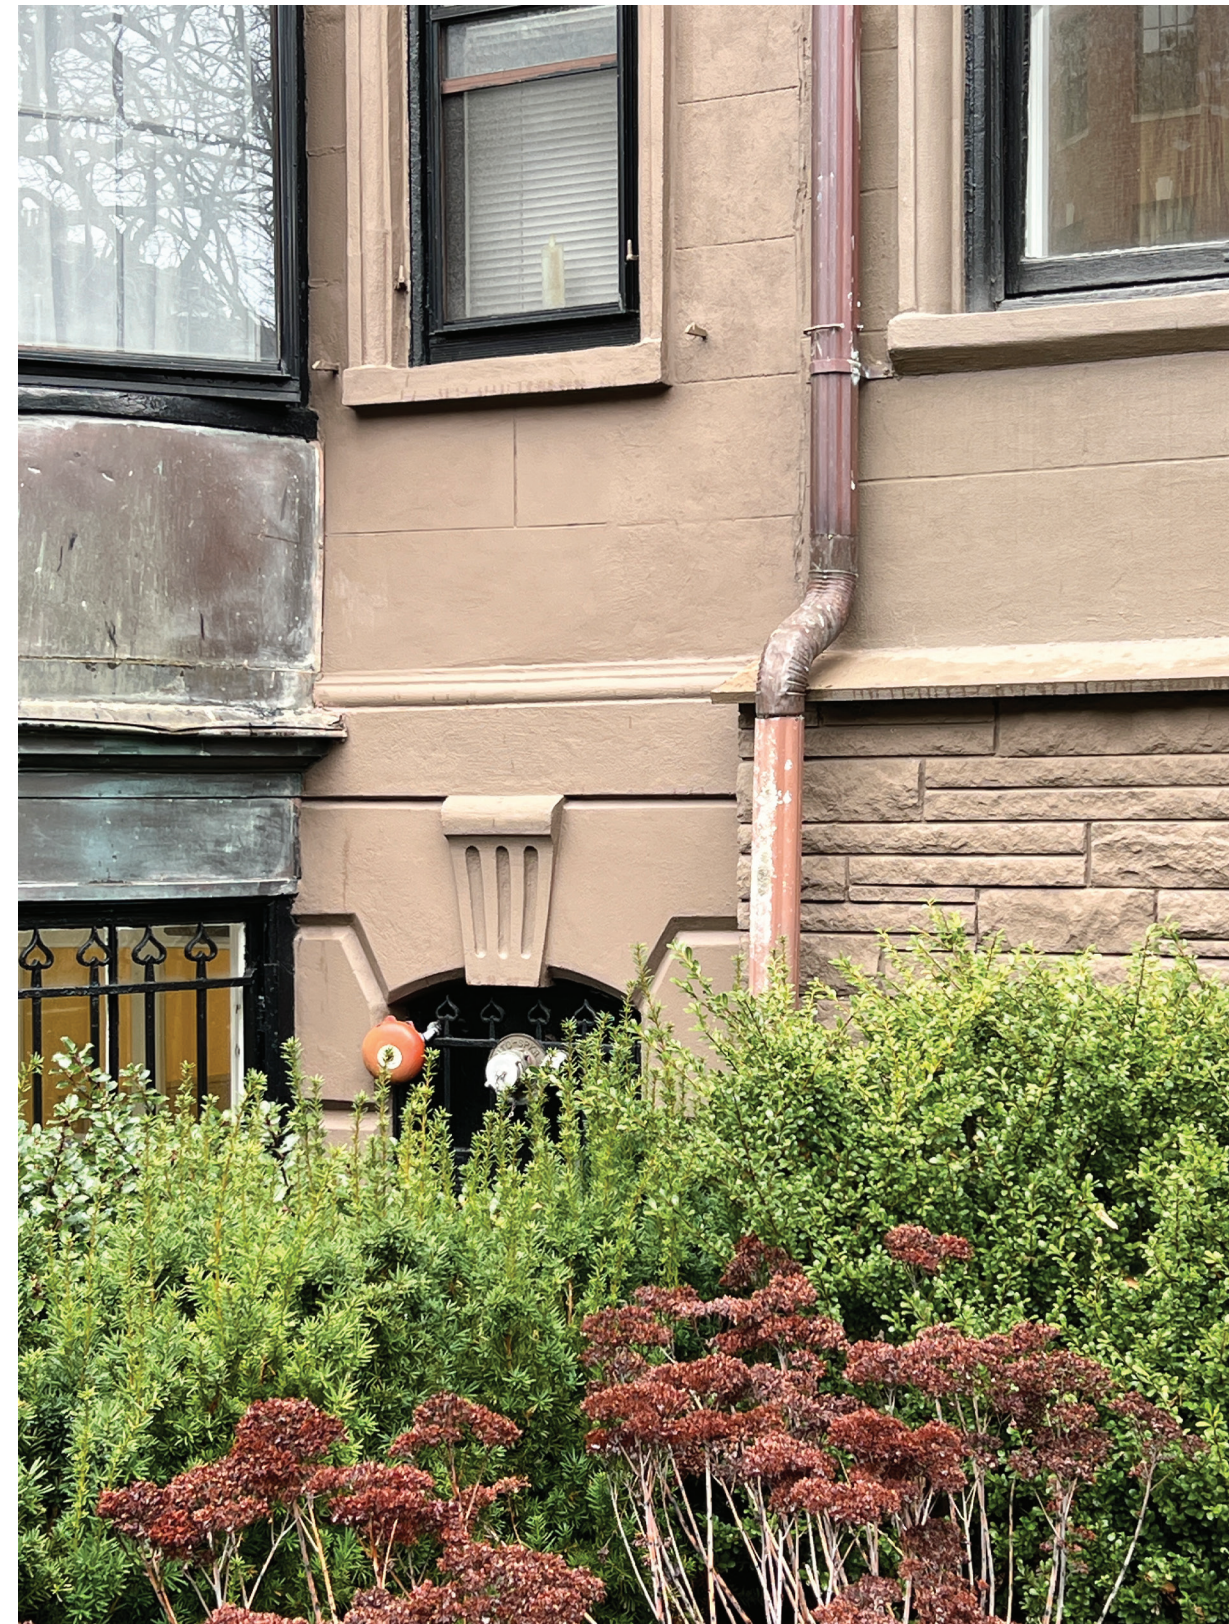
*Existing Applied Rock Face Veneer Next to Historic Stonework at Neighboring Property*

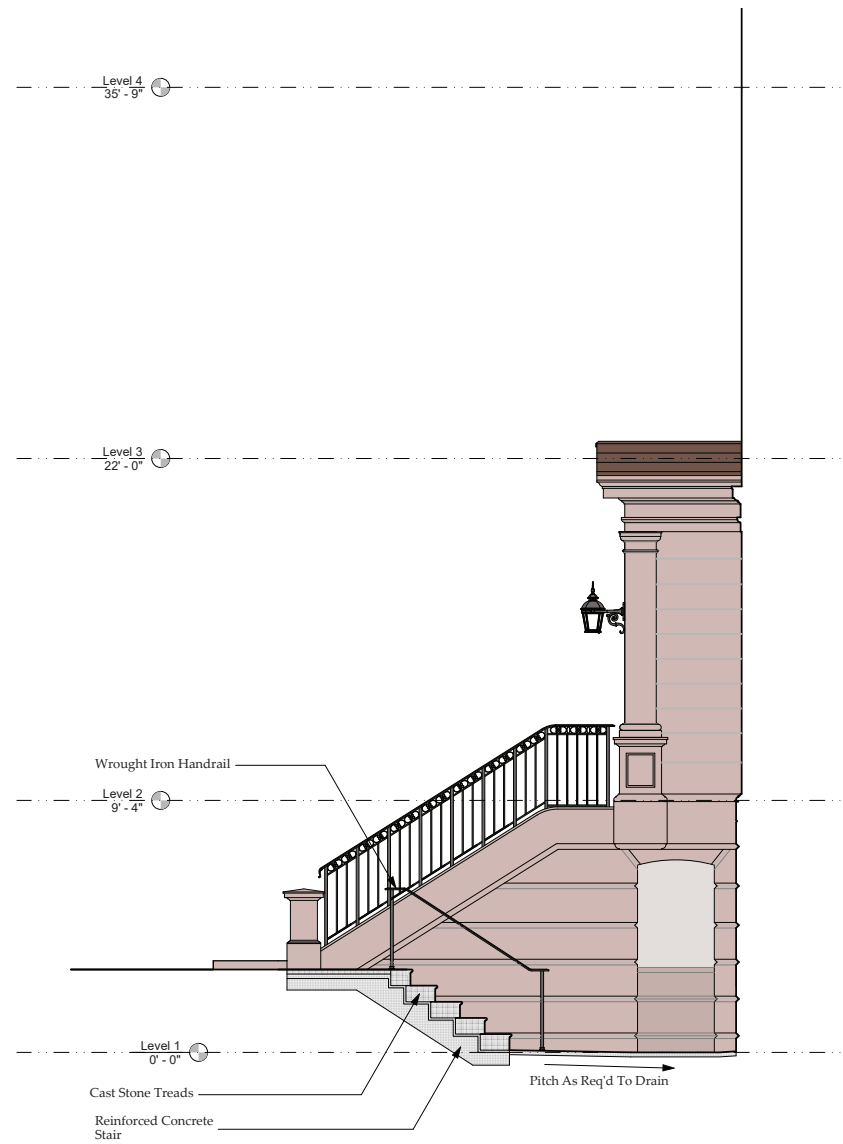
*Proposed East Side Elevation*

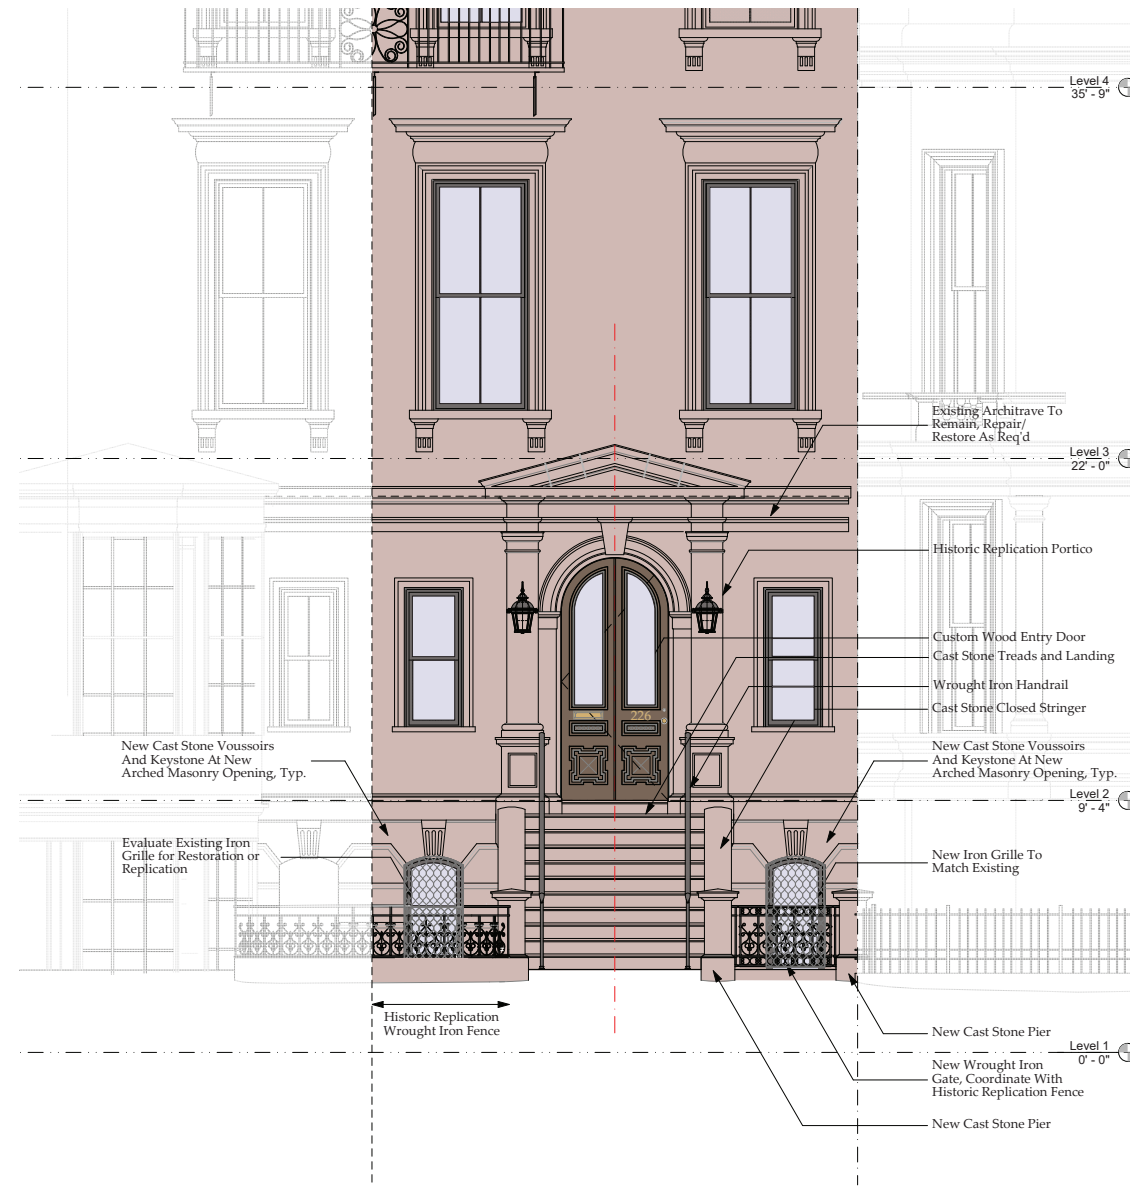
*Proposed South Elevation*

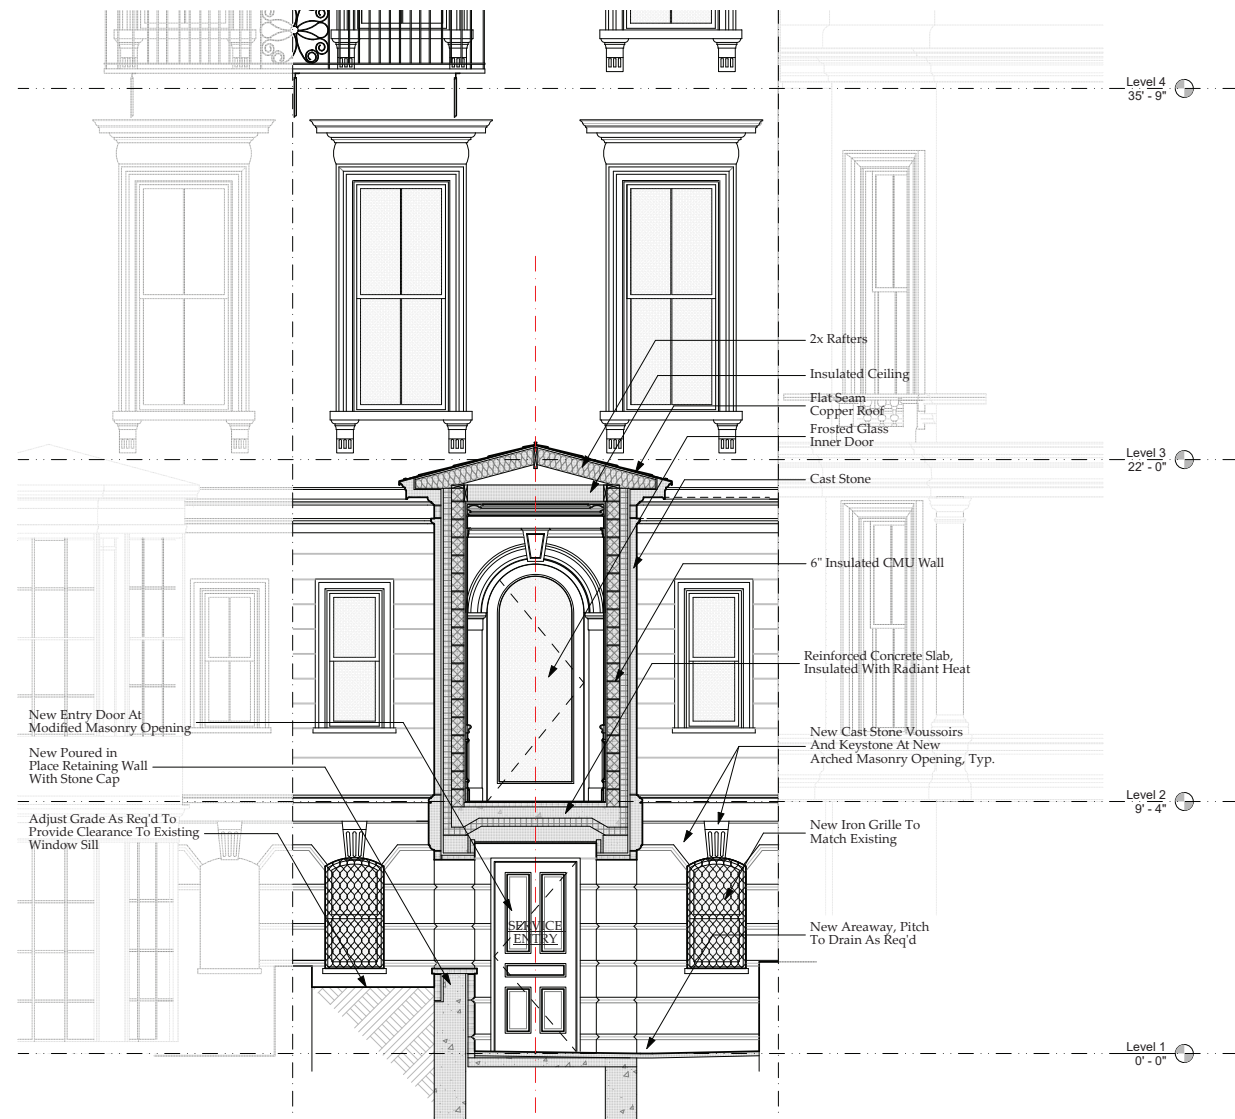
*Proposed Section Looking North*
