## 226 Beacon Street

### *Applicaton for Design Review to the Back Bay Architectural District Commission*

Prepared By:  
Carpenter & MacNeille Architects and Builders  
106 Western Ave, Essex, MA 01929

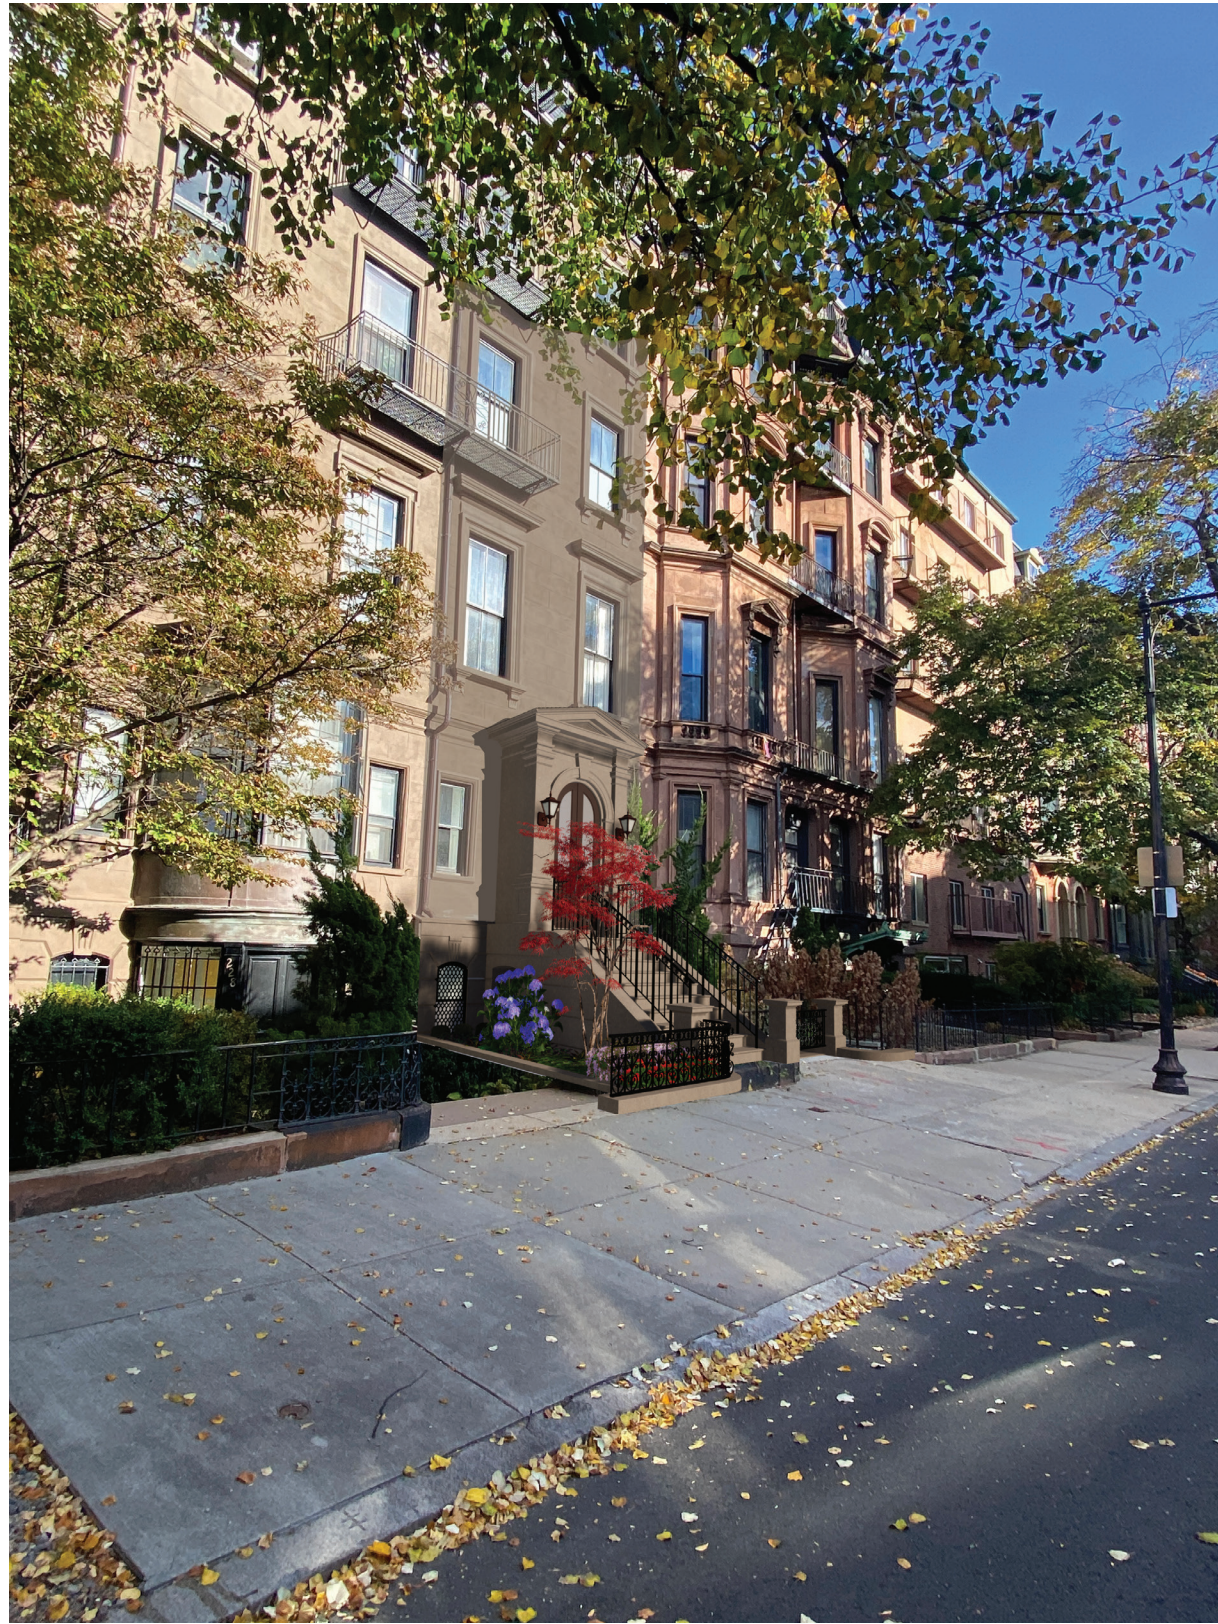
*Proposed View Along Beacon Street*

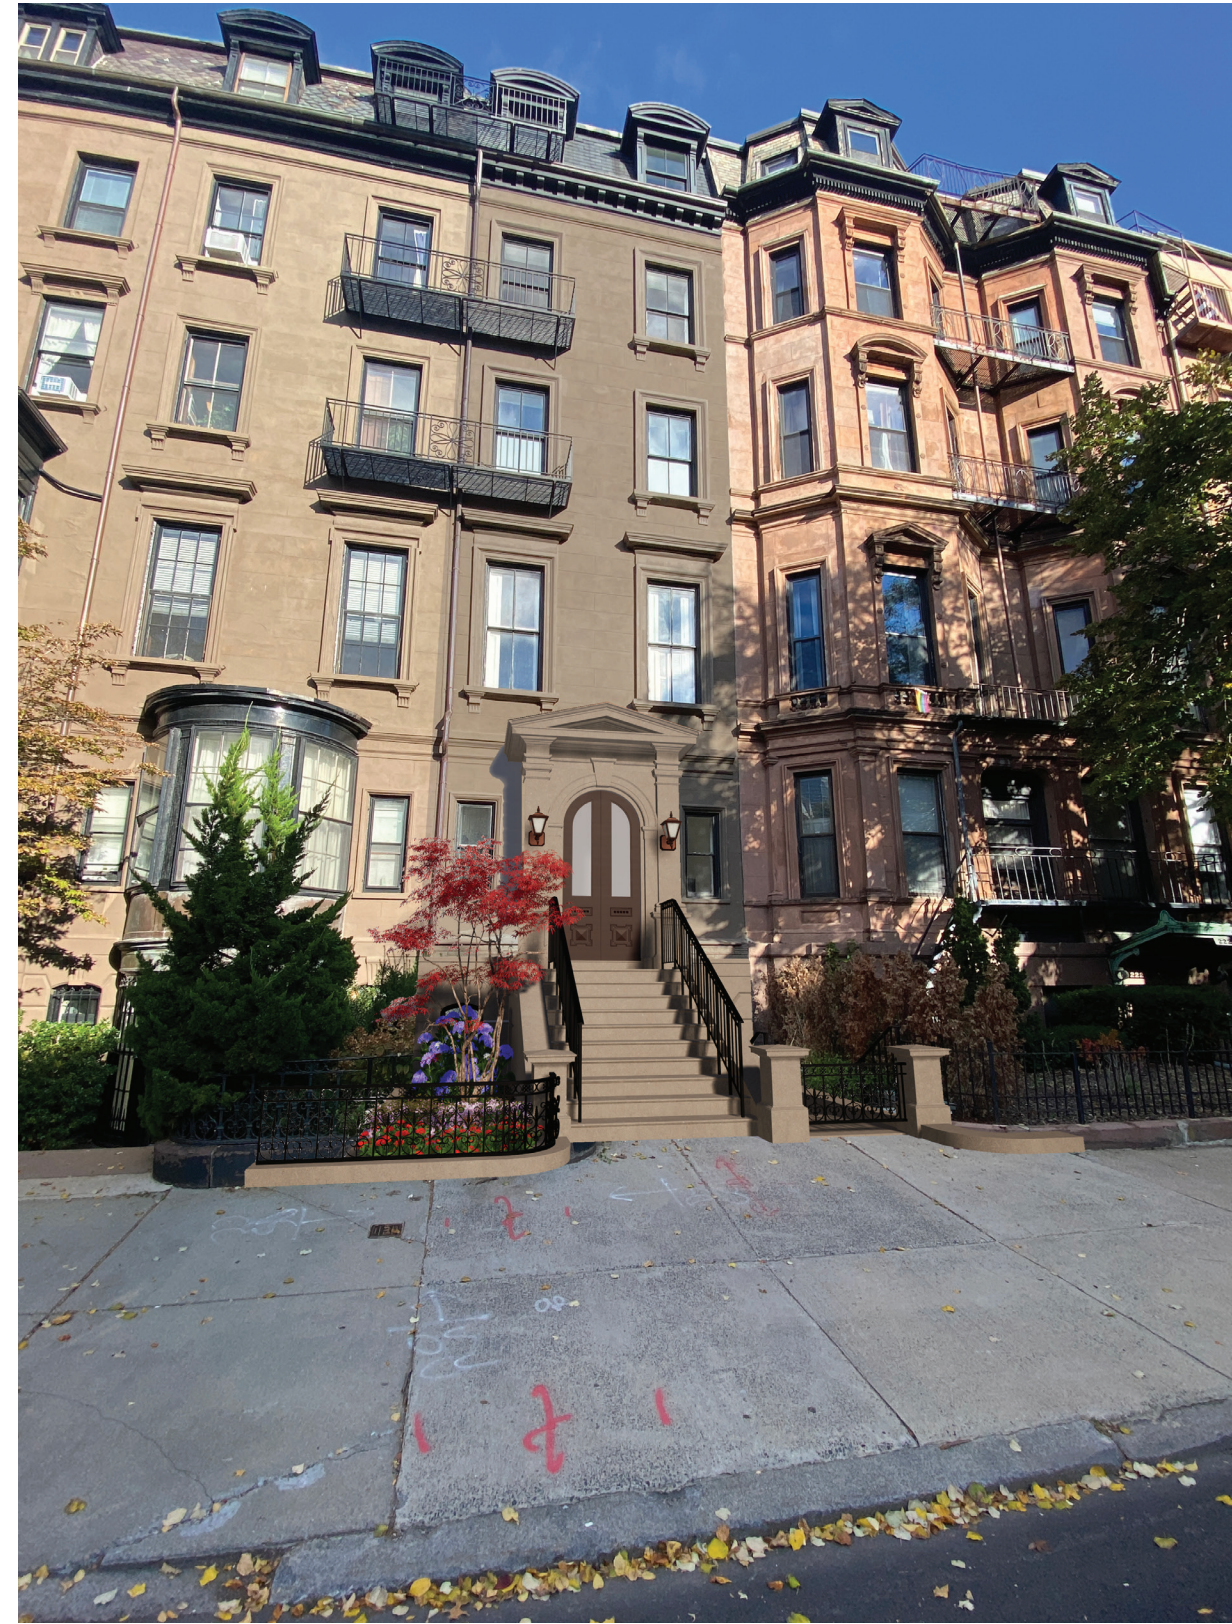
*Proposed View From Public Sidewalk*

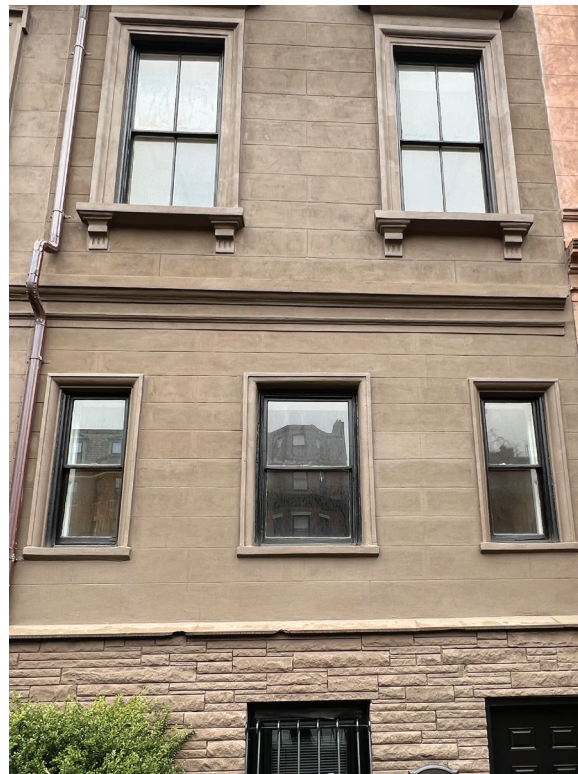
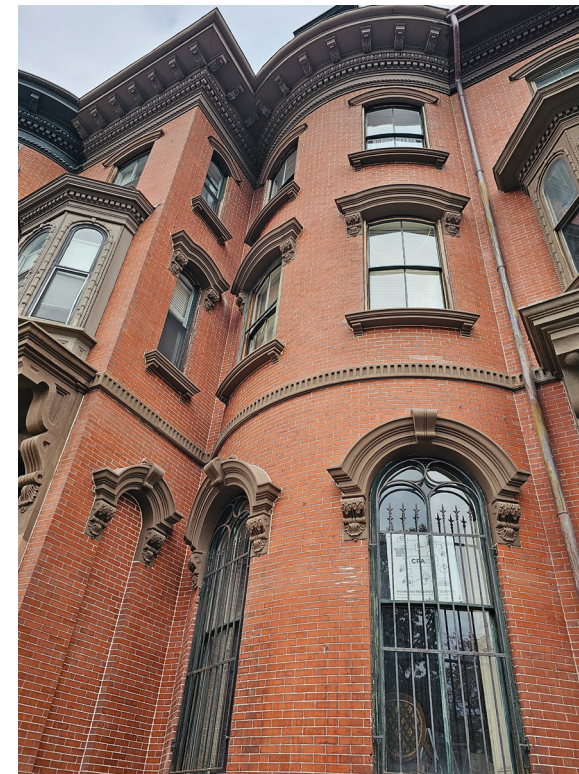
## Cast Stone

*Left:*  
Existing Brownstone Facade  
-painted  
-varying levels of repair

*Right:*  
Proposed 'Simulated Brownstone'  
-cast stone  
-custom color and texture to match  
field sample of existing brownstone  
-sample installations by cast stone  
manufacturer Northern Design

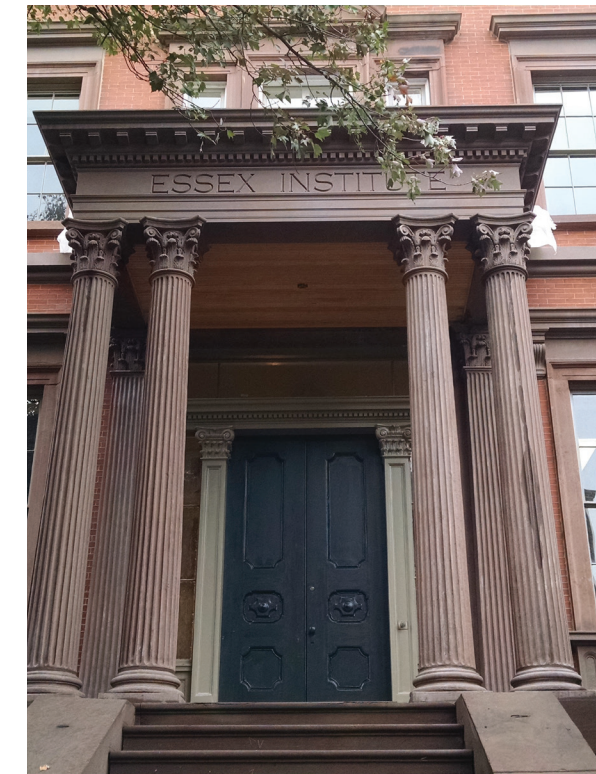
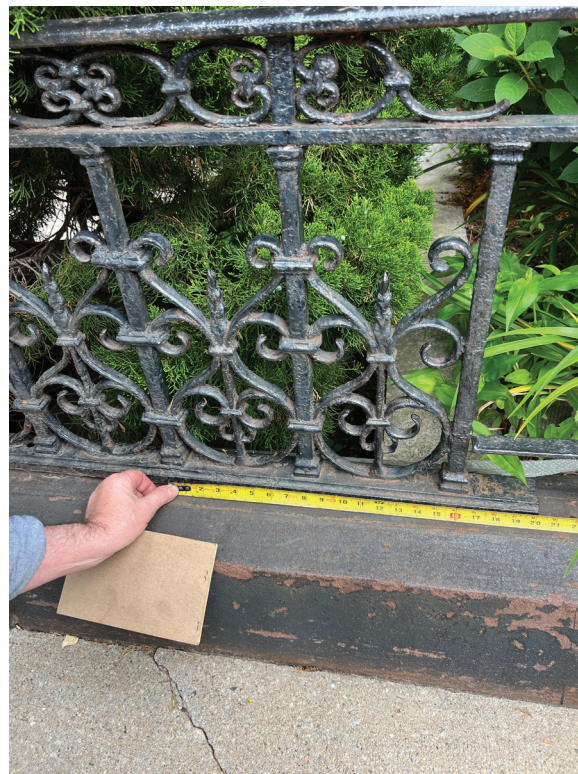
## Decorative Fence

*Left:*  
Existing decorative wrought  
iron fence extant at neighboring  
property

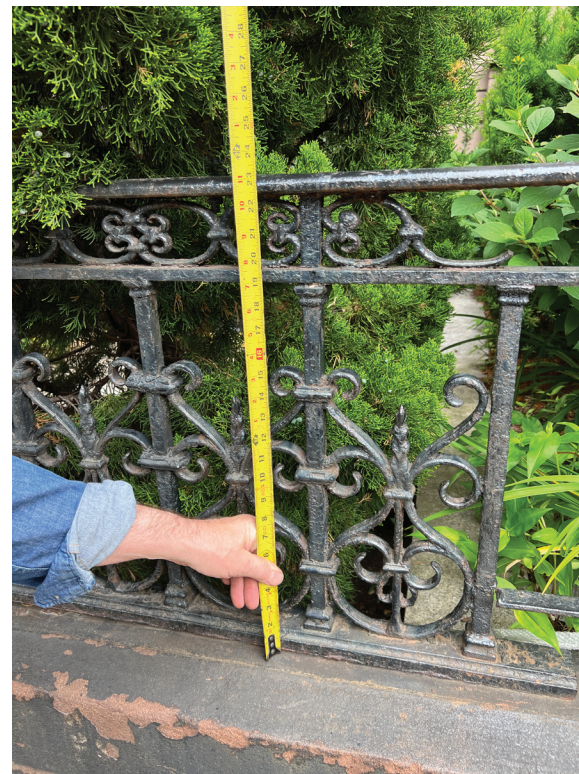
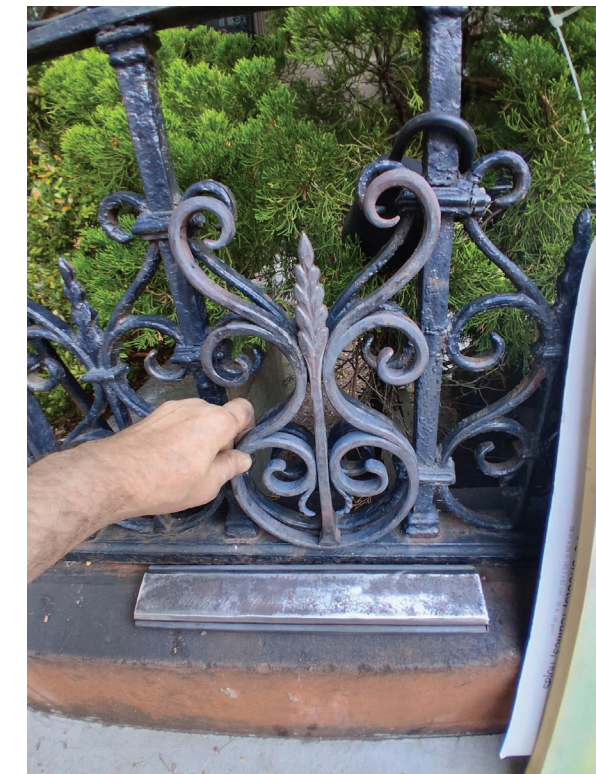
*Right:*  
Proposed custom replication  
wrought iron fence  
-mock up by  
Hammersmith Studios

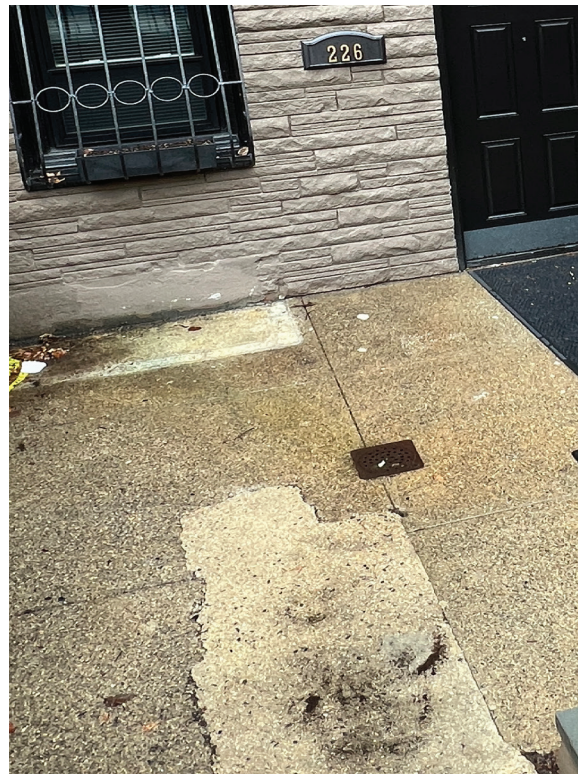
**Paving**  
*Left:*  
Existing Paving

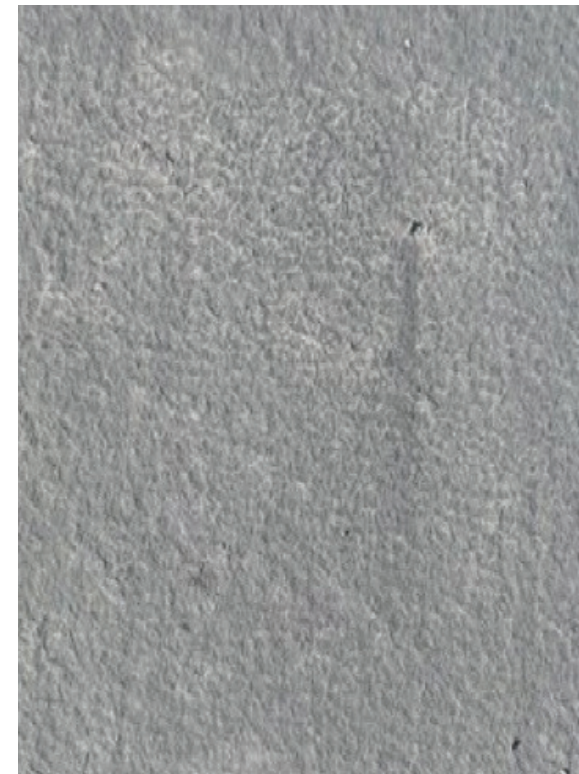
*Right:*  
Proposed Bluestone  
and Brick Paving

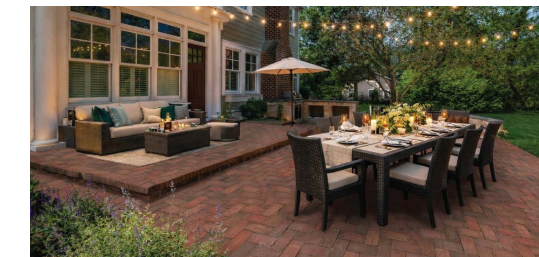
All of these products meet or exceed the requirements set forth in ASTM C902 for Class SX Type II pedestrian and light traffic paving brick.

Size	Width	Height	Length	Weight	Brick per Sqft
Modular Paver	3-1/2"	2-1/4"	7-5/8"	4.7 lb	4.2

(left) Augusta Paver | (right) Jamestown Paver

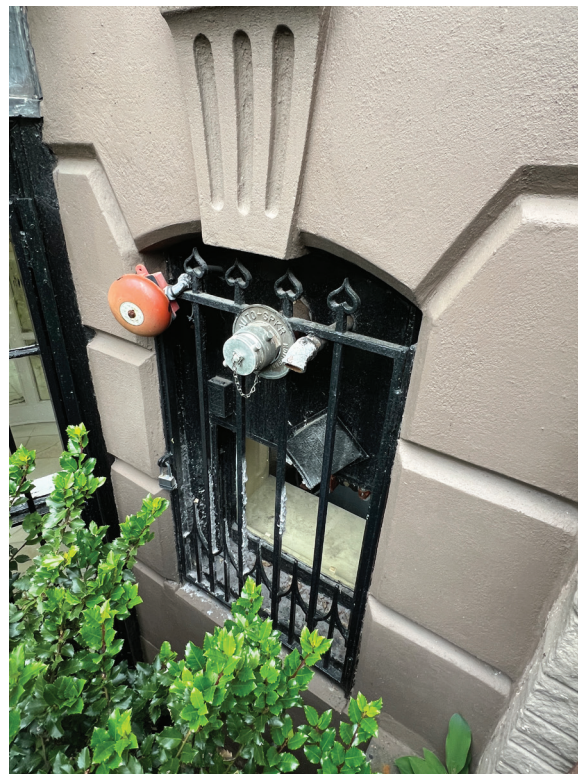
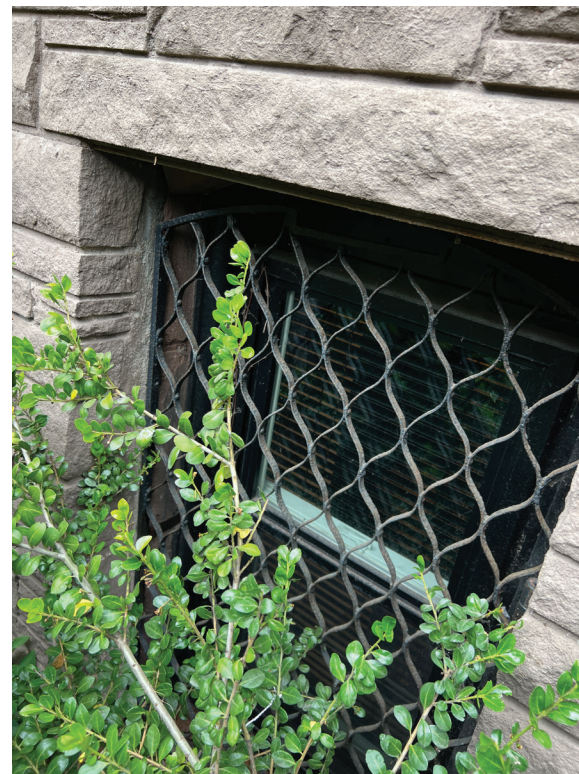
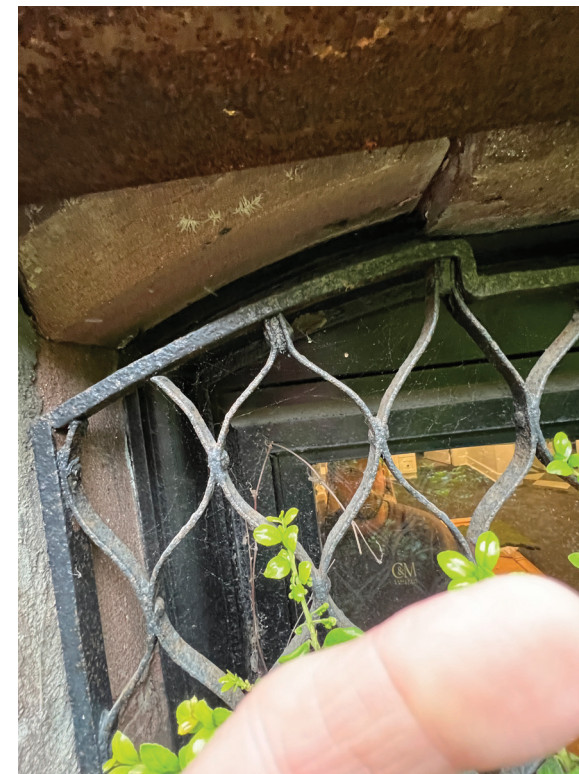
**Extant Details**  
*Far Left:*  
Historic rustication, window opening, and keystone at sister property  
*Middle and Right:*  
Historic window grate  
*Right:*  
Remnants of original window opening and keystone

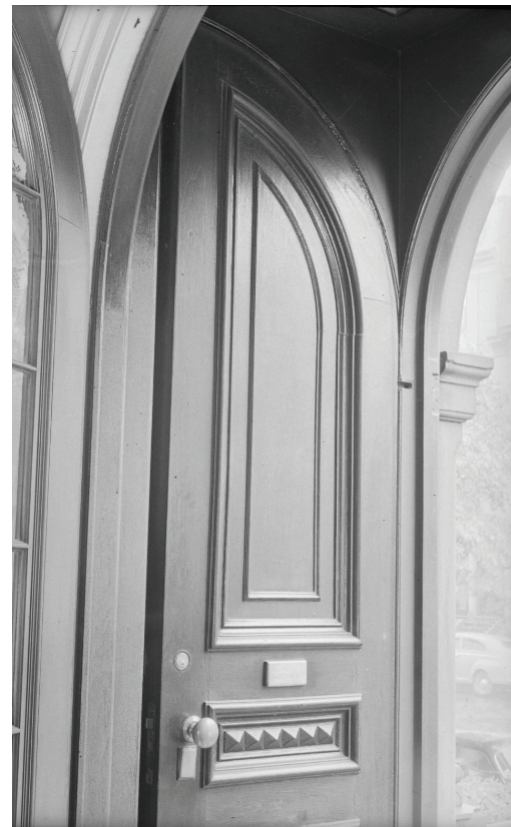
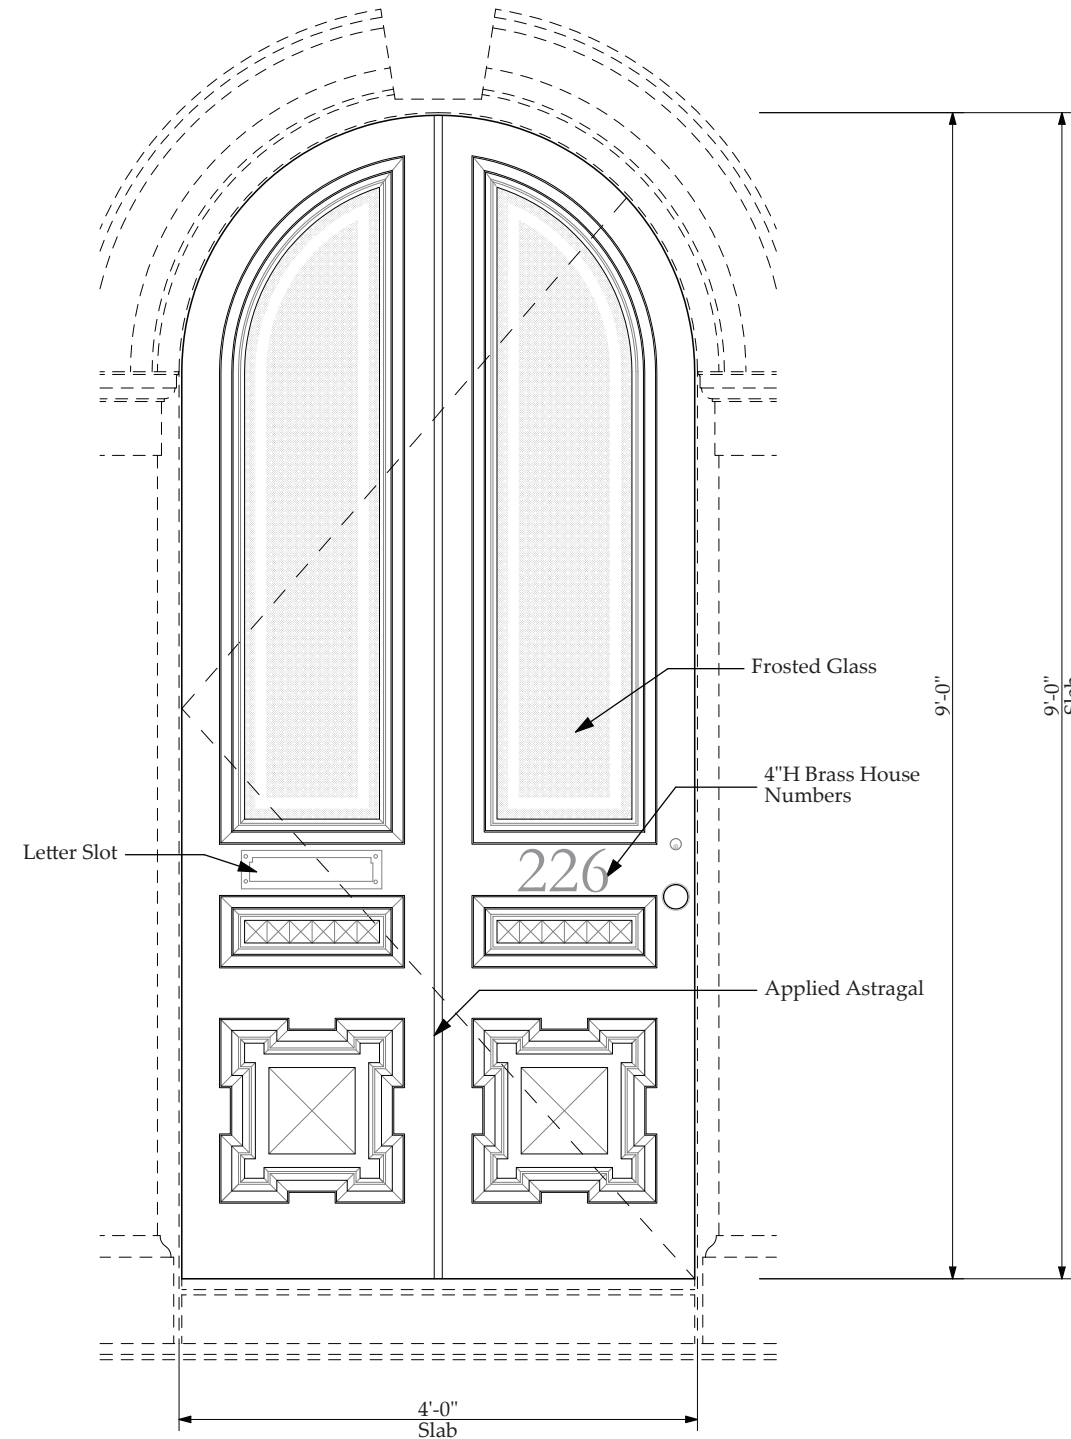
*Right:*  
Proposed Entry Door

Stained mahogany entry door

Single leaf with applied astragal to mimic  
appearance of double door

Panel and inlay details inspired by original  
double door

*Below:*  
ca. 1941 photo of original double door

2 1/4" Thick  
Mahogany Raised Panel Entry Door  
With Mortise Lock  
Architectural Stained Finish

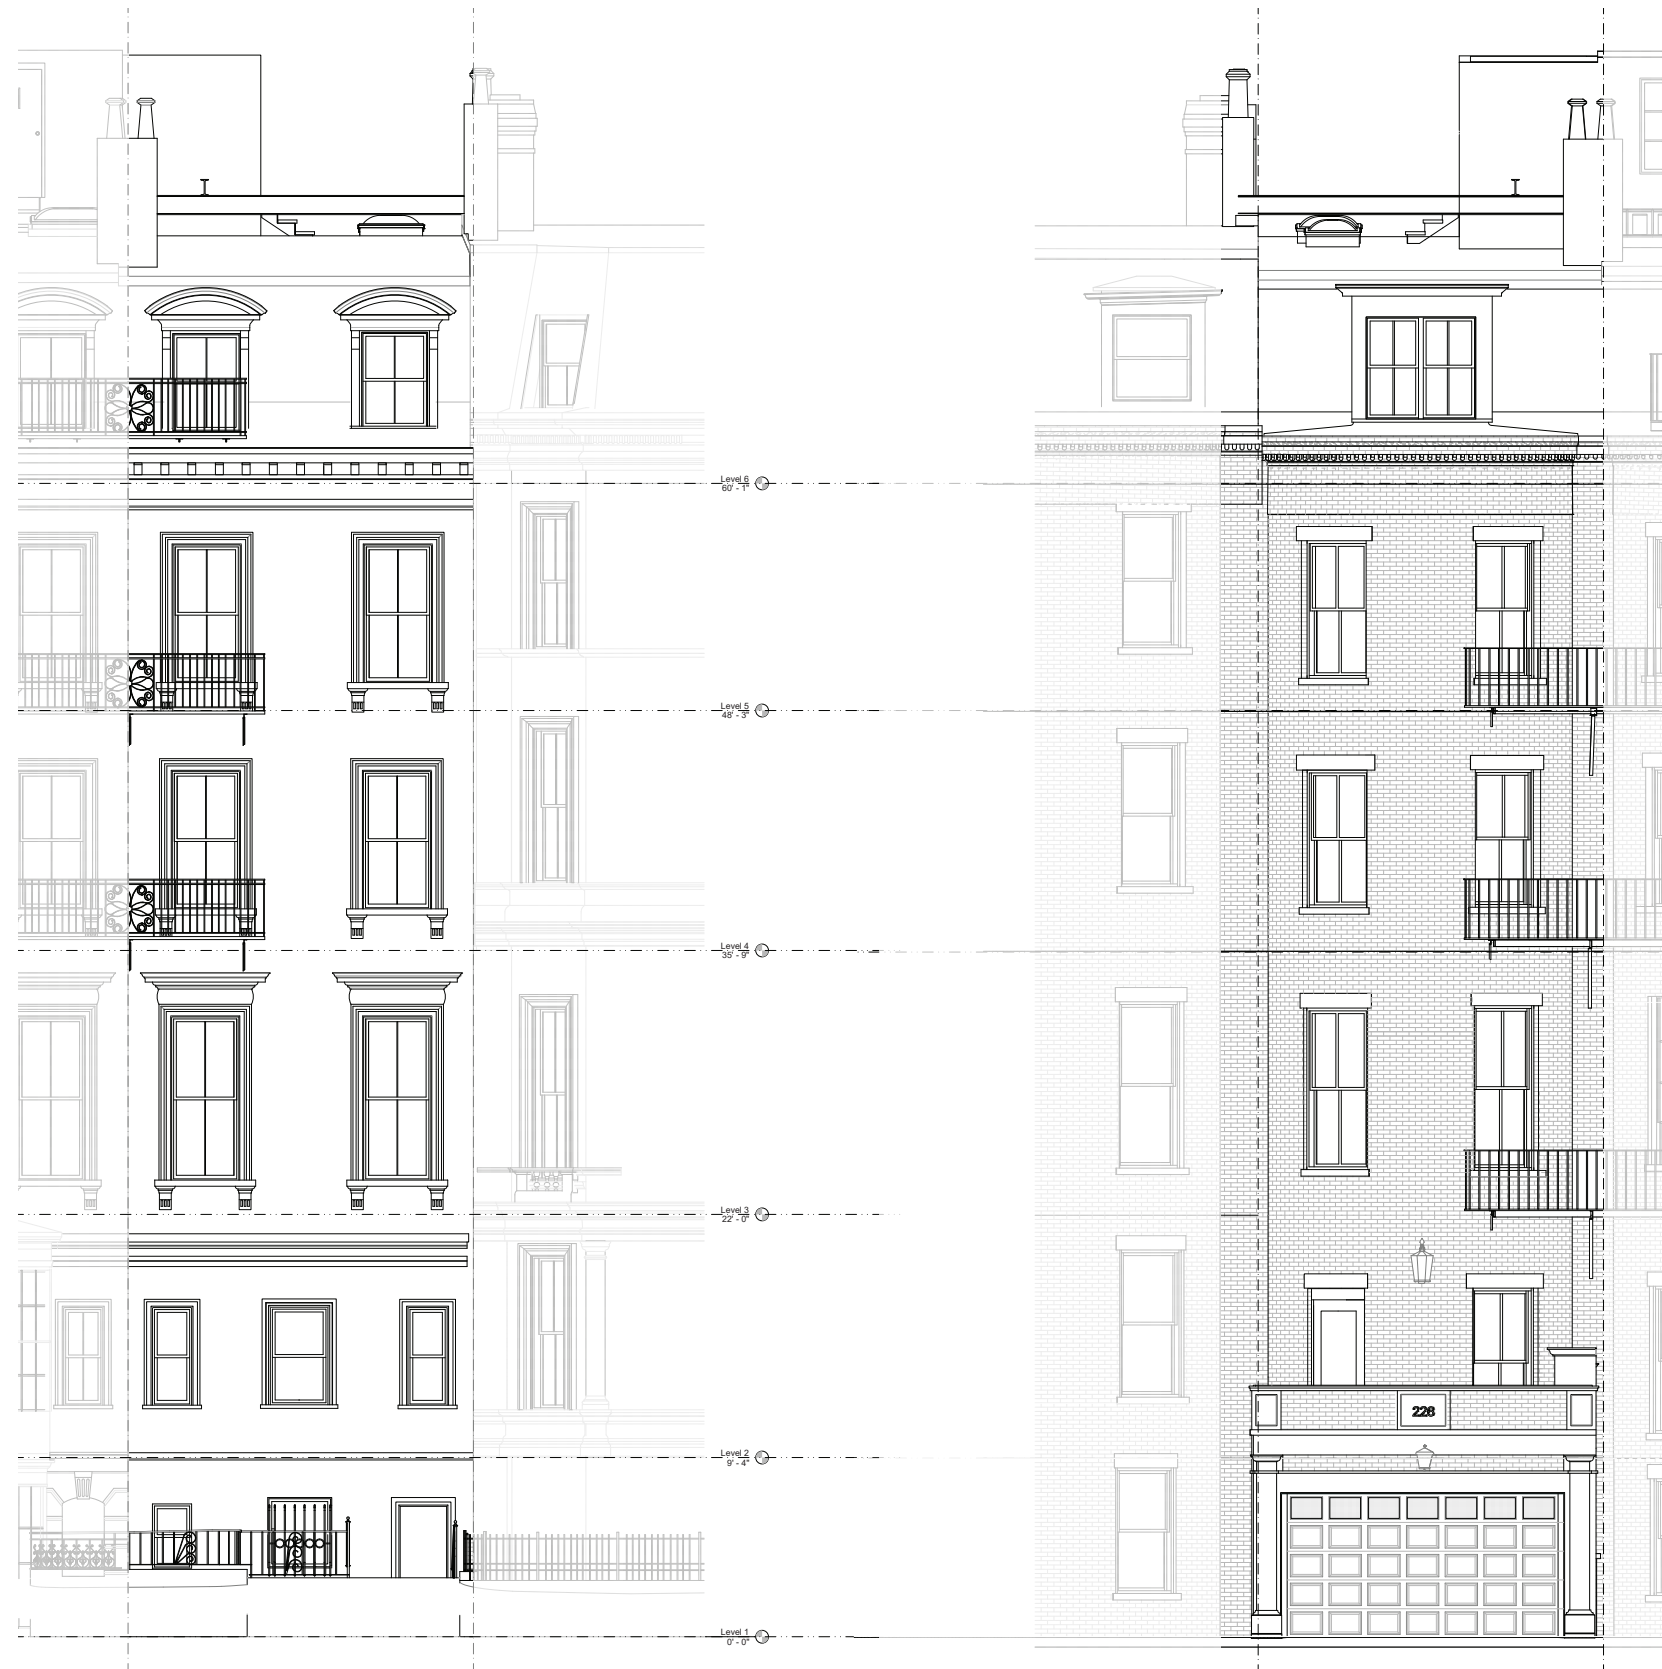
## Existing Front Windows (Beacon Street)

### 5th Floor Windows

Modern Replacements

Wood Frame and Sash, Double Glazing, Balances

Appearance of good condition  
Evaluate for Repair

### 4th Floor Windows

Historic

Wood Frame and Sash, Single Glazing, Chain and Pulley

Sash damage and rot at lower sash  
Evaluate for Restoration

### 3rd Floor Windows

Prior Replacements

Difficult to operate, visible damage  
Evaluate for Restoration

### 2nd Floor Windows

Wood Frame and Sash, Single Glazing, Cord and Pulley

Unable to open, lower sash in need of repair  
Evaluate for Restoration

### 1st Floor Windows

Historic Replacements

Wood Frame and Sash, Double Glazing, Cord and Pulley

Unable to open, Center window to be requires removal for new portico entrance,  
Evaluate for Restoration

### Garden Level Windows

Vinyl Frame and Sash, Double Glazing, Balances

Reconfiguration required for new portico entrance

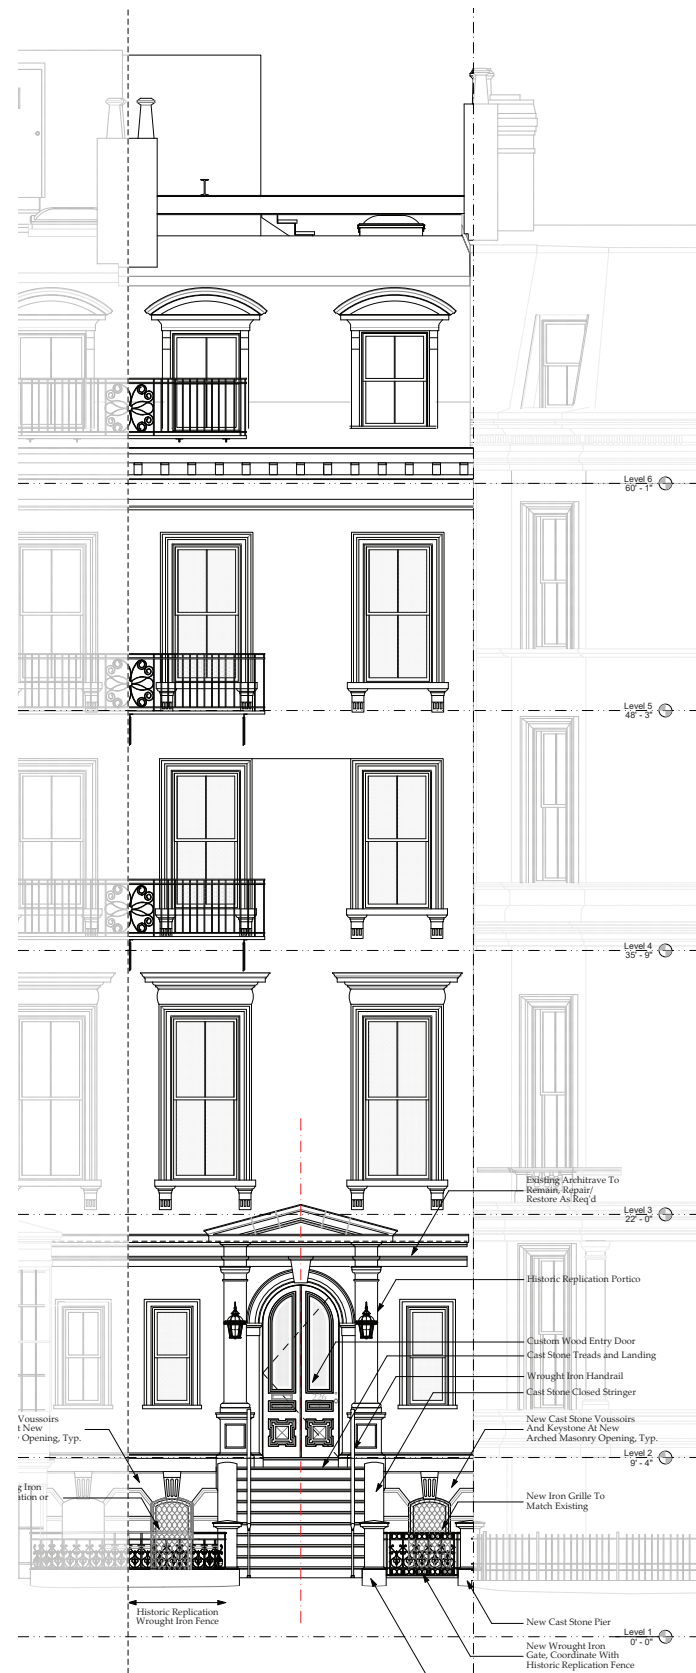
## Proposed Front Windows (Beacon Street)

### 5th Floor Windows

No Change  
 Clean and paint

### 4th Floor Windows

Repair Existing Window

### 3rd Floor Windows

Sash Replacement in Existing Jamb

### 2nd Floor Windows

### 1st Floor Windows

New Sash in New Jamb

### Garden Level Windows

New Sash in New Jamb  
 in Restored Arched Opening

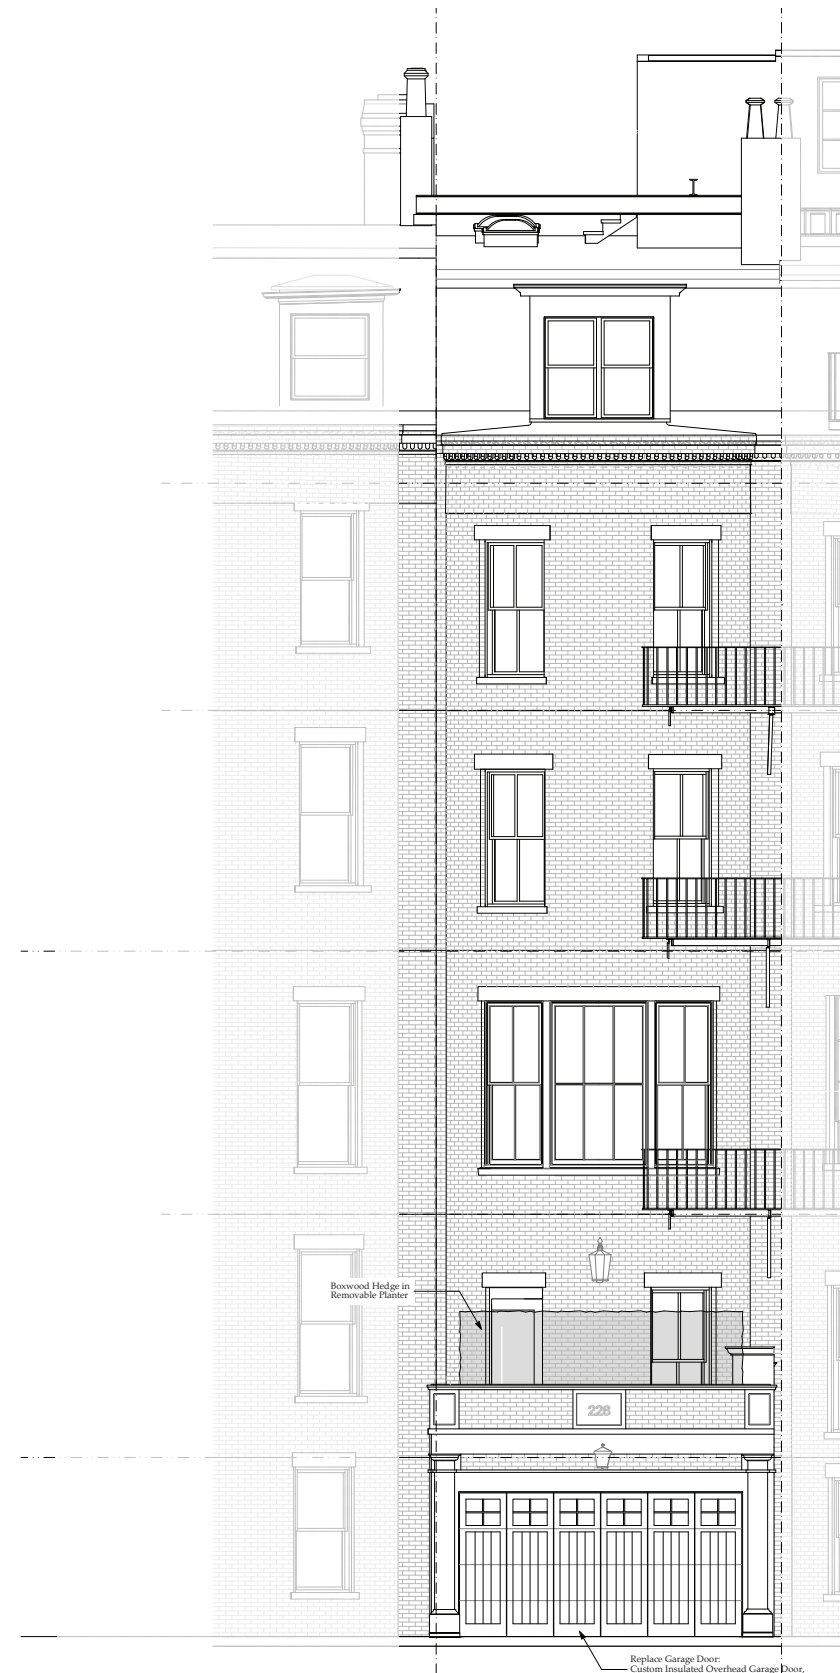
## Proposed Rear Windows (Back Street)

### 5th Floor Windows

Sash Replacement in Existing Jamb

### 4th Floor Windows

Left Unit: Repair  
 Right Unit: Sash Replacement in Existing Jamb

### 3rd Floor Windows

### 2nd Floor Windows

Requested Window Configuration

### 1st Floor Windows

Repair Existing Window

### Garden Level Windows

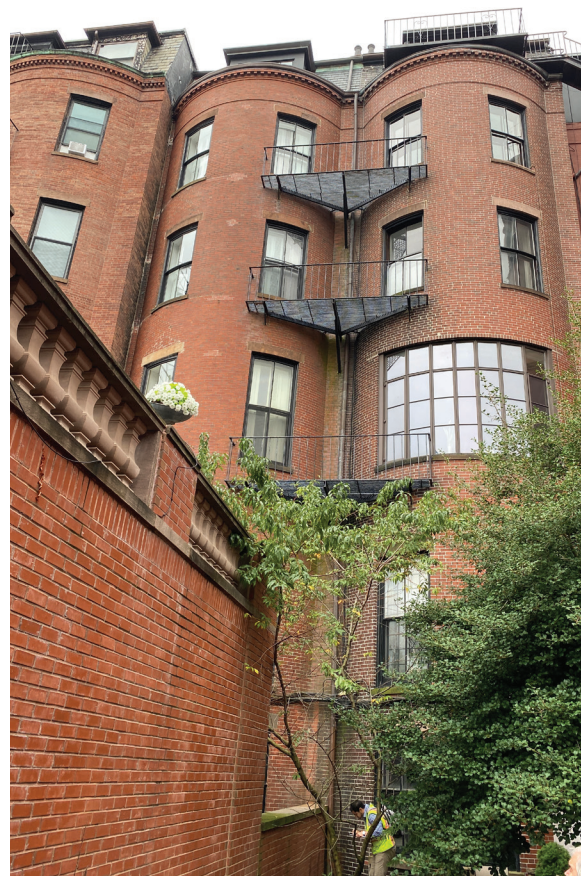
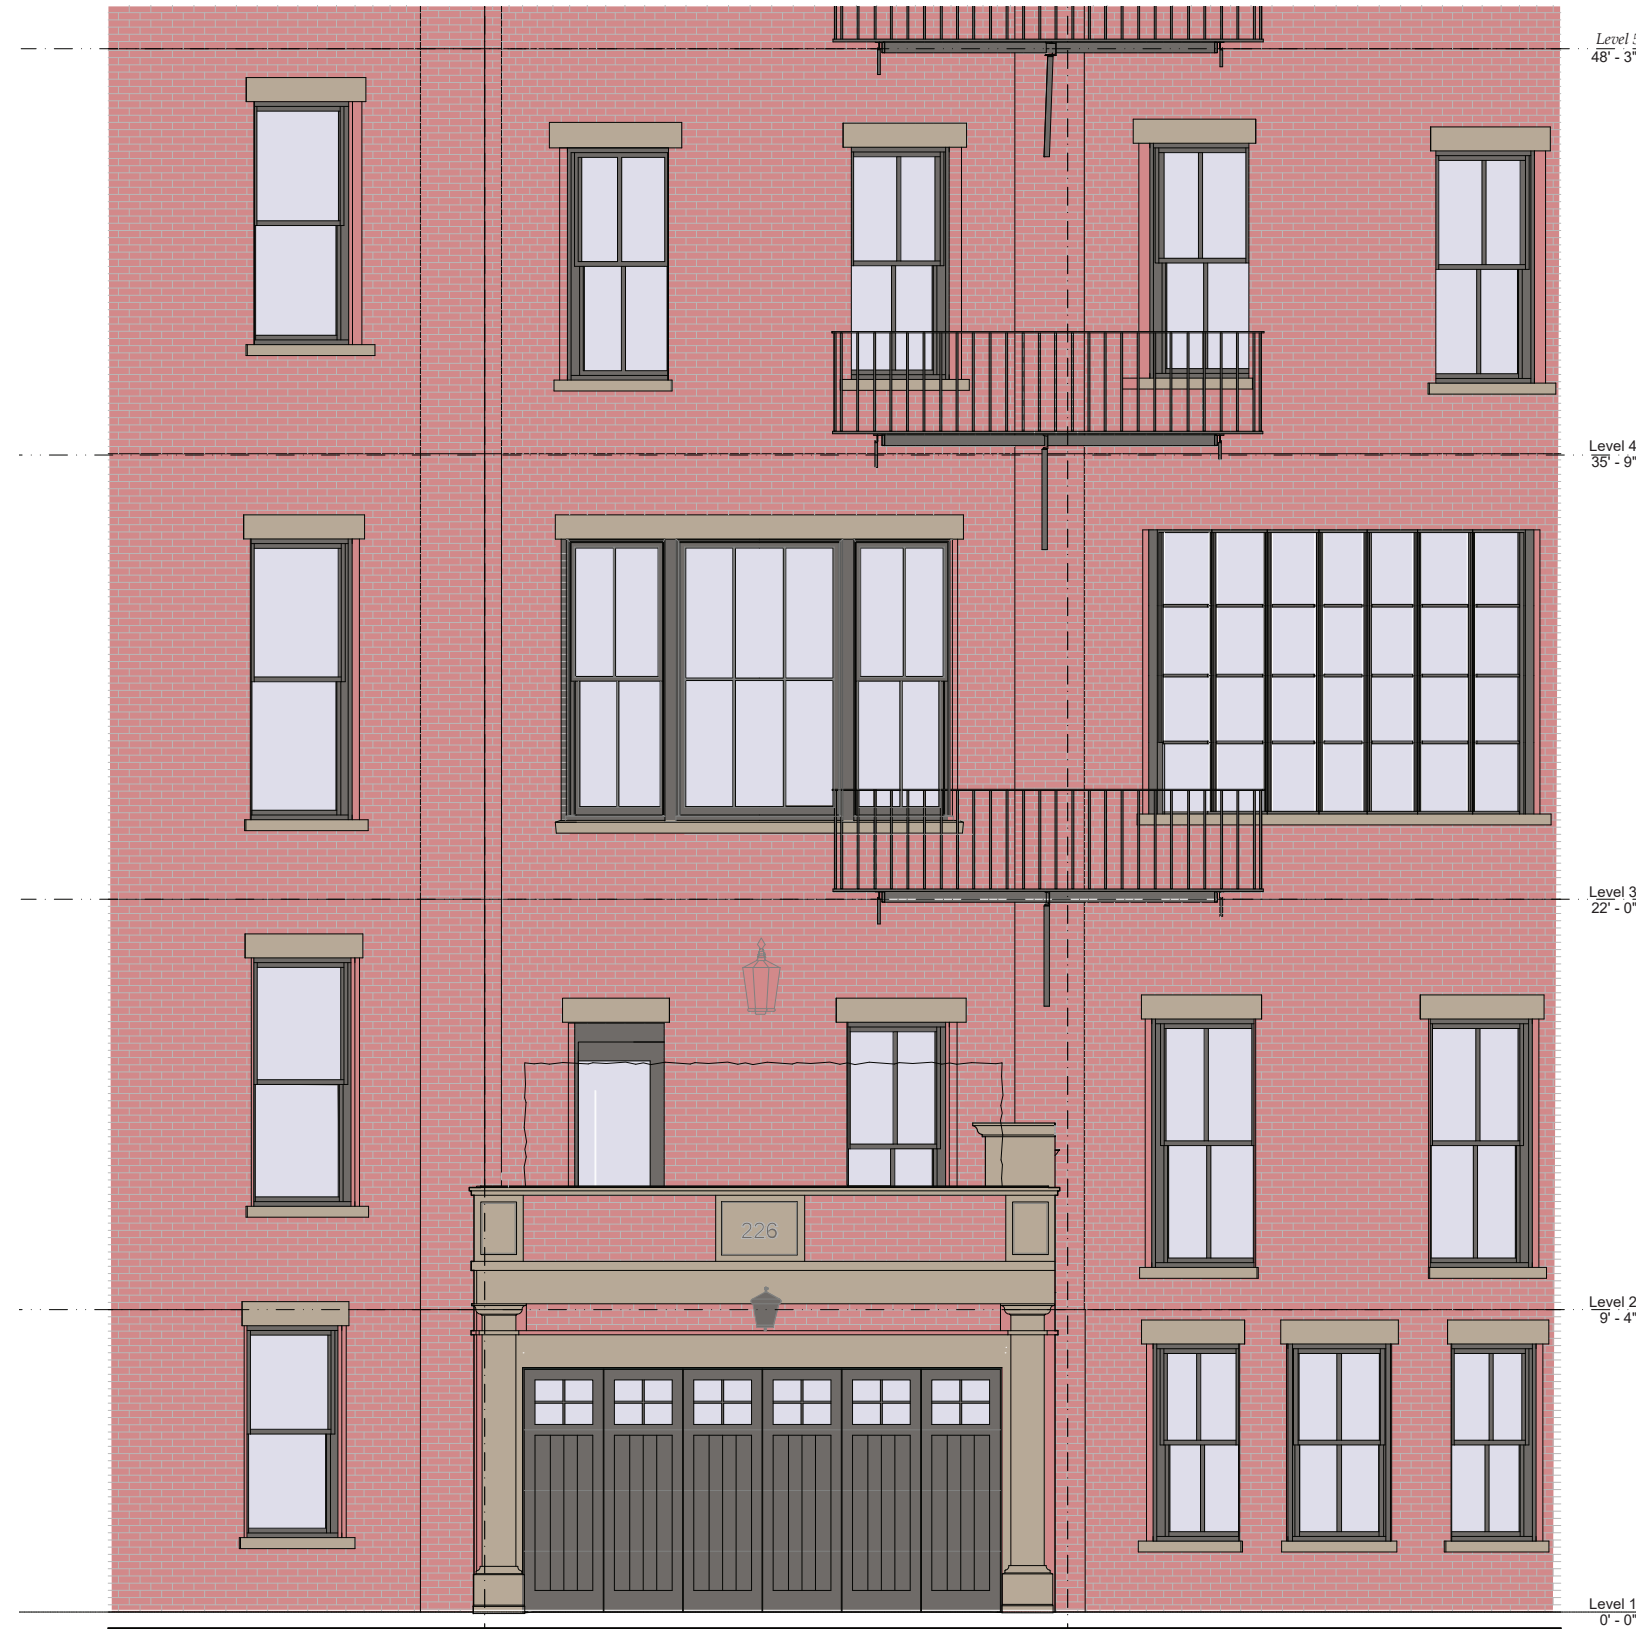
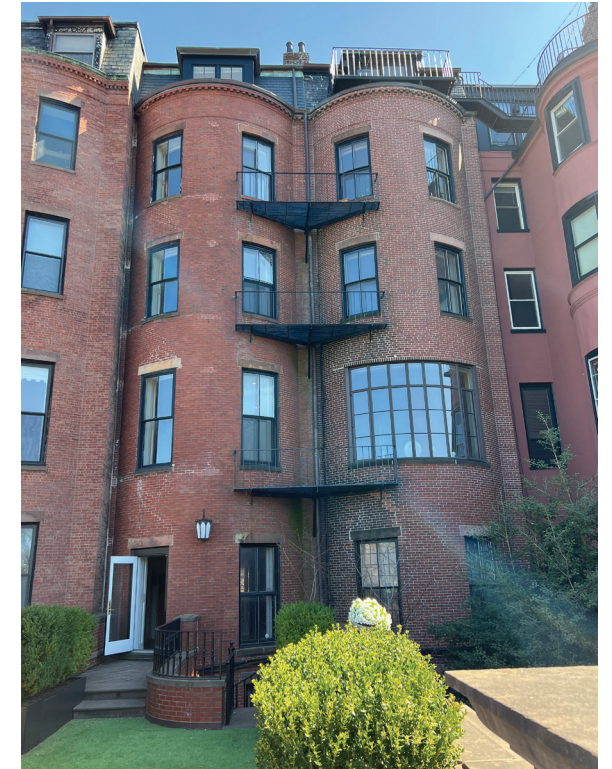
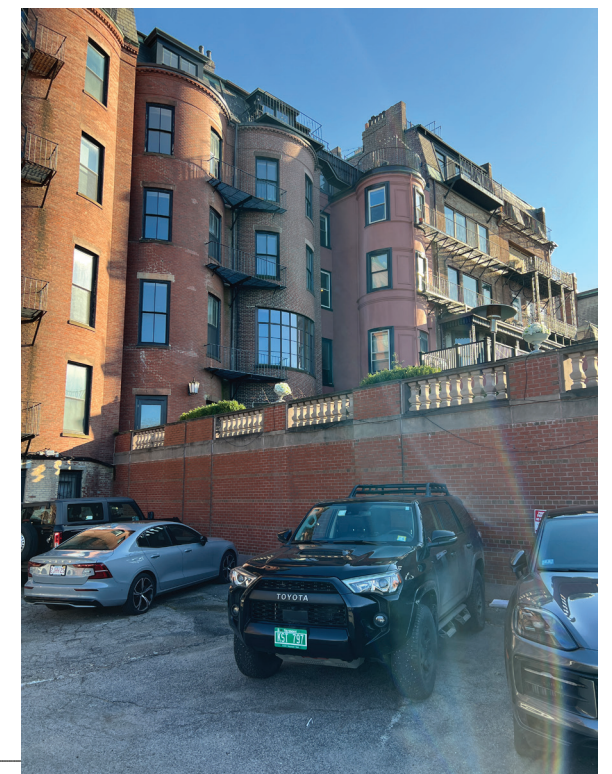
## Proposed Second Floor Window

*Double Hung-Picture-Double Hung*

*Painted Wood Window  
(Match Existing Historic  
Window Profiles)*

*Stone Lintel (Match Existing)*

*Stone Sill (Match Existing)*

*2-over-2 lite pattern (Match Existing)*
