## 226 Beacon Street

### *Applicaton for Design Review to the Back Bay Architectural District Commission*

Prepared By:  
Carpenter & MacNeille Architects and Builders  
106 Western Ave, Essex, MA 01929

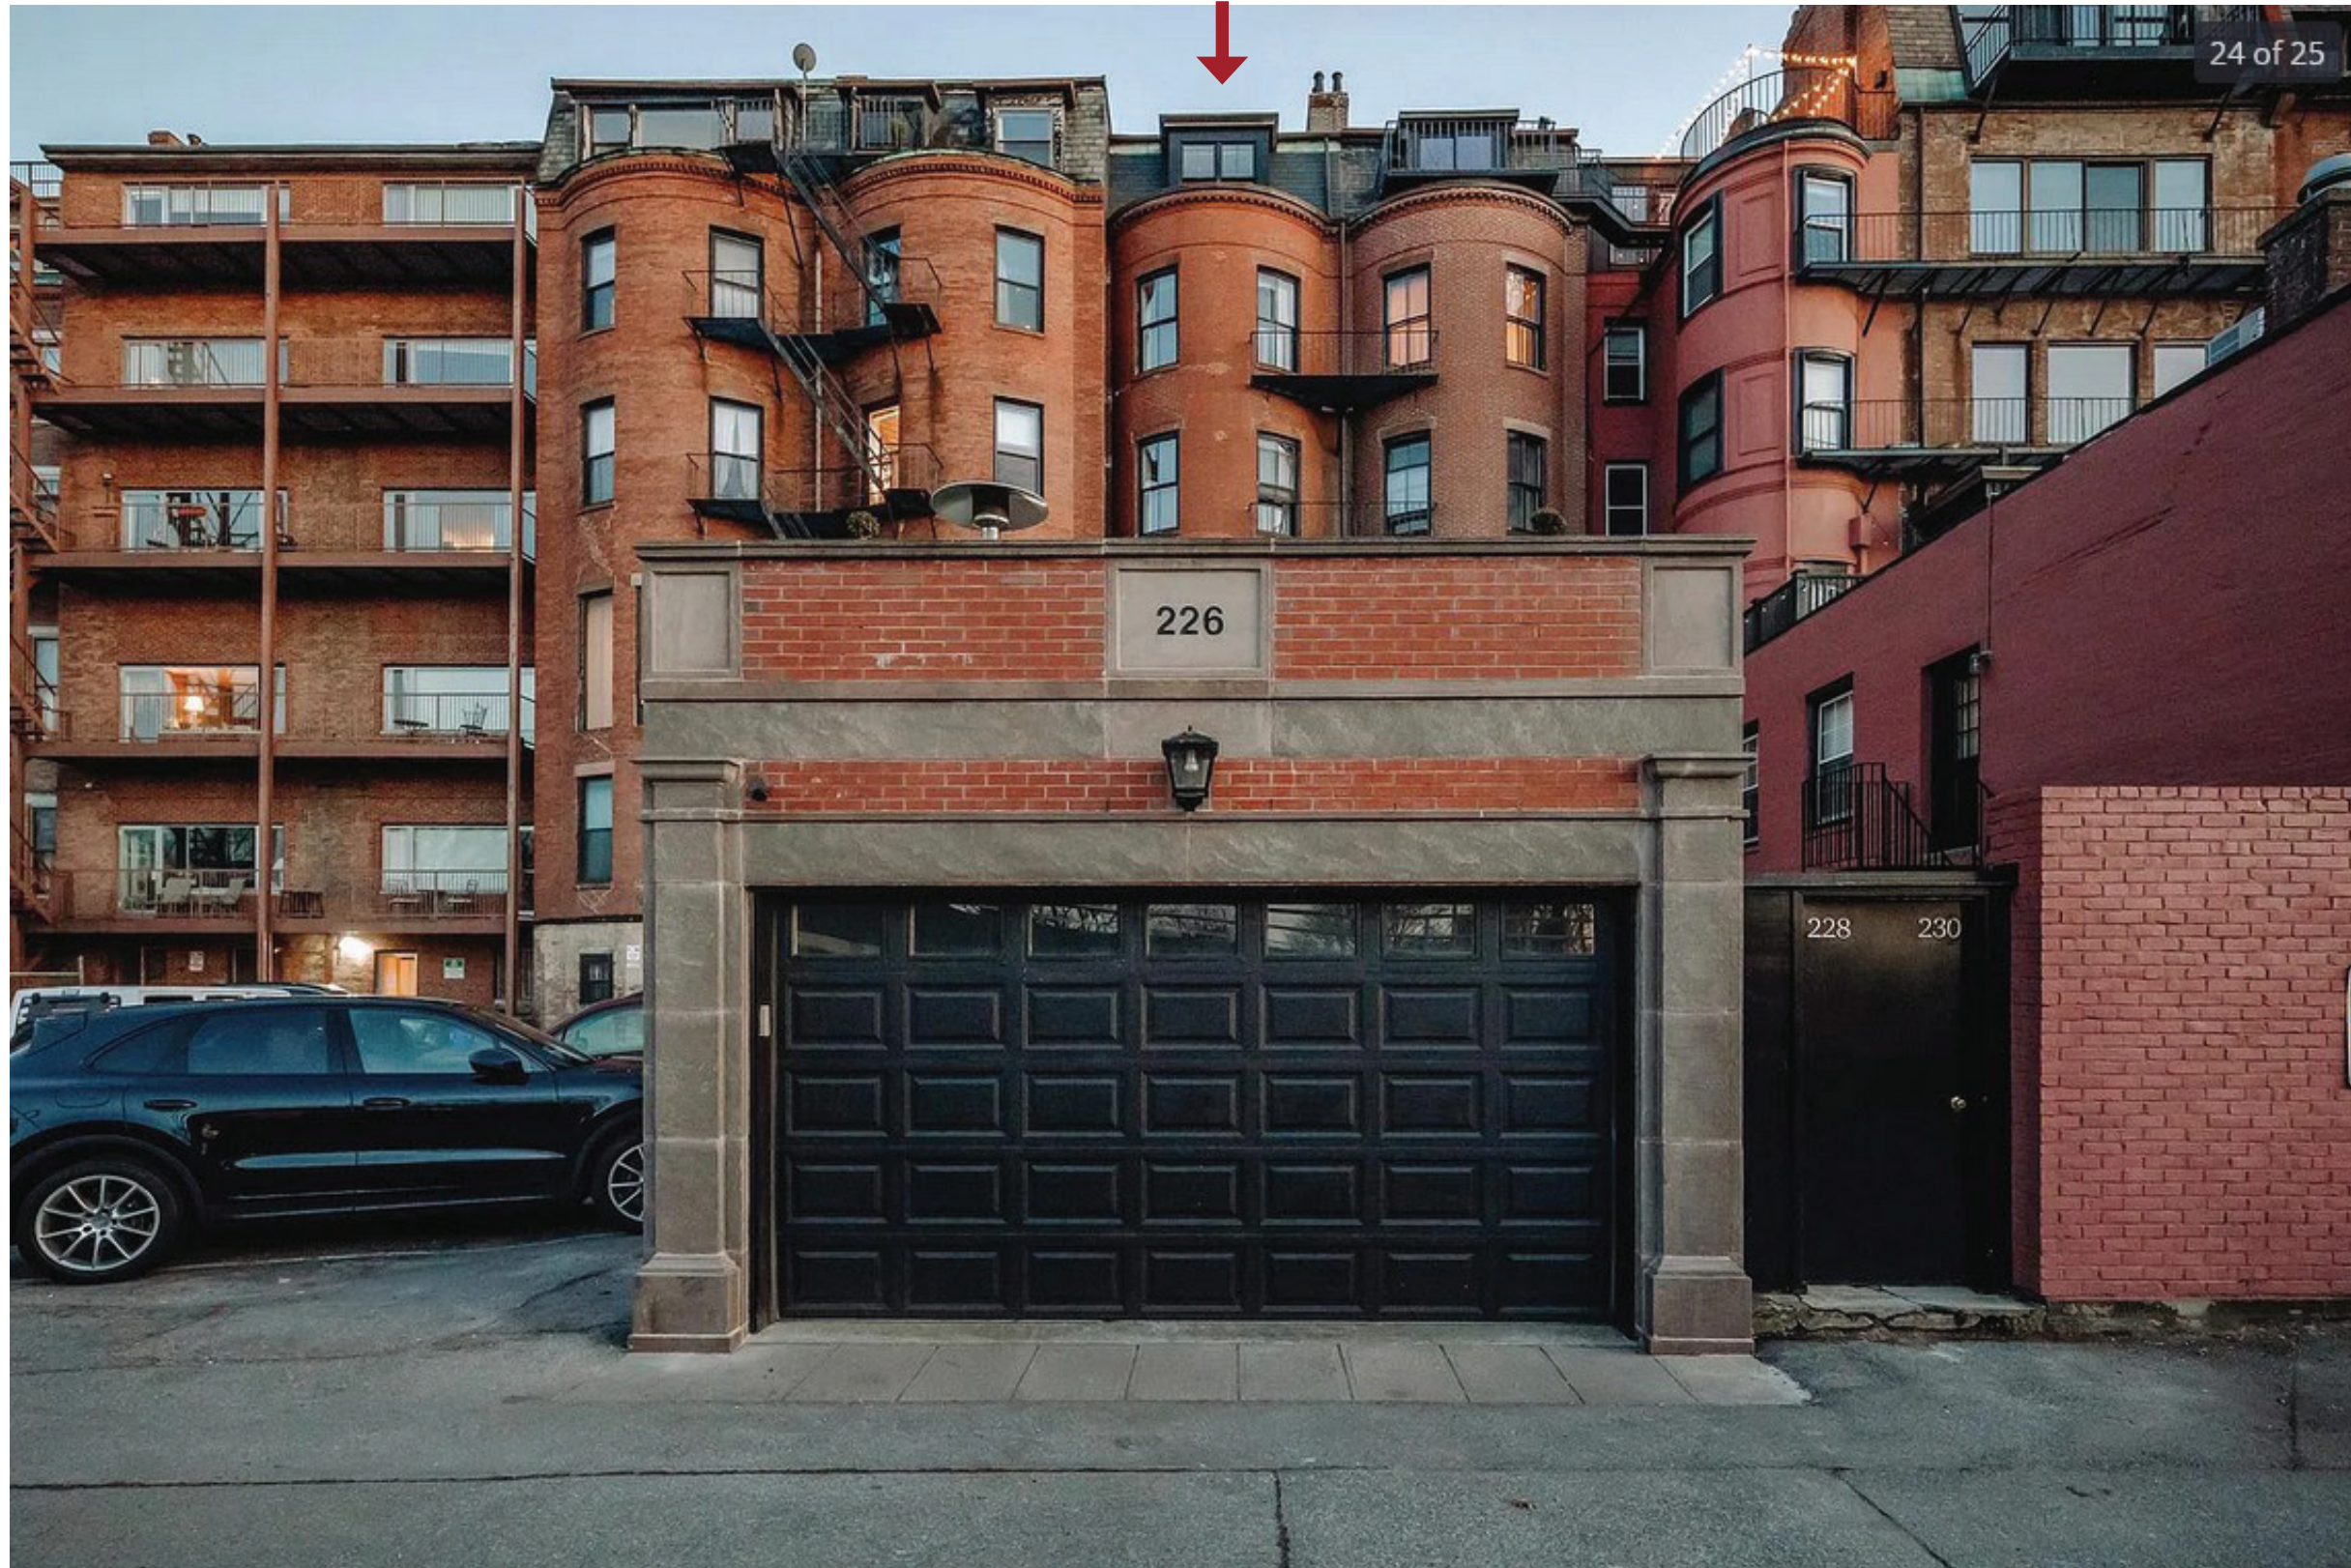
Existing Rear Facade and Garage Door  
Garage and Terrace constructed ca. 2011

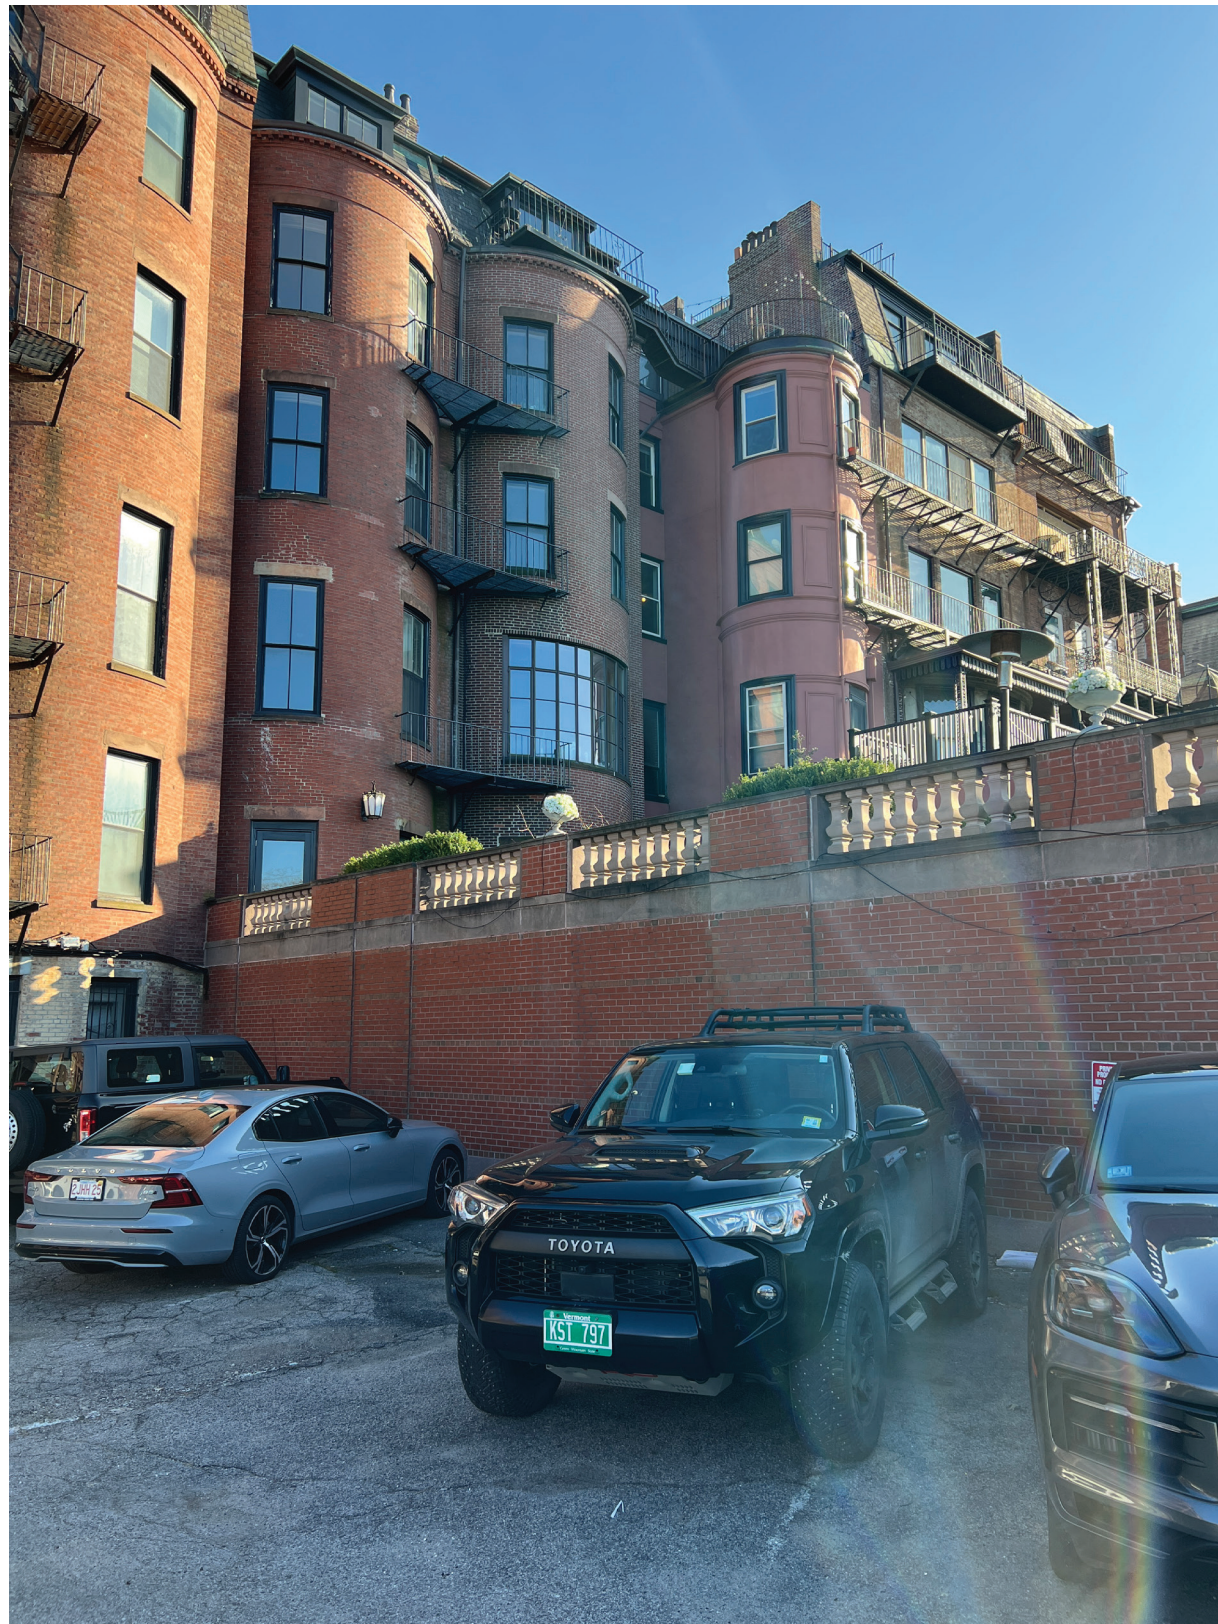
Existing East Facade  
Garage and Terrace constructed ca. 2011

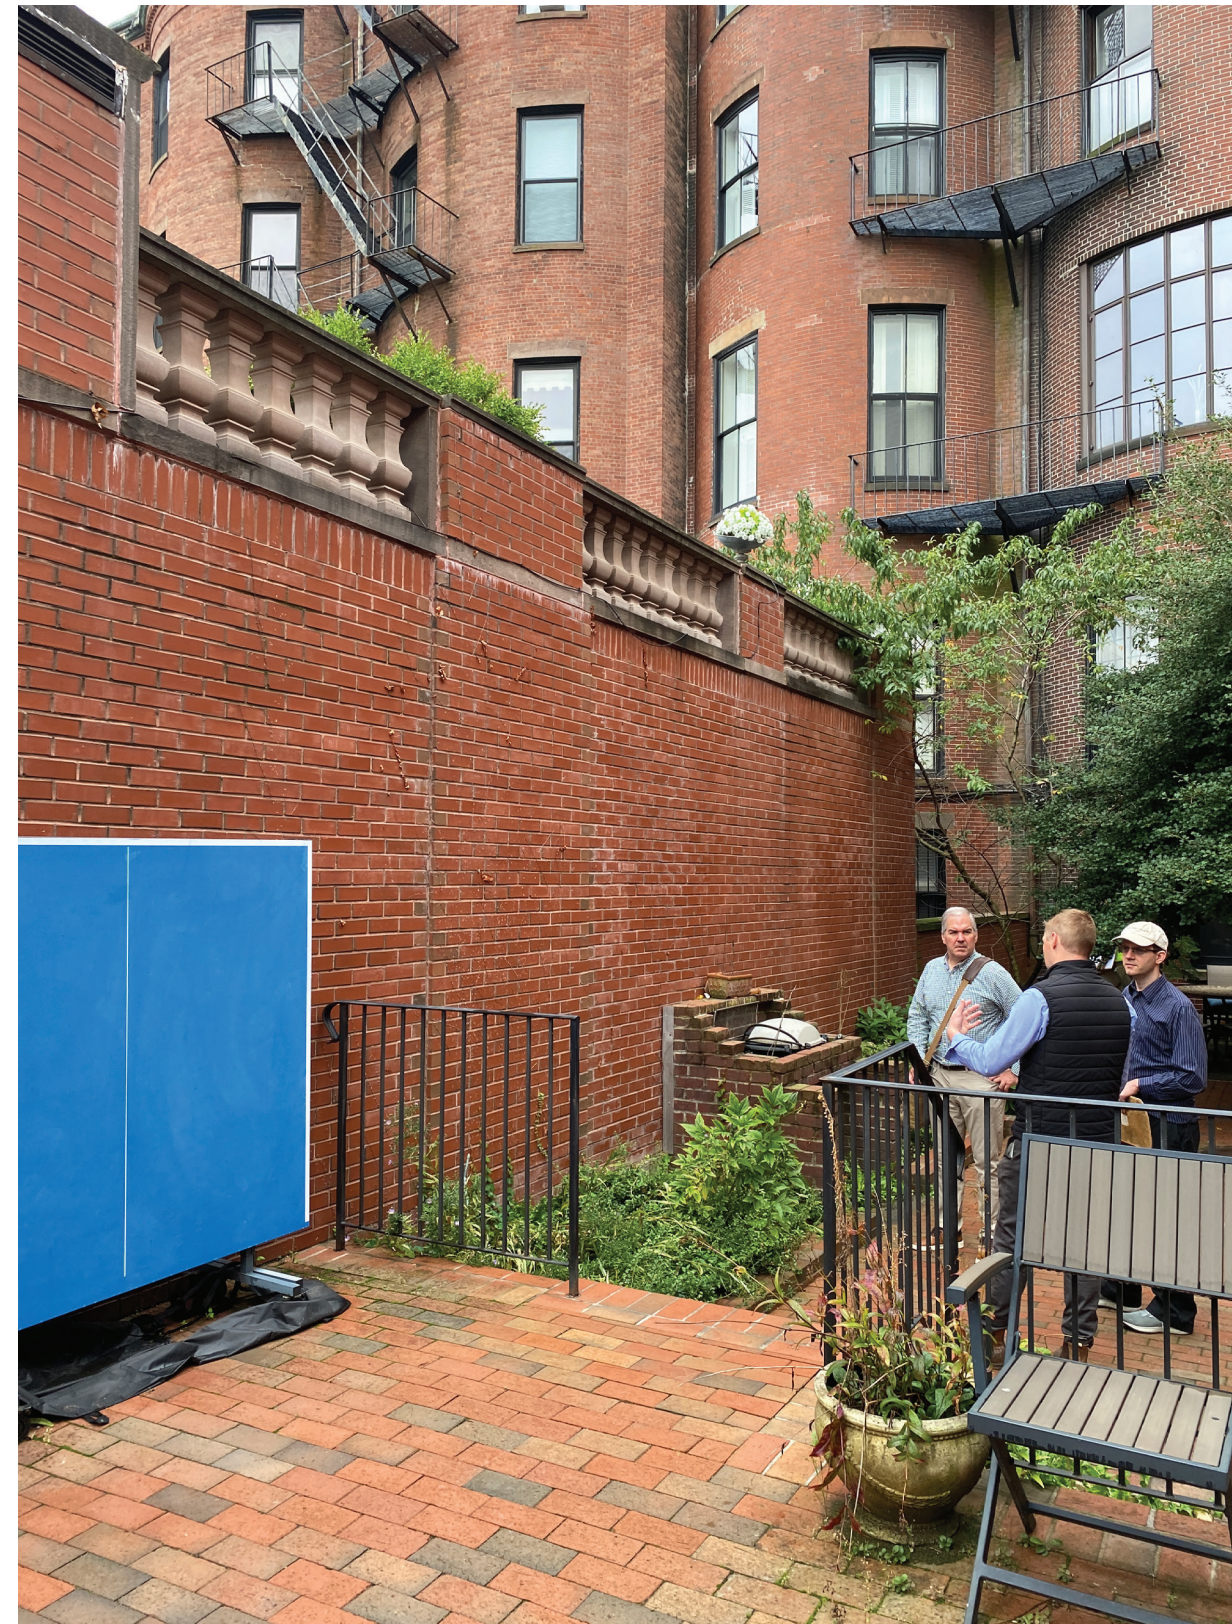
Existing West Facade  
Garage and Terrace constructed ca. 2011

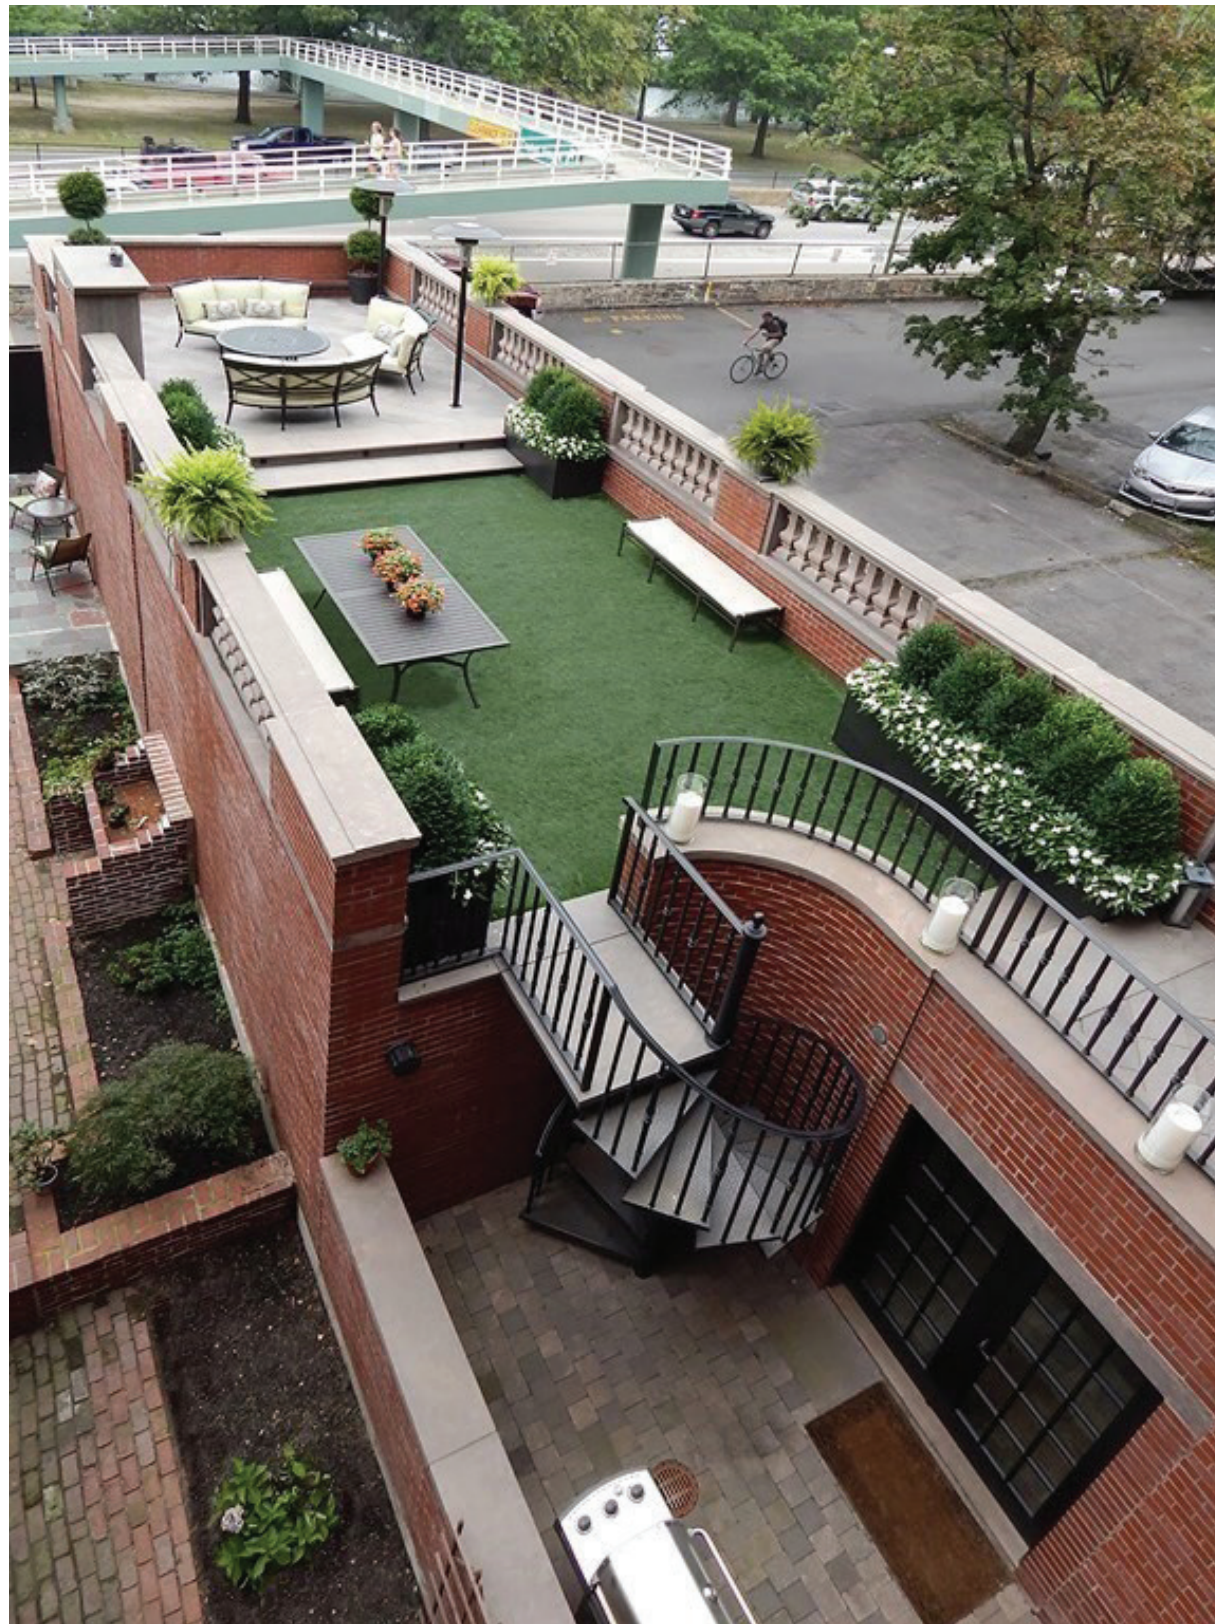
April 2025 - Condition of Rear Terrace

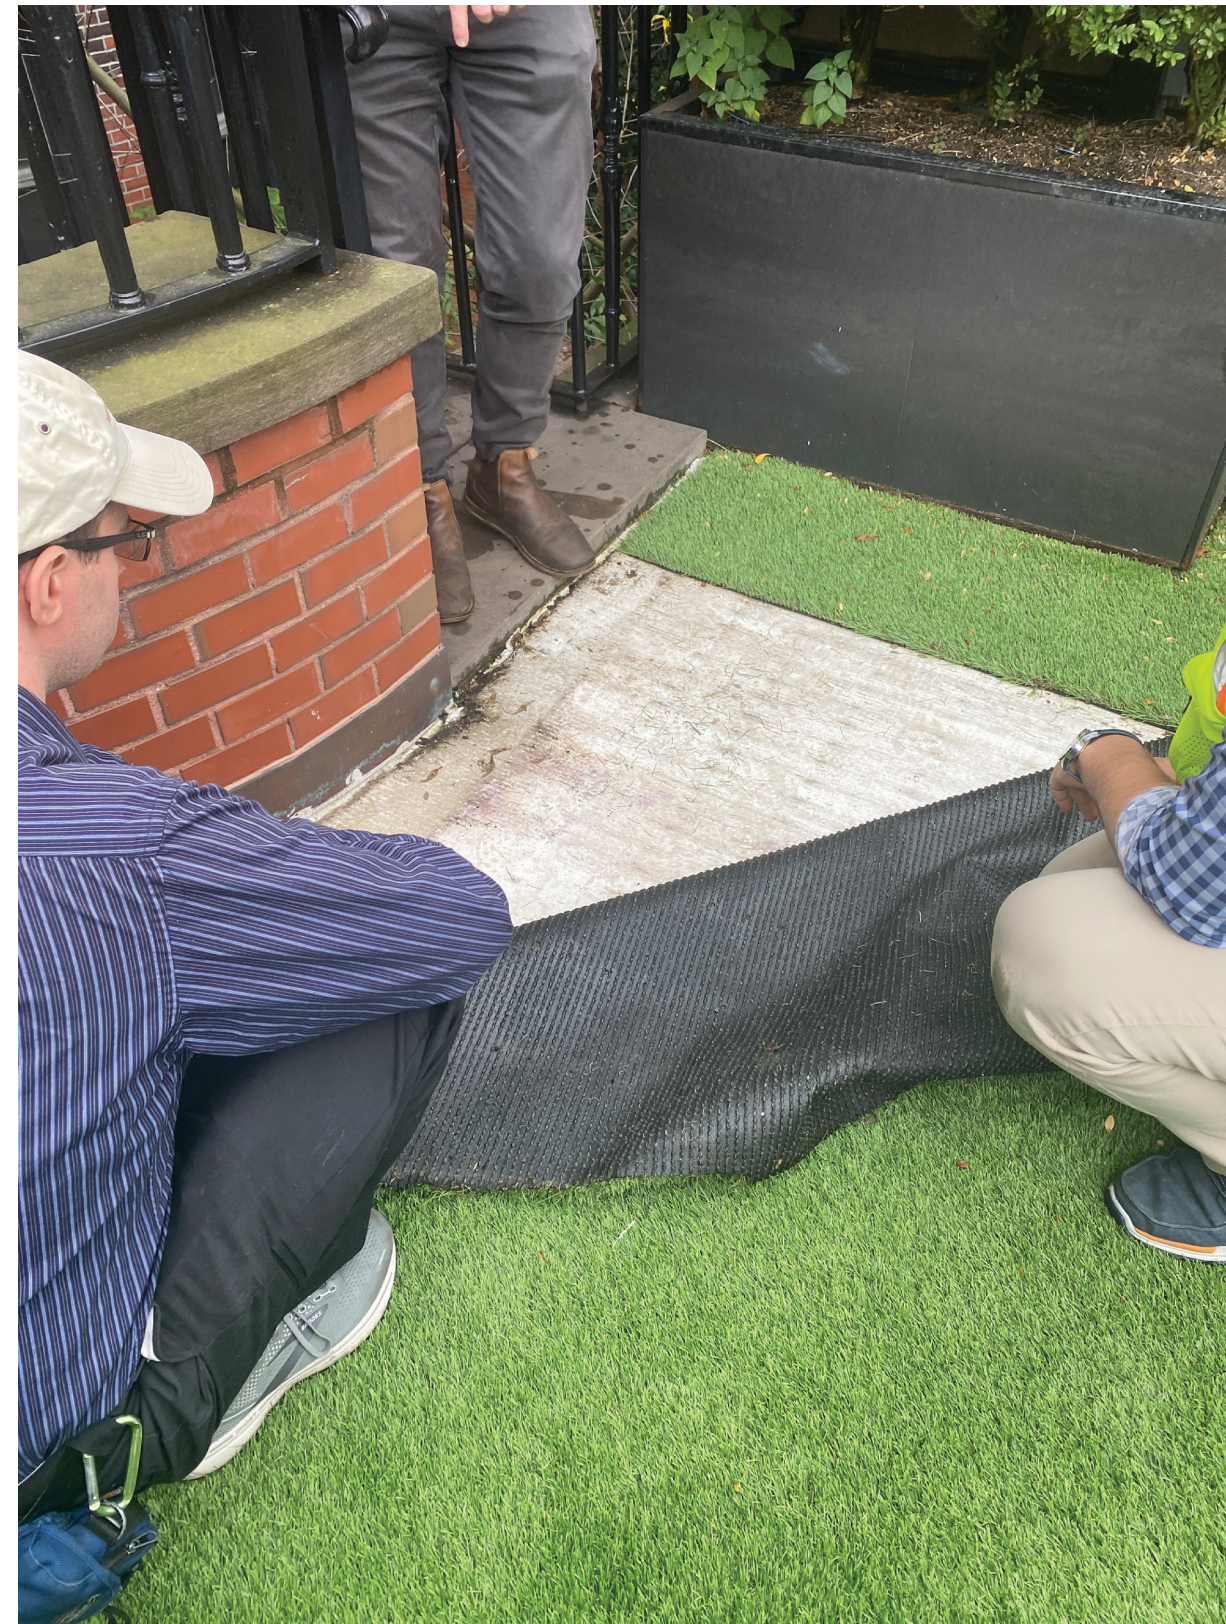
September 2025 - failing membrane roofing below outdoor carpet and stone pavers

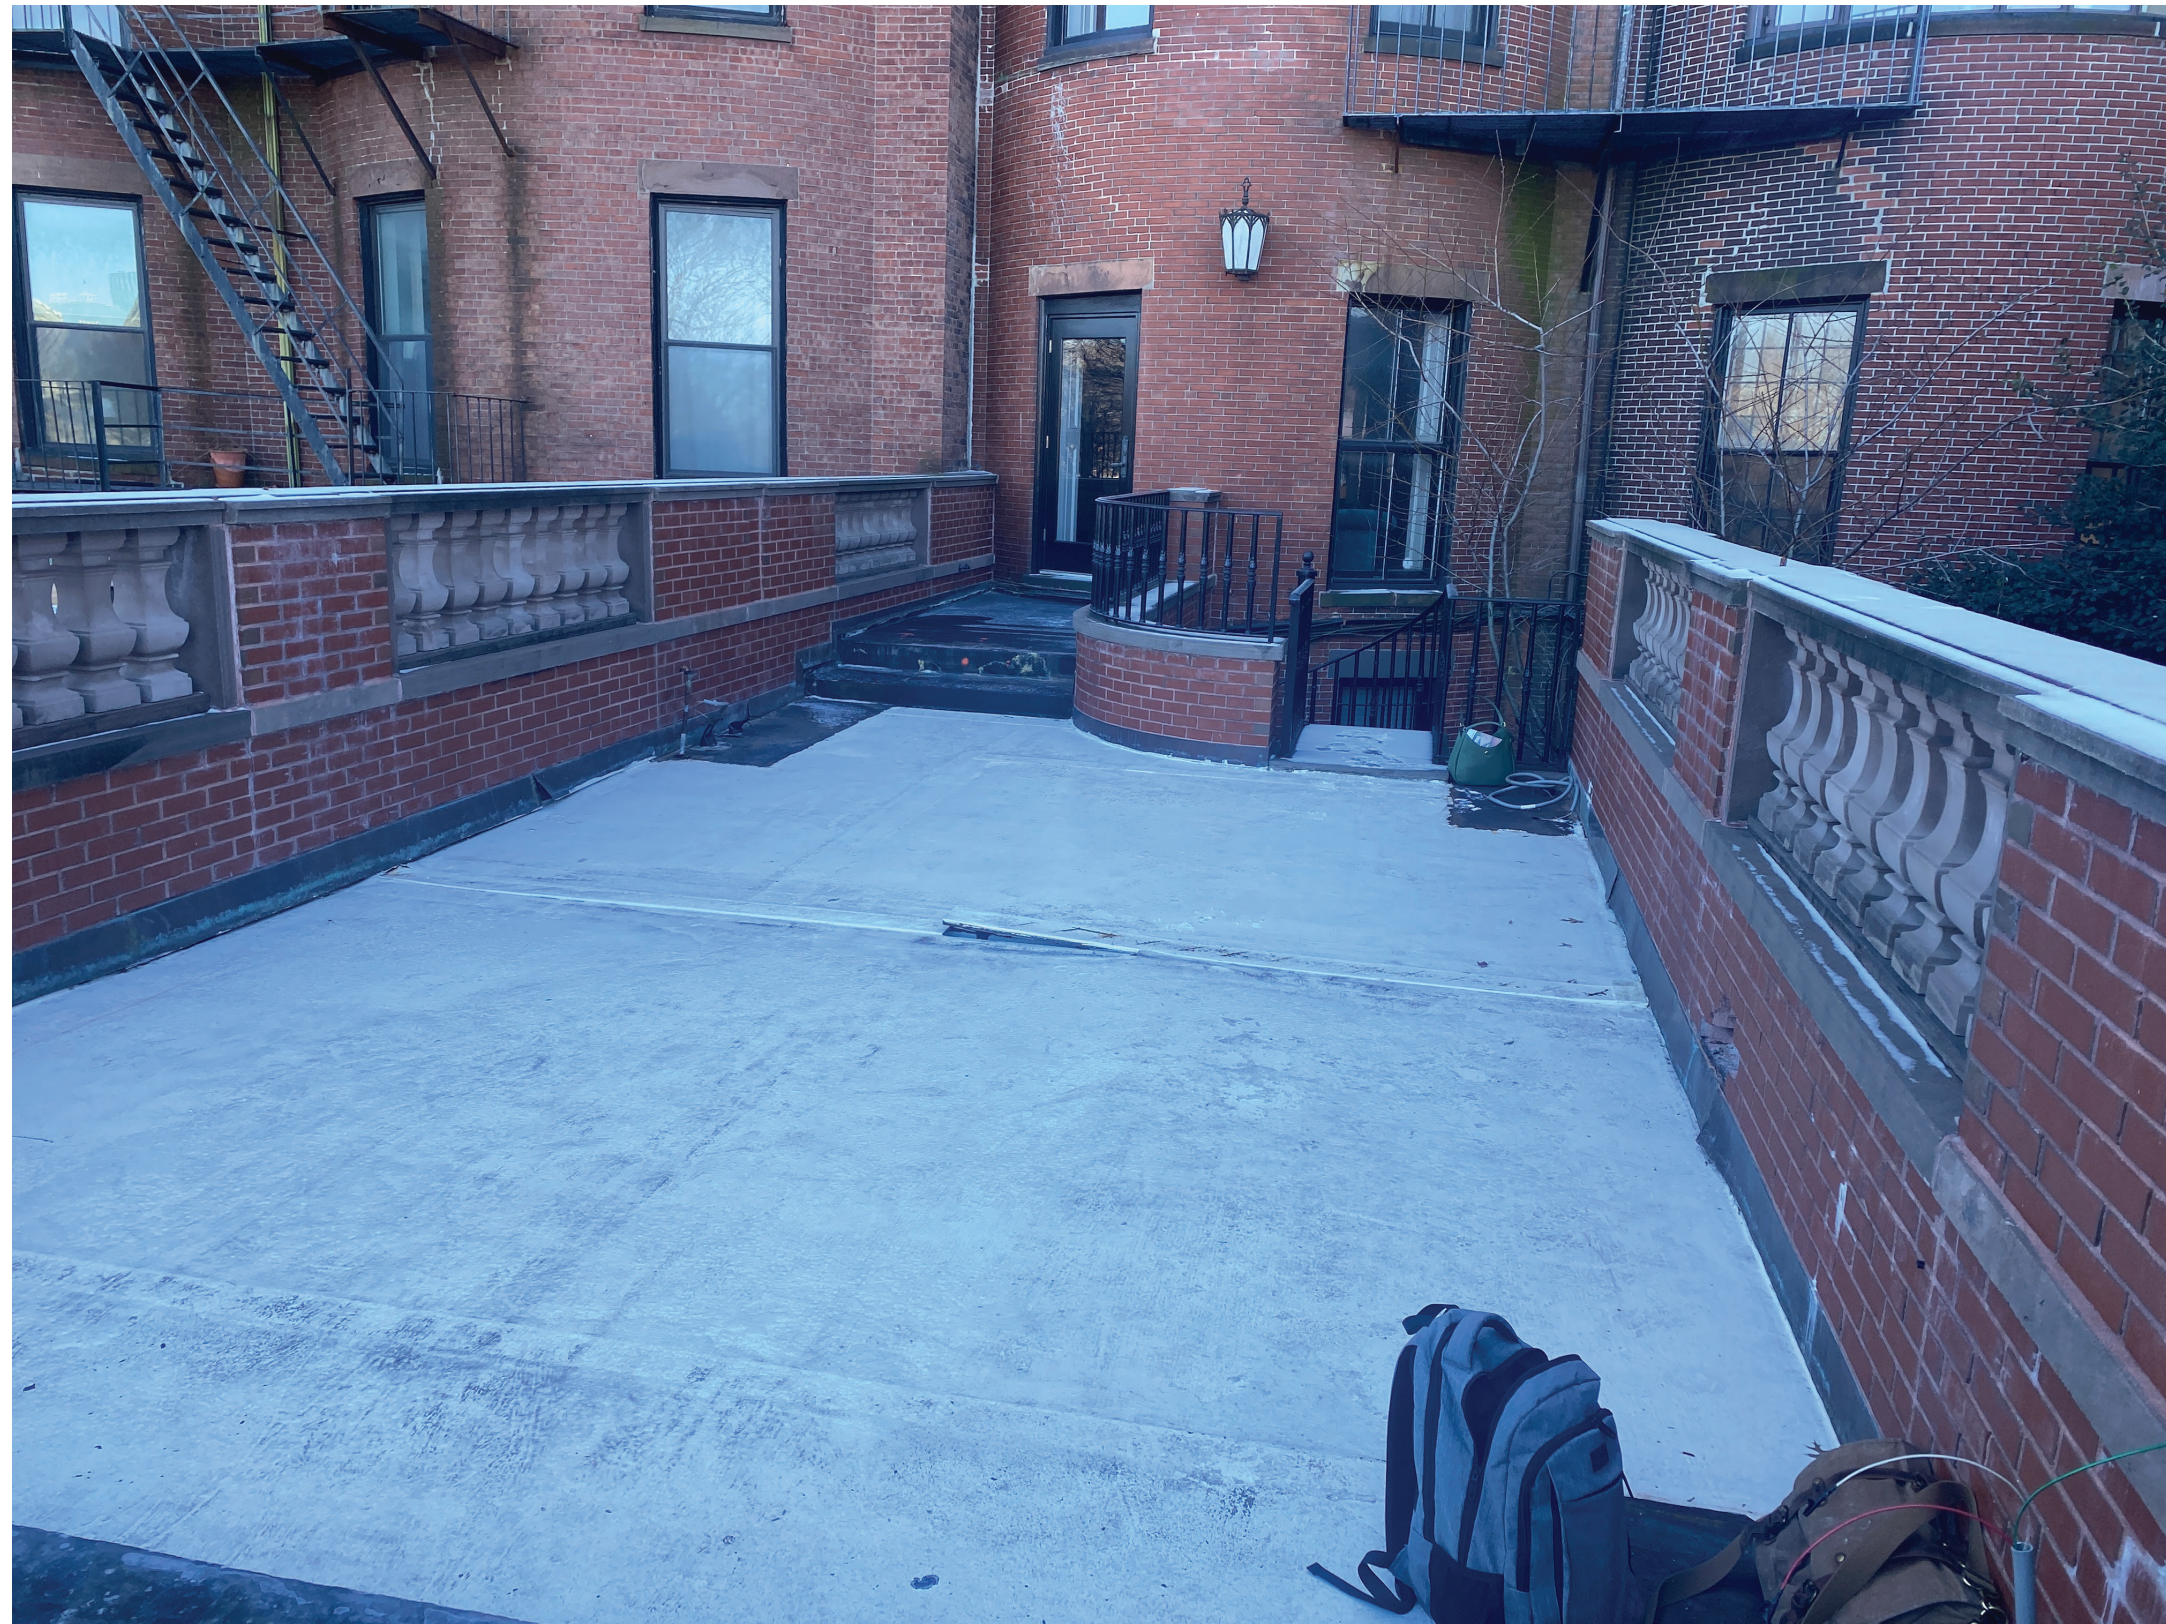
January 2026 - removed pavers showing failing membrane roofing

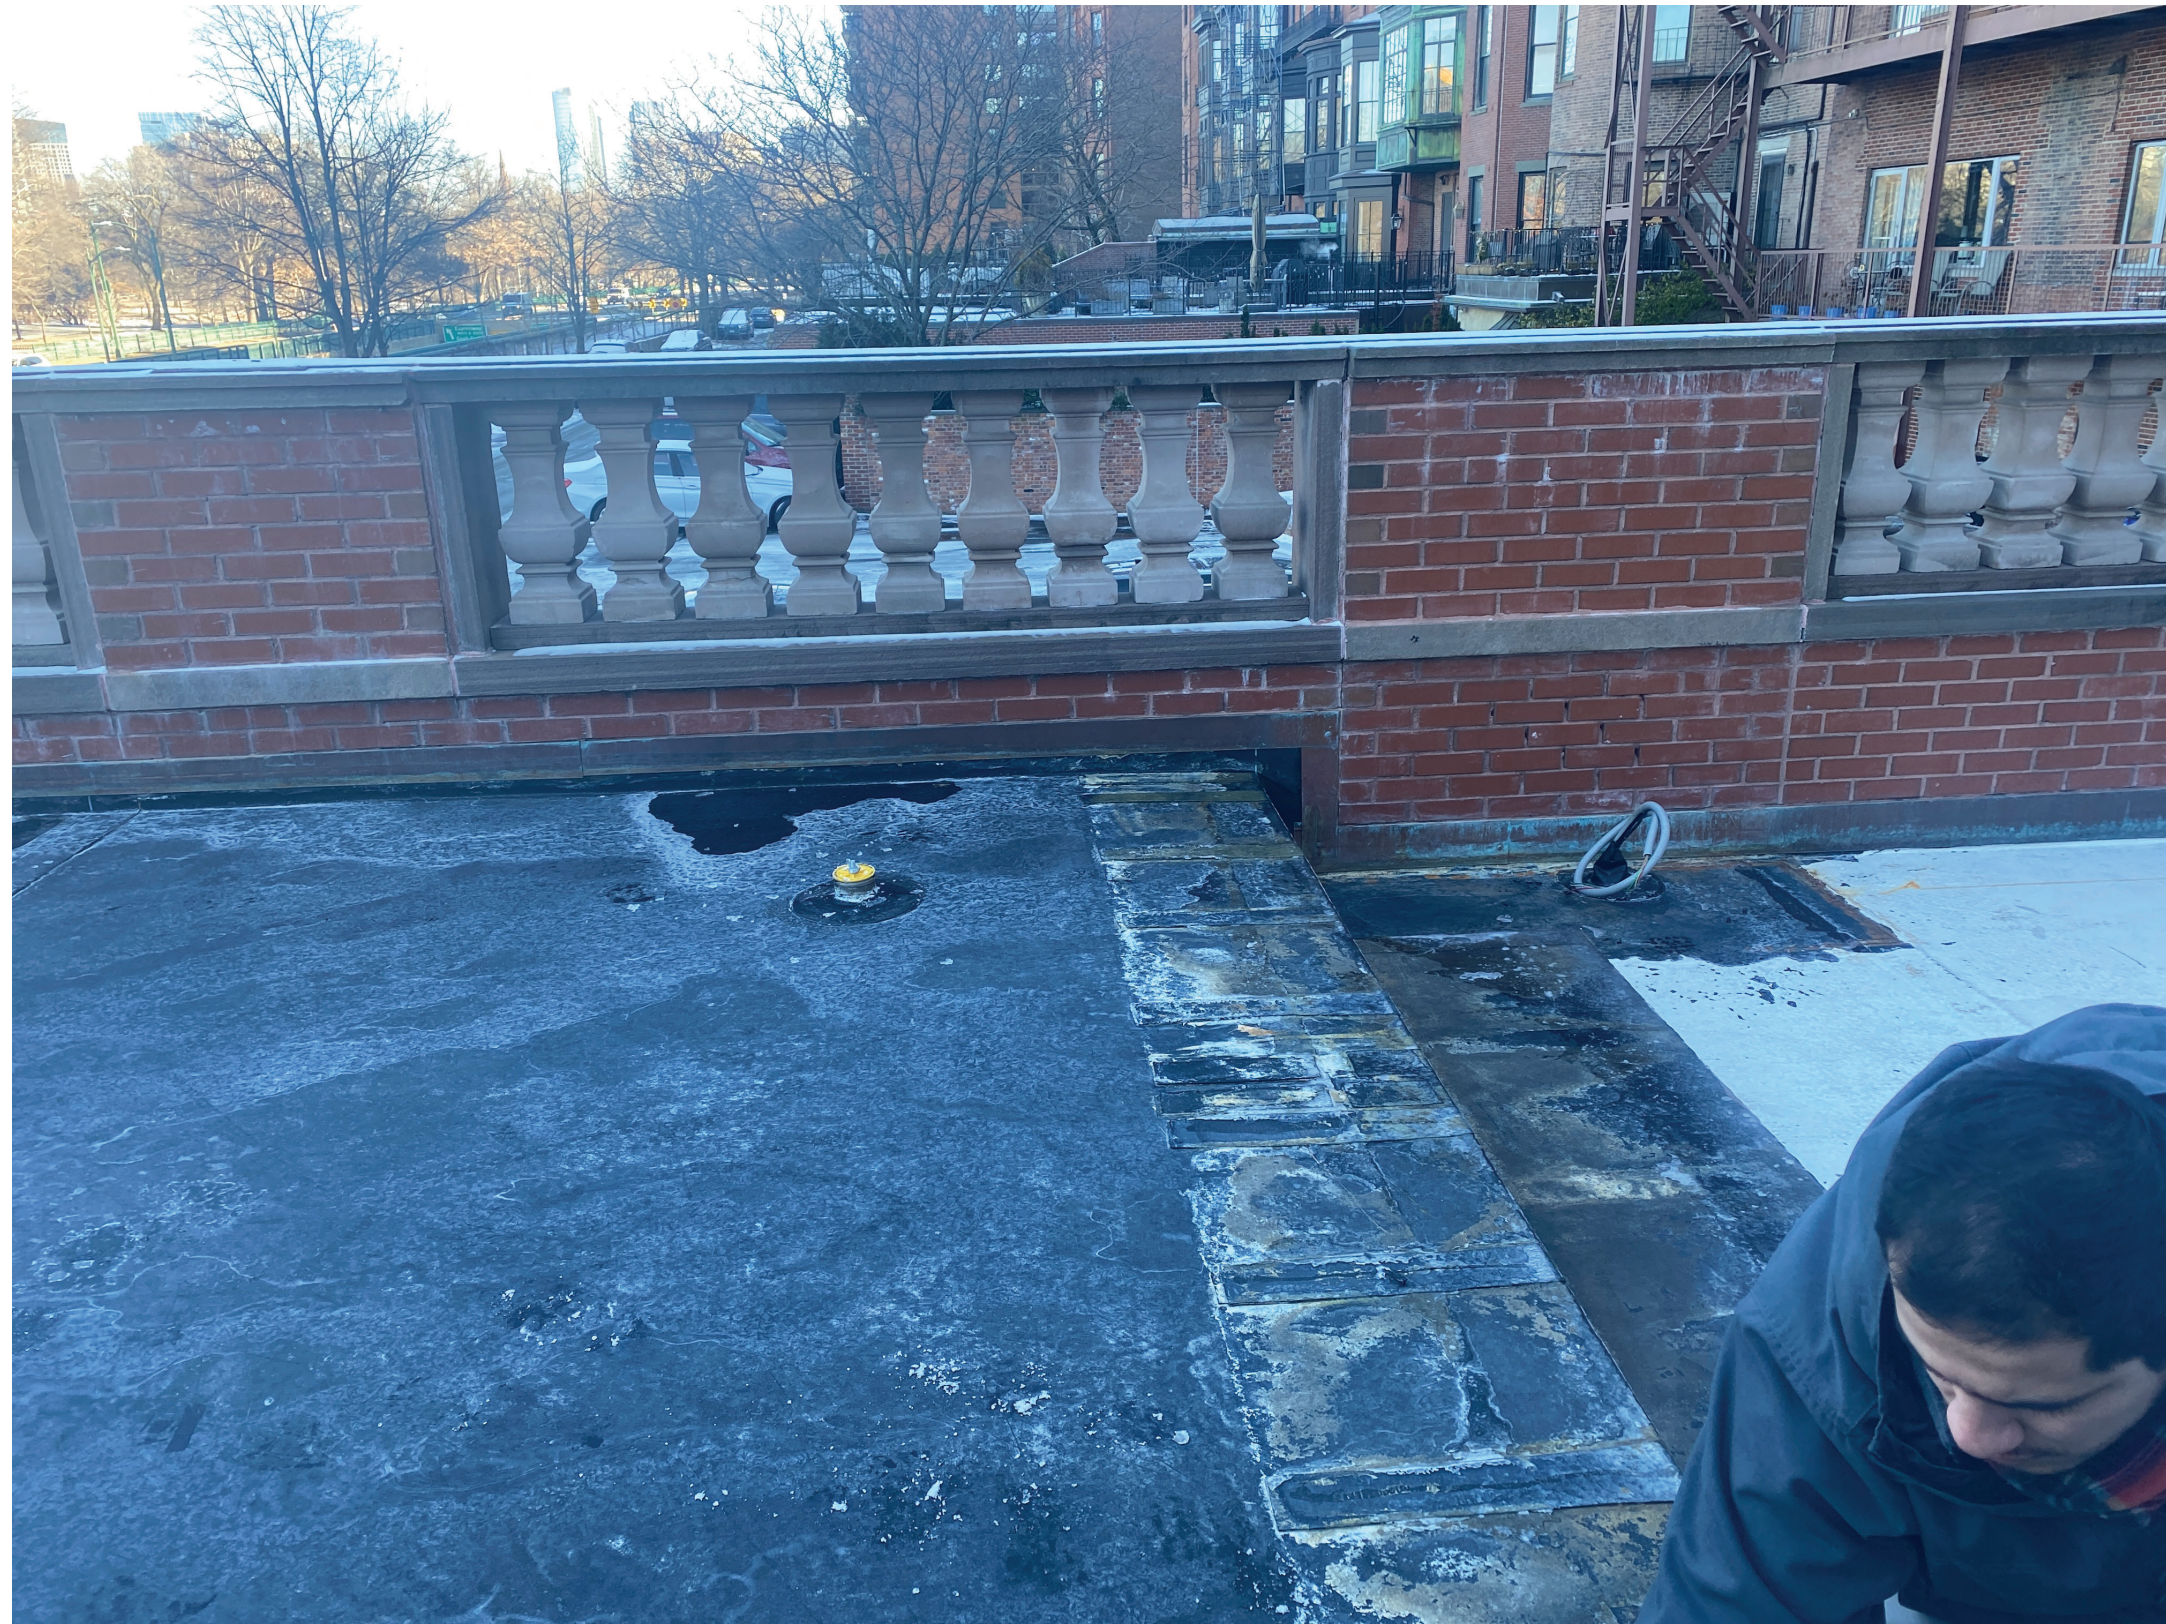
January 2026 - Existing Brick and Stone Terrace Walls
