The Learning Project

*Proposed Alteration to
263 Clarendon Street*
BBAC Landmarks Hearing

May 13, 2026

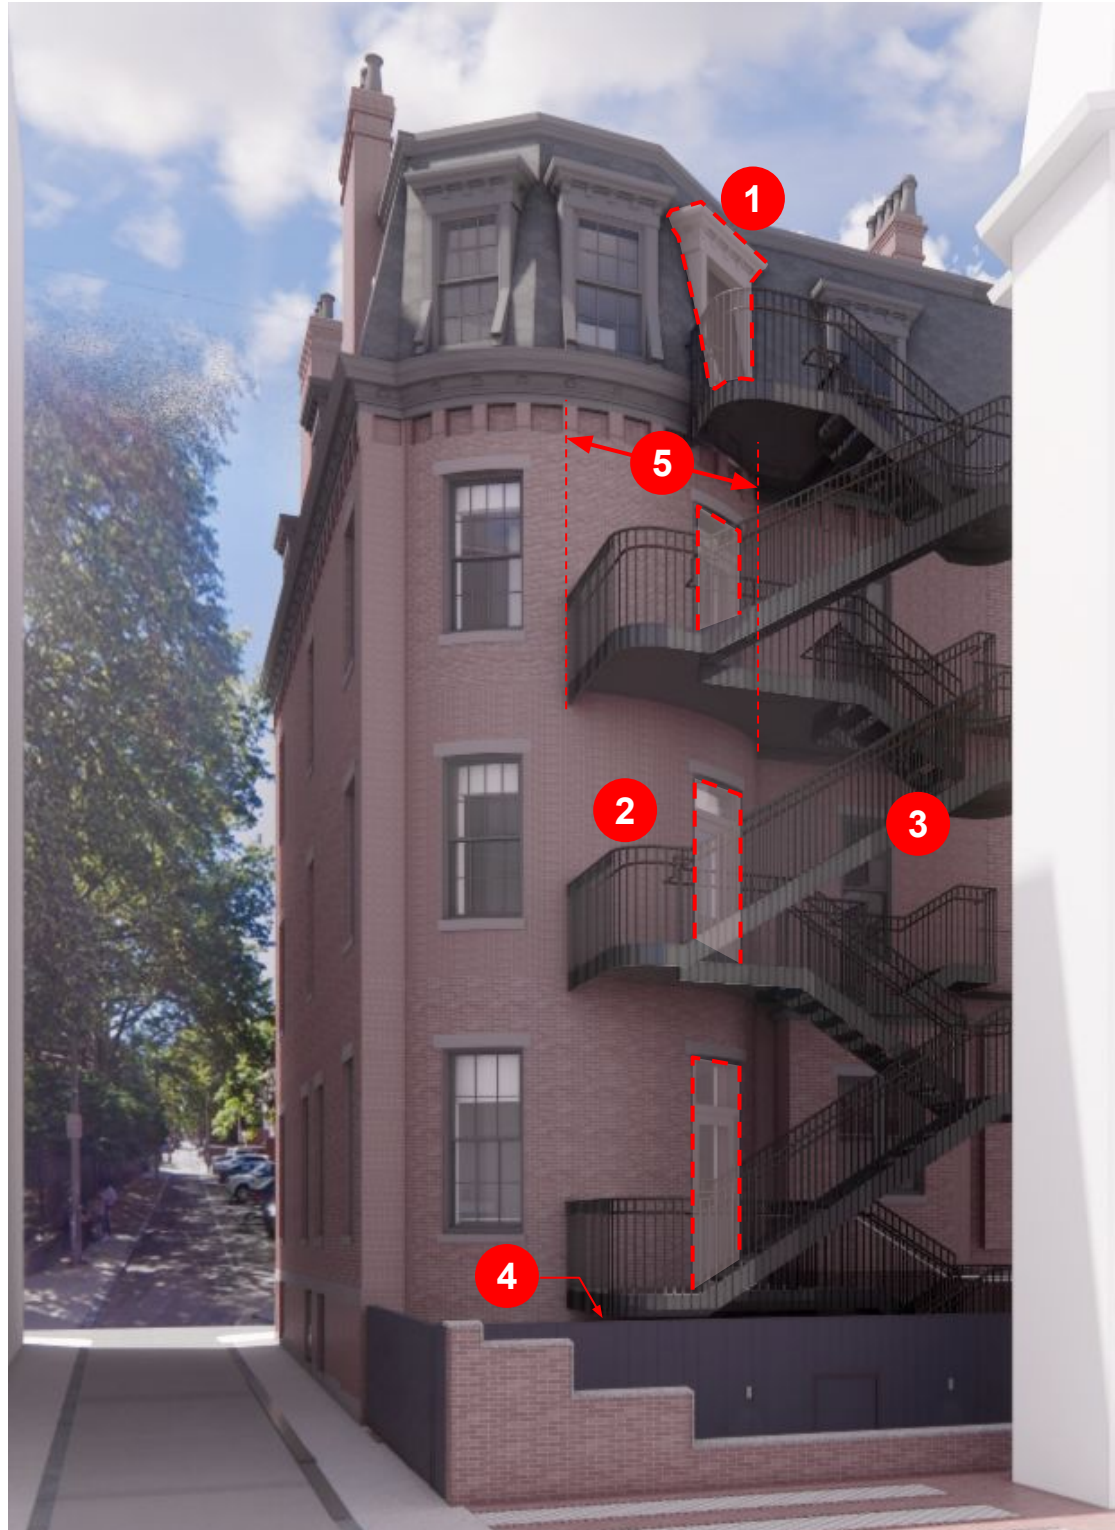
Previous Proposal

1. New opening at Mansard Roof
2. (3) Enlarged window openings on Bay of each level
3. Additional exterior structure
4. (1) Additional opening on rear of lower level
5. Visible obstruction of rear bow facade

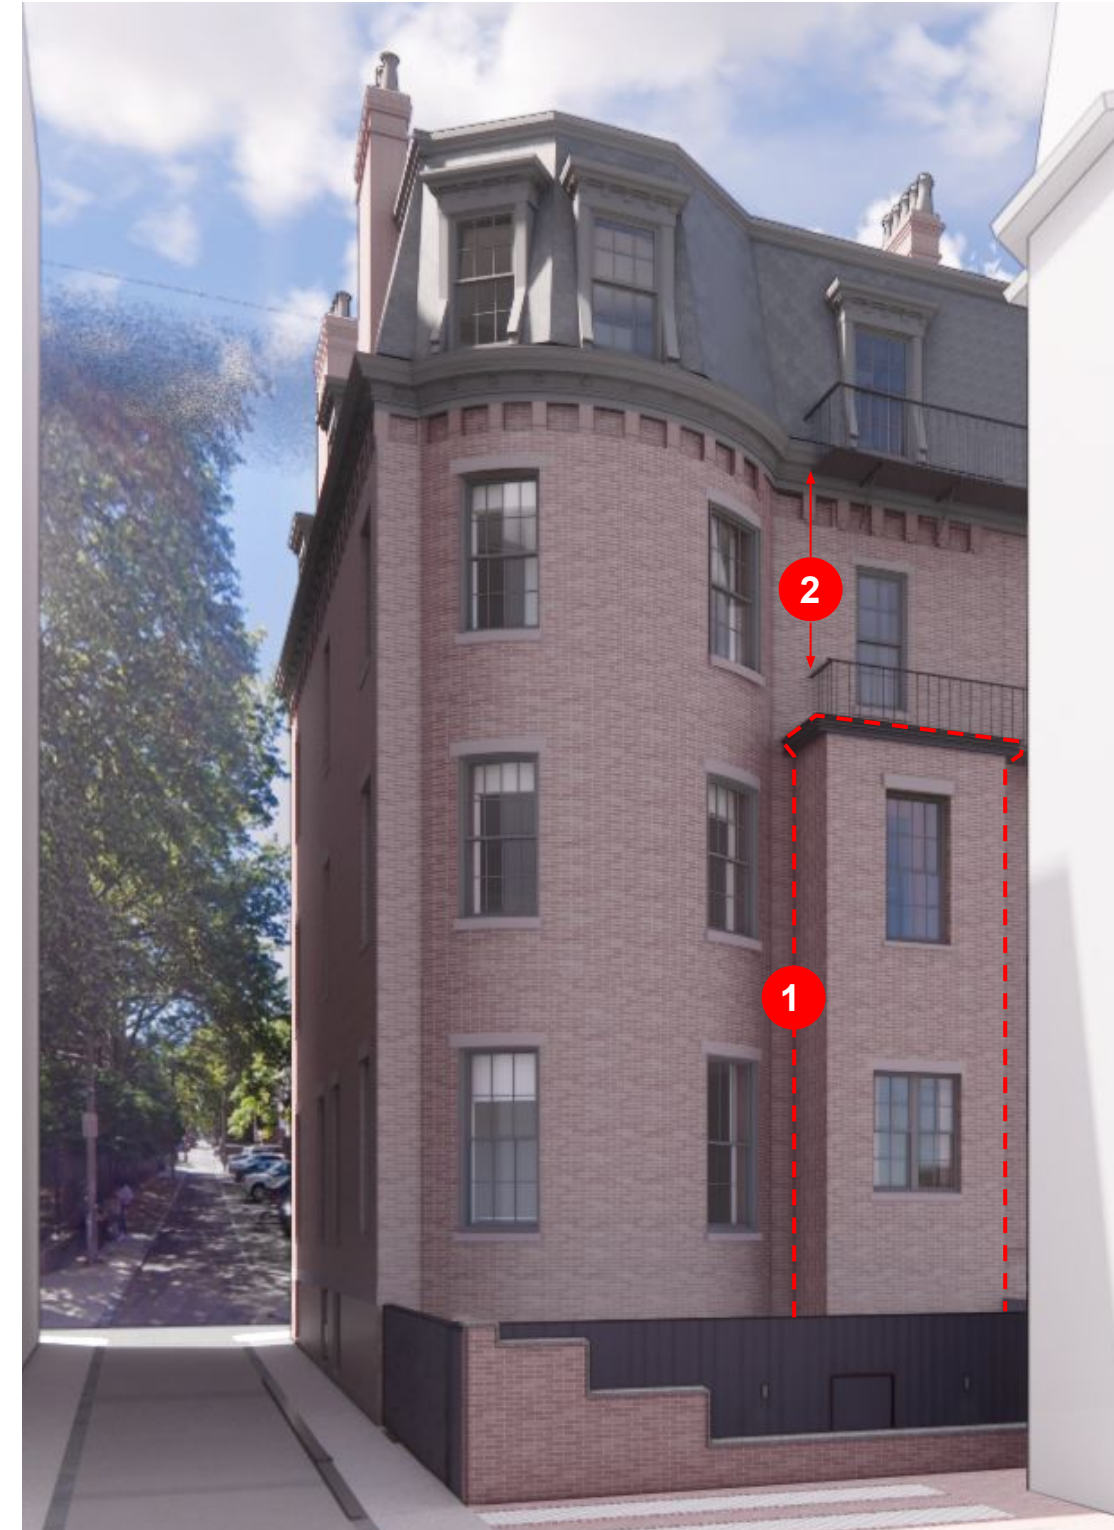
Current Proposal

1. Remove inappropriate additions and reconstruct the rear bay in a matching material
2. Reduce extents of existing fire balconies

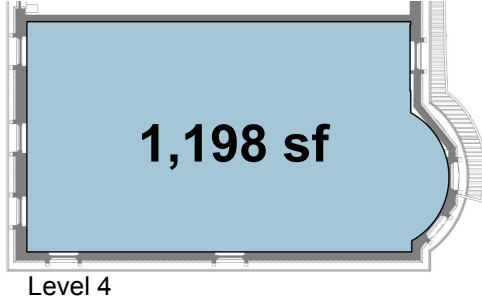
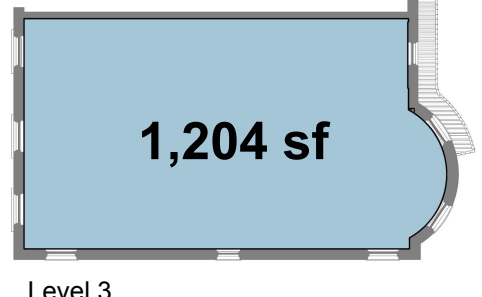
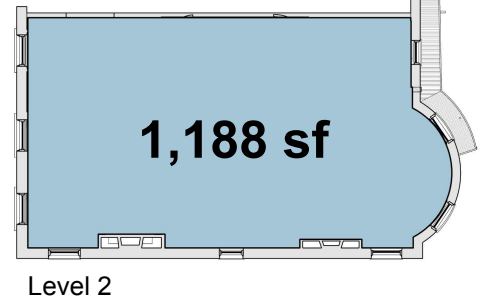
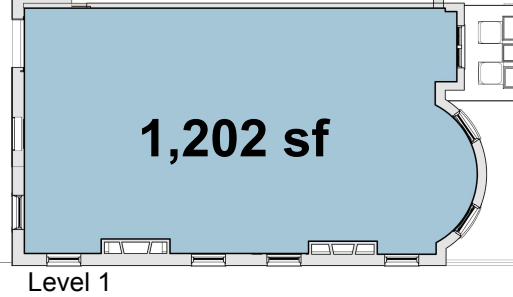
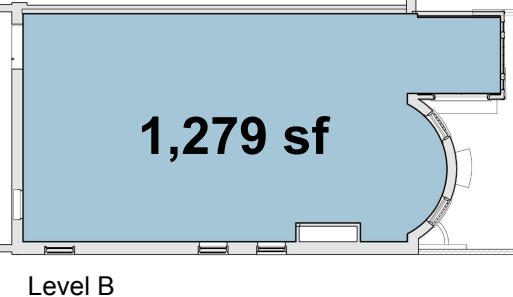
Existing vs Proposed, Area Comparison

Existing Condition, Interior Area by Level	
Level 4	1,198 SF
Level 3	1,204 SF
Level 2	1,188 SF
Level 1	1,202 SF
Level B	1,273 SF
Net Interior Area	6,065 SF

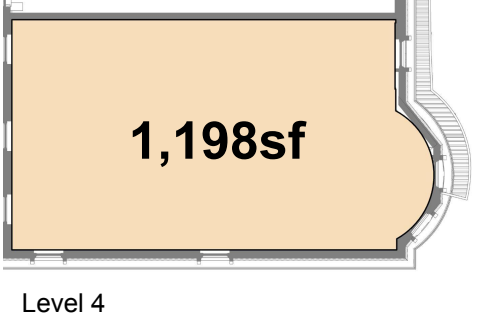
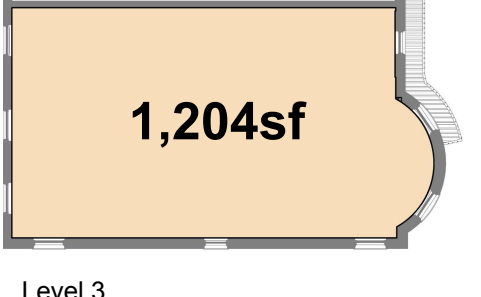
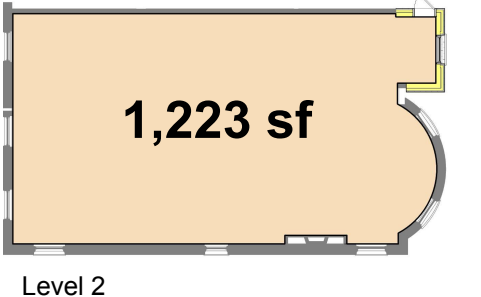
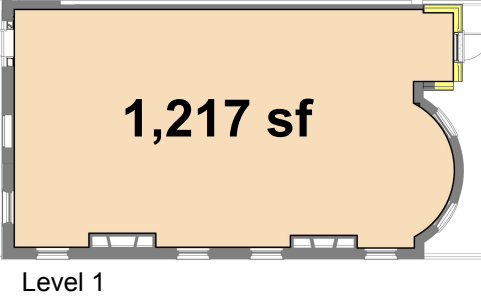
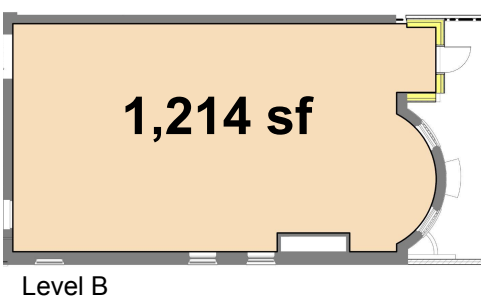
Proposed Alteration, Interior Area by Level		Delta
Level 4	1,198 SF	0 SF
Level 3	1,204 SF	0 SF
Level 2	1,223 SF	35 SF
Level 1	1,217 SF	15 SF
Level B	1,214 SF	-59 SF
Net Interior Area	6,056 SF	-9 SF

The proposed alteration does **not** increase the net interior area of 263 Clarendon from the existing condition.

The proposed net area is **9 sf less** than the current condition.

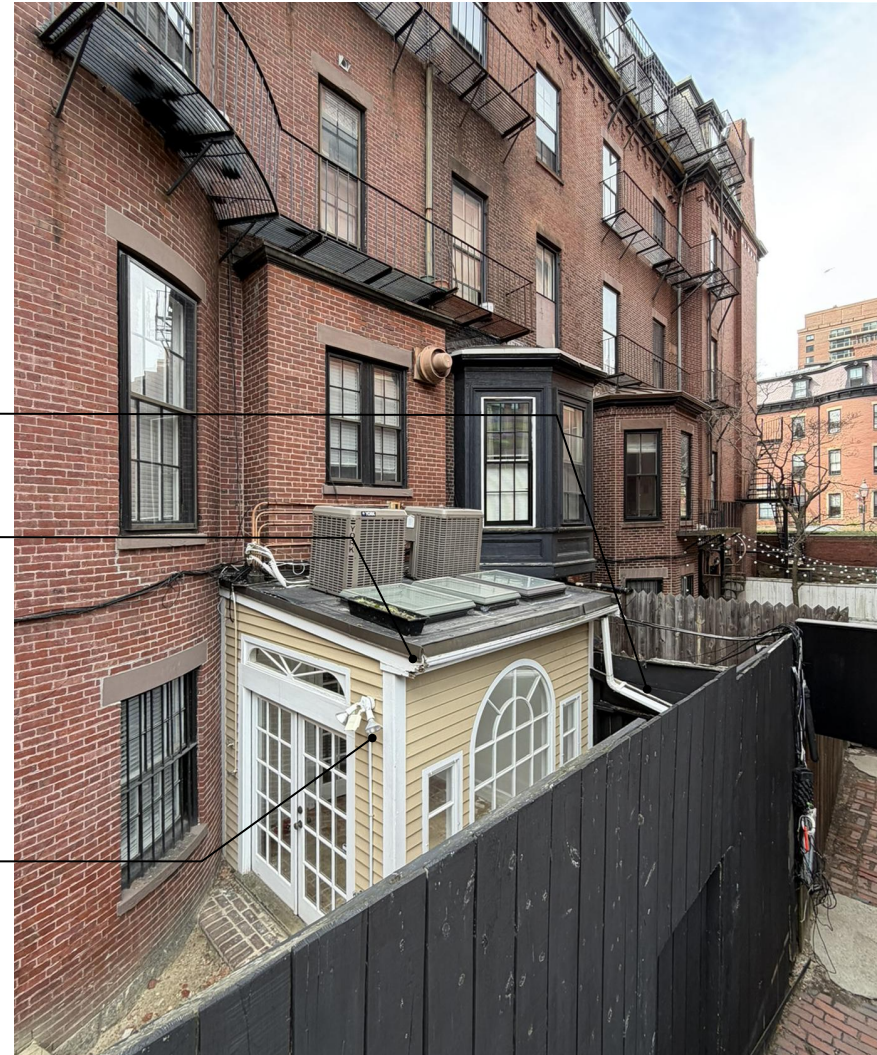
Existing Rear Addition

Haphazard downspout

Rotting trim

Exposed conduit and emergency lighting

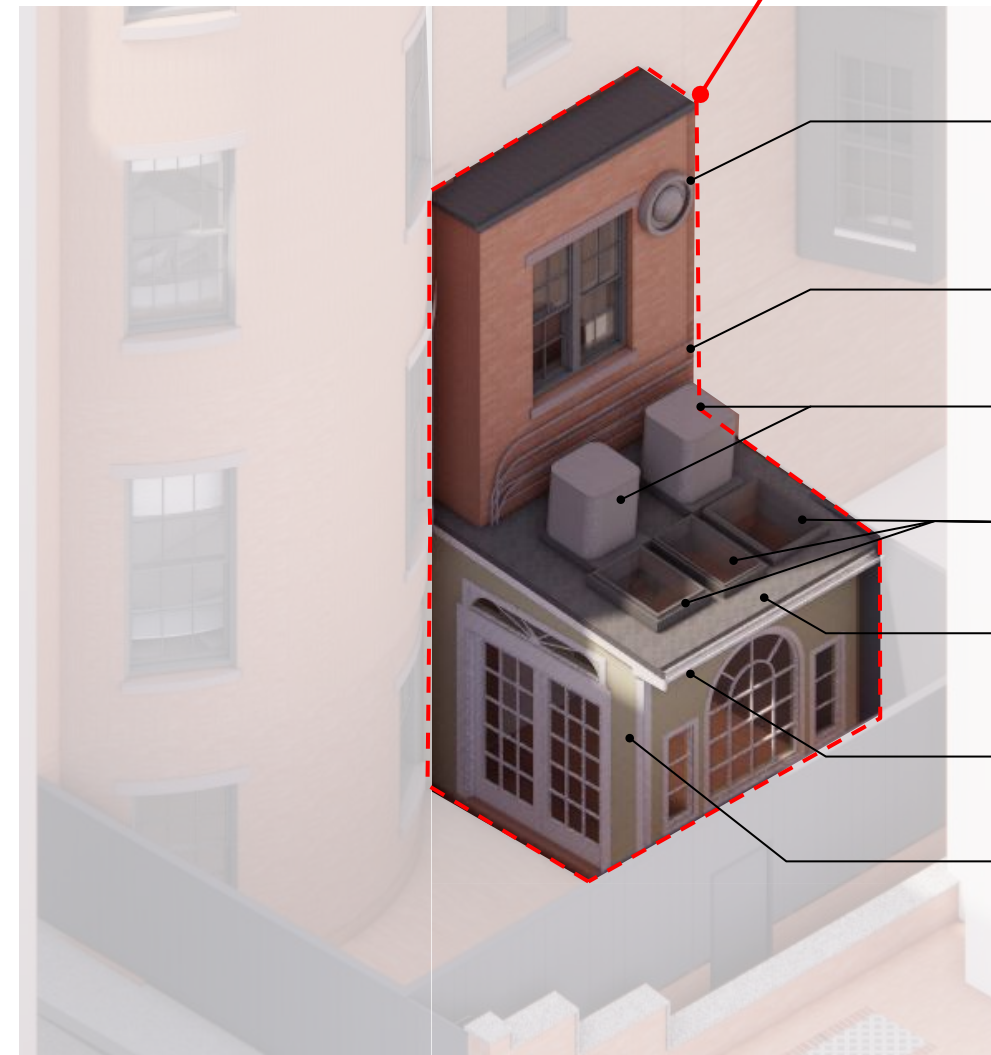
Existing Rear Addition

Kitchen Exhaust Fan

Exposed Refrigerant lines and conduit

(2) Highly Visible Mechanical Equipment

Multiple skylights on raised curbs

Black single ply roofing

White, K-Style residential gutters

Yellow painted wood siding

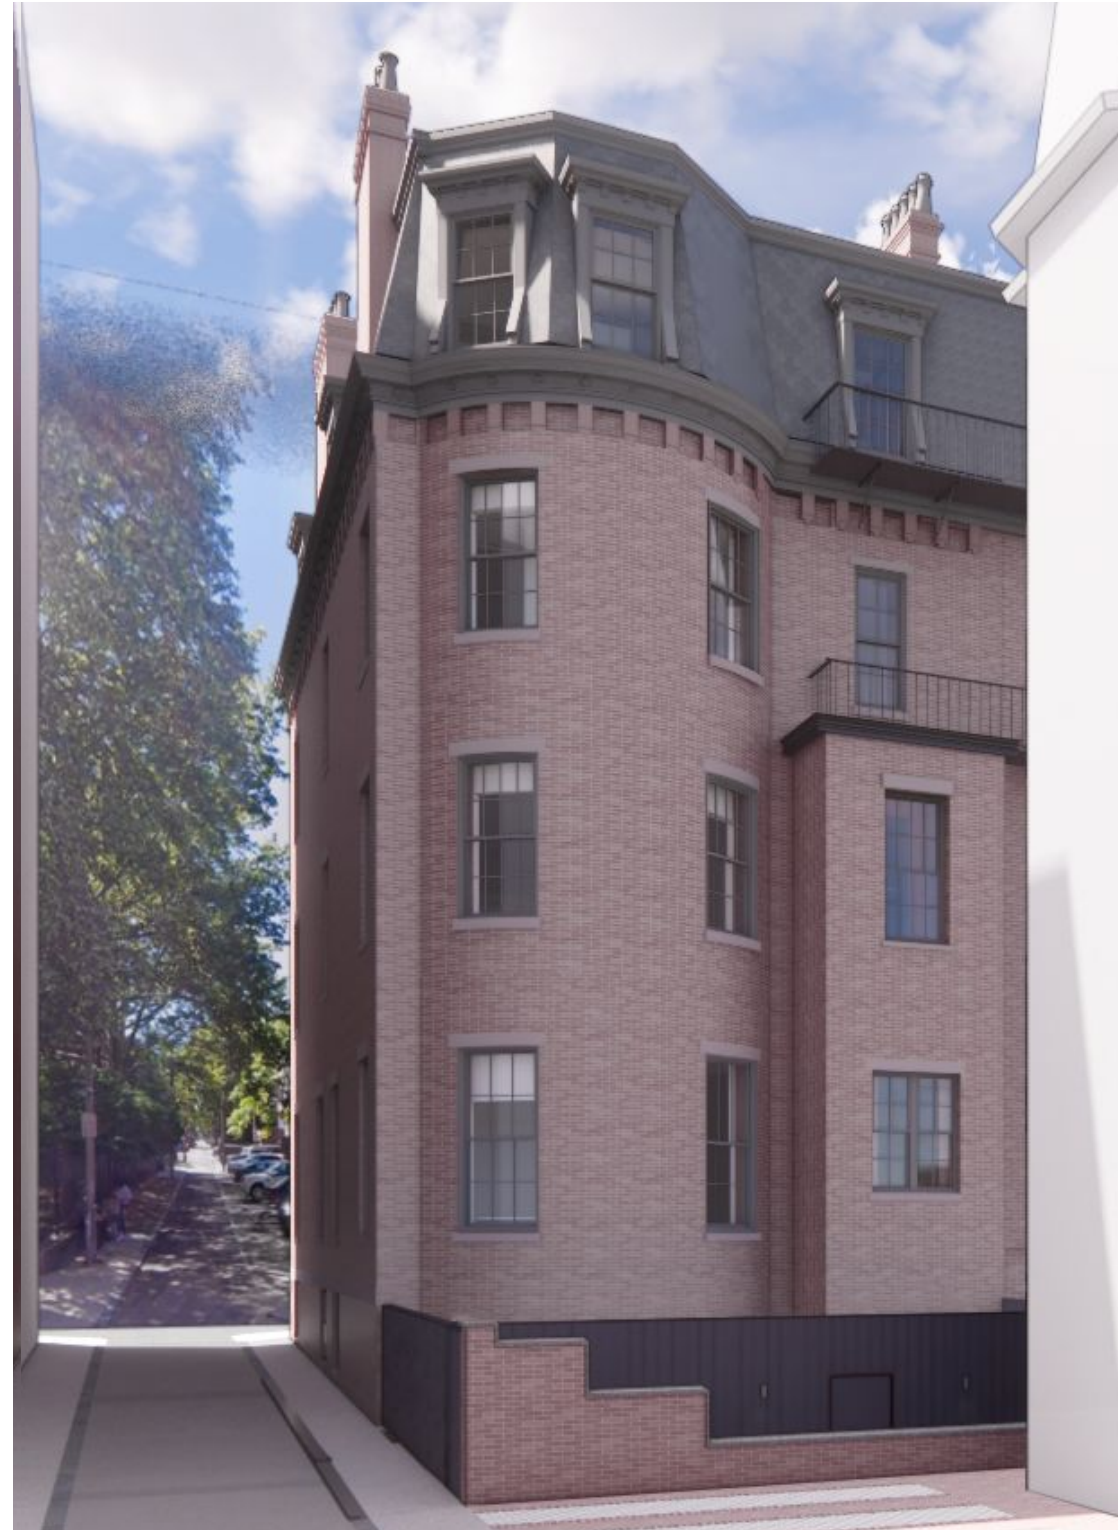
Proposed, view from back alley

- Remove non-historic additions
- Rebuild portion of the rear wall as shown on the next slides

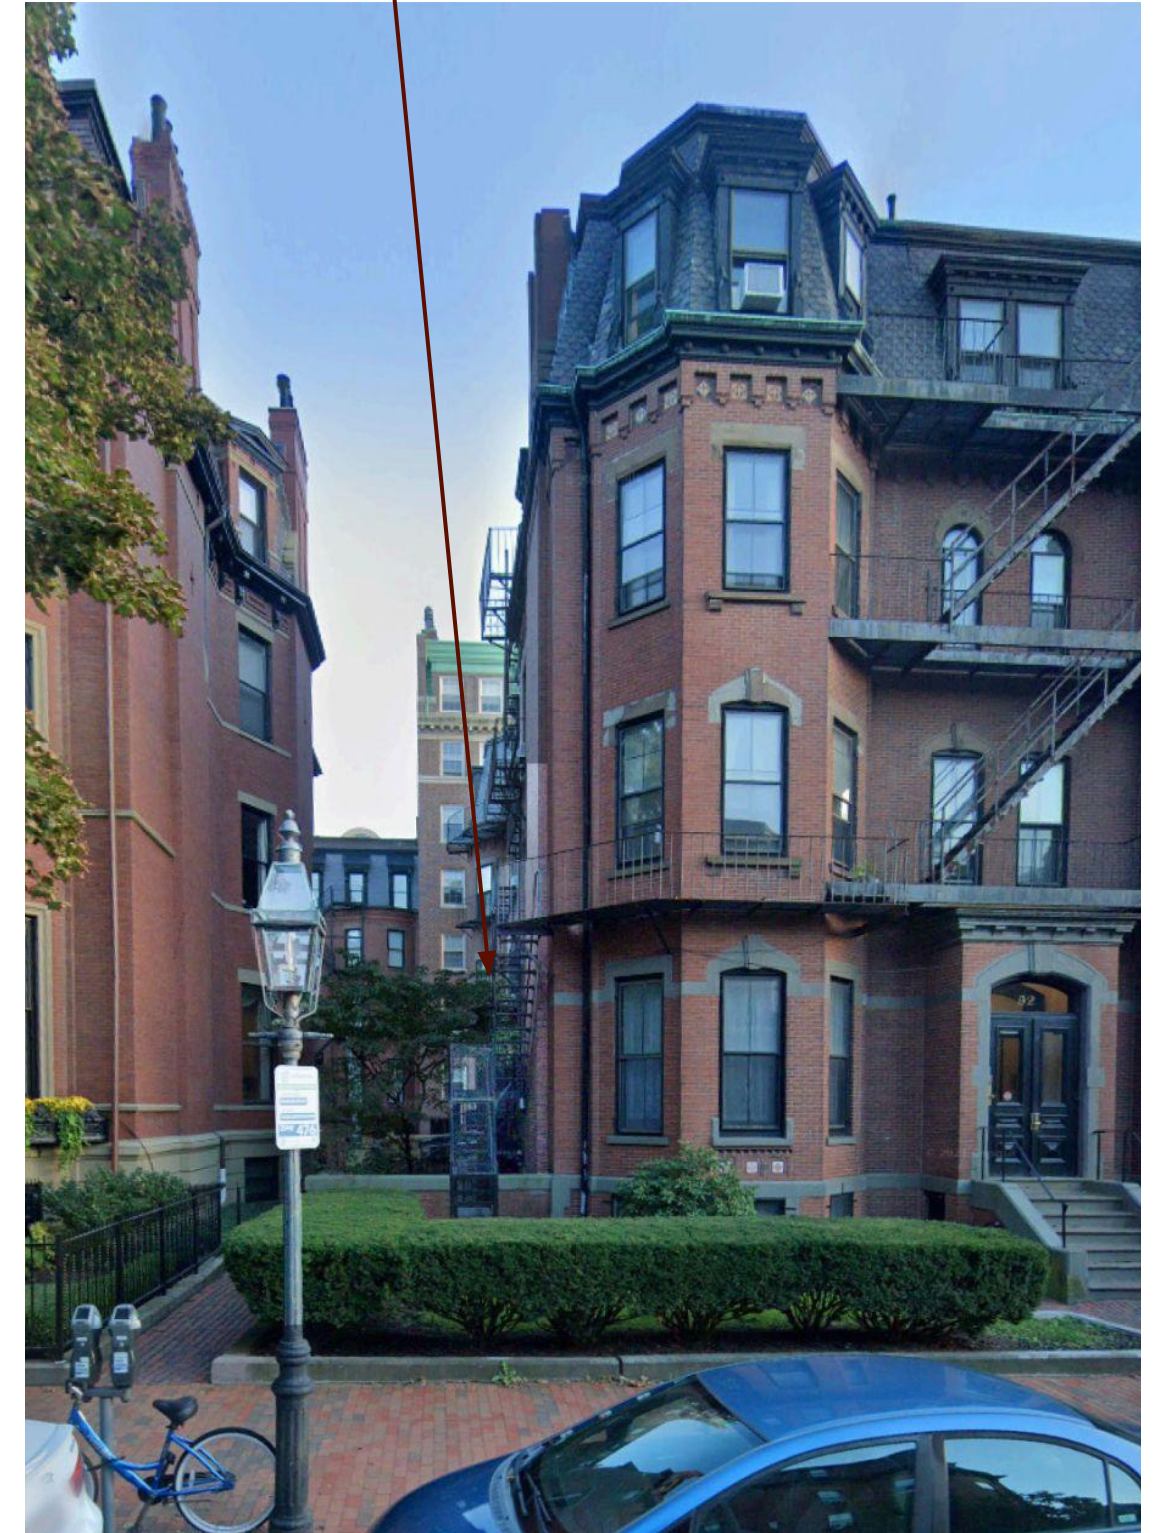
View from Marlborough Street

Not visible from Marlborough Street

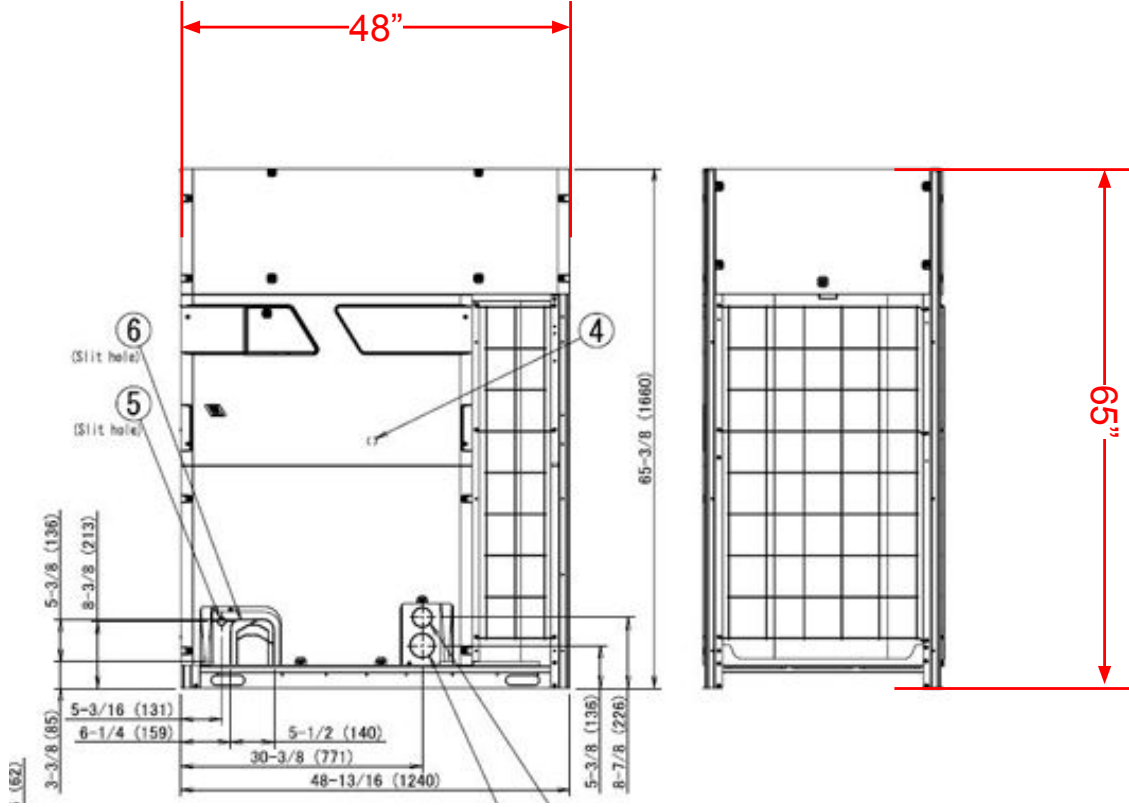
(1) 14-ton VRF Condenser

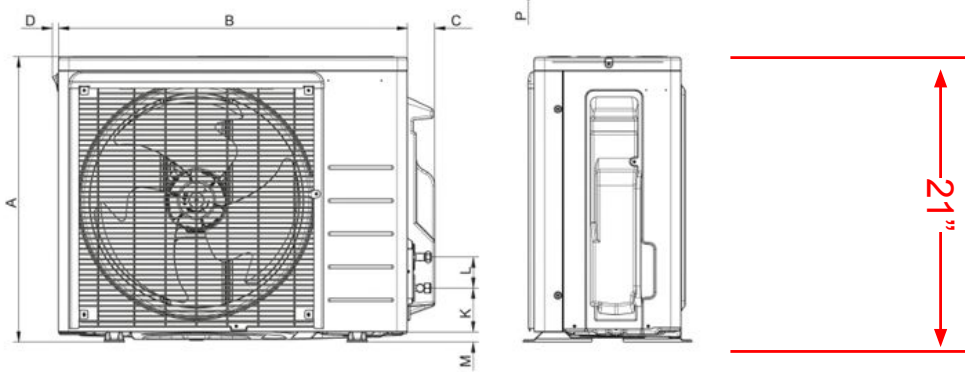
(2) 1-ton VRF Condensers

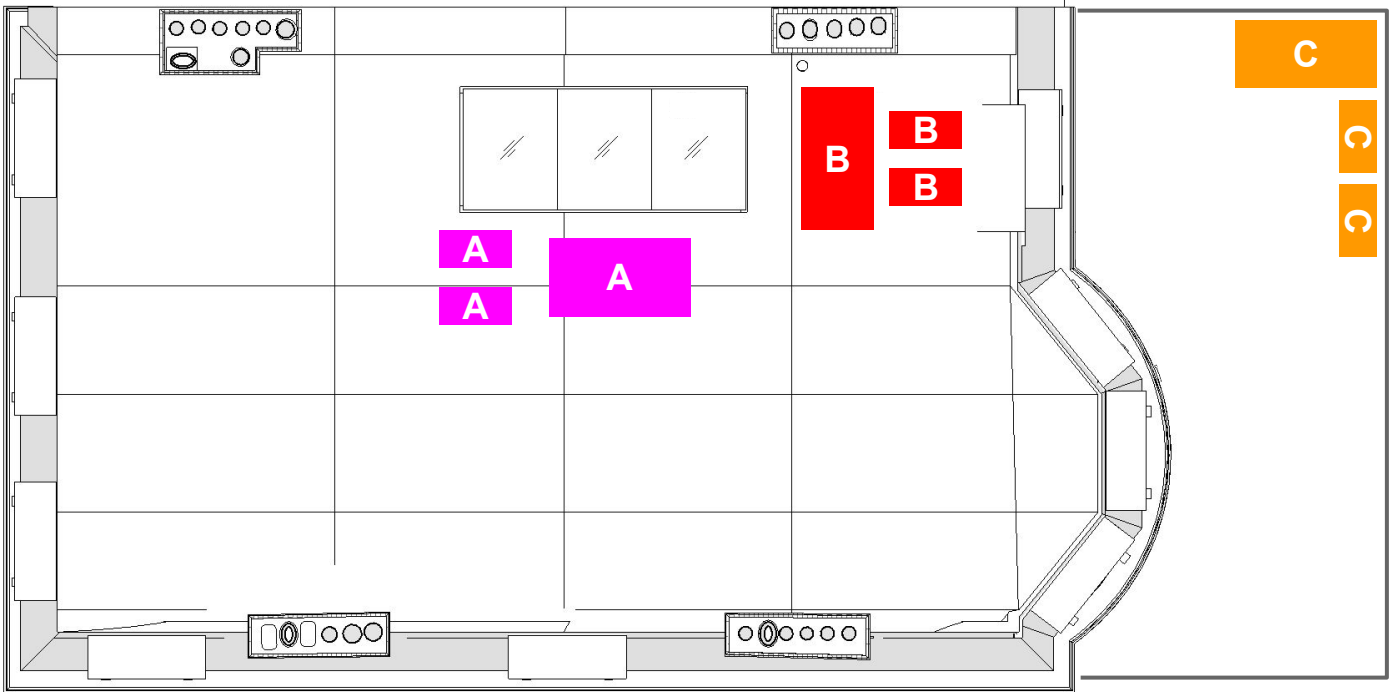
Proposed Mechanical Equipment

3 locations were tested for the mechanical equipment; two on the roof and one in the rear yard.

Location	# of visible locations
A. Center Roof	5 Locations
B. Rear Roof	3 Locations
C. Rear Yard	0 Locations

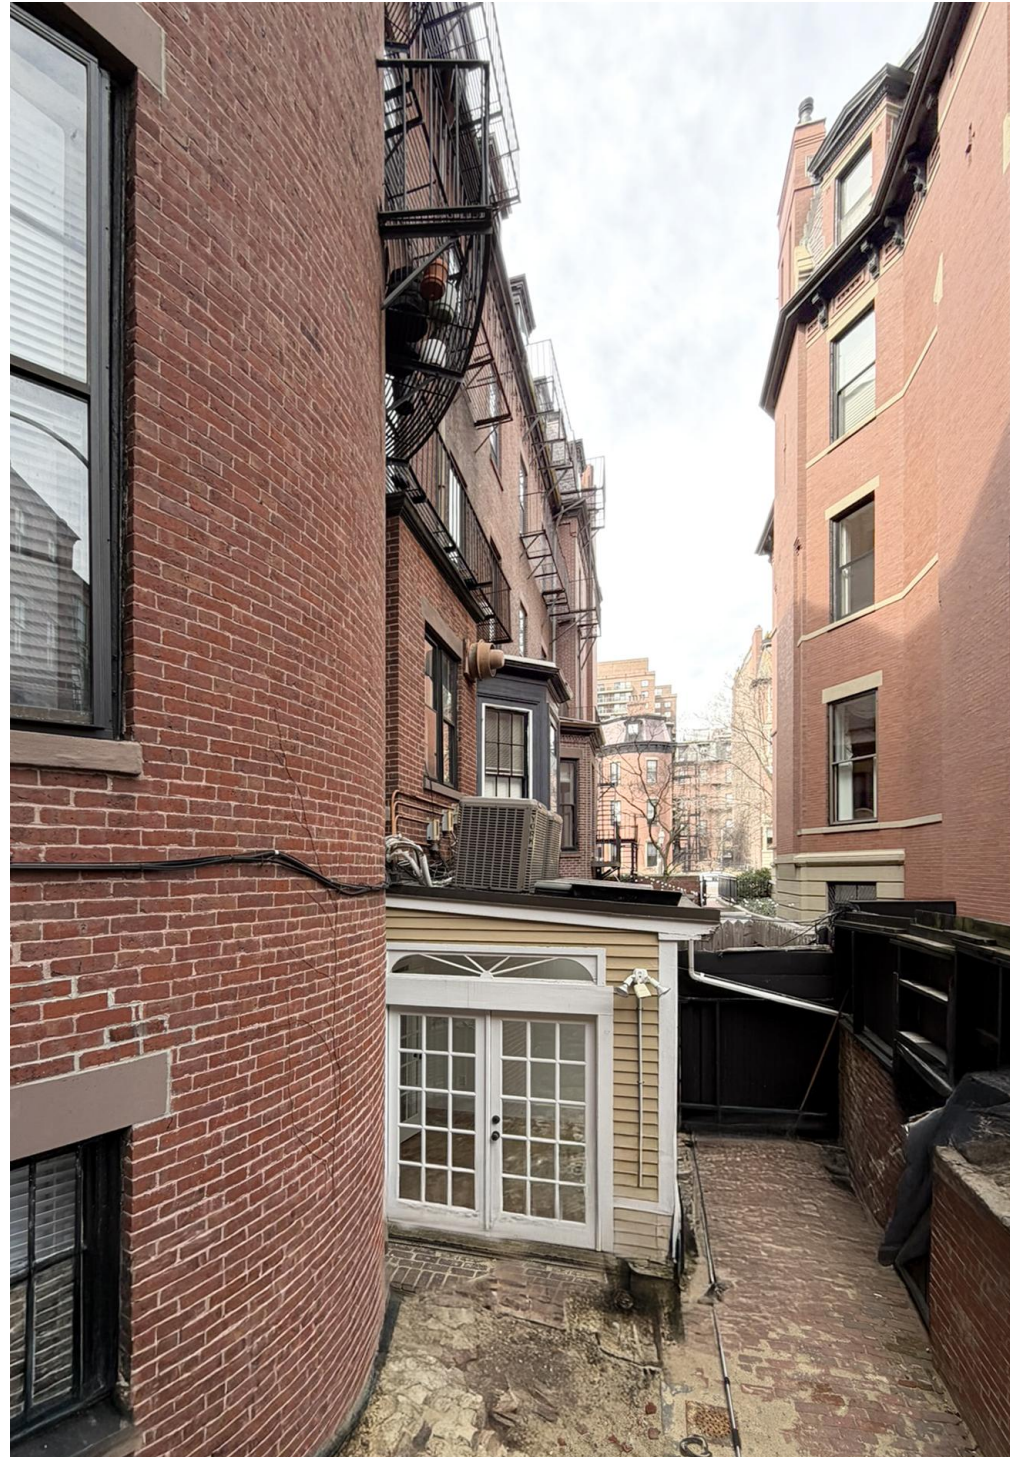
Existing

Rear Yard

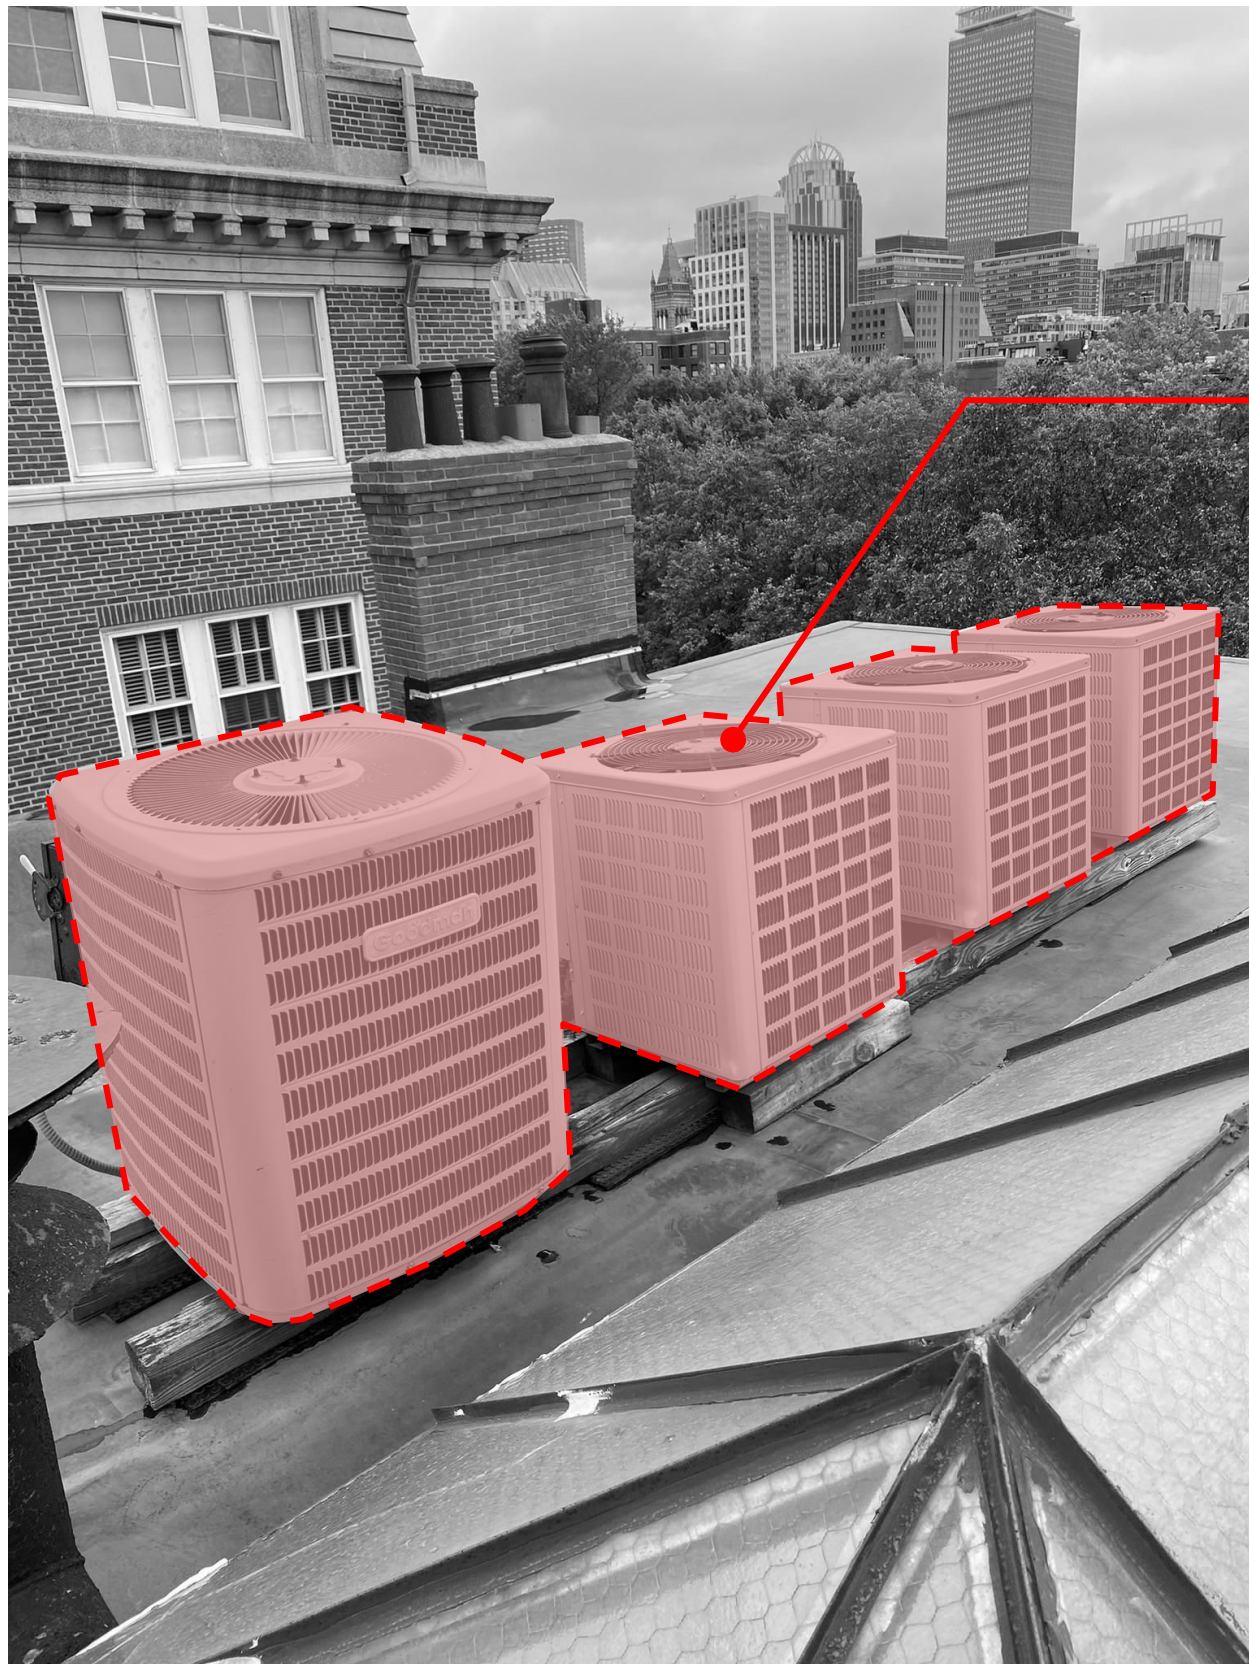
Eliminate (4) Rooftop Condensing Units

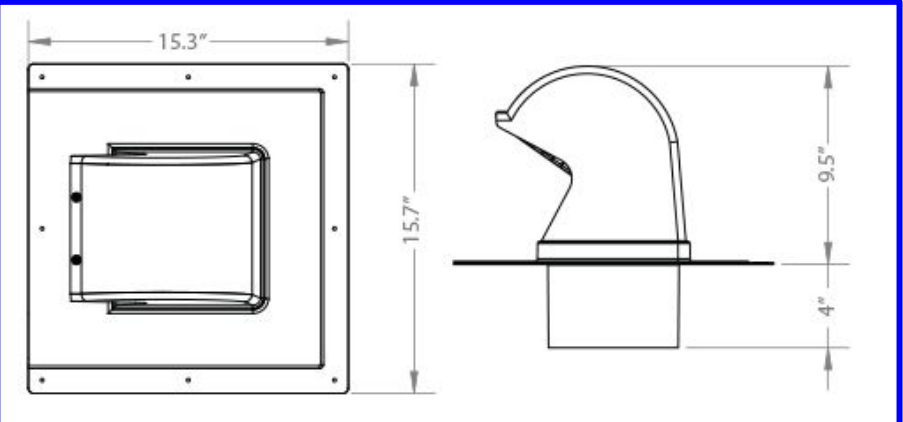
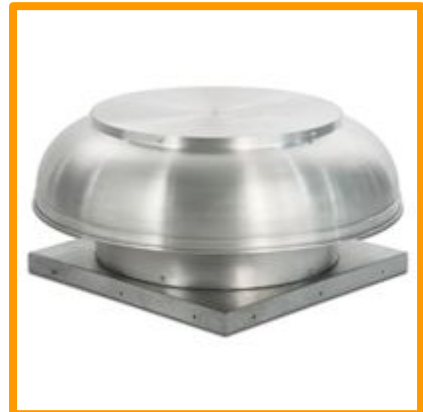
Air Intakes

Two small gooseneck air vents must be added to the roof with a small curb. These will be less than 18", and will not be visible from the street.

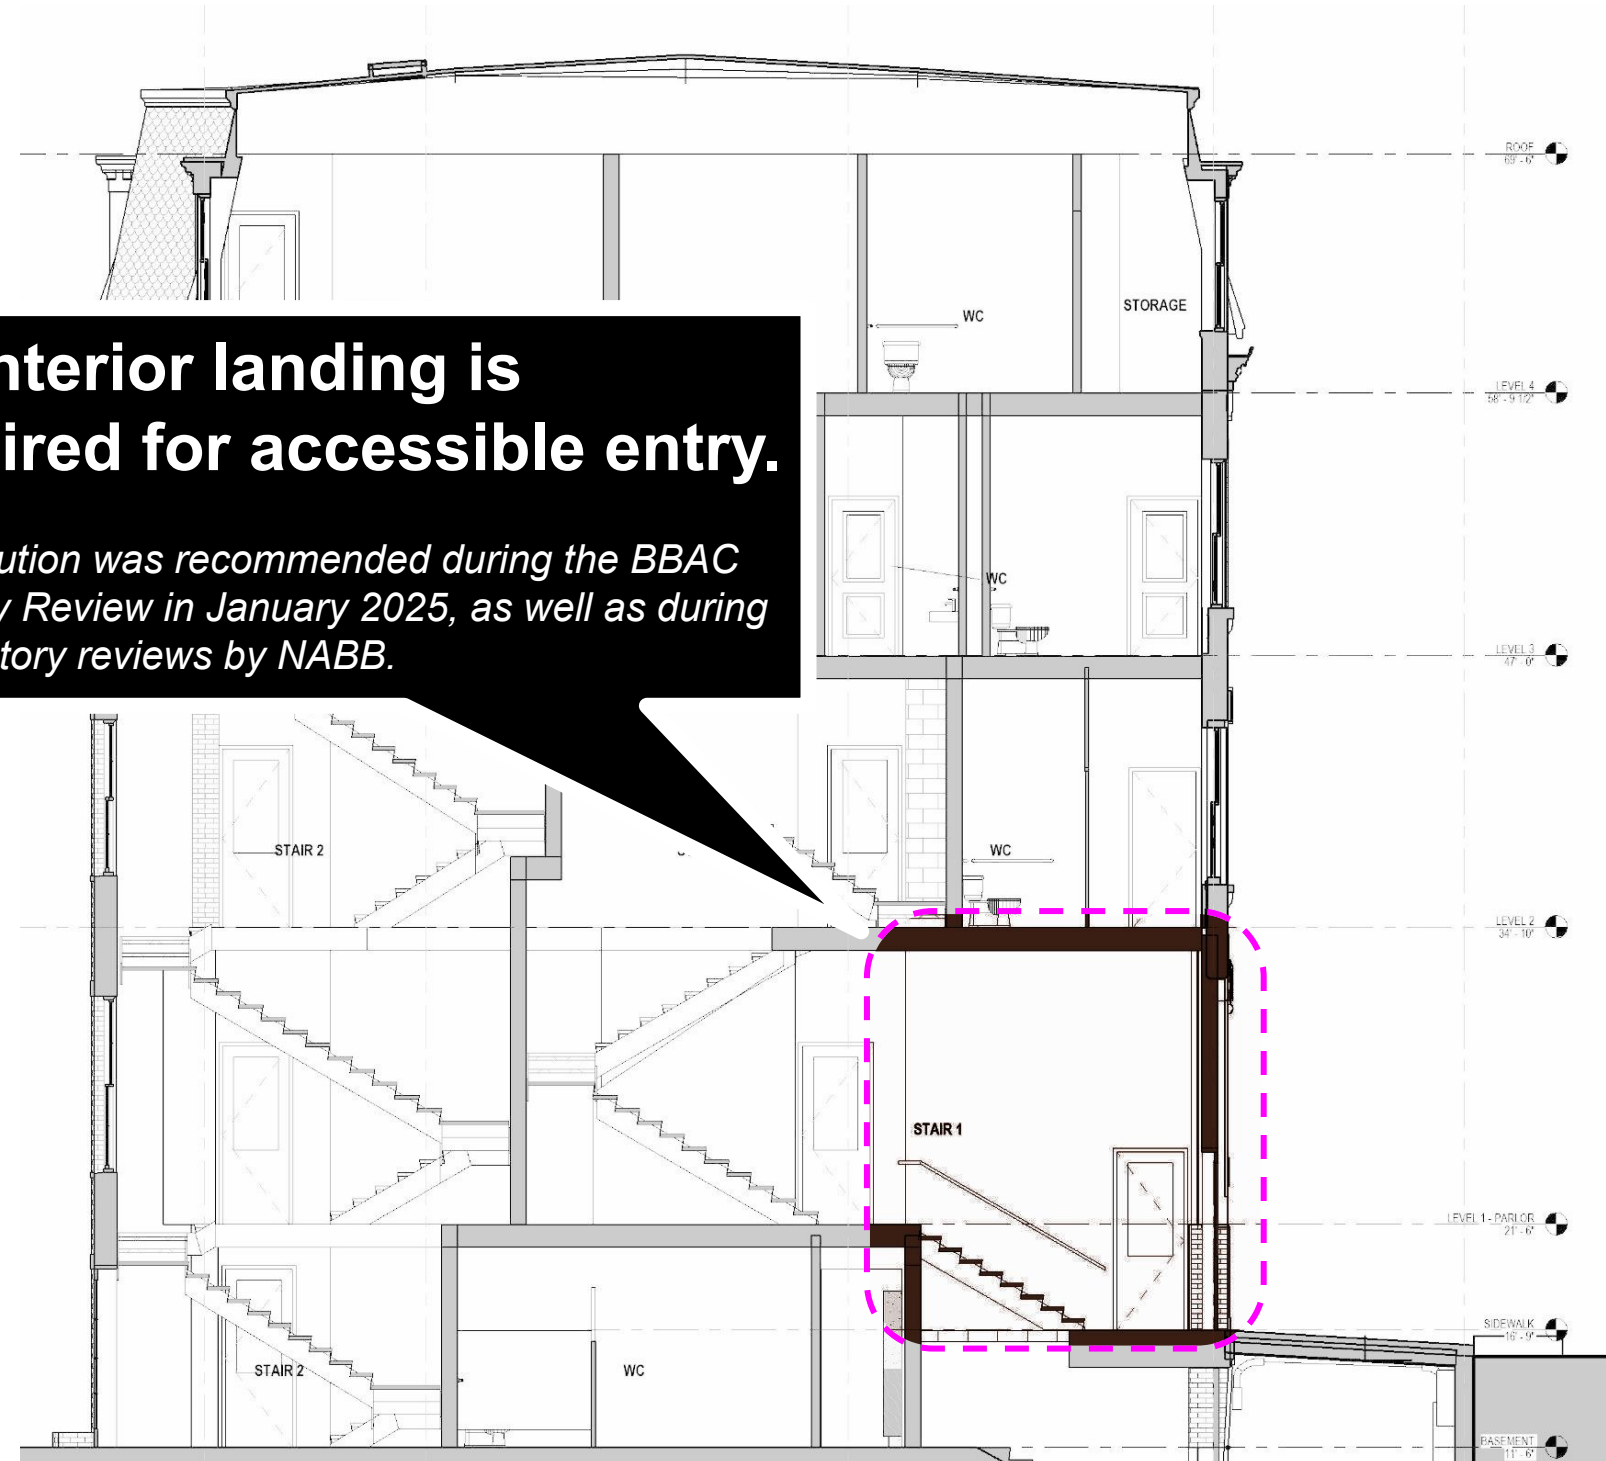
Proposed Section

An interior landing is required for accessible entry.

This solution was recommended during the BBAC Advisory Review in January 2025, as well as during introductory reviews by NABB.

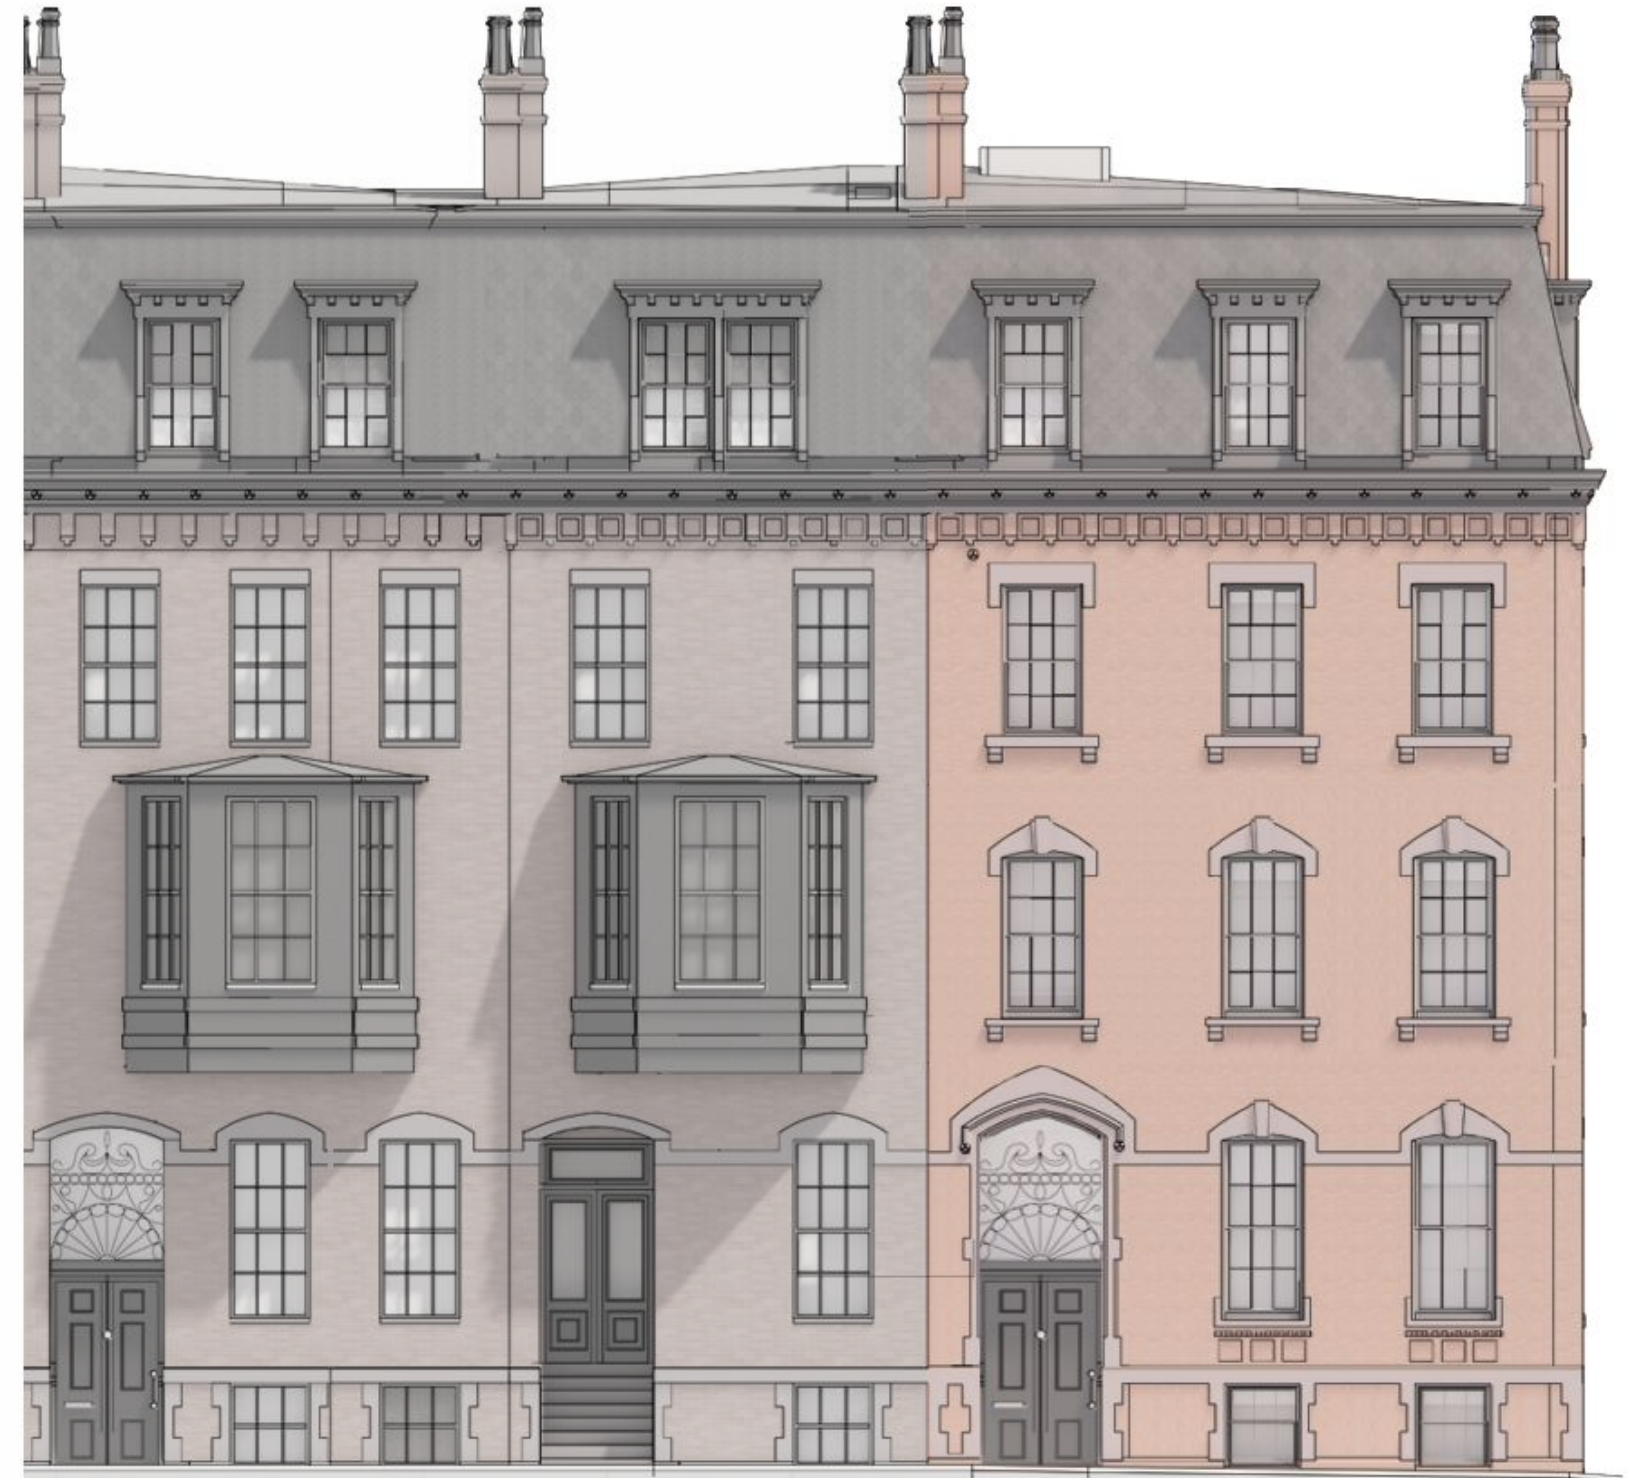
Proposed Elevation

267 Clarendon (existing)

263 Clarendon (proposed)
