The Learning Project

*Proposed Alteration to
263 Clarendon Street*
BBAC Landmarks Hearing

May 13, 2026

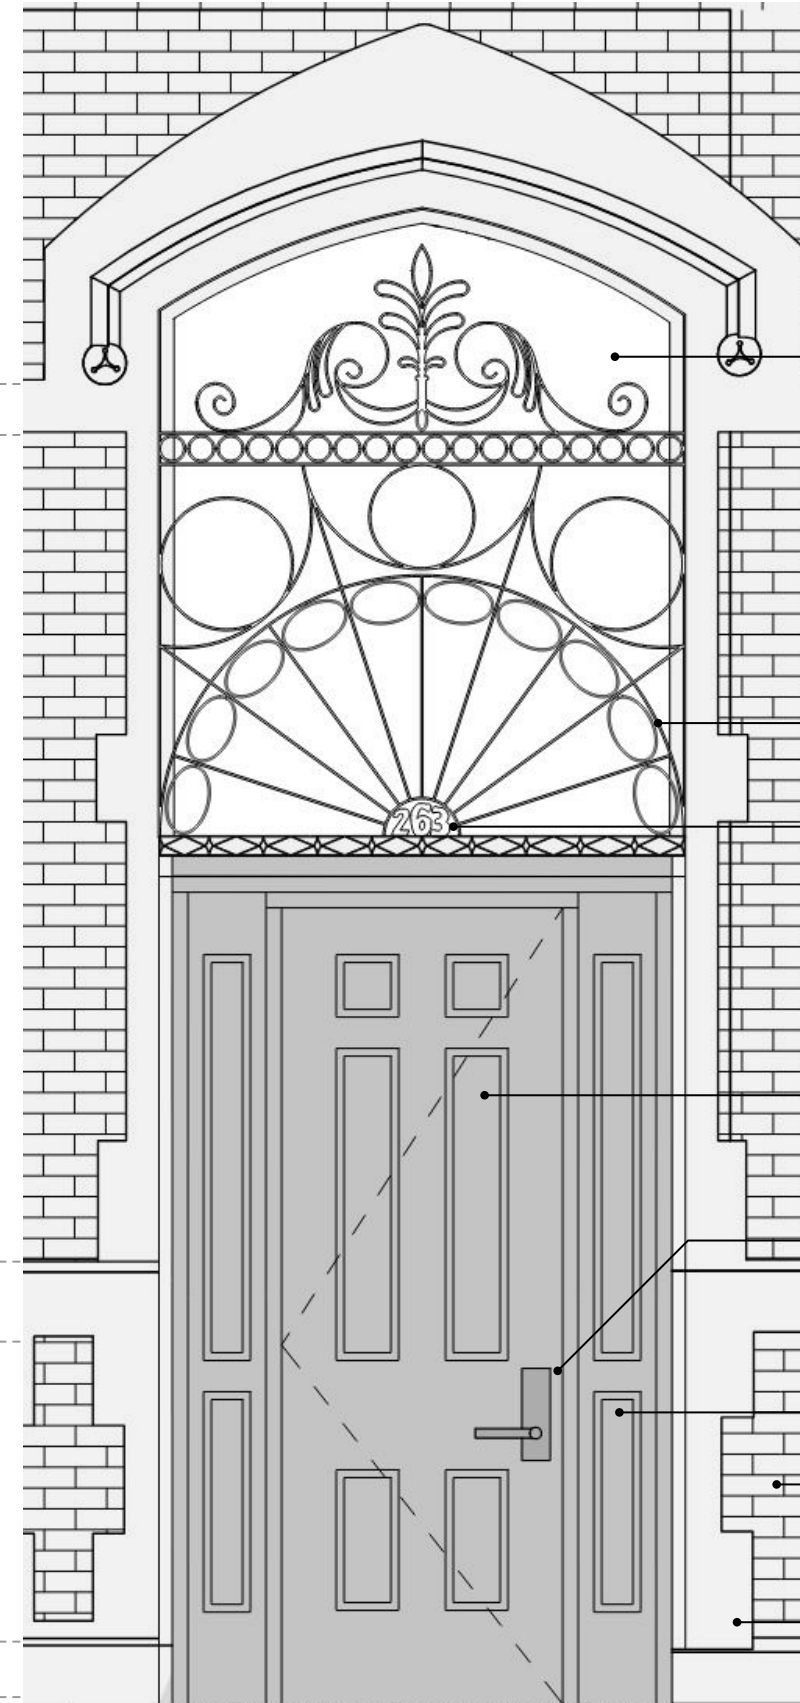
263 Clarendon Street, Proposed Door, Option 1

Glazed Transom, beyond

Wrought iron grille, to match 267 Clarendon

Bronze lettering

6-panel wood door, painted black

Entry lever, Brass Finish

Fixed side panel, painted black

Existing Masonry, to remain

Existing Rustication, to remain

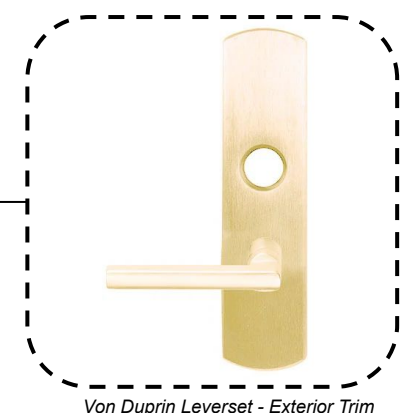
Von Duprin Leverset - Exterior Trim

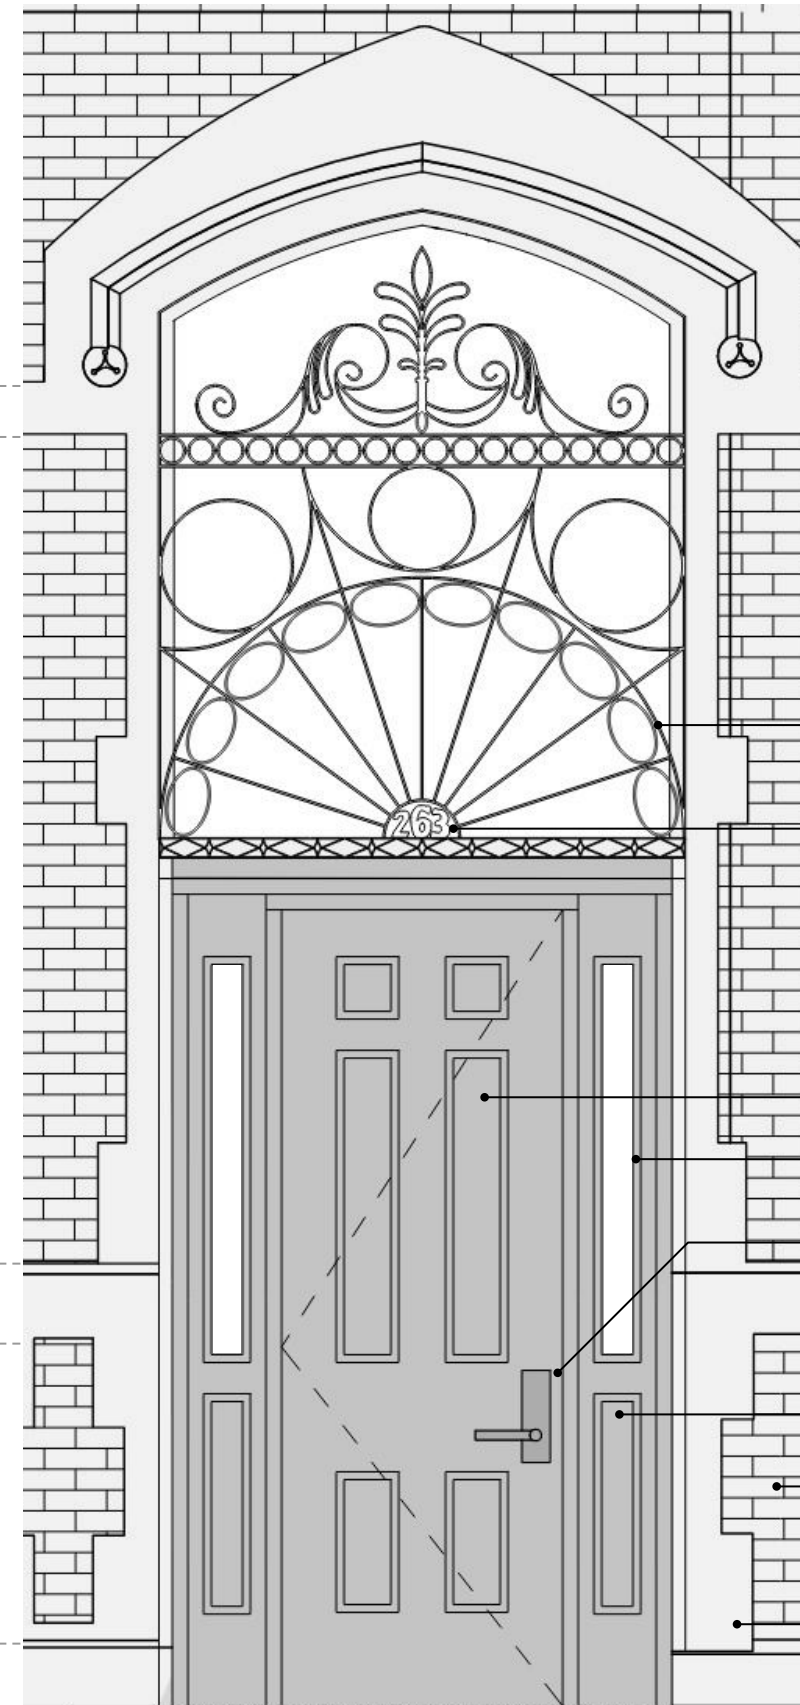
263 Clarendon Street, Proposed Door, Option 2

Glazed Transom, beyond

Wrought iron grille, to match 267 Clarendon

Bronze lettering

6-panel wood door, painted black

Panel Sidelites

Entry lever, Brass Finish

Fixed side panel, painted black

Existing Masonry, to remain

Existing Rustication, to remain

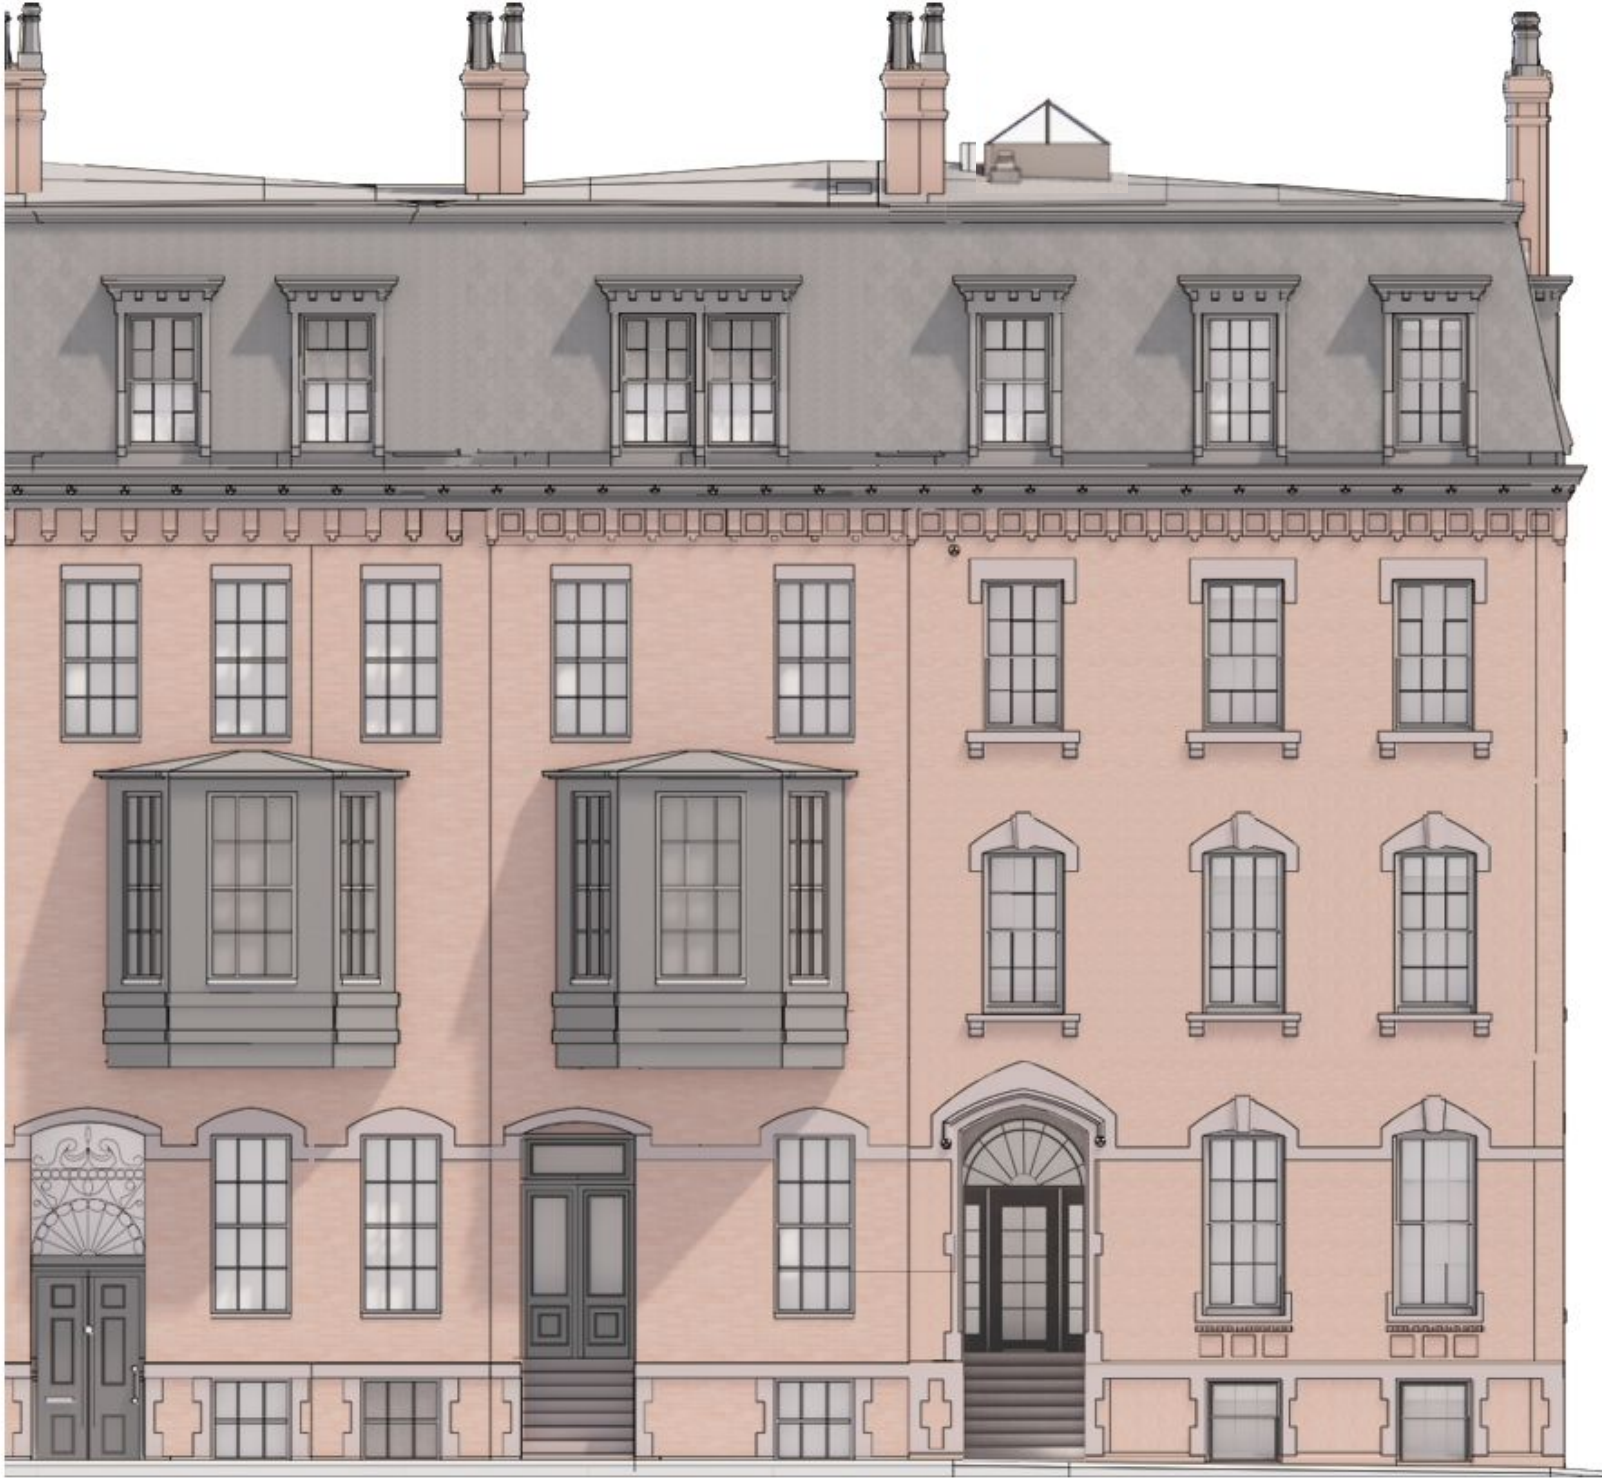
Existing

Front Elevation

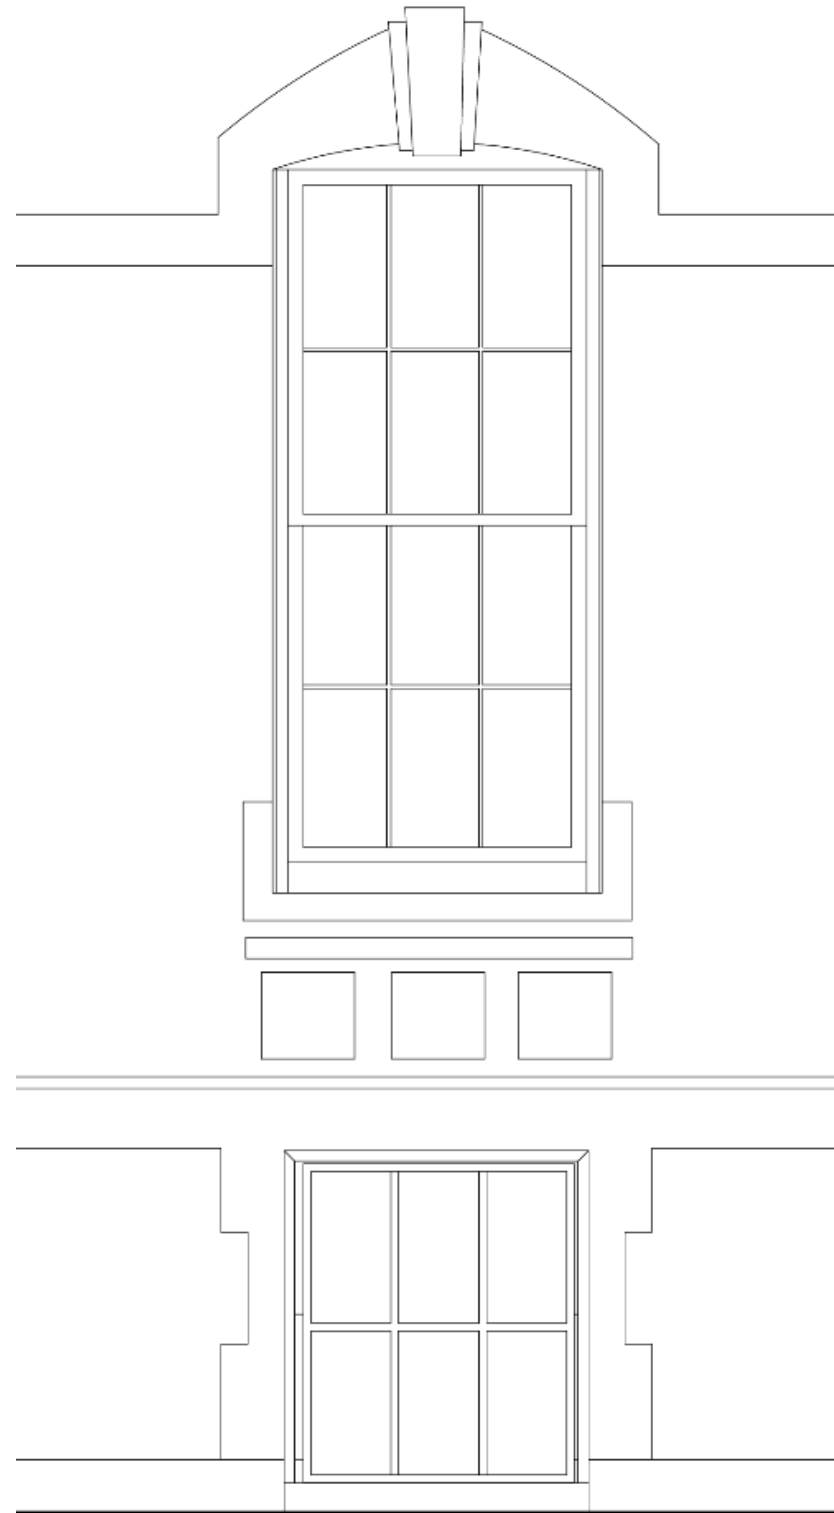
Elevation of Existing Window at Street Level

All windows will be replaced with new wood windows.

- Painted black
- True divided Lite glass
- Historic bevelled/moulded profiles
- Remove exterior storm windows

Exterior Storm Windows will be removed.

Masonry Sills and lintels will not be modified.

Note that the current windows are not original, and were replaced in a 1921 renovation of this building.

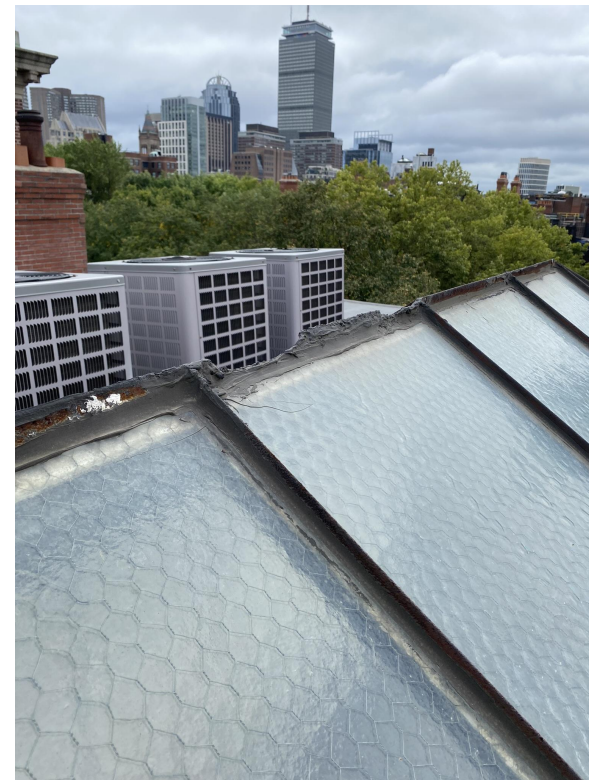
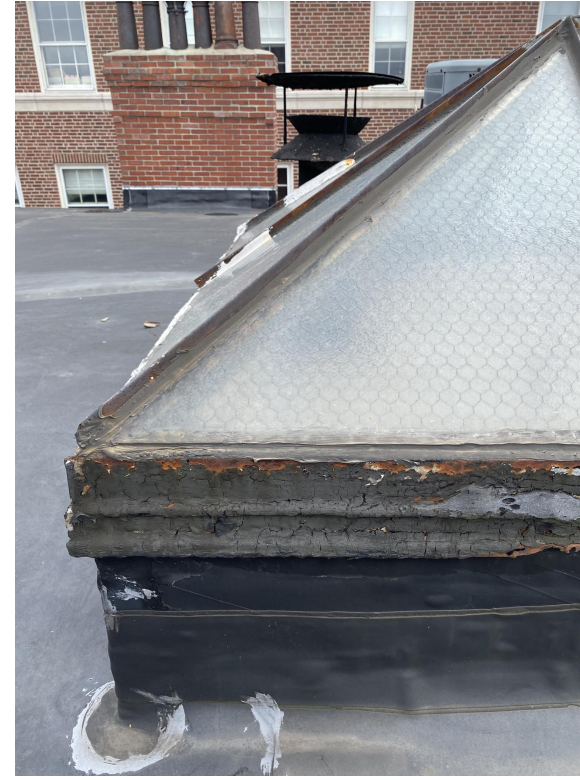
Existing skylight, showing failing glazing putty and corrosion at joints.

The existing skylight will be replaced in kind.
Neither the existing, nor the proposed skylight will be visible from the street.

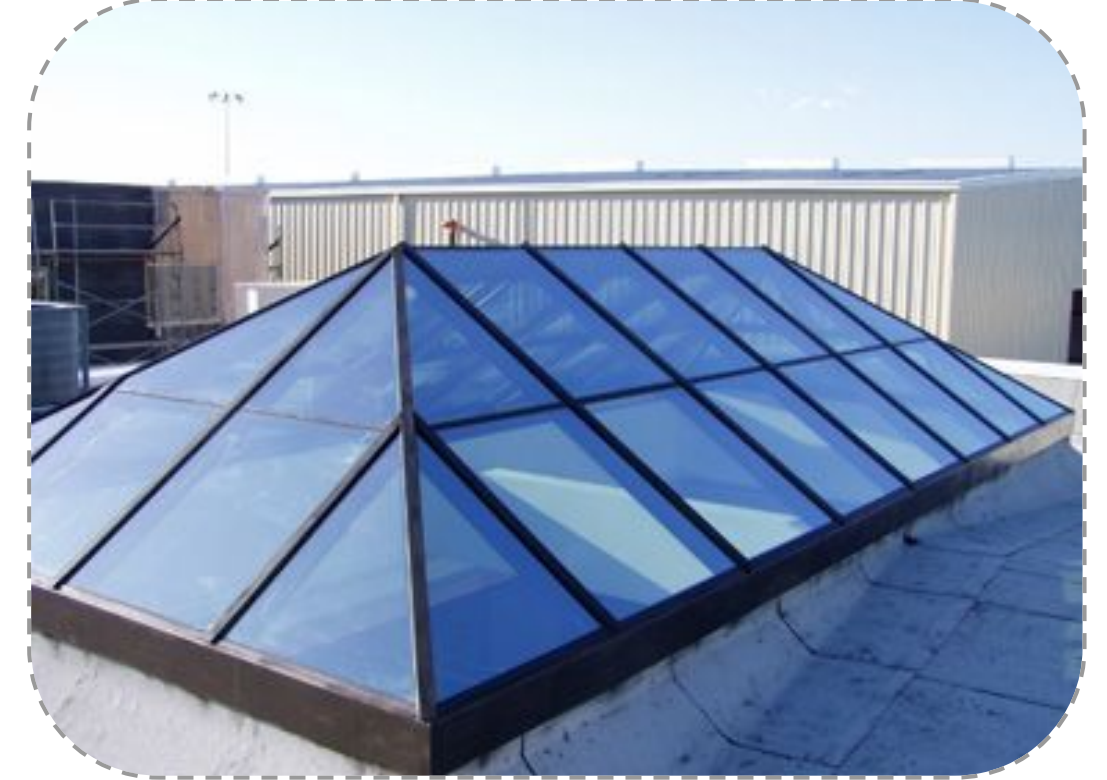
Example of similar skylight.

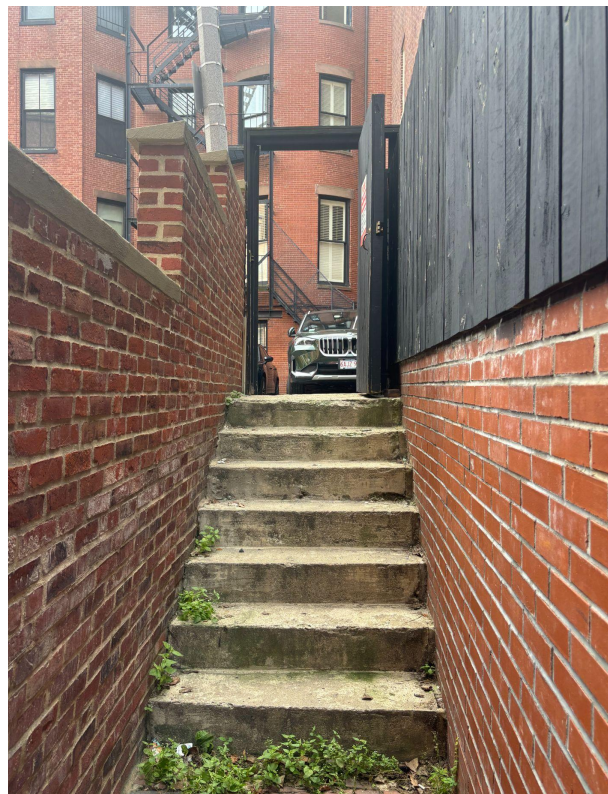
Gate
fence height

Wood Fence,
Painted

Wood Door,
Painted

Metal Railings

6 ft

Existing to
Remain, Stairs
and Brick Wall

New Wood Door,
Painted

Low Profile
Wall Sconce

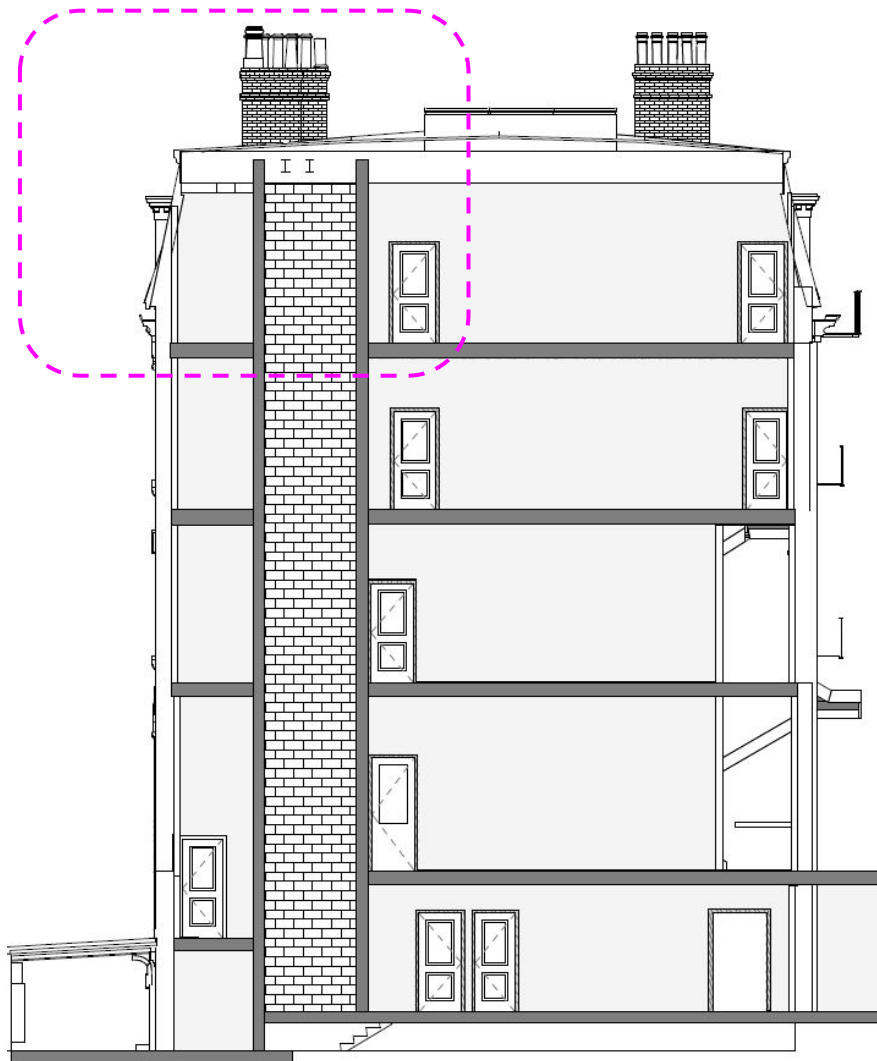
Section

Elevator Design

A new 5 stop elevator is planned for this building, located near the front entry.

Restructuring of the roof support members will be required, with the intent to preserve the existing exterior bounding condition.
