**Frank McGuire Architects**

drawing **CHESTNUT ST. ELEVATION**

project **102 CHESTNUT**

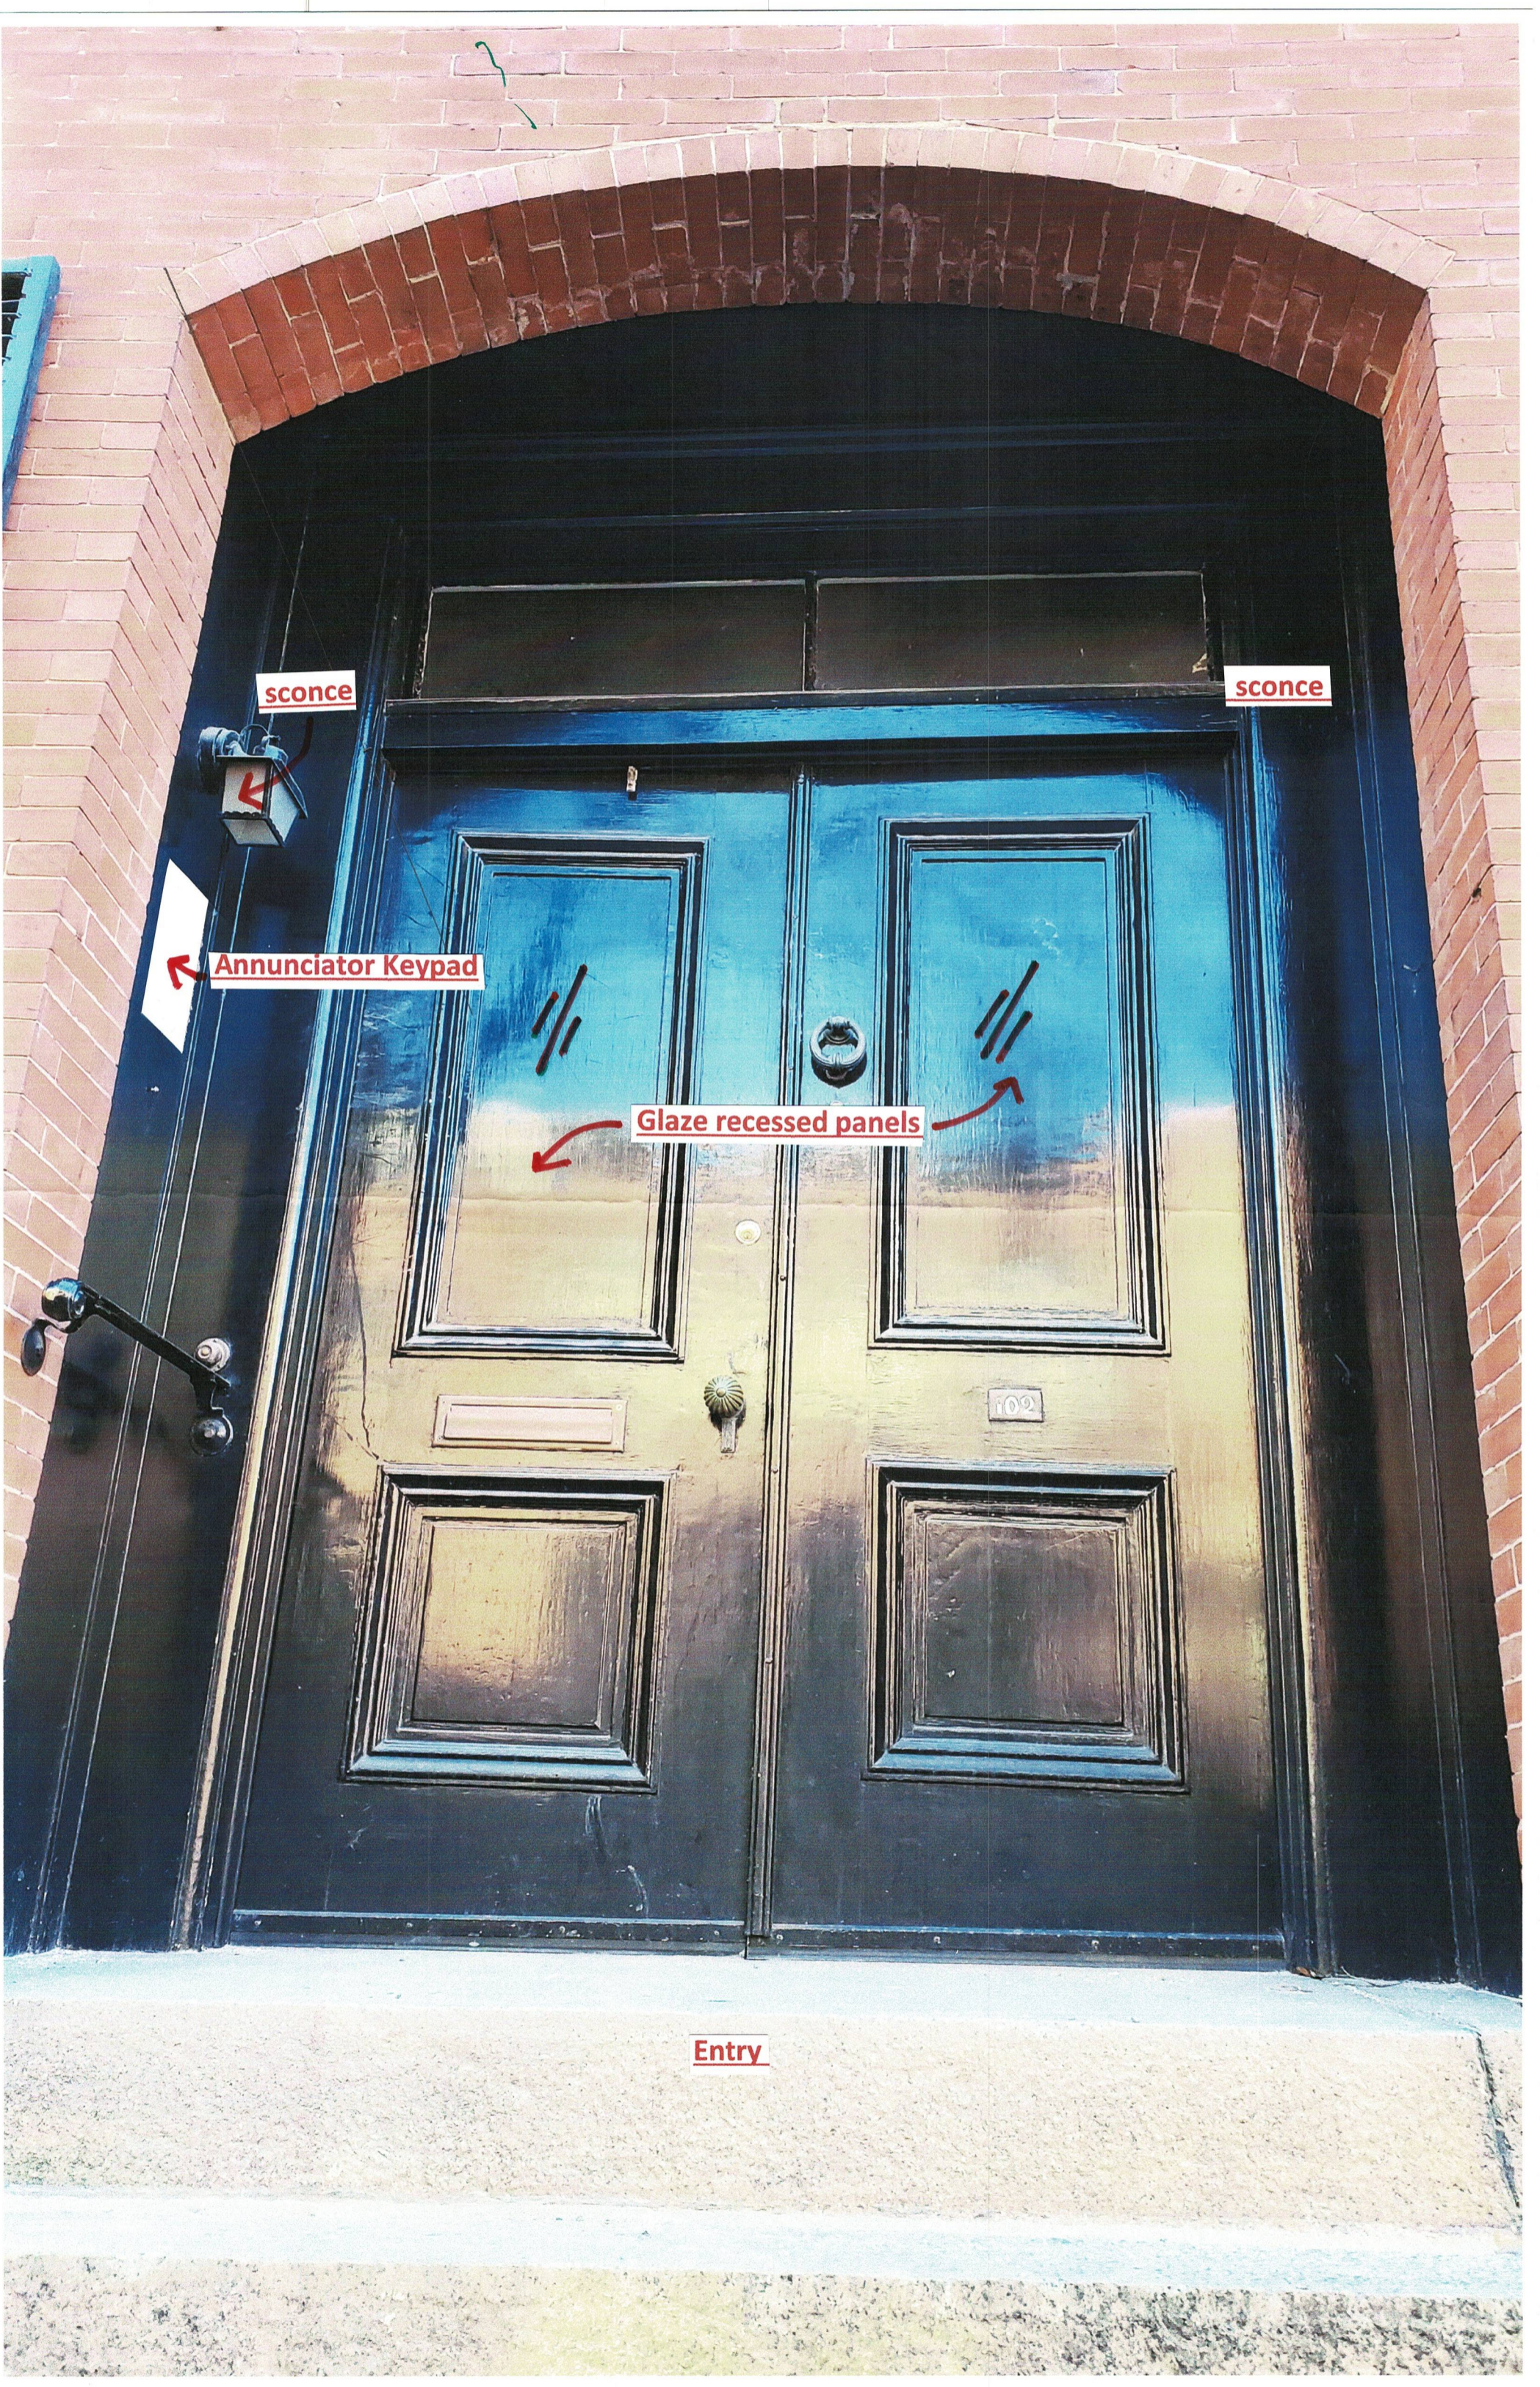
sconce

Annunciator Keypad

Glaze recessed panels

Entry

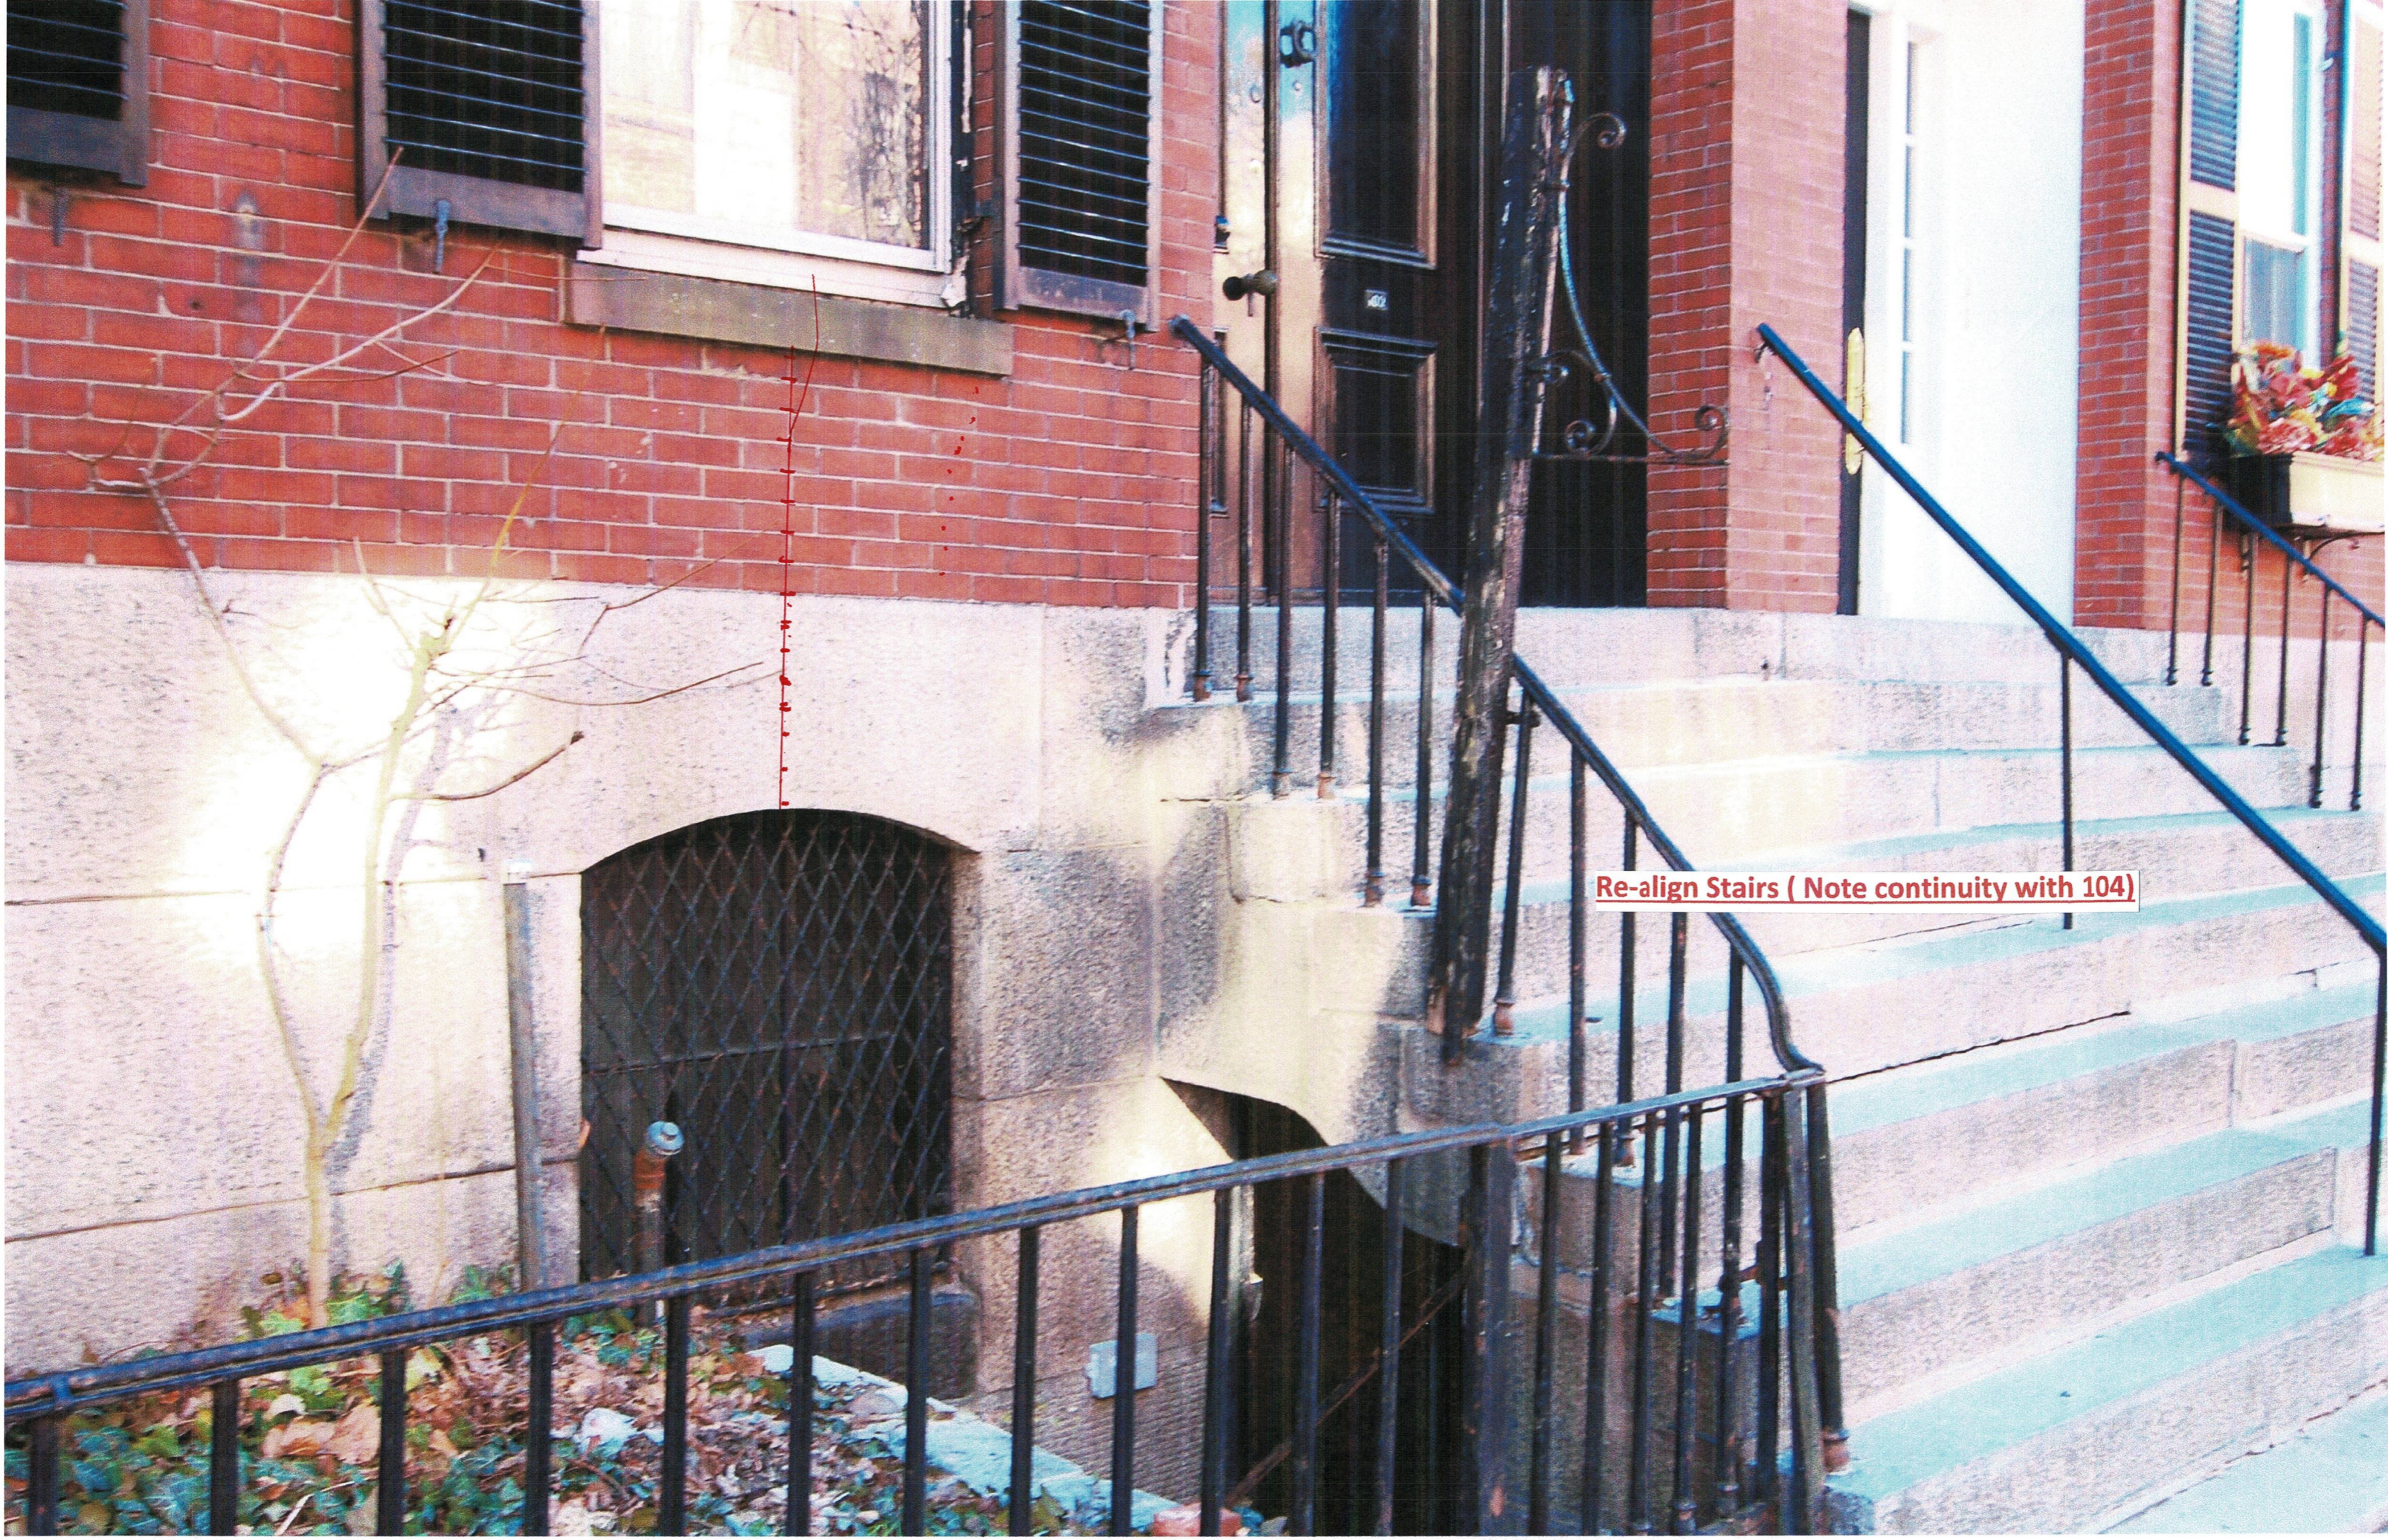
Re-align Stairs ( Note continuity with 104)
