# THE WARREN HOUSE

## BOSTON LANDMARKS COMMISSION

### STUDY REPORT

**The Warren House**  
**130 Warren Street, Roxbury (Boston), Massachusetts**

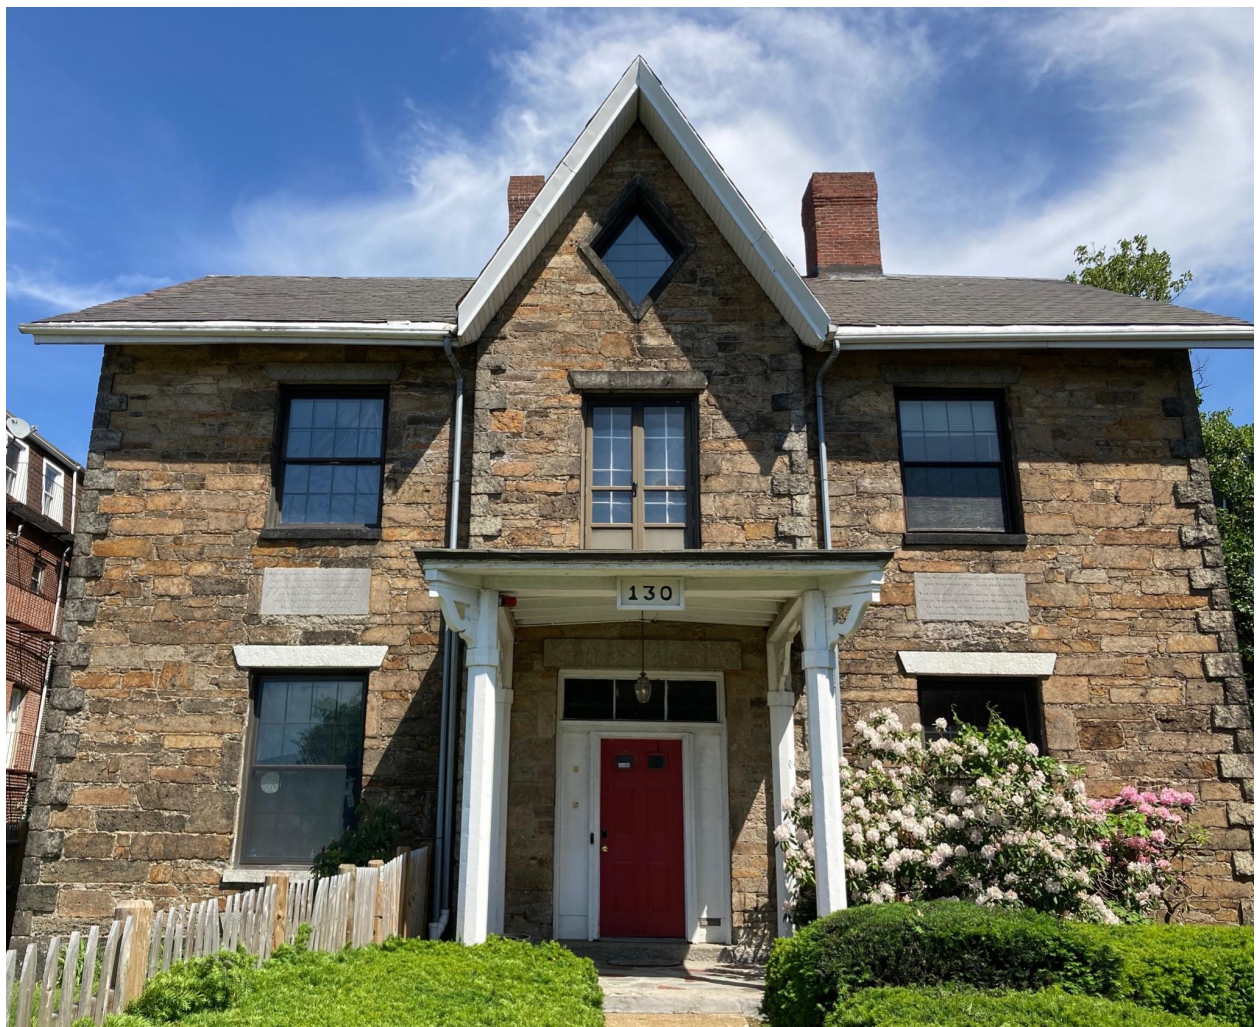
**Figure 2: Entrance**  
Front facade (west elevation)

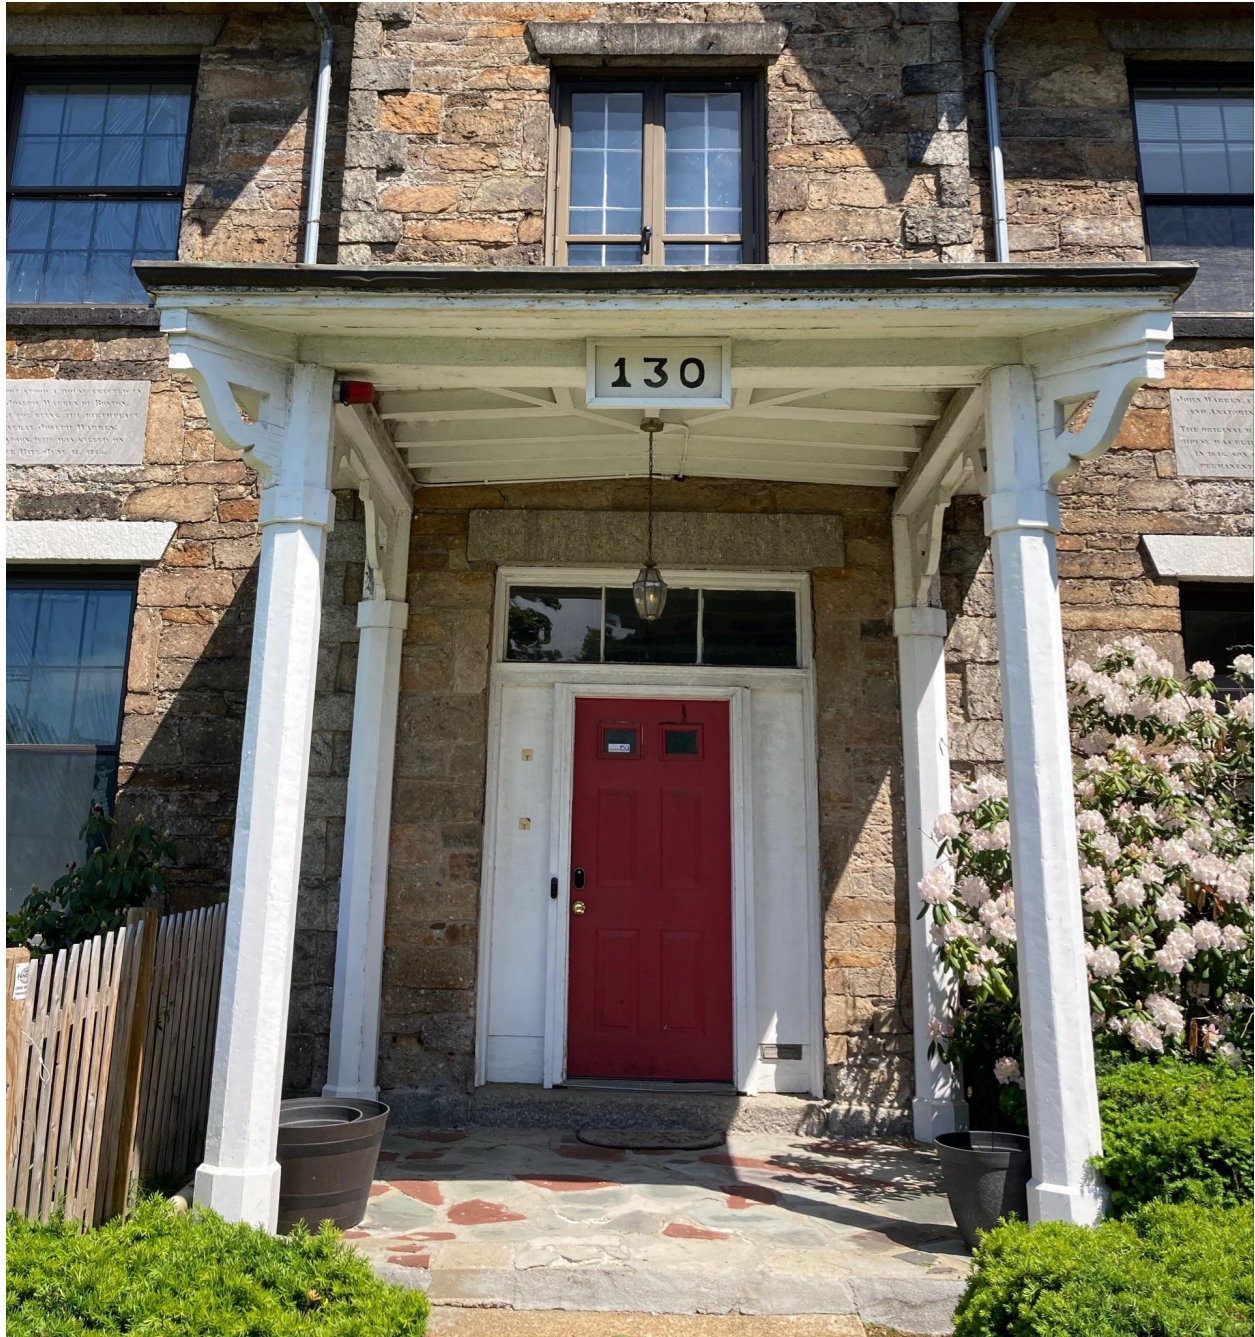
**Figure 3: Wooden entrance porch**  
Front facade (west elevation)

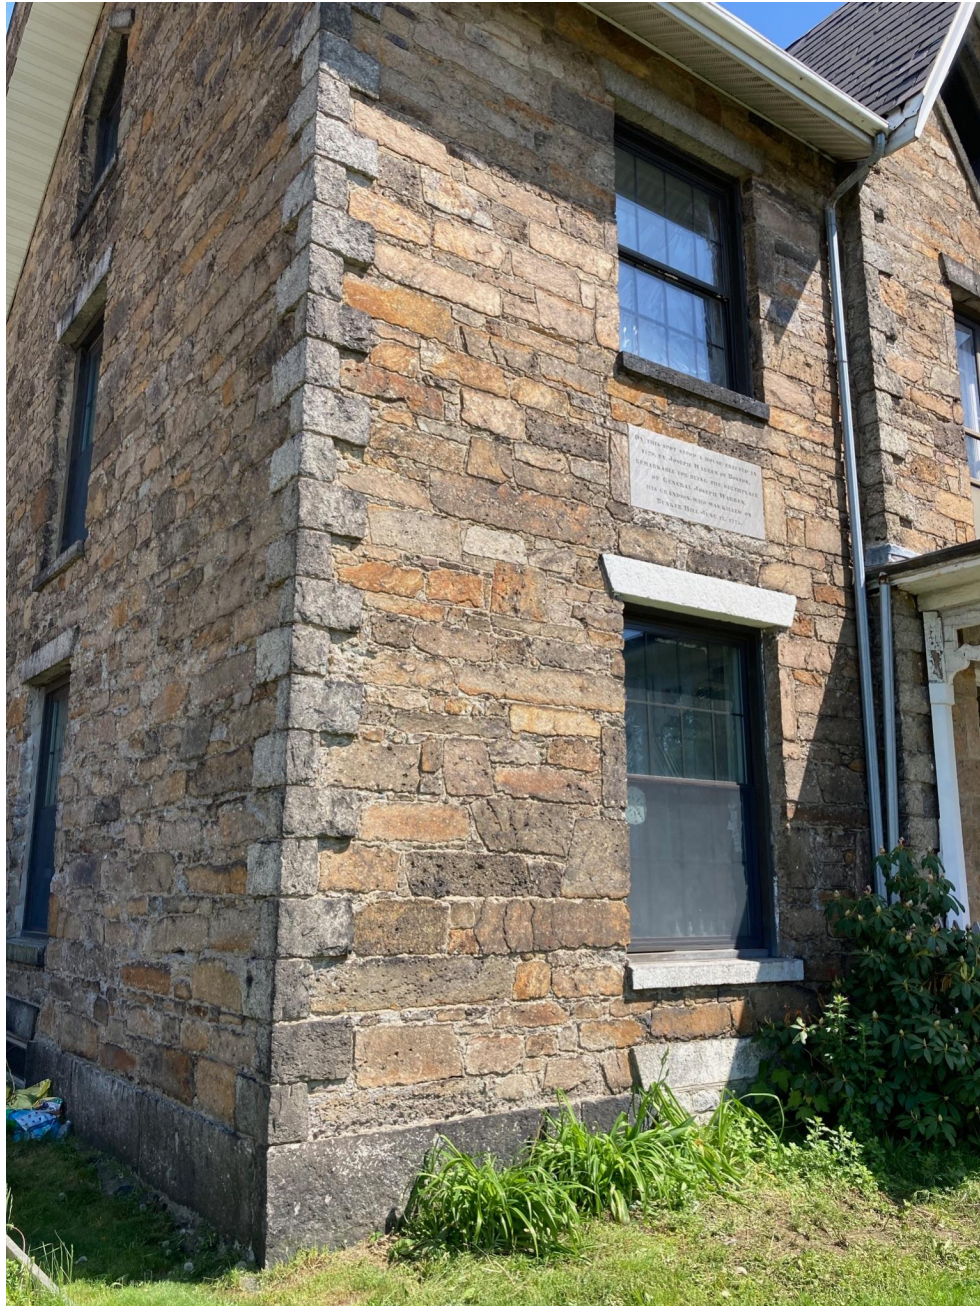
**Figure 6: Quoins detail**  
Corner between the west- and north-facing facades

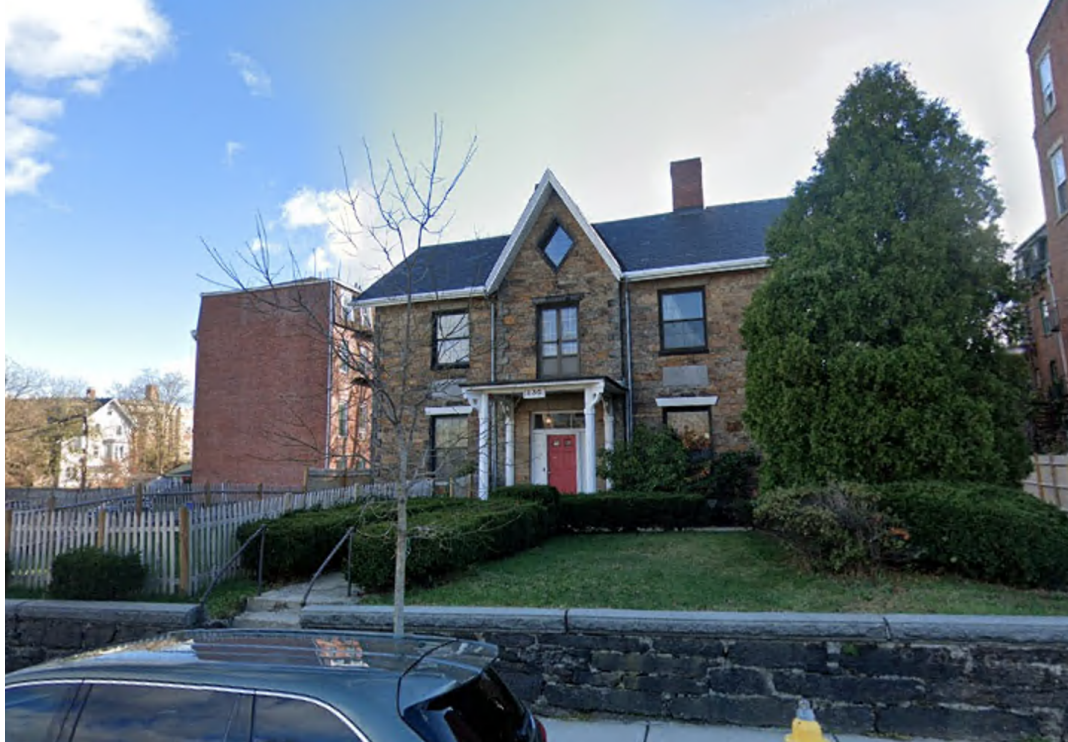
**Figure 10: Front lawn and puddingstone wall (looking east)**

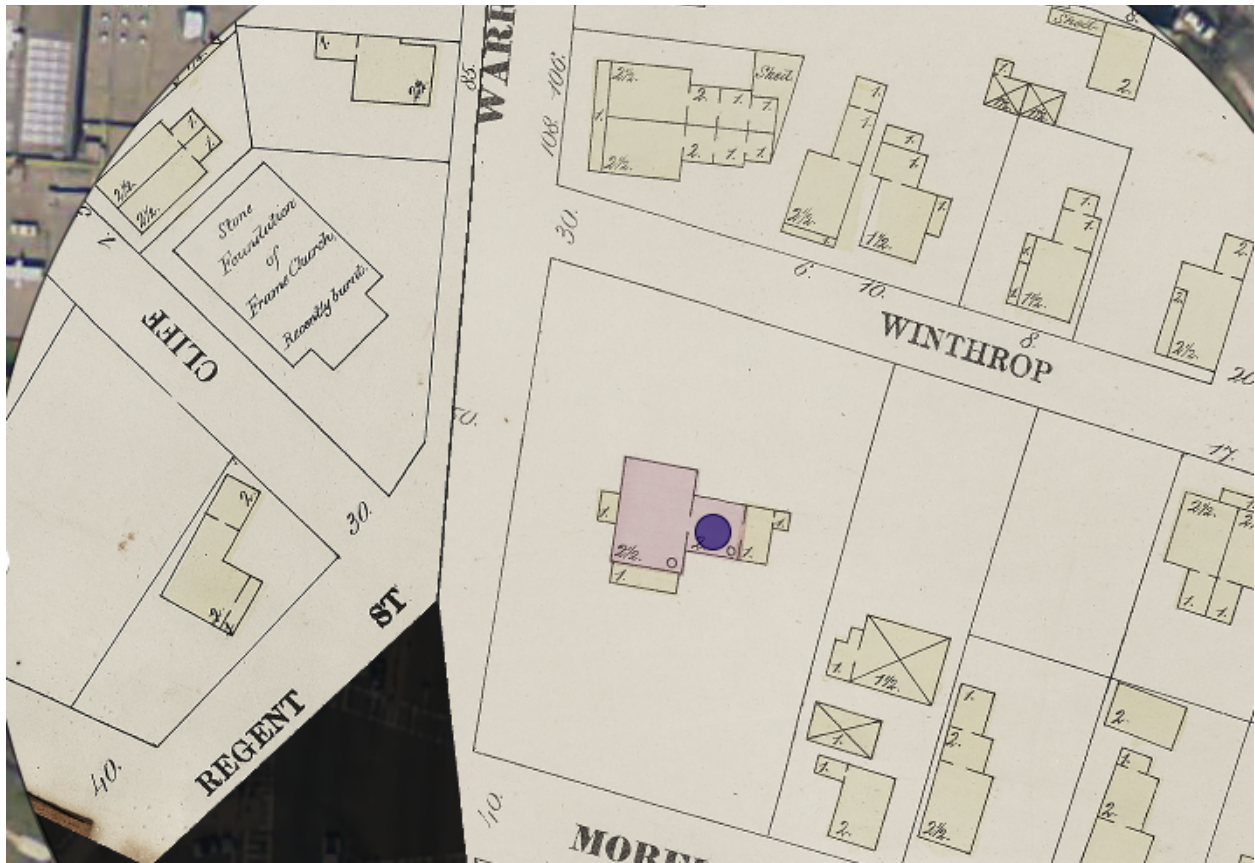
### Historic Image 1

This map dates from 1868 and shows the Warren House before other structures abutted it on Warren Street.
