THE TILESTON HOUSE

BOSTON LANDMARKS COMMISSION STUDY REPORT

Report on the Potential Designation of

THE TILESTON HOUSE
13 River Street, Mattapan, Boston, Massachusetts

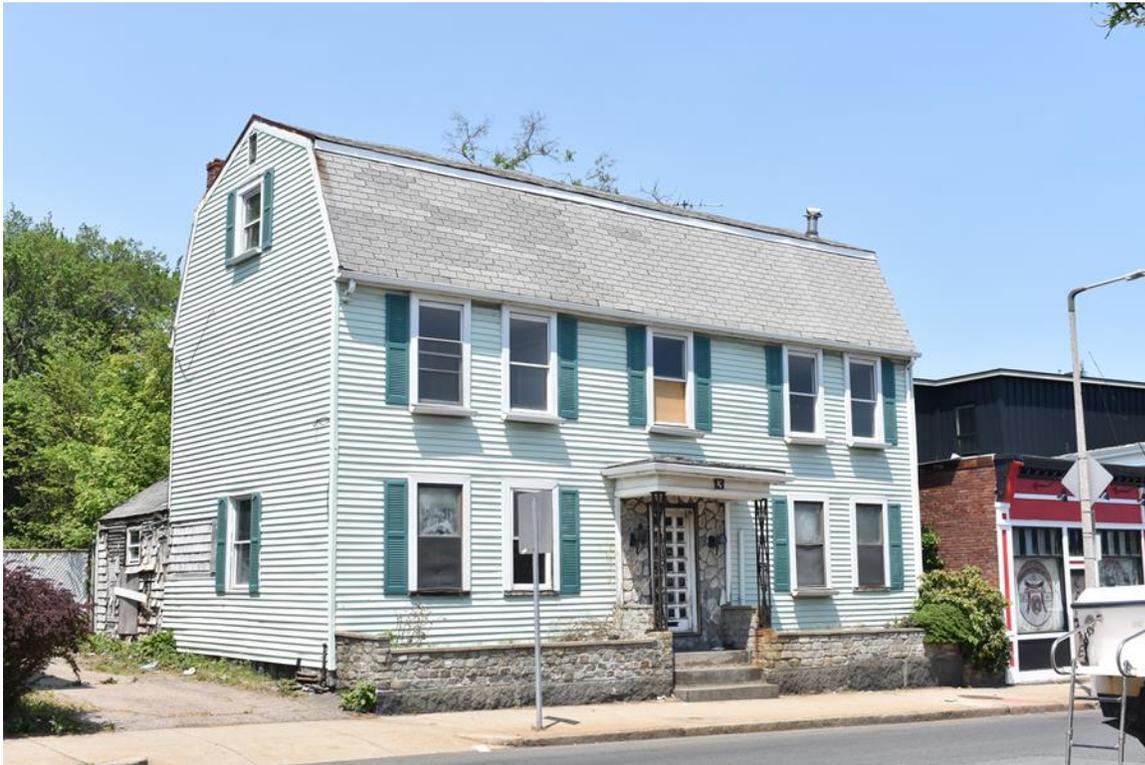
Figure 2. Front (south) and west elevations (The Public Archaeology Laboratory, Inc. 2021).

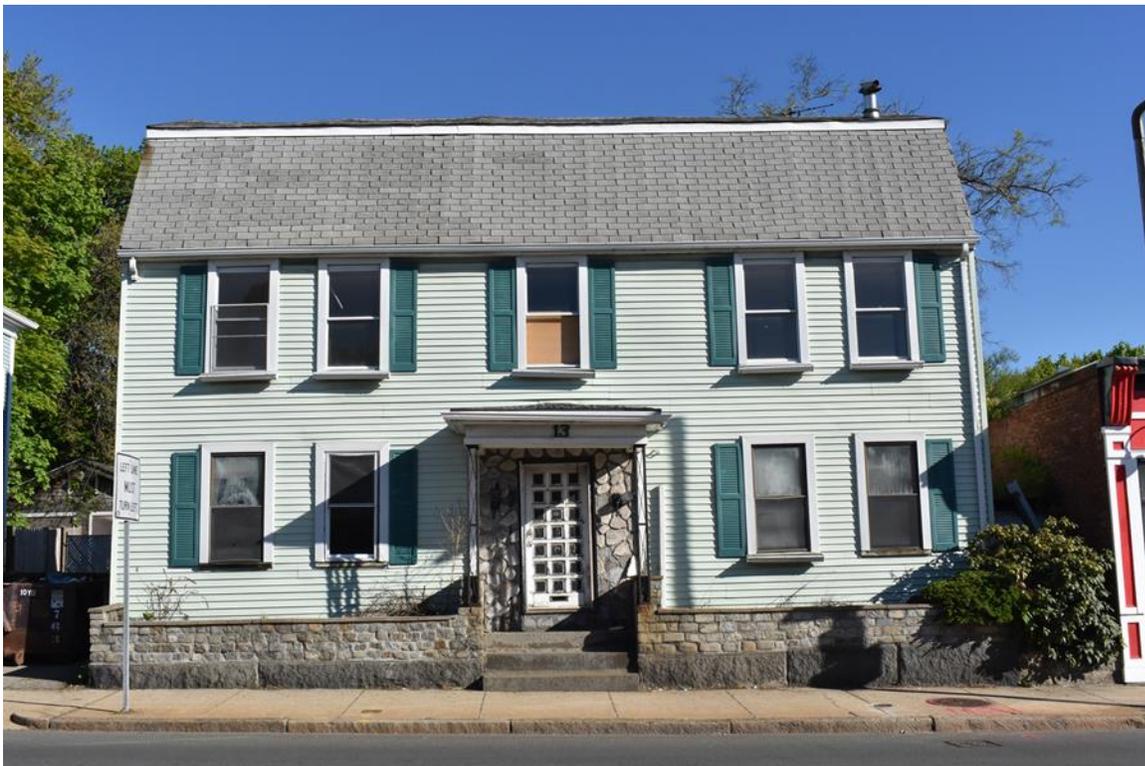
Figure 3. Front (south) elevation (The Public Archaeology Laboratory, Inc. 2021).

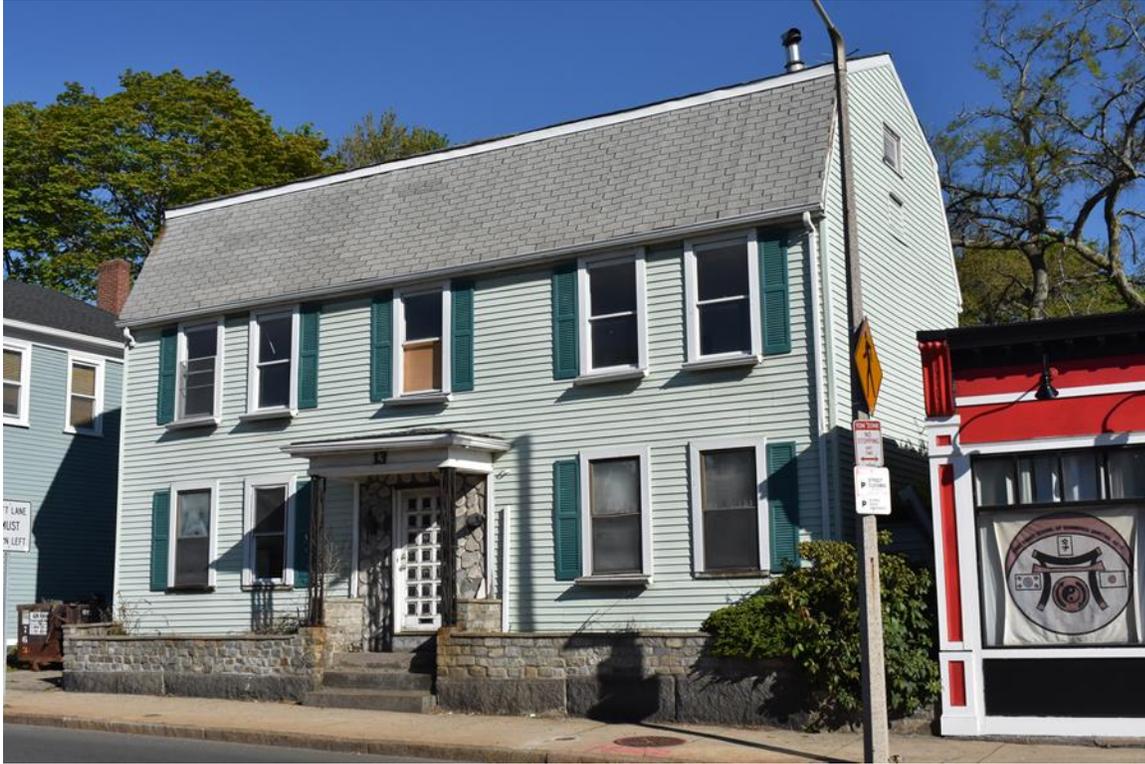
Figure 4. Front (south) and east elevations (The Public Archaeology Laboratory, Inc. 2021).

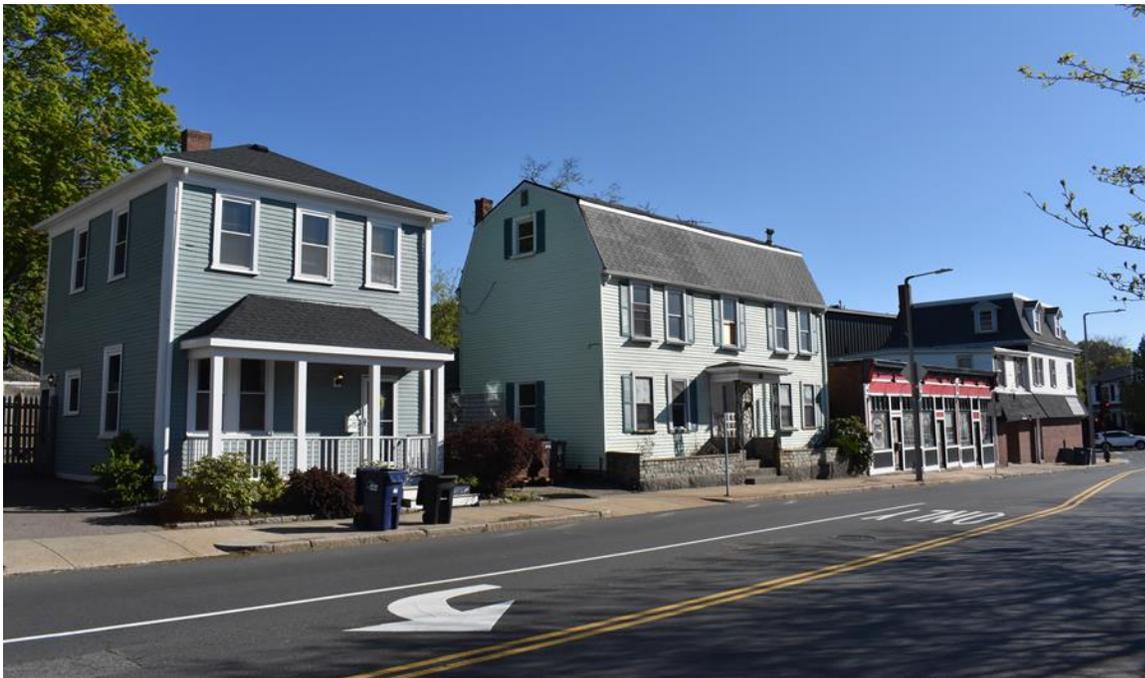
Figure 5. Front (south) and west elevations, view northeast along River Street toward Washington Street. Charles Tileston's tin shop was in the far right, Second Empire-style building, 1141 Washington Street (The Public Archaeology Laboratory, Inc. 2021).

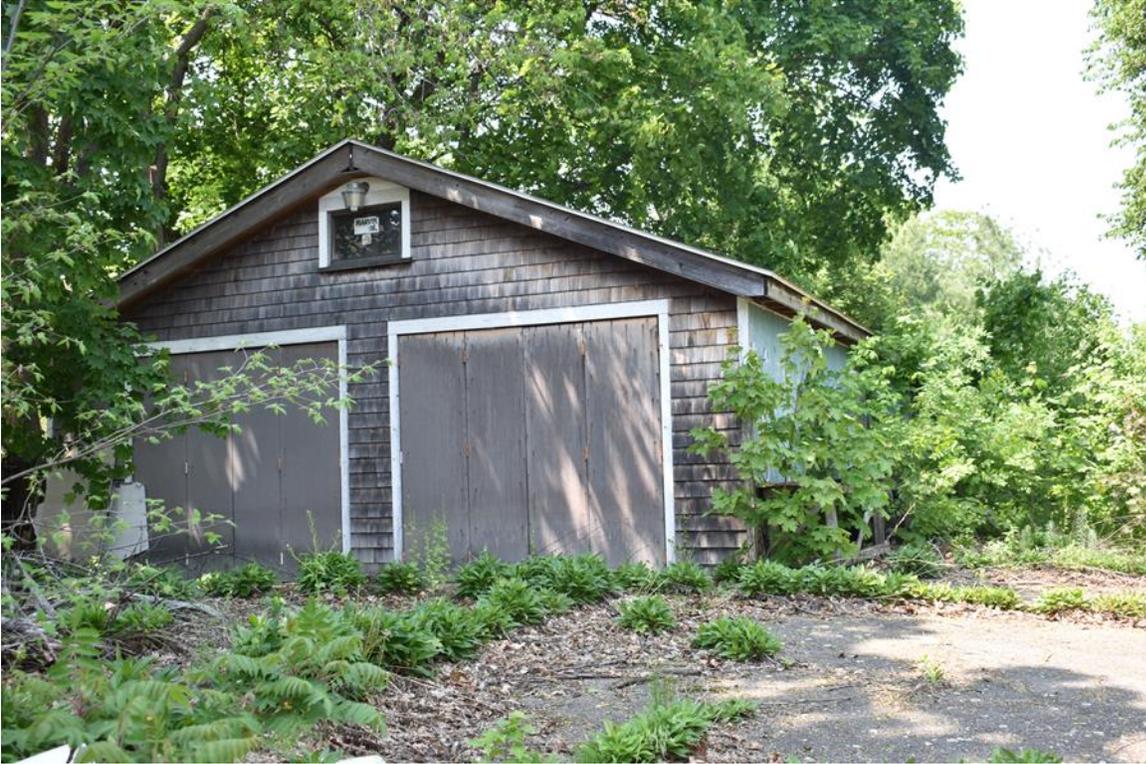
Figure 6. Garage, south and east elevations, looking north from drive (The Public Archaeology Laboratory, Inc. 2021).

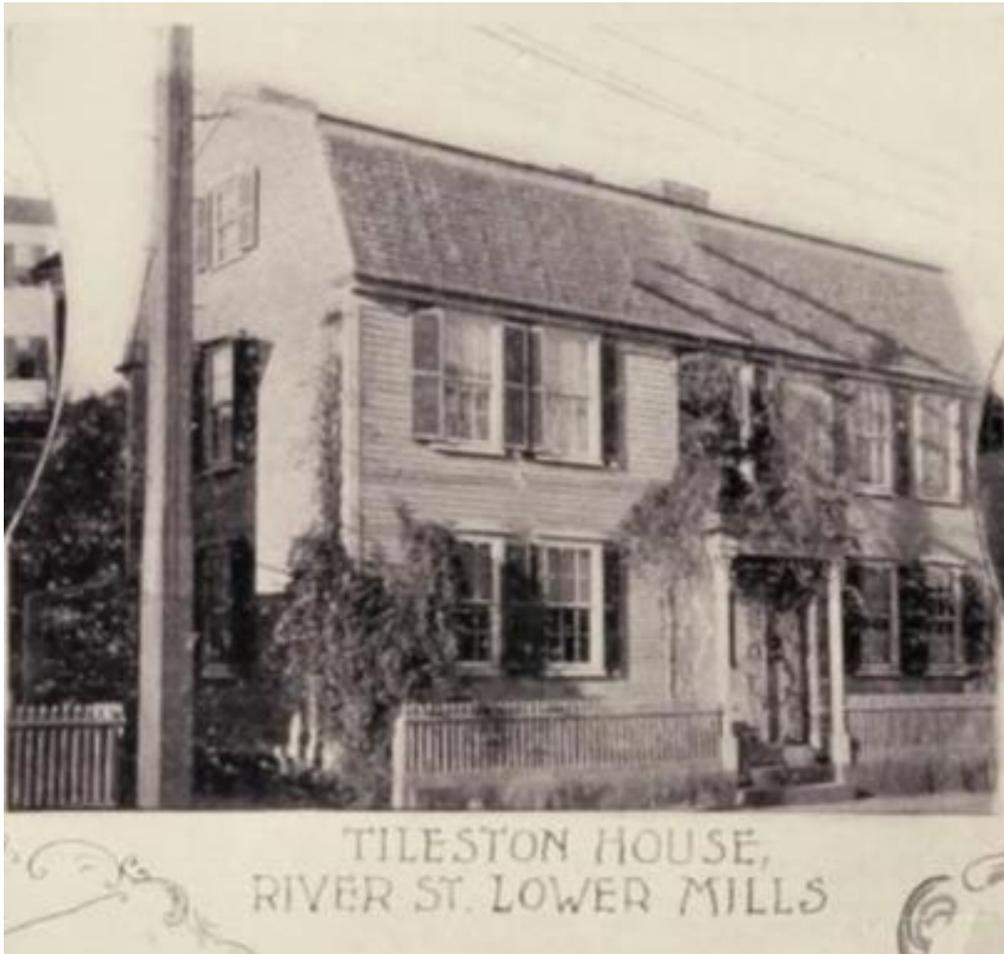
Figure 7. A late nineteenth-century photograph of 13 River Street, showing columns supporting entry porch roof, six-over-six windows with projecting surrounds, and chimney placement (Branch Alliance of Christ Church Unitarian (Christ Church). *The Dorchester Book*. Boston, MA: George H. Ellis, Printer, 1899).

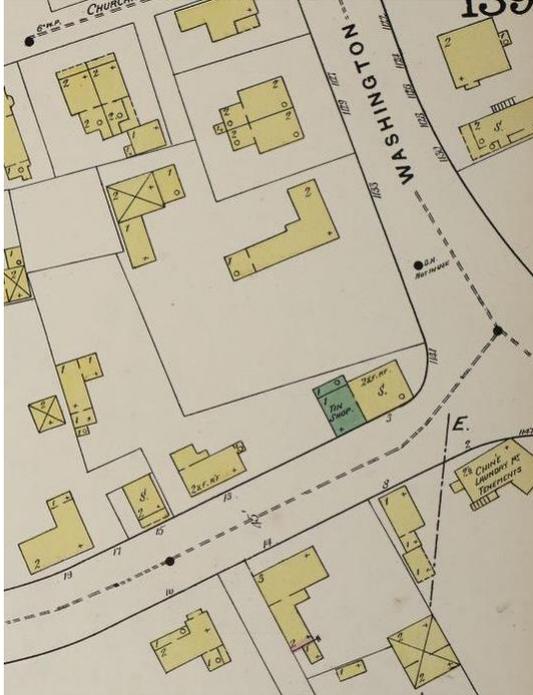
Figure 14. 1888 Sanborn map showing a 1-story tin shop off the west side of the store building at 1141 Washington Street, at the corner of River and Washington Streets. Charles Tileston owned the entire lot (Sanborn Map Company (Sanborn). *Sanborn Fire Insurance Map from Boston, Suffolk County, Massachusetts, Volume 4, Plate 140*. New York: Sanborn Map & Publishing Company, 1888).

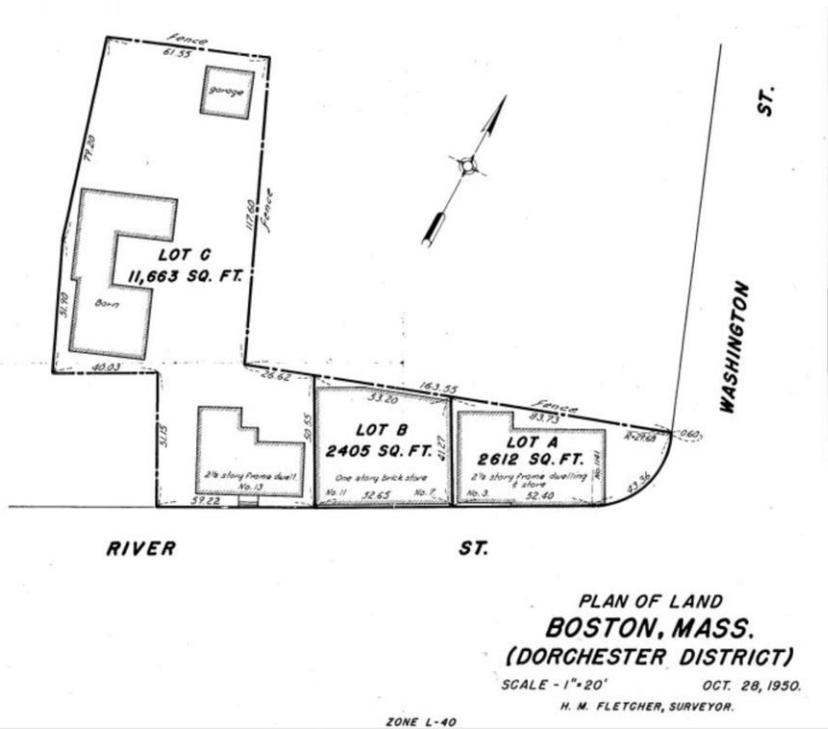
Figure 18. 1950 site plan of Tileston property. Lot C conforms to the subject property at 13 River Street (barn not extant), and Lot A is 1141 Washington Street (Suffolk County Registry of Deeds 6855/411).
