FREDERICK AYER MANSION INTERIOR

BOSTON LANDMARKS COMMISSION STUDY REPORT

**The Interior of the
Frederick Ayer Mansion
395 Commonwealth Avenue, Boston, Massachusetts**

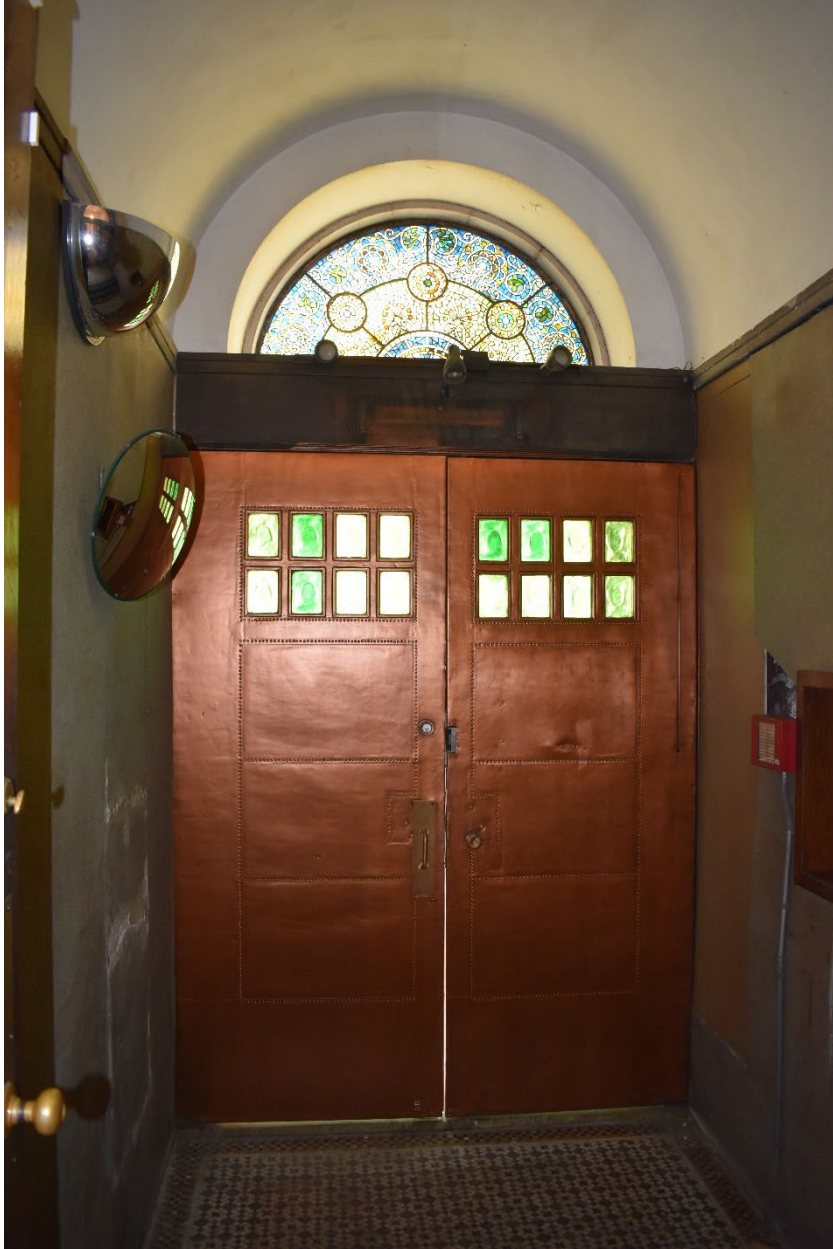
Photo 7. Outer Vestibule, main entrance doors, view south.

The copper-clad main entrance doors, flanked by inset stone columns with inlaid glass mosaic and topped by a stained-glass fanlight, lead from the exterior stoop into a rectangular, barrel-vaulted Outer Vestibule (Photos 7, 8, and 9). The original mosaic floor of the Outer Vestibule is constructed of glass and stone mosaic tiles in white, green, and light ochre. The original green marble walls of the Outer Vestibule are in place but concealed behind an applied sand and resin parging, which was likely applied in the 1950s by a commercial owner. In 2015, Daedalus Conservation removed several small areas of parging to reveal the original green-veined marble beneath, which matches the green marble in the vestibule’s floor (Photo 10). Plans for the house, dating from 1961, indicate that the small window in the west wall, which opens to the neighboring building, was added at a later date and is not original to the house. The barrel-vault ceiling is white-painted plaster.

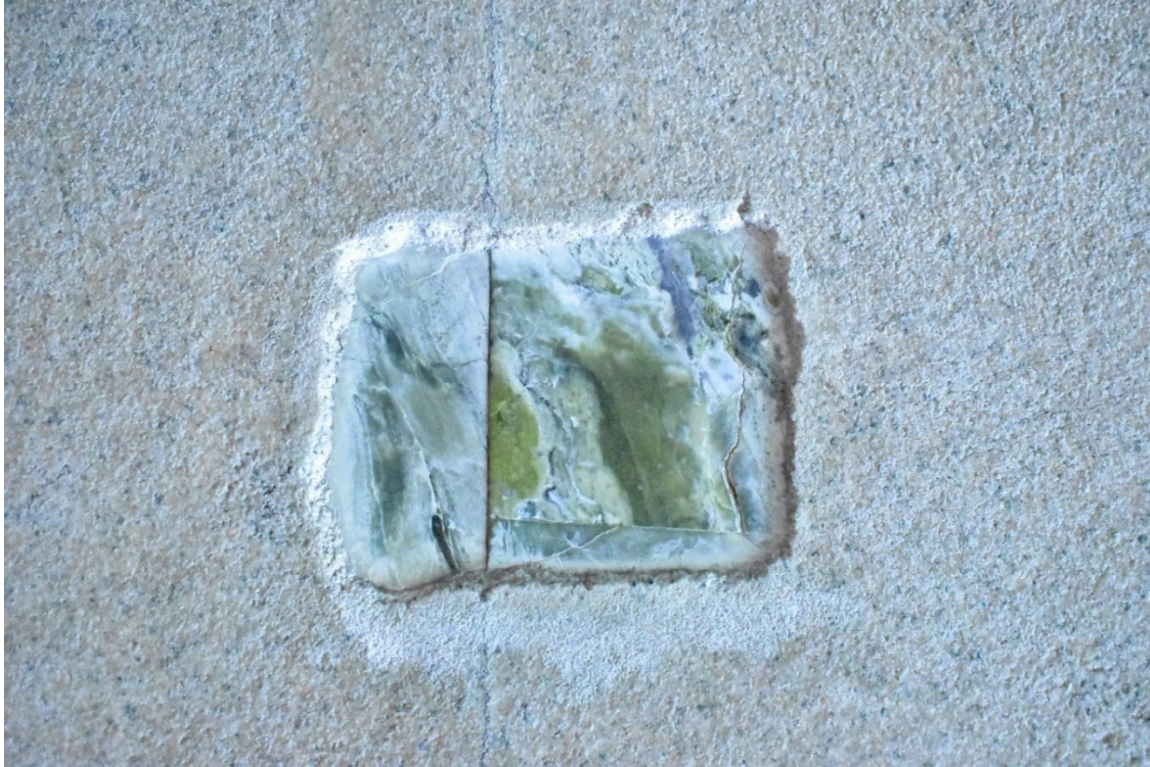
Photo 10. Outer Vestibule, wall detail showing original marble under covering, view east.

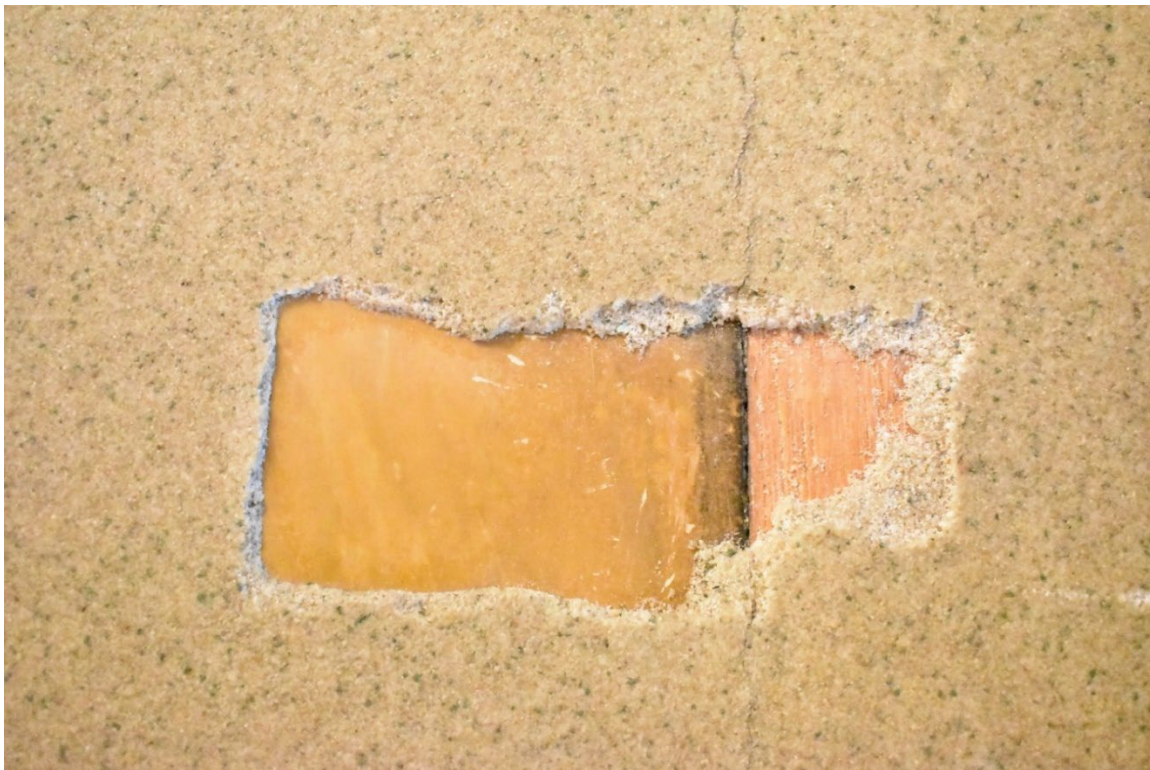
Photo 11. Inner Vestibule, wall detail showing original marble under covering, view east.

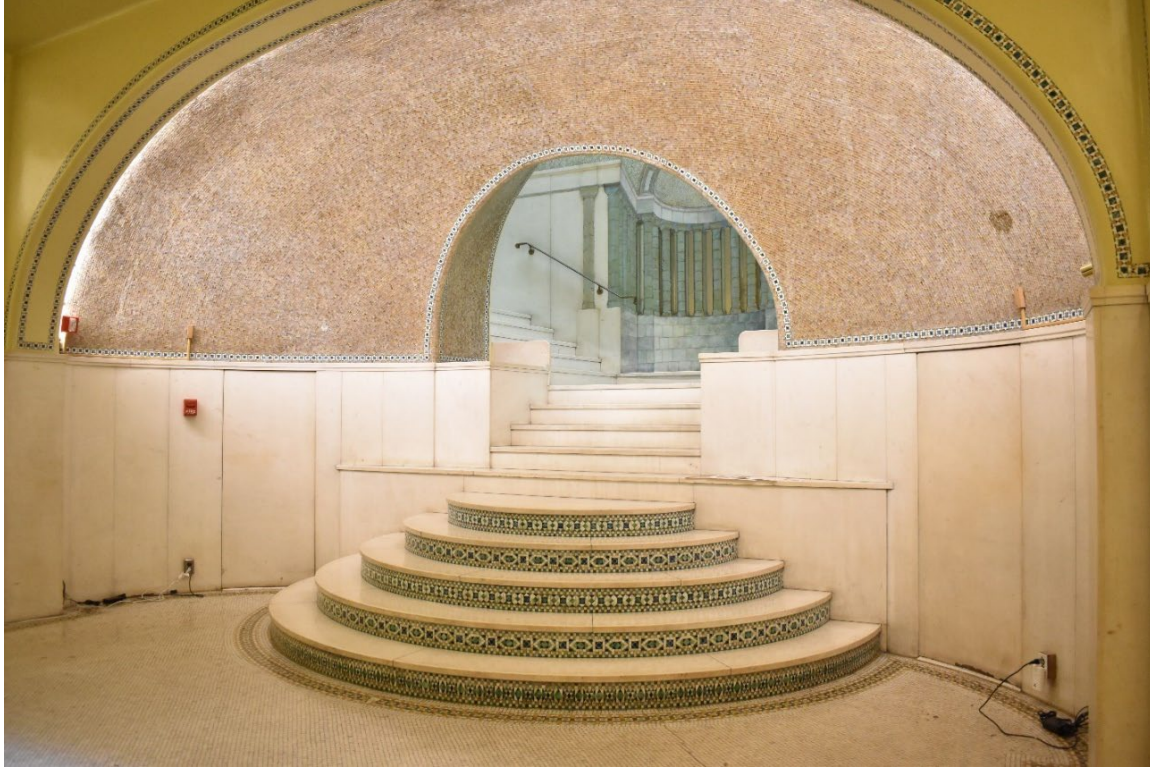
Photo 12. Marble Hall, east wall, proscenium arch and semi-circular stairs, view east.

The east wall of the Marble Hall is dominated by projecting semi-circular stairs and a proscenium archway accentuated by mosaic banding (Photos 20 and 21, see Photo 12). As noted in the National Historic Landmark nomination, “[b]lue, green, white and gold tesserae are set into the plaster of the intrado and the face of the arch. A ring of electric sockets is hidden behind the arch, suggesting their use as proscenium lighting for amateur theatricals. The entire half dome beyond the arch is sheathed with gold foil-backed glass mosaic above the marble wainscoting. The tesserae are laid in a radial pattern following the curvature of the dome. The molded cap at the top of the wainscot broadens to form a shelf at the rear of the apse where a smaller, round arch opens on an imperial stair to the second floor Hall. The arch frames a spectacular trompe-l’oeil peristyle mosaic at the rear wall of the double stair.”⁹ The trompe-l’oeil mosaic is described below under Main Stair. The semi-circular stairs are white marble faced with blue and green mosaic (Photo 22). The wainscoting in the curved archway contains two concealed doors, constructed of matching white marble. The doors originally accessed a “flower room” and a “coat room,” both described in the 1903 Inventory.

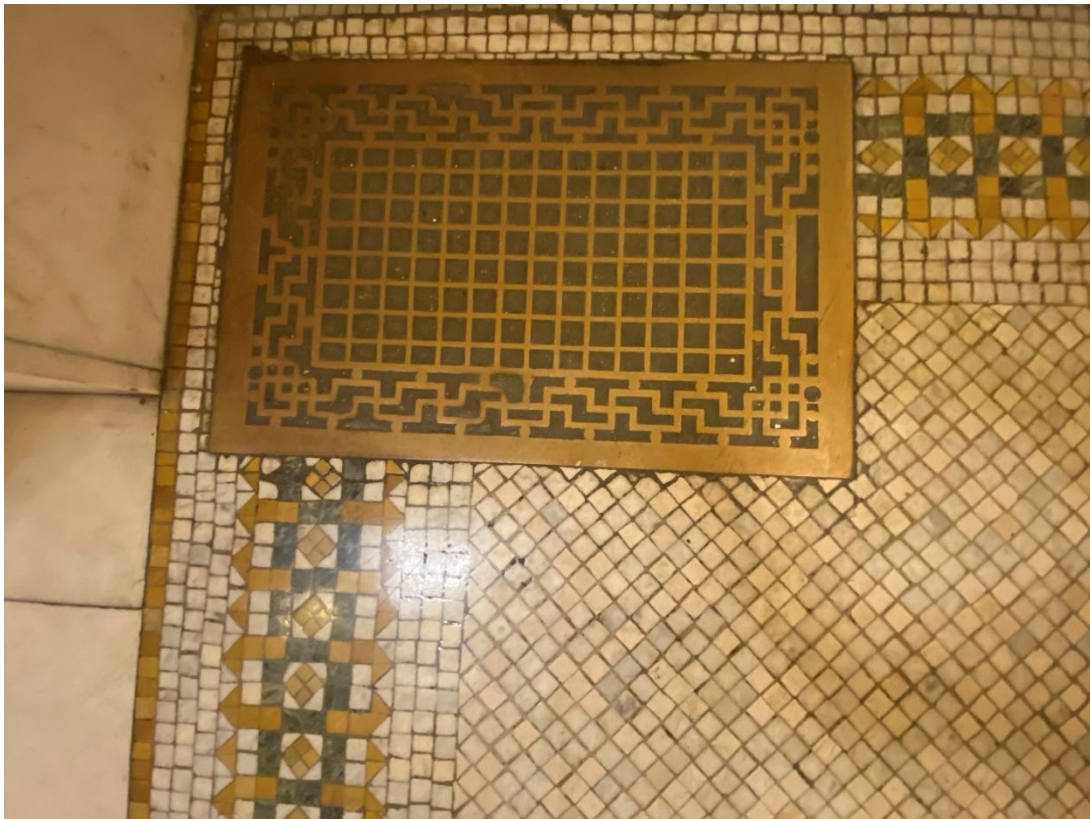
Photo 16. Marble Hall, floor detail, view down.

Drawing Room, as well as the columns that run from the floor to the ceiling, and then continue across the hall as beams to the opposite side. The white marble mosaic floor incorporates a pattern of ochre tesserae scattered throughout, and a geometric mosaic band on the perimeter of green, white, and ochre marble, repeating the patterns, colors, and materials found in the Outer and Inner Vestibules. Decorative brass grilles for the heating system are set in the mosaic (Photo 16).

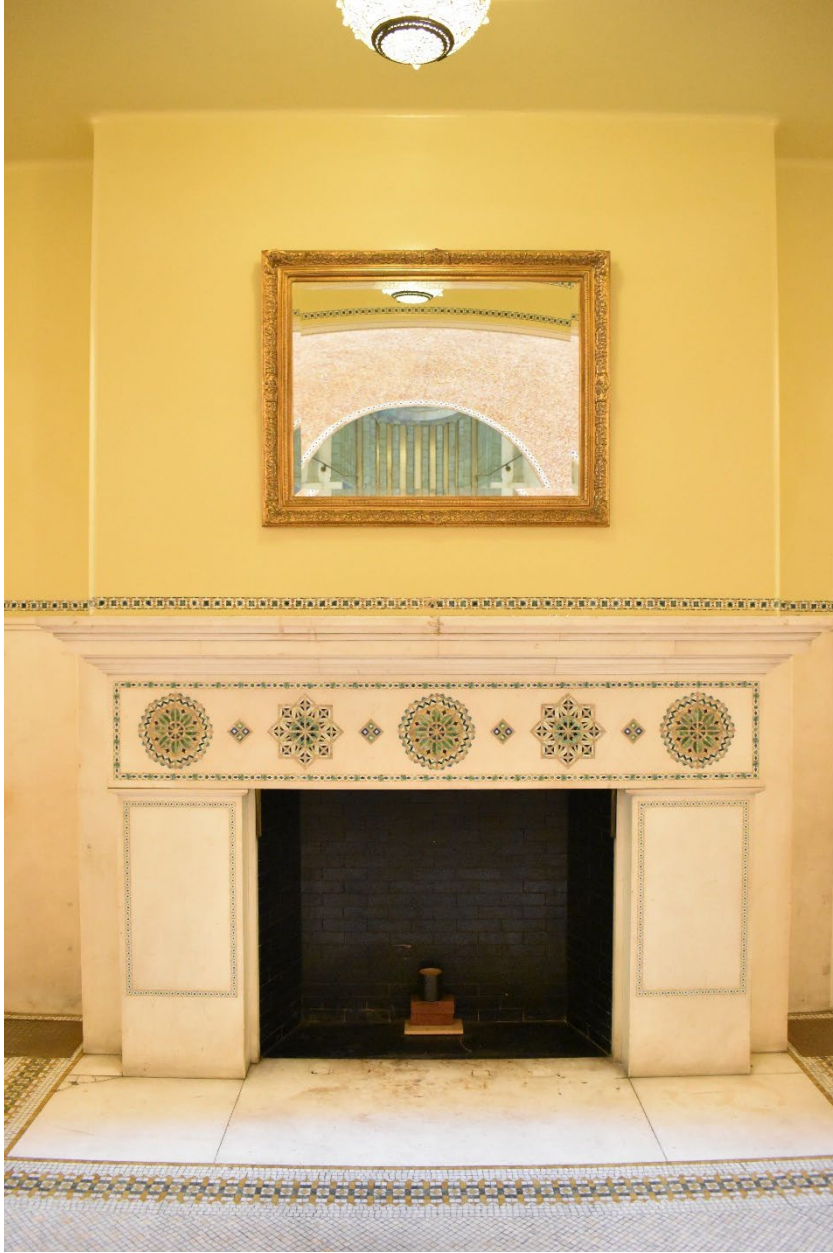
Photo 17. Marble Hall, fireplace, view west.

The west wall of the Marble Hall is dominated by a white marble mantelpiece set in a projecting chimneybreast (Photo 17). As noted in the National Historic Landmark nomination, “the mantelpiece is inset with mosaic medallions and a mosaic border. Both medallions and border feature gold-foil backed tracery in-filled with opalescent green, blue, and white tesserae.”⁷ A door on the west wall, leading to the neighboring building, appears in the plans for the 1961 renovations and is not original.

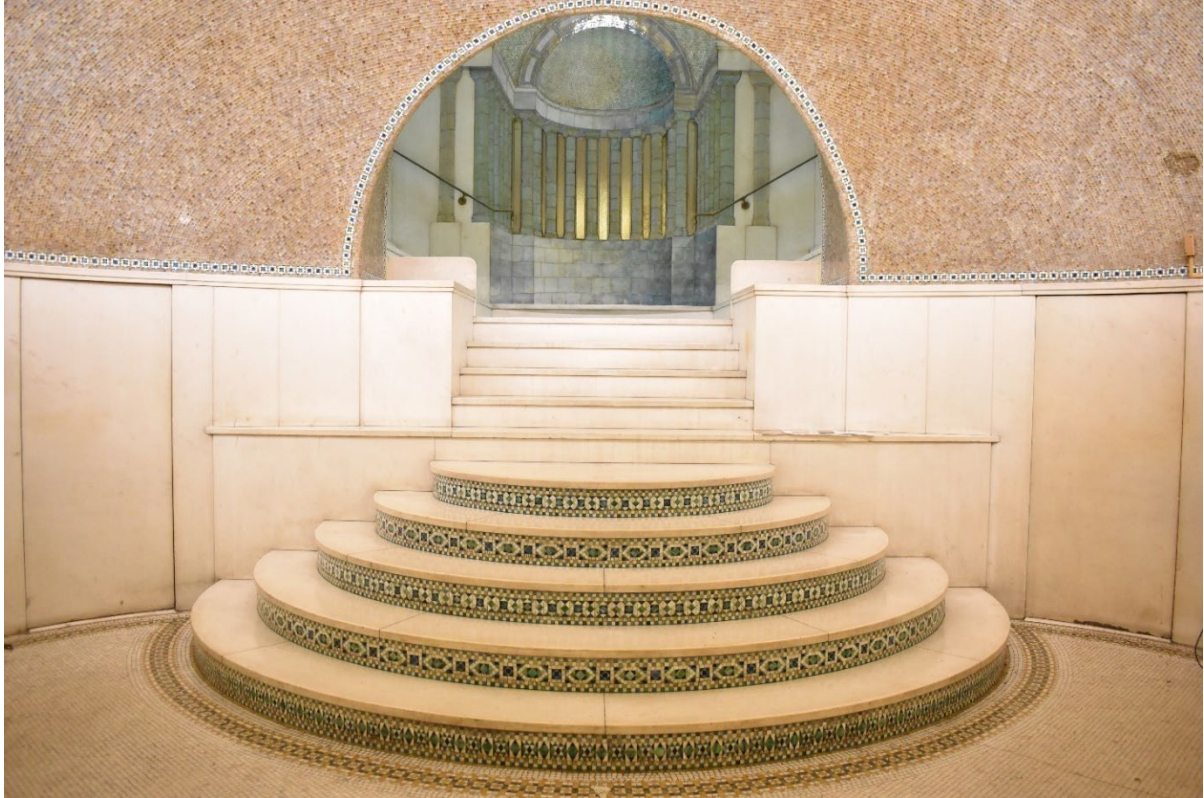
Photo 20. Marble Hall, proscenium arch and semi-circular stairs detail, view east.

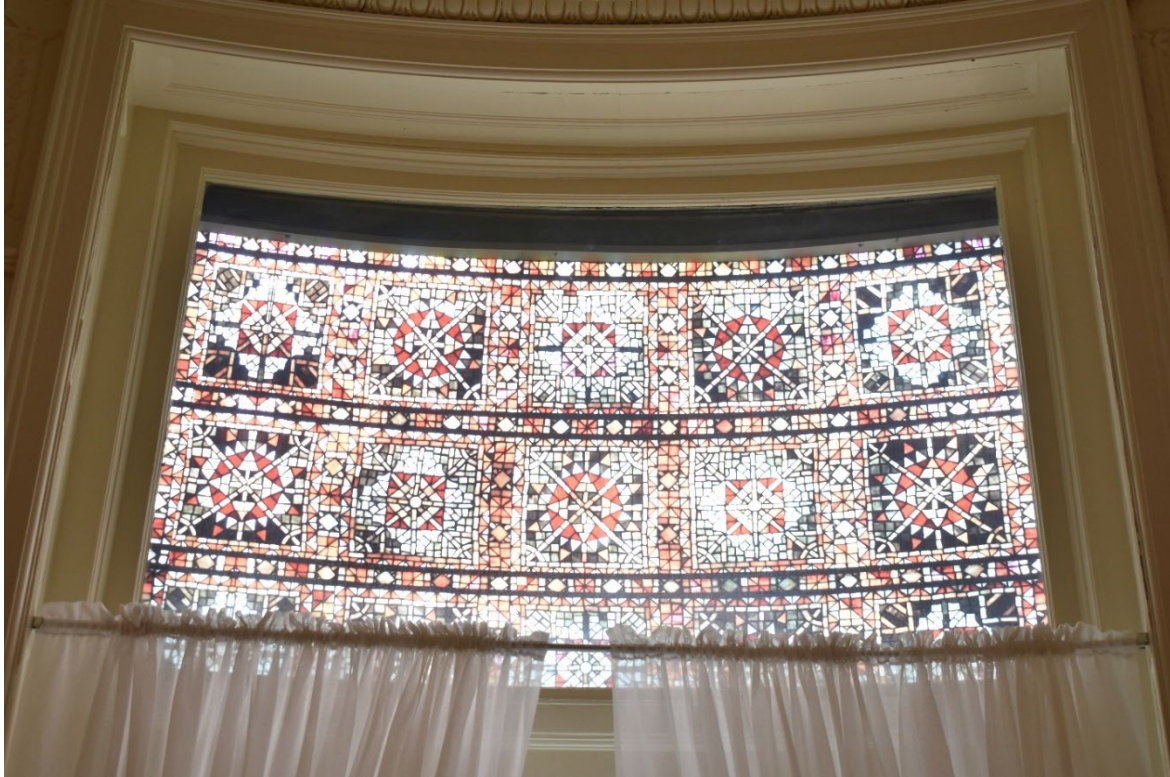
Photo 32. Drawing Room, stained-glass window plastic sheet reproduction detail, view south.

The three “transom” areas above the bow windows currently contain Lexan panels, printed with an image of the original stained-glass screens which Tiffany designed for these openings (Photo 32). In preparation for work on the building's façade in 2009, the Campaign for the Ayer Mansion hired Lyn Hovey Studios to remove and crate the sole surviving Tiffany-designed stained glass ‘screen’ from the center transom. Lyn Hovey Studios and Jeanne Pelletier report that the window is currently stored in the basement of the house. Images of the window *in situ*, used to create the Lexan panels, show a remarkable masterpiece of red, ochre, green, and white glass, in a Byzantine pattern that

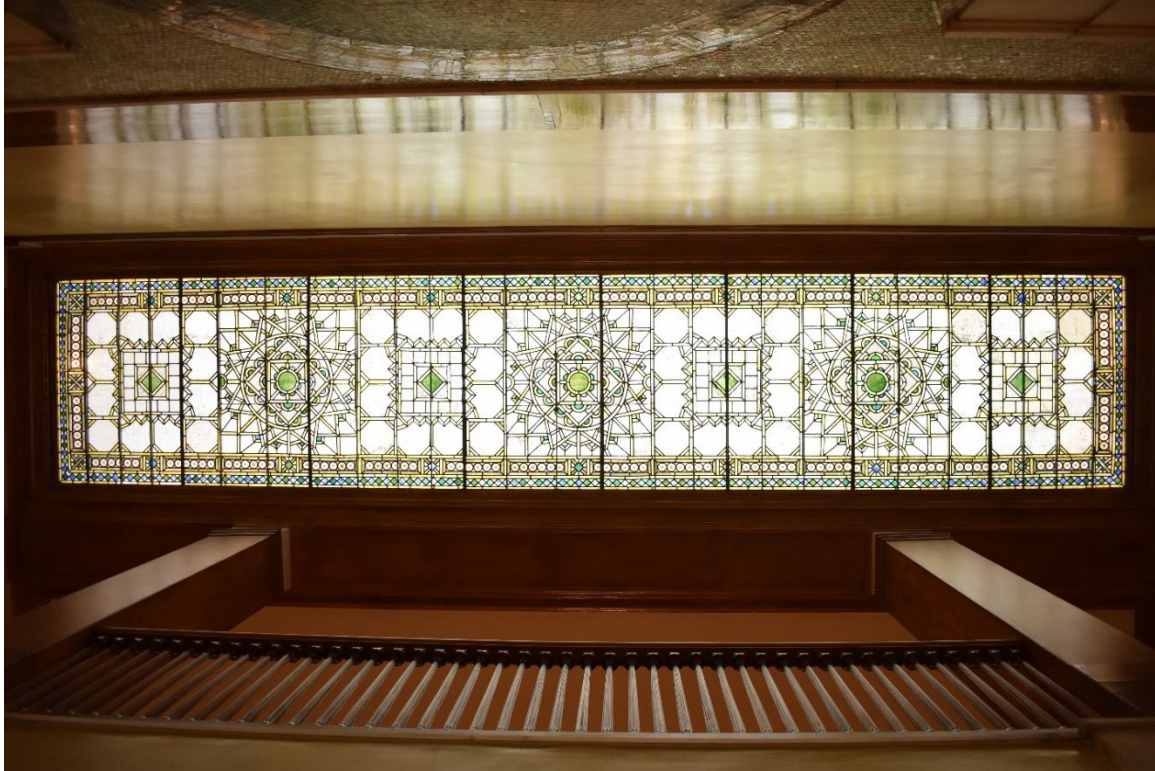
Photo 34. Main Stairs stained-glass laylight, view up.

Directly above the landing is a 20 x 4-foot stained-glass Tiffany laylight, which Lyn Hovey Studios restored in 2003, using replacement glass where necessary from the Neustadt Collection in New York City (Photo 34). During the day, the laylight is illuminated by natural light, which enters the shaft above the laylight through a clear glass and metal skylight on the roof that is integral to the original design. During evening hours, six light fixtures above the laylight -- which were original to the house and restored in 2003 -- illuminate the space. As described in the National Historic Landmark nomination, “[t]he eight-panel laylight incorporates a wide variety of glasses in a lead matrix and employs the same color scheme found in the Marble Hall mosaics as well as the clouded and corrugated glass of the pendant globe. The design consists of “[a] series of alternating squares-within-circles and diamonds-within-squares . . . cut from a milky semi-opalescent glass with ‘mottles and freckling’ set in a field of clear ripple glass. Glittering gold ripple glass is used in the borders and crisscross lattice pattern, while an inner border of 2-inch-round opal cast glass jewels frames the Moorish-style geometric composition. The outer border and parts of the inner design are highlighted with diamonds and half-circles of blue and green opalescent glass.”¹¹ In 2019, Lyn Hovey Studios fabricated and installed additional steel support bars to the structure of the laylight to arrest deflection of the laylight, which is sagging along the edges of the composition and in areas of the pattern where the lead coming is particularly intricate.

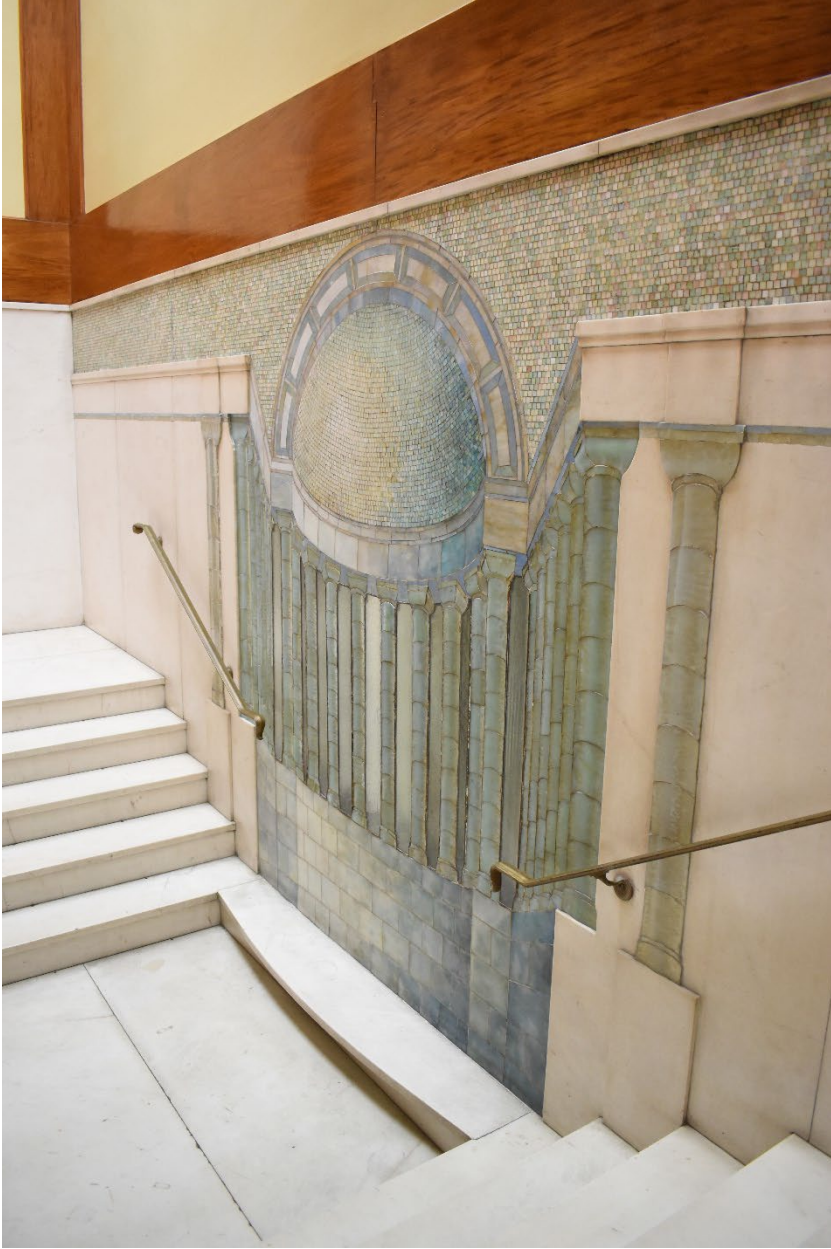
Photo 35. Main Stairs, tromp l'oeil mosaic and split stairs showing part of wall above, view northeast.

In the center of the Stair Landing wall is a magnificent tromp l’oeil glass mosaic, largely of blue tones, representing a Greek or Roman temple or a garden folly, with columns topped by a semi-circular dome (Photo 35). As stated in the National Historic Landmark nomination, “[t]his architectural illusion presents a tour de force of Tiffany’s mosaic technique.”¹² The glass columns, constructed of semi-opaque glass backed with gold foil, curve slightly outward. Furthering the illusion of depth, between the columns are inset glass blocks backed on five sides by highly polished nickel. As noted in the National Historic Landmark nomination, “subtle gradations of color [in the dome] create the illusion of a receding peristyle surmounted by a hemispherical half dome. Set flush

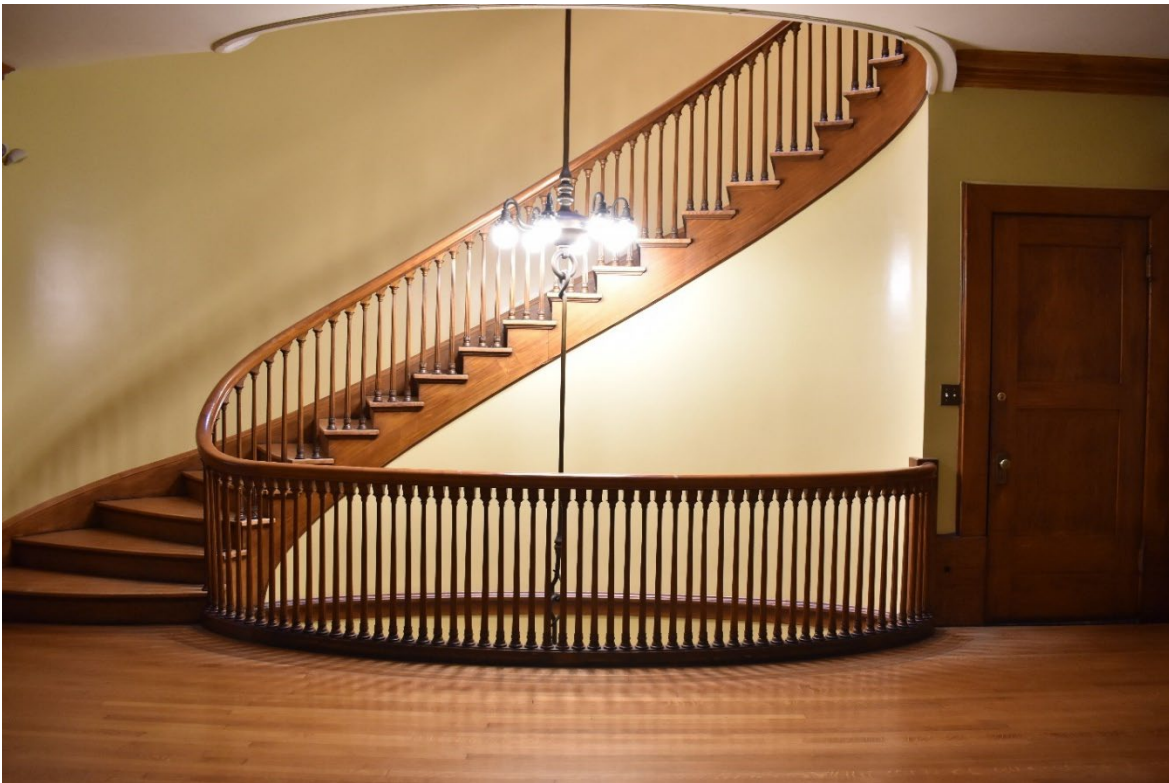
Photo 37. Stair Hall with Elliptical Stair, view west.

The Elliptical Stairs rise along the west wall of the Stair Hall from the second floor to the fifth floor, forming the elliptical opening seen from the Marble Hall (Photos 37–40). As noted in the National Historic Landmark nomination, “[t]he same fluted balustrade continues up the staircase with a transition to a simplified design at the third floor” (Photos 41 and 42).¹⁵ The original stair treads, which have been restored, are of oak, now protected by sheet vinyl on the upper floors. The elliptical opening of the stair is treated with a paneled soffit at each landing above the second floor, and the elliptical stair hall has raised plaster chair rail and doorway molding (see Photos 39 and 42). Where the four-story staircase reaches the top floor, an elliptical clear glass skylight is set in the roof in what is presumably the original opening for what the 1903 Inventory describes as a “stained glass window.” It is lit by a raised skylight on the roof that is part of the original design (Photos 43 and 44).

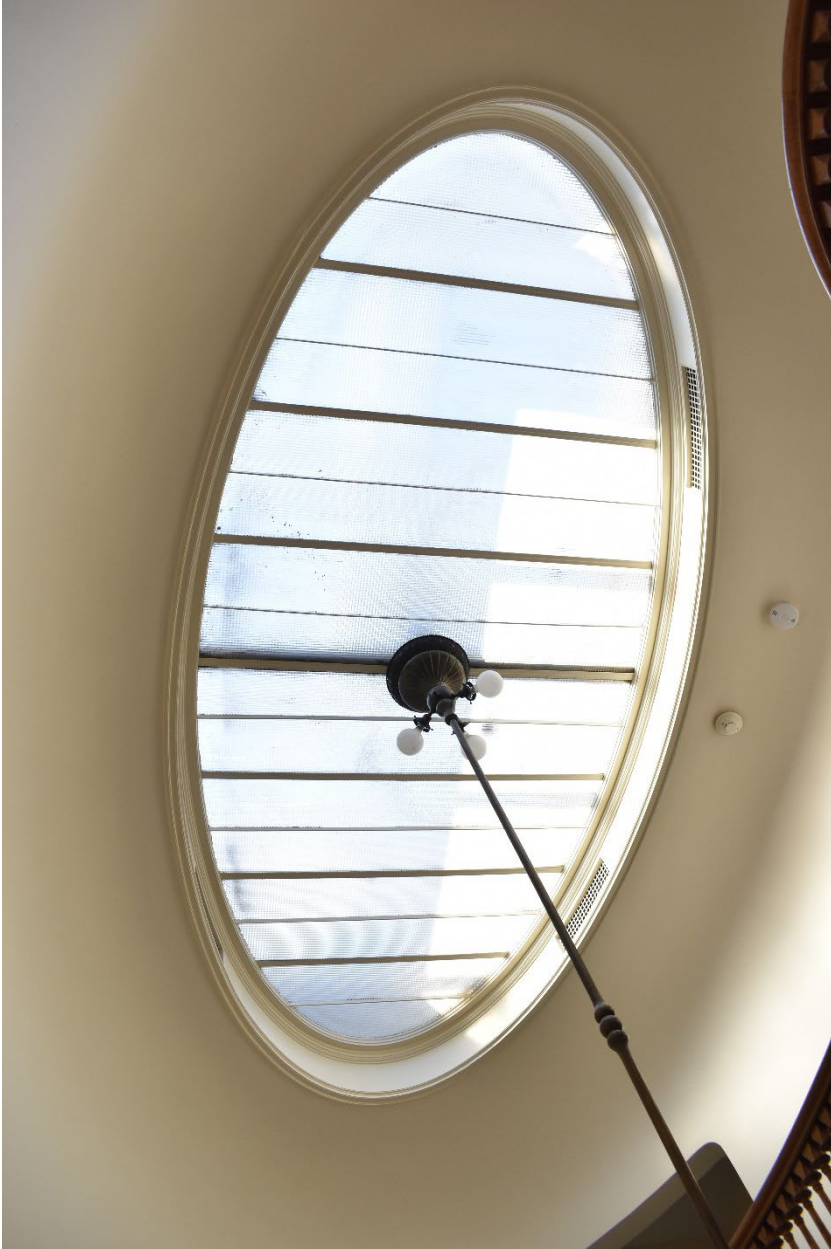
Photo 43. Elliptical Stair, elliptical skylight, fifth floor, view up.

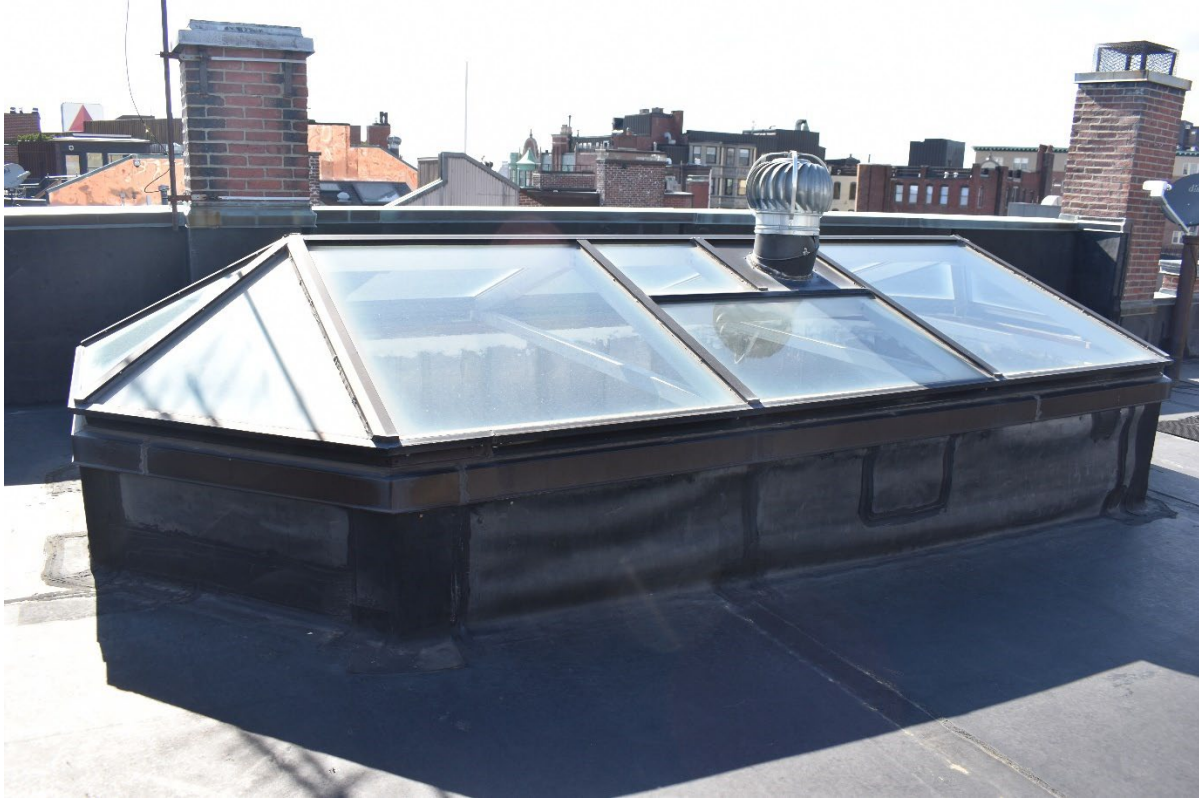
Photo 44. Elliptical Stair, rooftop structure, view southeast.

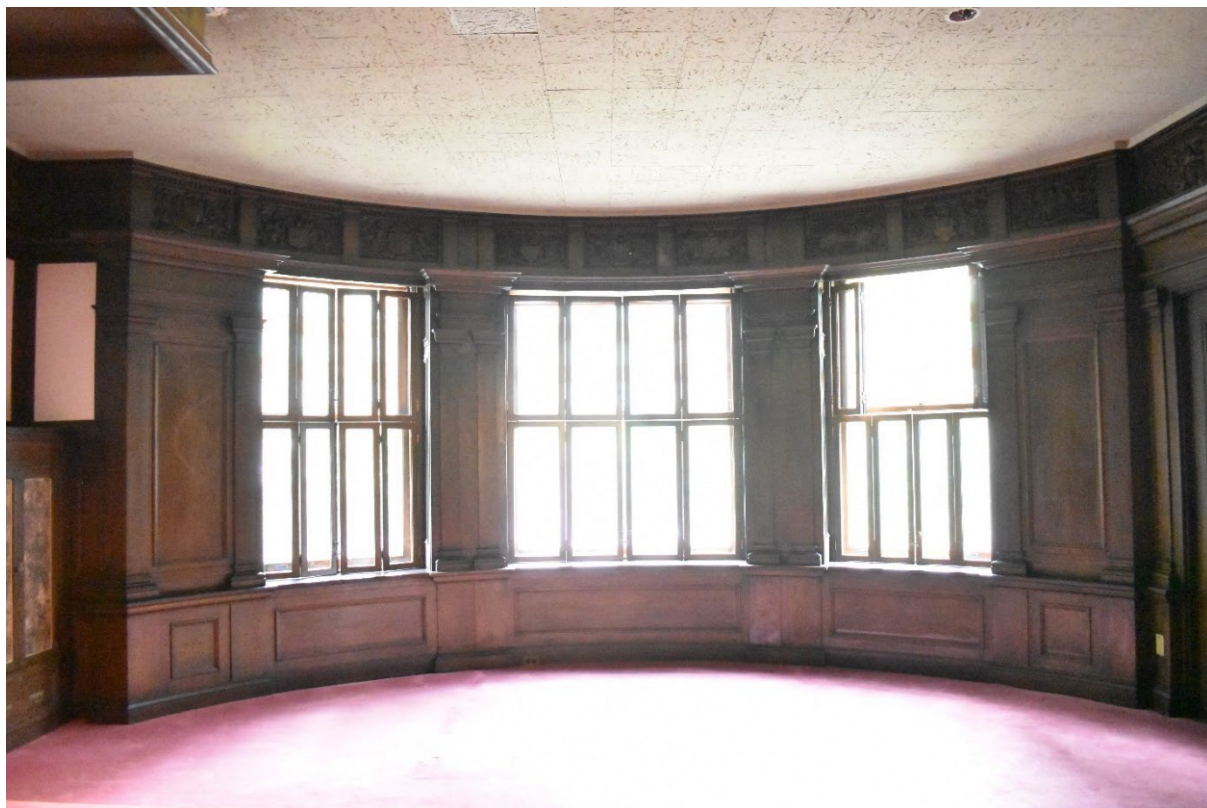
Photo 53. Library, bow windows, view south.

As noted in the National Historic Landmark nomination, “[t]he original double hung curved sash windows with curved glass remain intact (see Photos 53 and 54). The windows are set in dark stained paneled recesses. Hinged shutters were installed during the 1977 renovation. The original stained glass exterior screens are described in the exterior description [above]. Two doors in the west wall of the library lead to the [Alcove]; the south door having been fixed closed. The [Alcove] is a narrow, rectangular room. It terminates to the south at a round, clear glass window with wood surround that is set above the main entrance on the exterior. The original stained-glass window has been lost.”²⁴ The Alcove room also now contains the original fourth bookcase missing from the Library as discussed earlier.

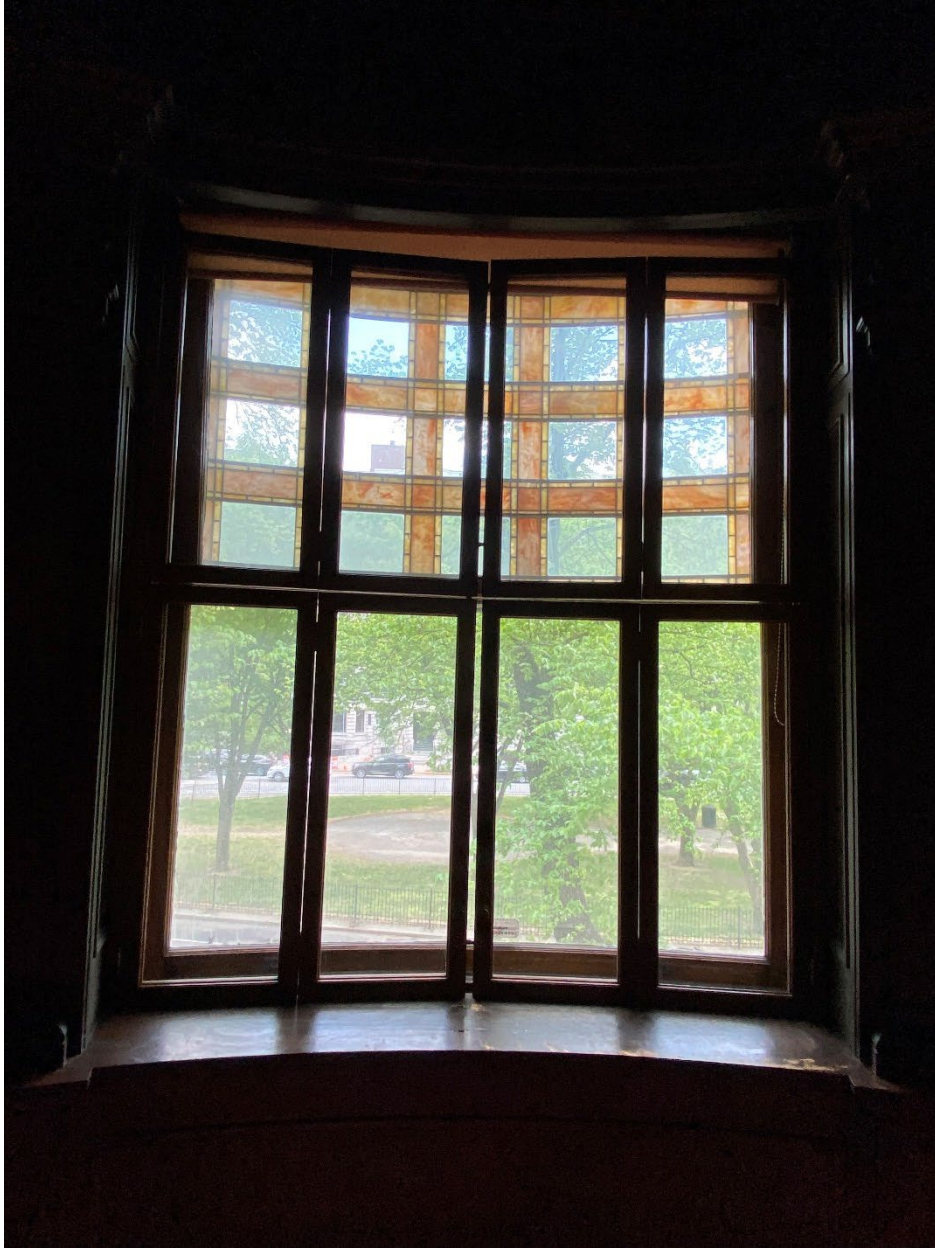
Photo 54. Library, curved window detail showing stained glass, view south.

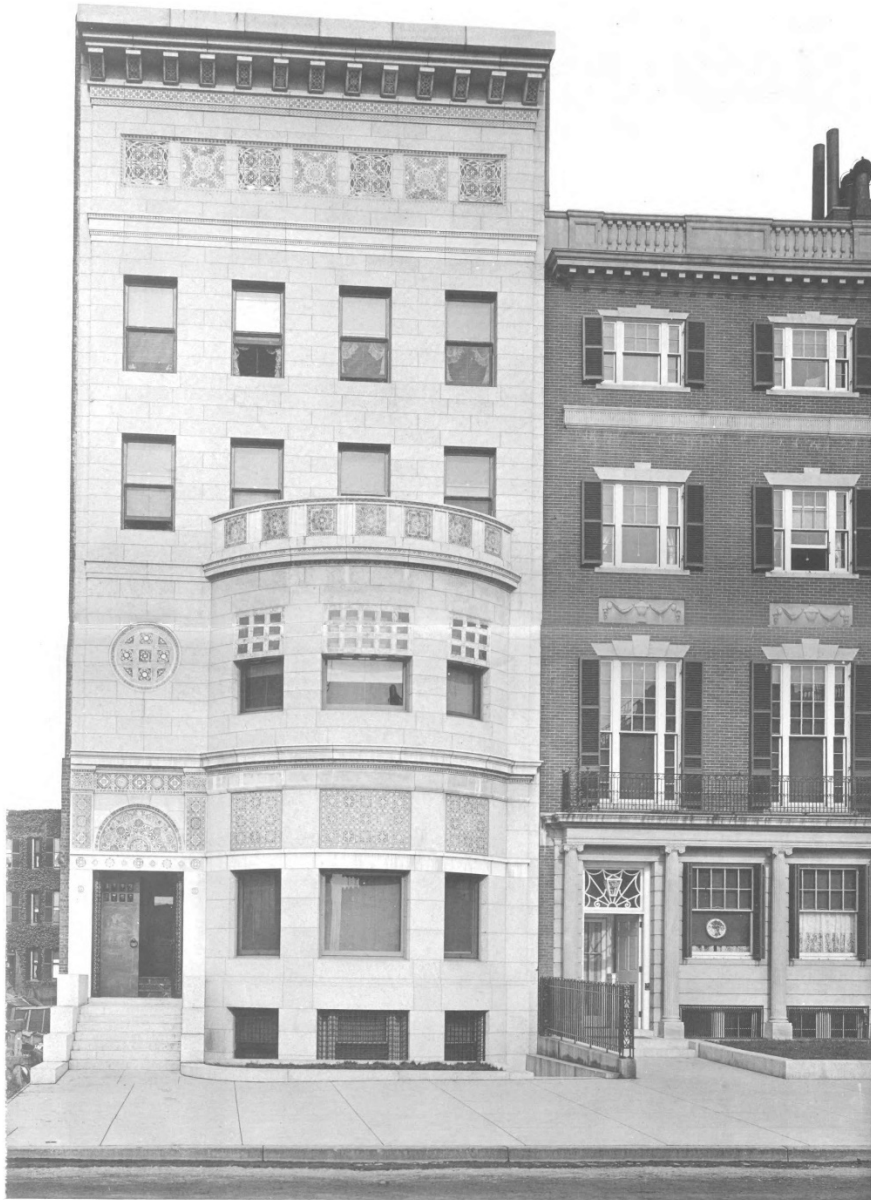
Figure 2. Photograph of 395 Commonwealth Avenue, south facade, 1901.
Source: *American Architect and Building News* 74 (December 21, 1901): 94.

The Frederick Ayer Mansion (Ayer Mansion) occupies a typical rectangular lot in Boston's Back Bay neighborhood set toward the middle of the block between Massachusetts Avenue and Charlesgate East on the north side of Commonwealth Avenue. A 1901 photograph published in *American Architect and Building News* shows the building much as it appears today and indicates the stained-glass windows that have been removed (Figure 2).
