THE RICHARDS BUILDING

BOSTON LANDMARKS COMMISSION

STUDY REPORT

The Richards Building
112-116 State Street, Boston, Massachusetts

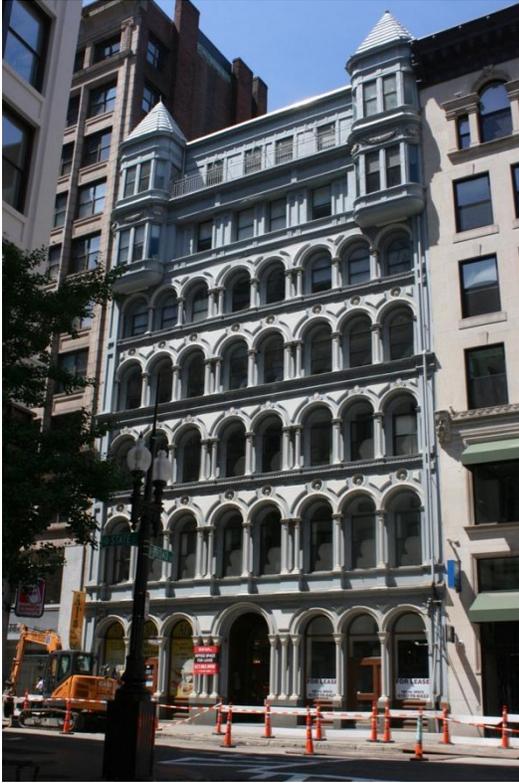
Figure 2. State Street façade.

- 1. Architectural style:** An elaborately embellished Renaissance Revival style characterizes the seven-story Richards Building with its cast iron-fashioned façade. Floors one through five are distinguished by arcades while floors six and seven, which were added ca. 1889 and replaced the original mansard roof, featuring oriel windows at both ends of the building. The eight-bay façade has three distinct horizontal levels: an arcade on the ground floor with a recessed center entrance and three-part storefronts at both sides; a midsection of four stories with arcade windows; and a two-story cap with four bays of rectangular windows.

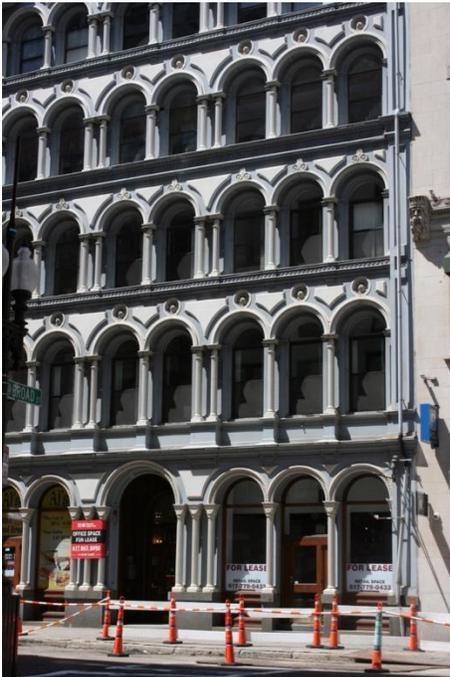
Figure 3. State Street façade; detail of 1st – 4th floors, east side of building.

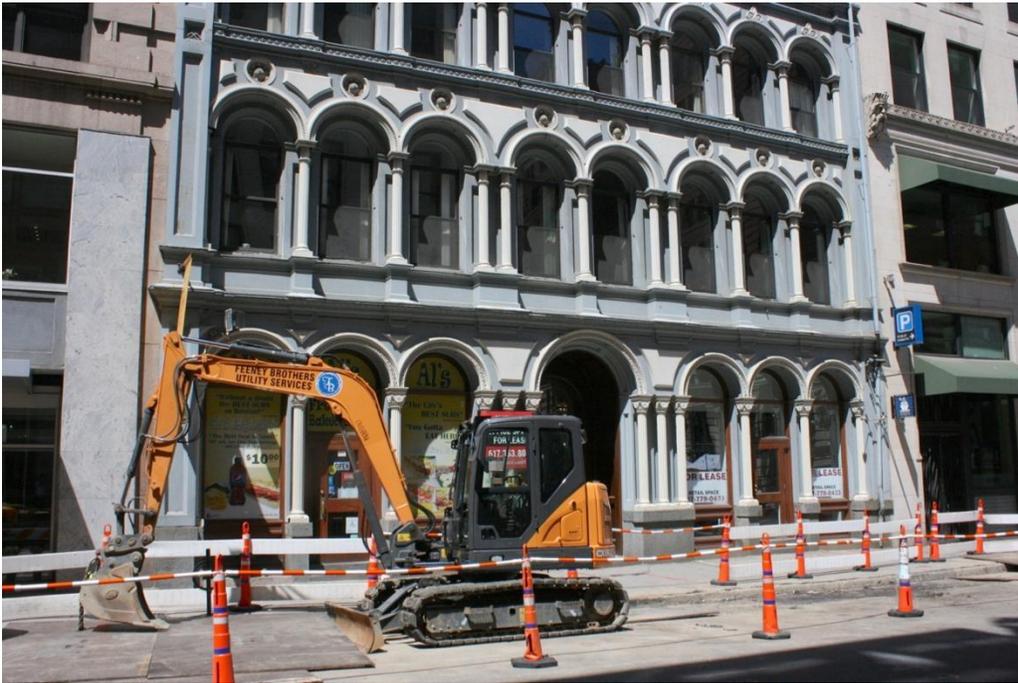
Figure 4. State Street façade; detail of 1st and 2nd floors.

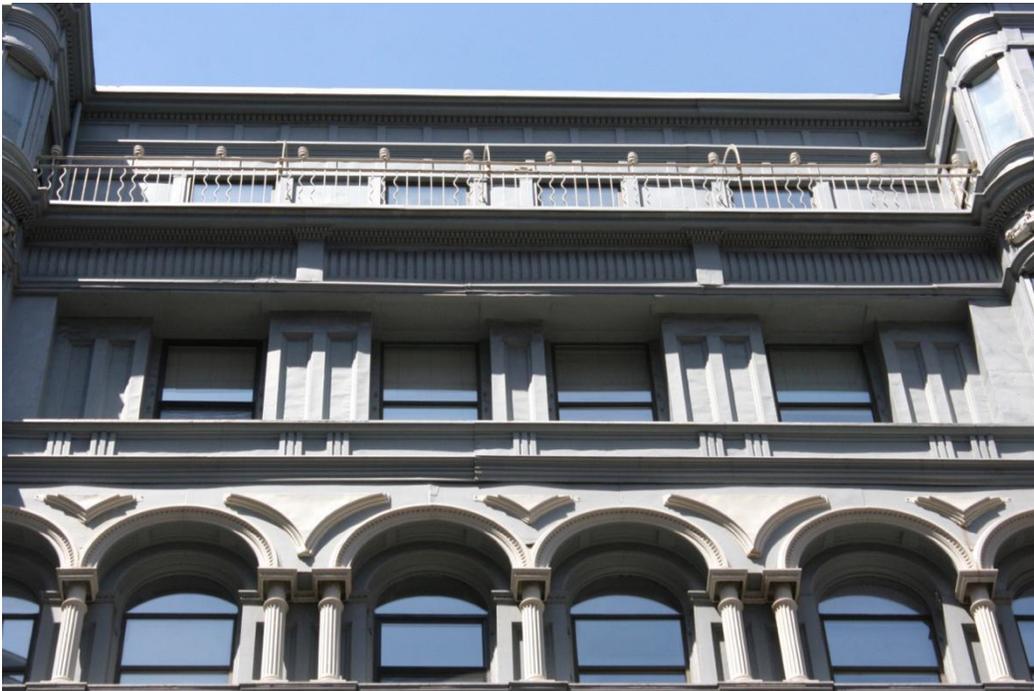
Figure 5. State Street façade; detail of 6th and 7th floors.

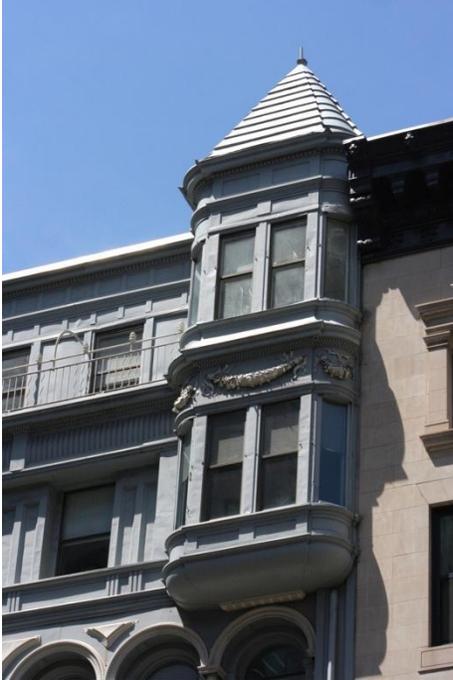
Figure 6. State Street façade; detail of oriel at 6th and 7th floors.

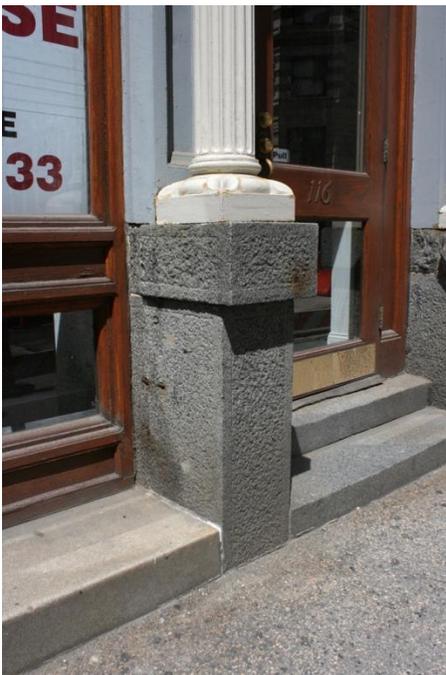
Figure 7. State Street façade; detail of column base at ground floor.

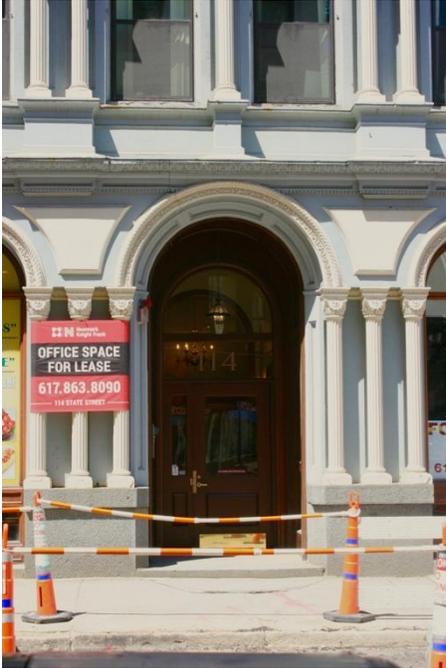
Figure 8. State Street façade; detail of main entrance.

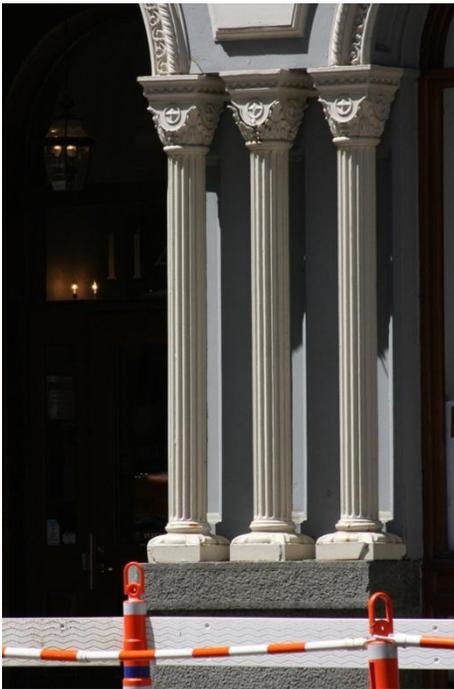
Figure 9. State Street façade; detail of columns at main entrance.

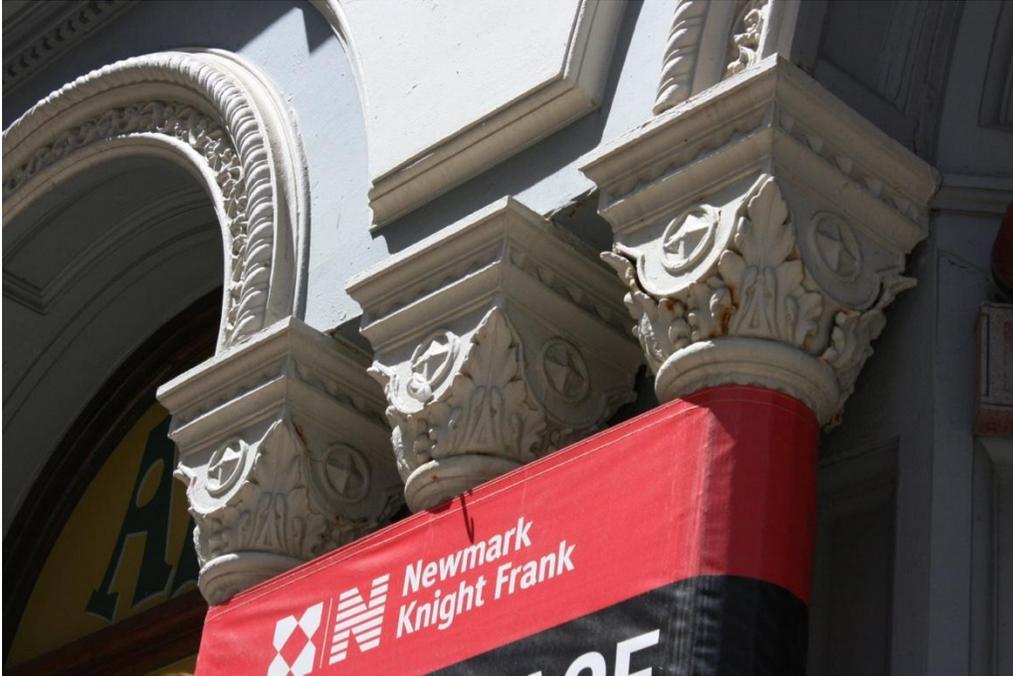
Figure 10. State Street façade; detail of column capitals at main entrance.

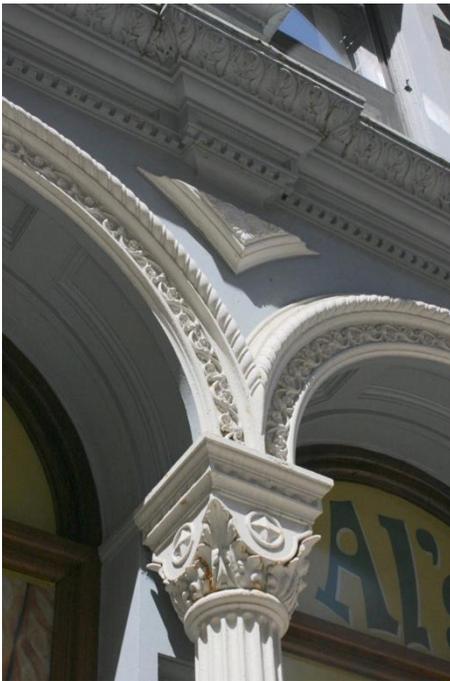
Figure 11. State Street façade; detail of ground-floor arcade.

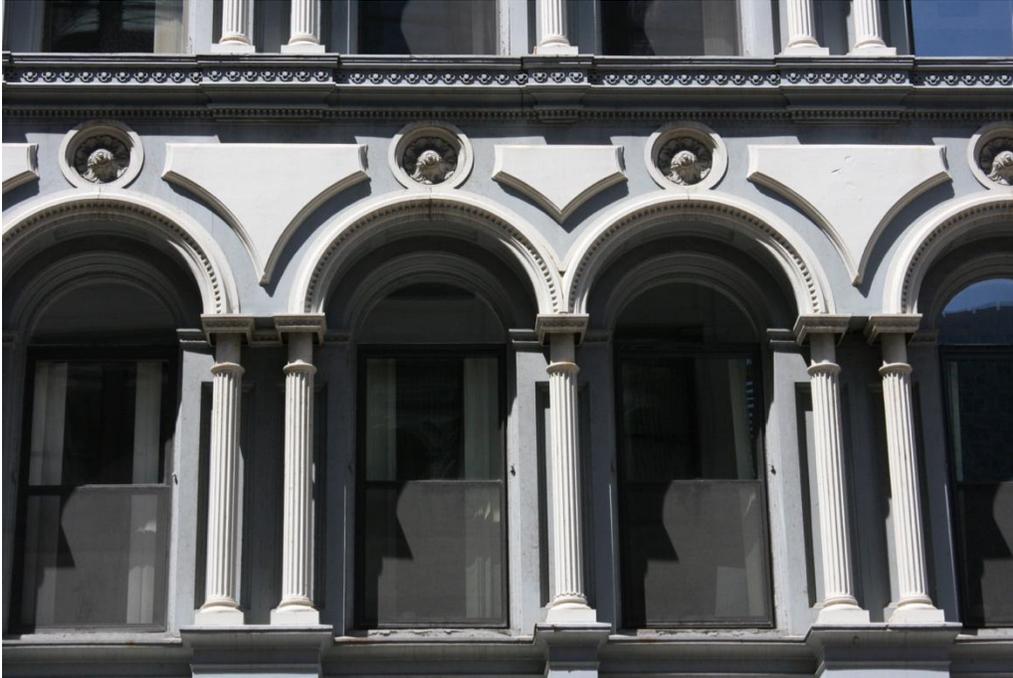
Figure 12. State Street façade; detail of second-floor arcade.

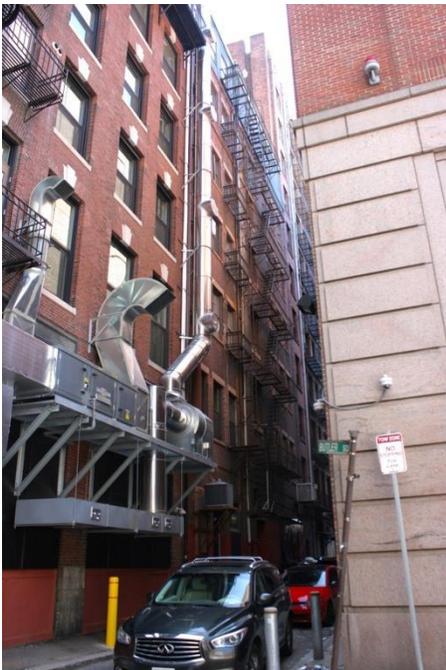
Figure 13. Butler Square elevation; Richards Building is in the center.

Clad with course red brick, the utilitarian rear elevation of the Richards Building, along Butler Square, is seven stories high and seven bays wide, rising from a low granite block foundation. Granite sidewalk slabs and curbs characterize the streetscape immediately adjacent to the building. The top floor of the rear elevation is clad with corrugated metal and surmounted by a copper cornice. Rectangular window openings contain 1/1 double-hung sash and are trimmed with rectangular sandstone sills and lintels; window heights appear to diminish with ascending floor levels. Windows in the center bay are a half-level off the flanking windows, suggesting a staircase in this location. Single window sash are typical, although there are four examples of paired windows: three of them in the next-to-outermost bays on the fourth and fifth floors and one on the second level of the middle bay.

3. Building materials and finishes: While the façade is constructed of cast iron, the rear elevation (Butler Square) is clad in course red brick. It is seven stories high with a low granite block foundation, and seven bays wide. Metal fire escapes cover the center three bays of the building. The top floor is clad with corrugated metal and surmounted by a copper cornice.

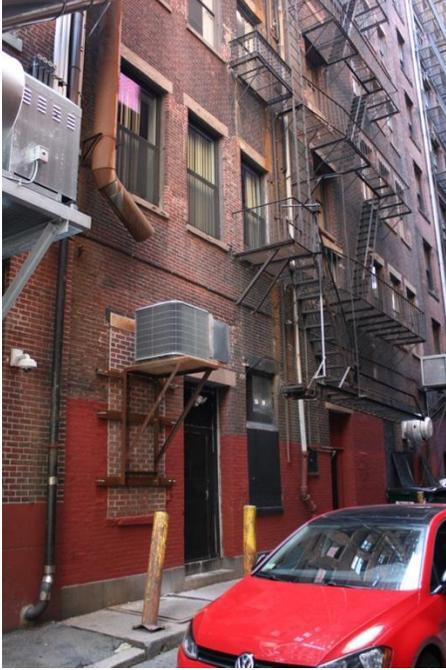
Figure 14. Butler Square elevation; floors 1 and 2.

Two plain entrances access the ground level of the back elevation – one in the center bay and one in the second bay from the left (east); both feature stone lintels, single-leaf doors, and blocked-in transom panels. Two small, square window openings are asymmetrically positioned above the center entrance, and one is set to its left (east). Utilitarian metal fire escapes cover the middle three bays of the building. Several windows are blocked in at the ground level, and there is evidence of numerous brick repairs around the perimeters of the windows on this elevation, especially on the western end of the building.

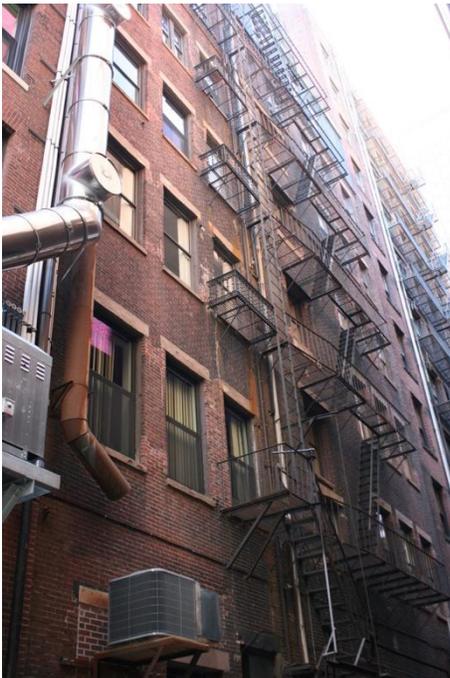
Figure 15. Butler Square elevation; floors 2 and above.

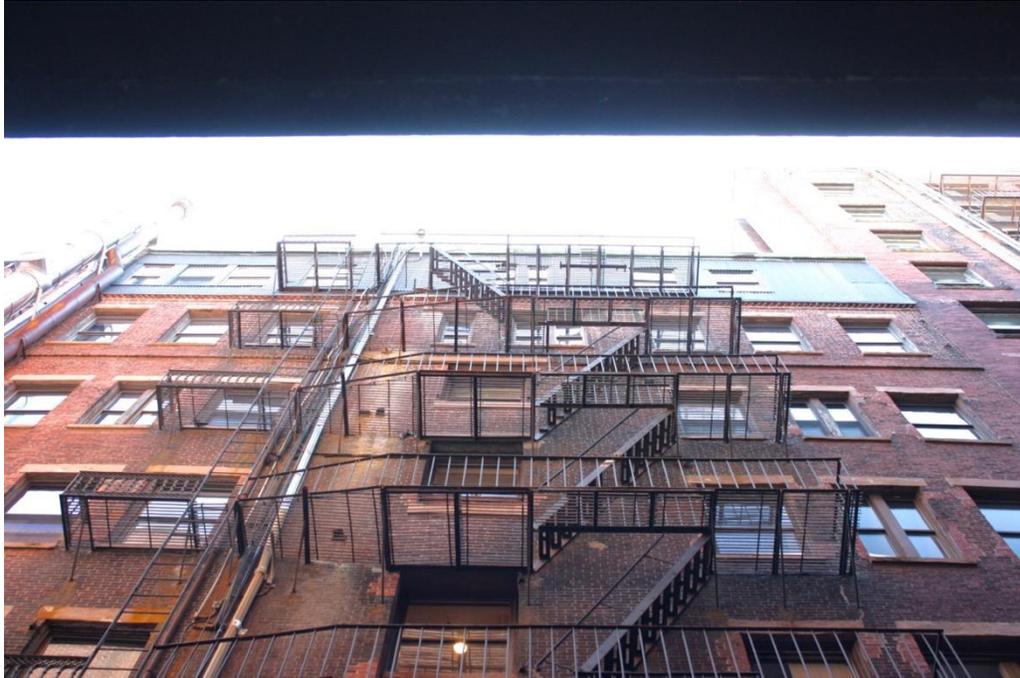
Figure 16. Butler Square elevation; floors 3 and above.

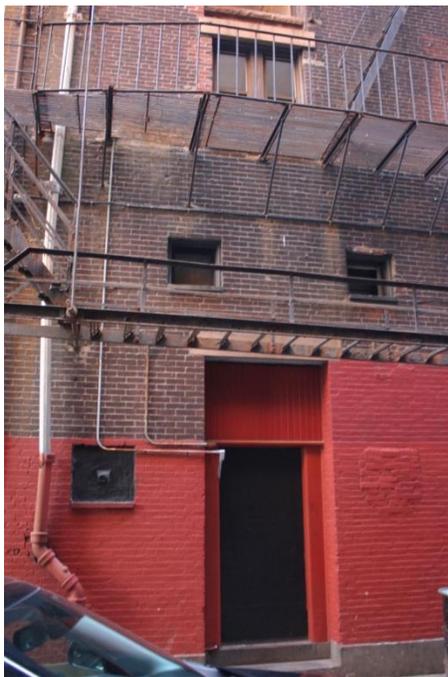
Figure 17. Butler Square elevation; center entry.

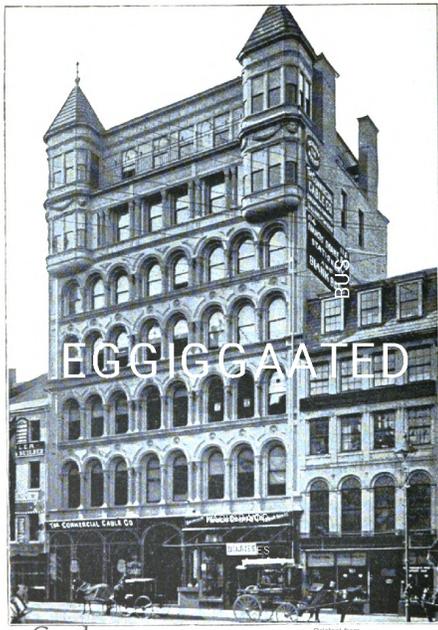
Historical Image 3. Richards Building, 1895. Top two stories and oriel windows added ca. 1889.
