# **Apollos Field House**

## **BOSTON LANDMARKS COMMISSION**

### **STUDY REPORT**

**The Apollos Field House**  
**30 Union Street, Charlestown (Boston), Massachusetts**

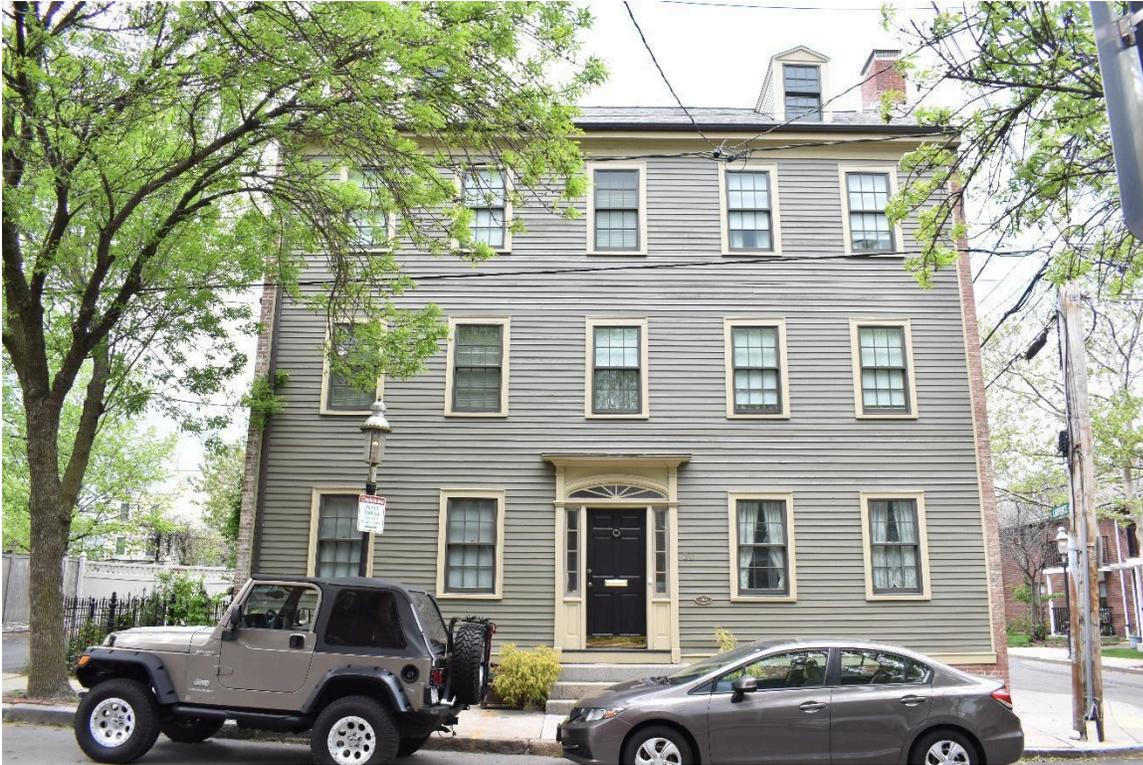
**Figure 2.** South façade, looking north. Photo by The Public Archaeology Laboratory, Inc.

The building is a three-and-one-half-story, wood-frame, brick-ender, Federal-style dwelling. It has a symmetrical, full-proportioned, five-bay façade and extends a single room in depth (**Figure 2**). The dwelling has a low-pitched, side-gable roof pierced by two pedimented gable dormers on each roof slope. Interior brick-end chimneys are centered within and integral to the brick-end walls that comprise the east and west elevations. These end walls are laid in common bond with a header course every five to 10 courses (**Figures 3–5**). The end walls are not parapeted and do not extend above the roofline. The façade and rear walls are clad in wood clapboards with a molded wood cornice beneath the roofline. The foundation consists of fieldstone below grade and common-bond-laid brick above grade.

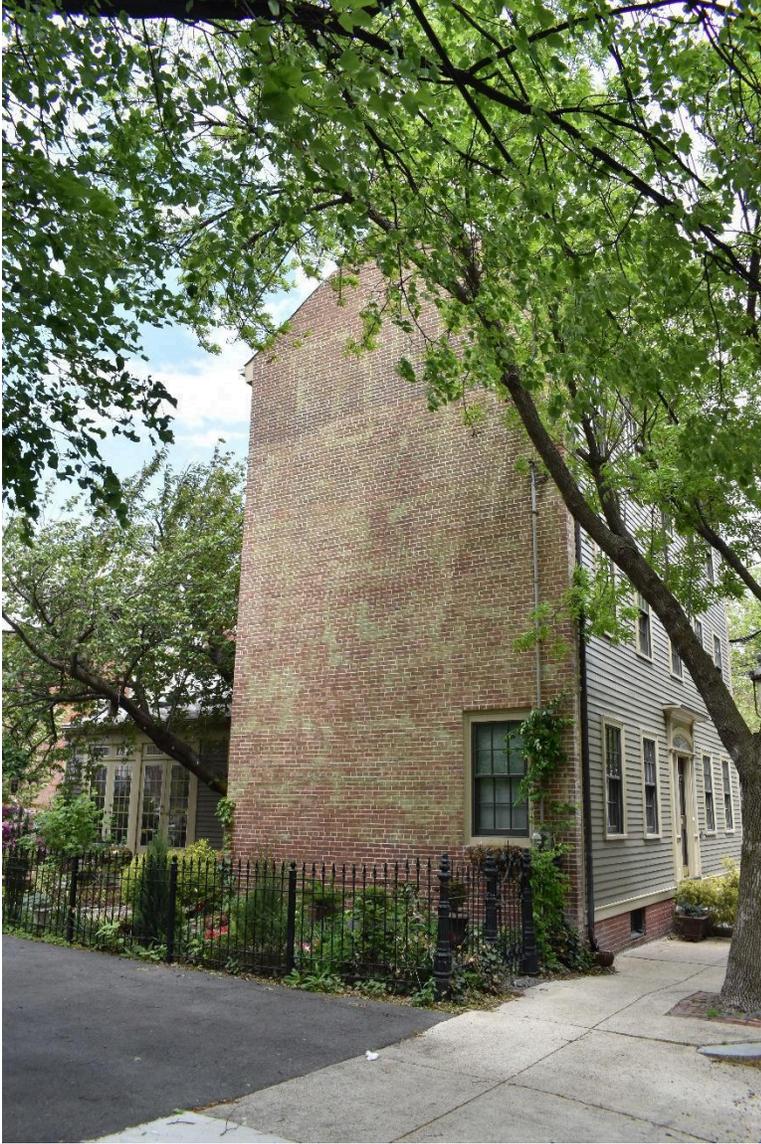
**Figure 3.** West elevation and drive, looking northeast. Photo by The Public Archaeology Laboratory, Inc.

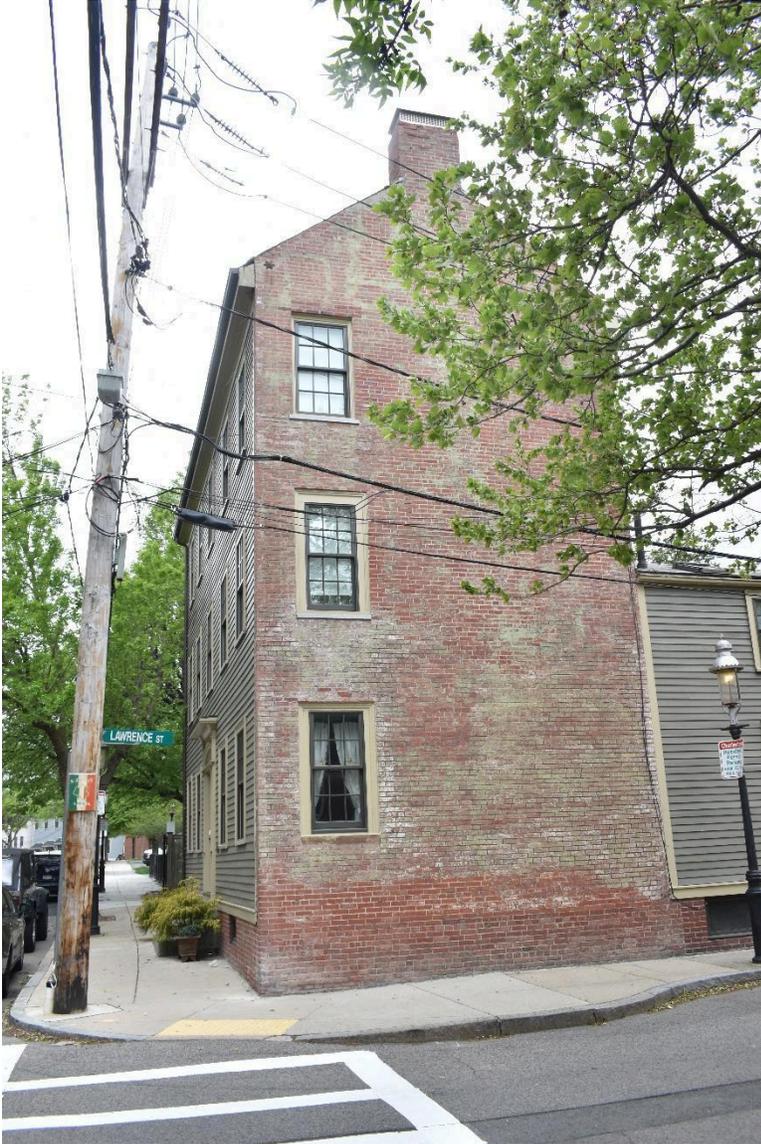
**Figure 4.** East elevation, looking northwest. Photo by The Public Archaeology Laboratory, Inc.

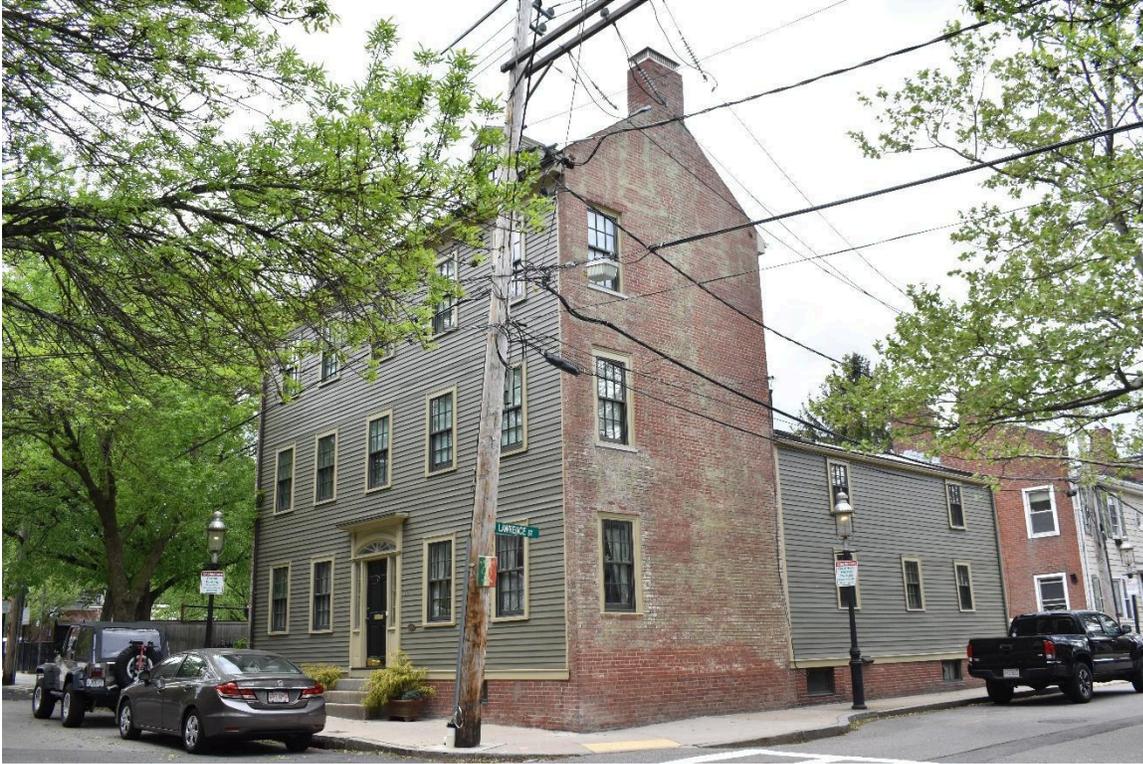
**Figure 5.** South and east elevations, looking northwest, 8 Lawrence St. at right. Photo by The Public Archaeology Laboratory, Inc.

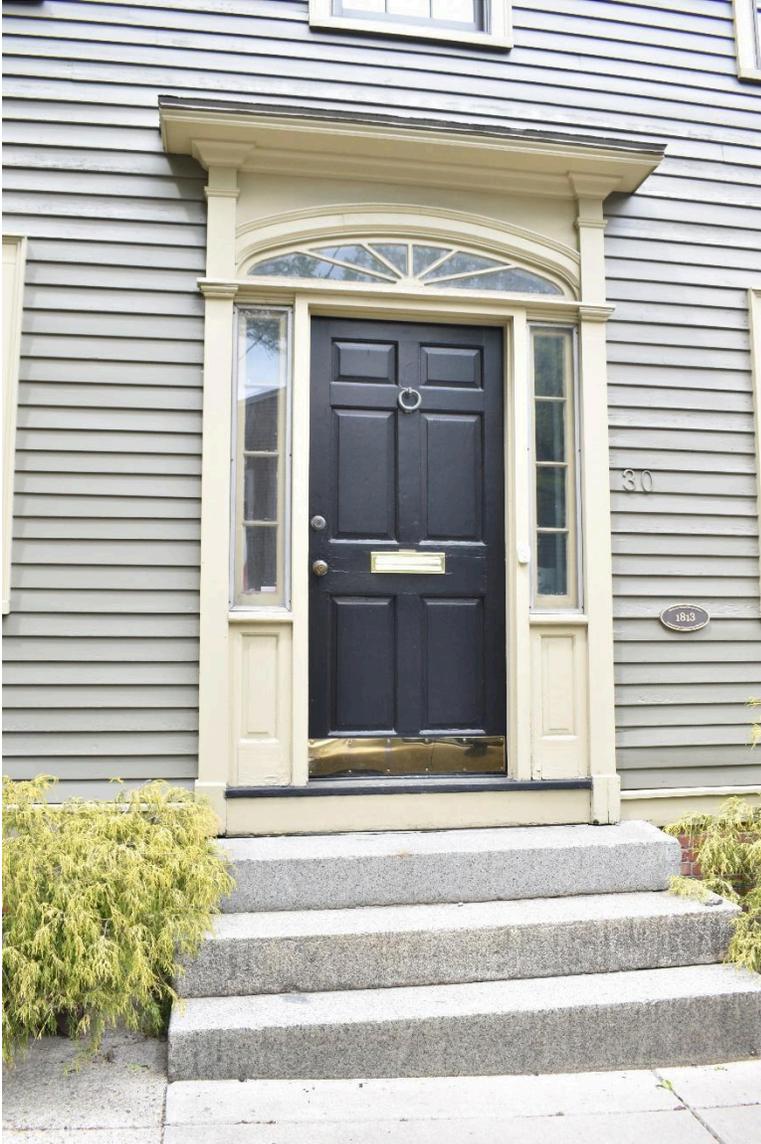
**Figure 6.** Primary entrance in center of south façade. Photo by The Public Archaeology Laboratory, Inc.

The Federal-style front entry occupies the middle bay on the first story of the façade. It consists of a six-panel wood door with four-light sidelights above wood panels and an elliptical fanlight with radial muntins and has a molded casing surrounded by a simple wood entablature with a molded wood cornice supported by Tuscan pilasters (**Figure 6**). Two windows flank the front entry to the east and west on the first story and five windows are evenly spaced across the second and third stories above the first-story openings. The west elevation has a single window on the first floor, south of the chimney. The east elevation has single windows on the first, second, and third stories, aligned on top of each other south of the chimney. Window openings are evenly spaced across the north elevation on the first, second, and third stories, except where it is covered by the rear ell. Fenestration throughout the main block consists of replacement double-hung, six-over-six wood sash with molded wood surrounds. A one-and-one-half-story, three-bay-by-one-bay, wood-frame ell extends from the north elevation of the main block.

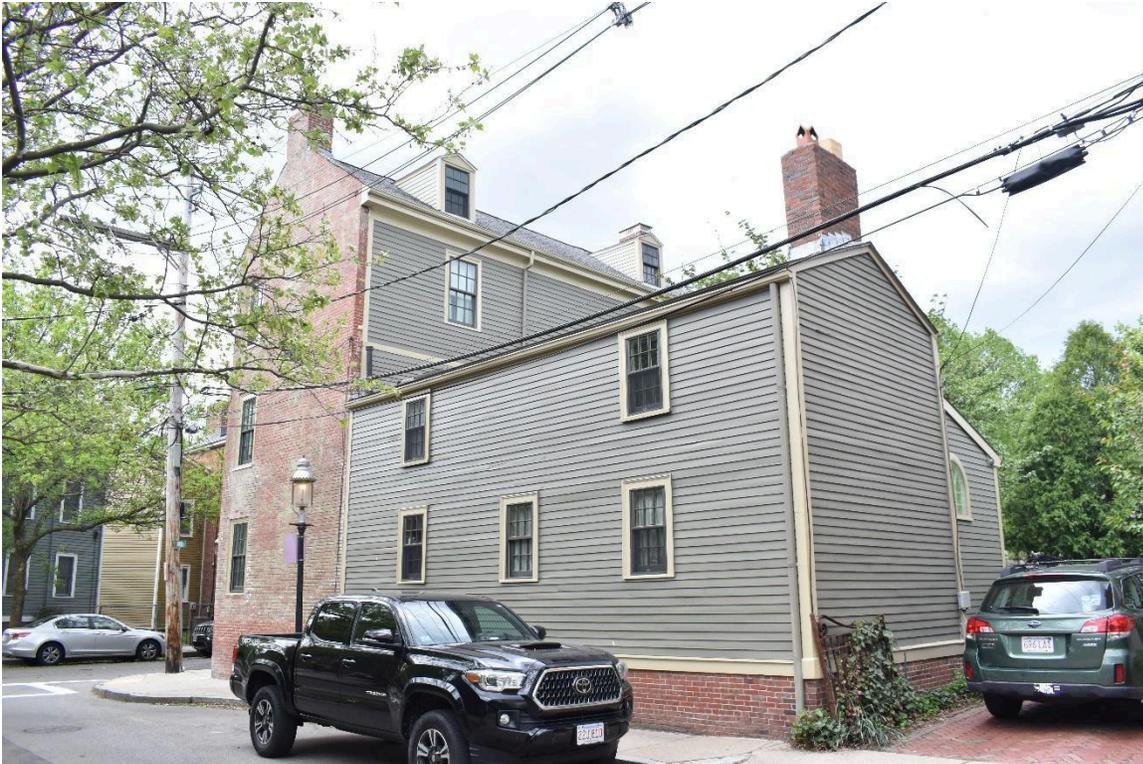
**Figure 8.** East (side) and north (rear) elevations and rear ell, looking southwest from Lawrence St. Photo by The Public Archaeology Laboratory, Inc.

The ell projects north from the two eastmost bays on the north elevation and is flush with the east elevation of the main block. It has a front-gable roof covered with asphalt shingles, which is pierced by an interior brick chimney at the center ridgeline above the north elevation. The walls are clad with wood clapboards with plain corner boards and narrow wood rakes beneath the eaves. Similar to the main block, the foundation of the rear ell consists of fieldstone surmounted by common-bond brick above ground. It is unclear from an interior inspection if the rear ell is contemporaneous to the main block or if it was constructed after the main block was completed; it first appears on historic maps in 1852 (see **Figure 20**). Three windows are evenly spaced across the east elevation on the first story, and two windows are situated above the outermost windows on the second story. All of the windows contain replacement double-hung, six-over-six wood sash set in molded wood frames.

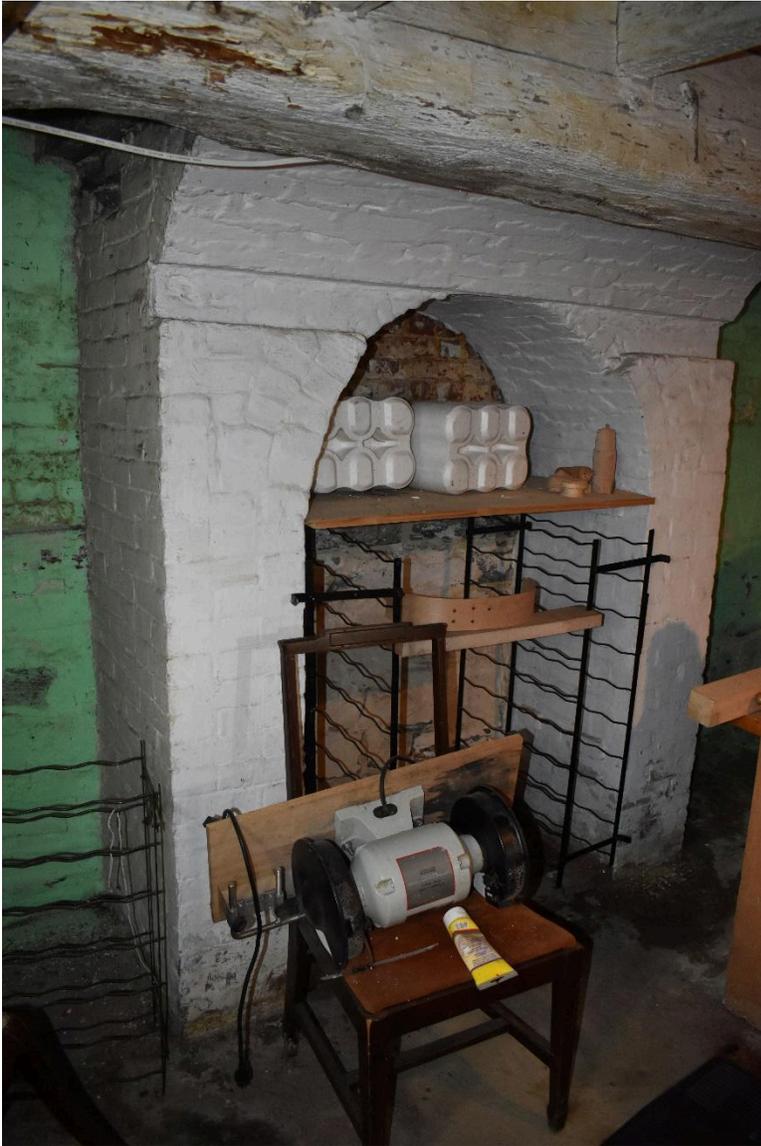
**Figure 9.** Basement, southwest chimney relieving arch. Photo by The Public Archaeology Laboratory, Inc.

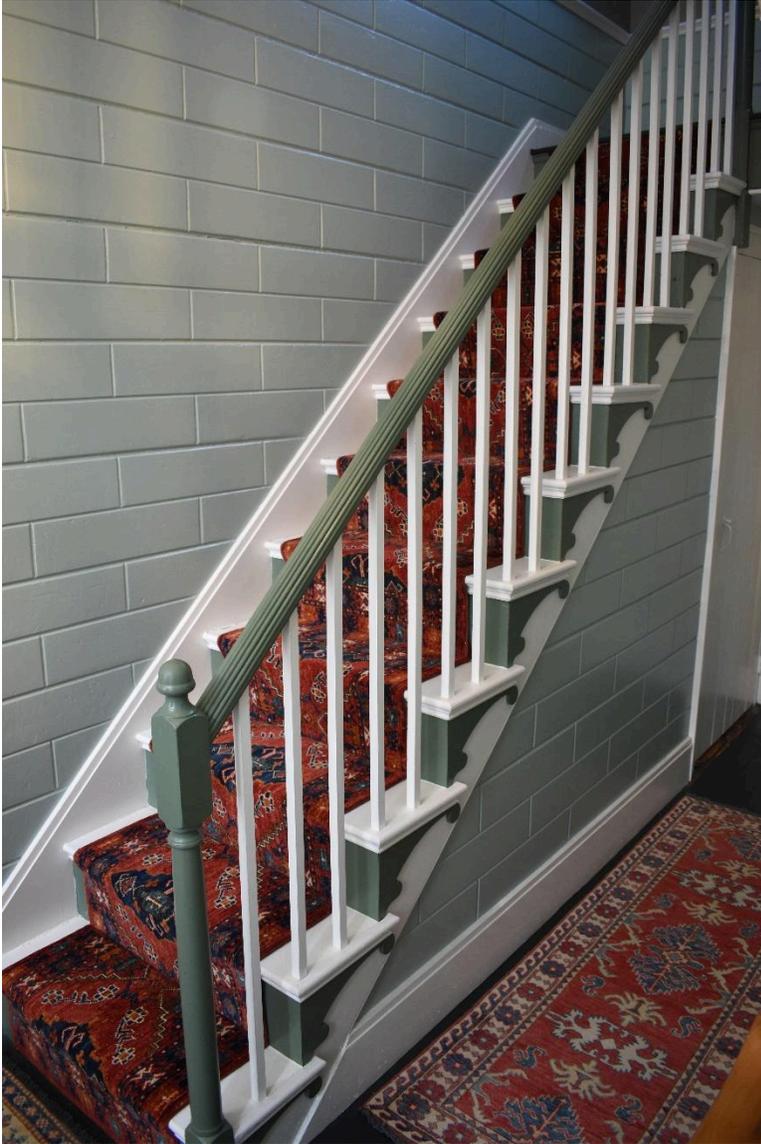
**Figure 10.** First Story, entry hall stairs and rusticated wood panel treatment, looking northwest.  
Photo by The Public Archaeology Laboratory, Inc.

The central hallway retains millwork and window and door trim that appear to be original, although sections have been altered and restored. On the first floor, the walls of the central stair hall are clad in rusticated wood blocks that imitate stone. The wood blocks extend to the ceiling and are capped by molded trim. The wood blocks on the east wall are not original and were restored in the early 21st century. The front entrance is enclosed by flat wood surround ornamented with hatch and star carvings. A wood keystone is centered above the fanlight. On the first floor, the staircase has turned wood newel posts, molded wood treads, scroll-shaped riser trim, square balusters, and a unique fluted wood handrail (see **Figure 10**). On the second floor, the staircase has turned-wood newel posts, molded-wood treads, round balusters, and a convex molded wood handrail. The riser trim is not present on the staircase at the second and third floors, and the third-floor balustrade has larger turned-wood newel posts (see **Figures 11-12**).

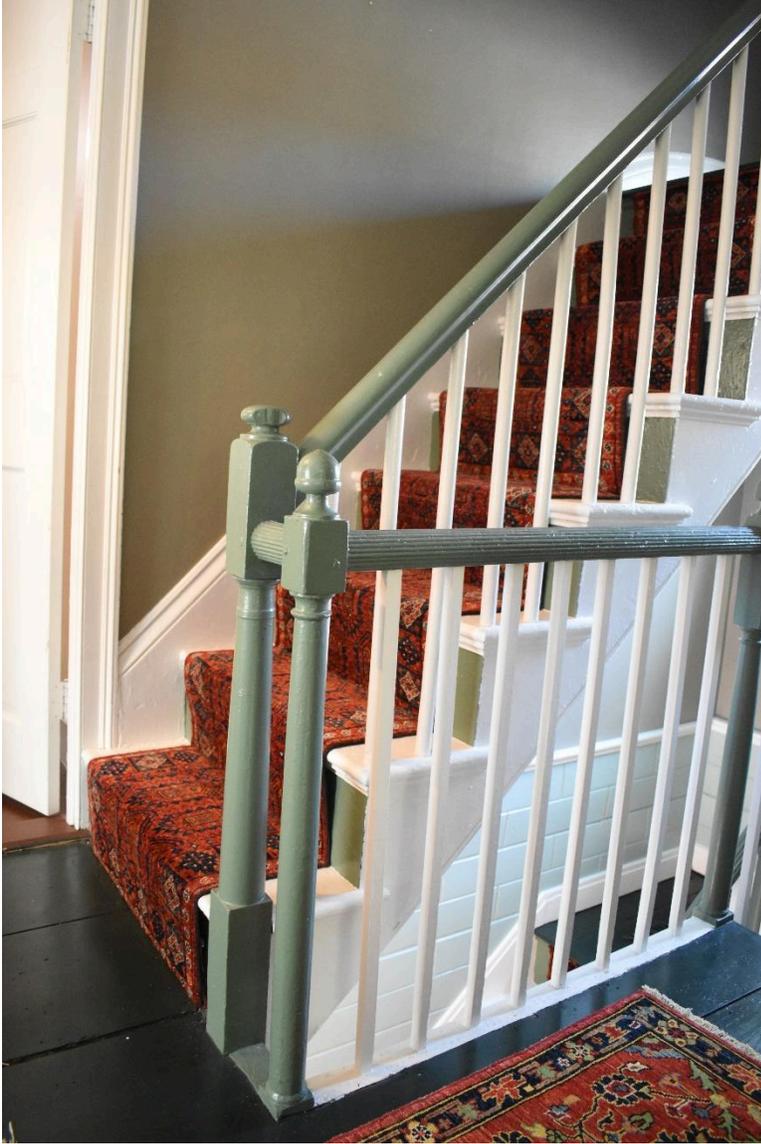
**Figure 12.** Second story, stair hall with balustrade change, looking west. Photo by The Public Archaeology Laboratory, Inc.

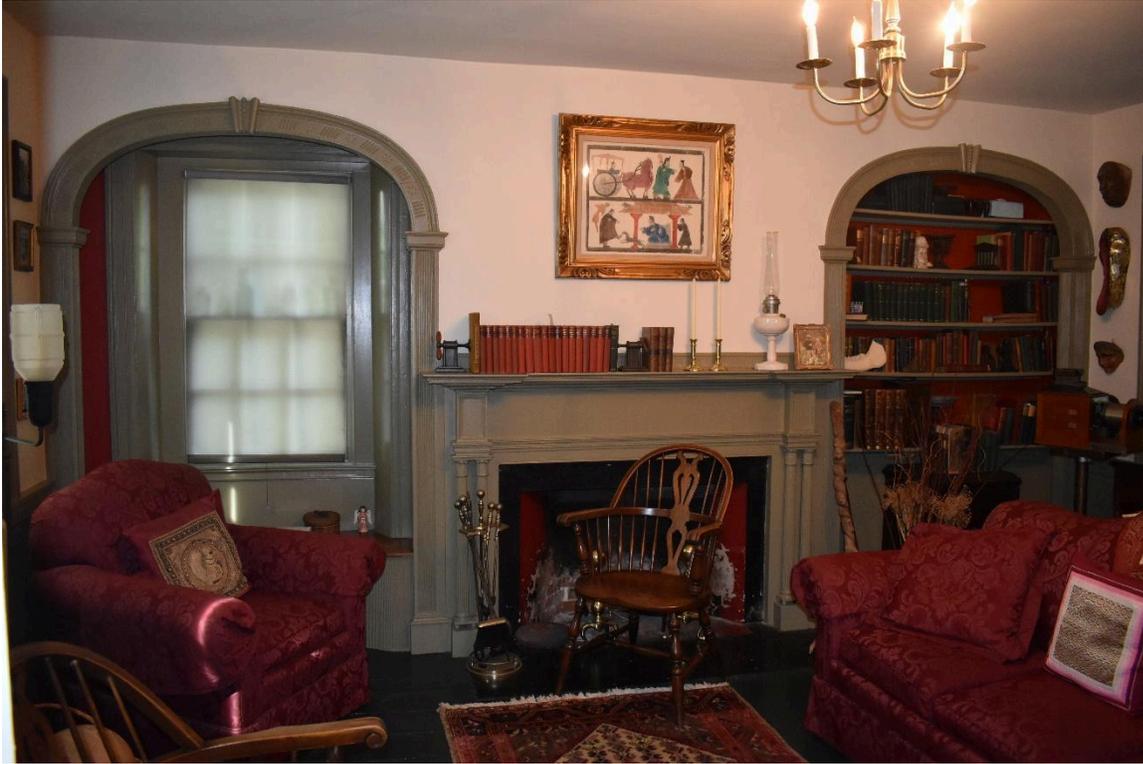
**Figure 13.** First story, parlor with ornate mantel, window, and inset cabinetry trim, looking west. Photo by The Public Archaeology Laboratory, Inc.

On the first floor, a parlor occupies the room on the west side of the central hallway. The parlor retains its original trim, fireplace, and cabinetry inset. The fireplace is centered on the exterior wall and has elaborately carved paired Corinthian pilasters that support a broad mantel. The flanking recessed bays (a window and bench to the south, and a cabinet and shelving to the west) have fluted, flush pilasters that support a molded wood flattened arch with a carved keystone. The same hatch-and-star detail found around the front entry is repeated on the arch trim and on a piece of molding above the mantel (**see Figure 13**). The room on the east side of the central hallway is used as a dining room. It has a fireplace centered on the exterior wall currently filled with a cast iron stove. The bay to the south contains a recessed window seat and the bay to the north has a closet. The fireplace has a brick hearth and wood paneling with a shallow mantel. The paneling continues into the window bay. A small, arched, recessed compartment is centered on the exterior wall above the fireplace.

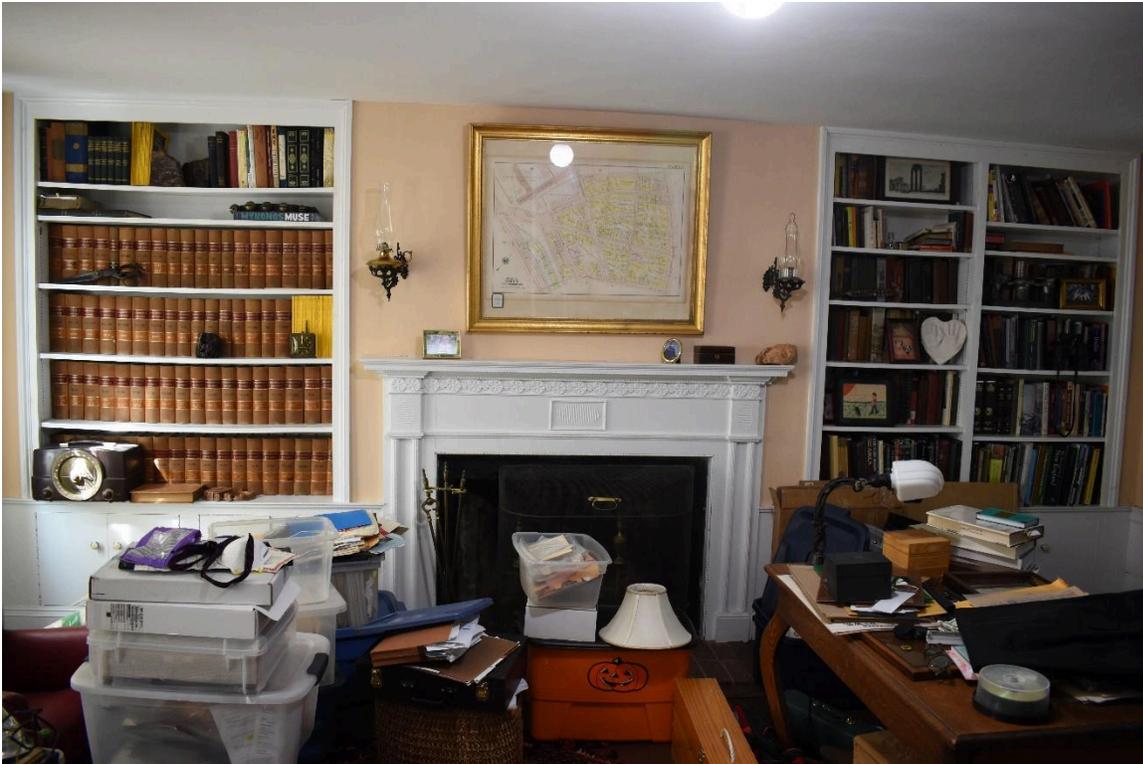
**Figure 14.** Second story, west room with mantel and trim, looking southwest. Photo by The Public Archaeology Laboratory, Inc.

The rooms on the second and third stories contain fireplaces flanked by recessed windows or built-in shelving. The trim and fireplaces in these rooms likely date to the mid-19th to early 20th centuries (**see Figures 14–15**).

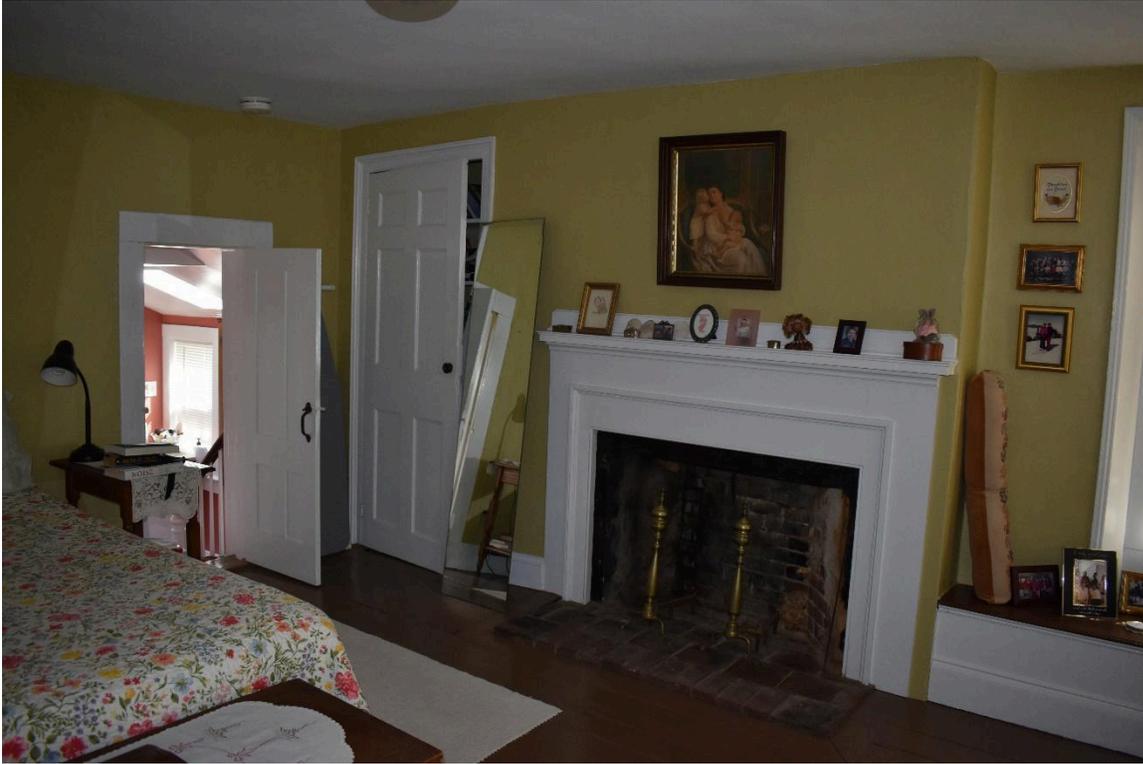
**Figure 15.** Second story, east room with mantle, trim, and passage to rear ell, looking north. Photo by The Public Archaeology Laboratory, Inc.

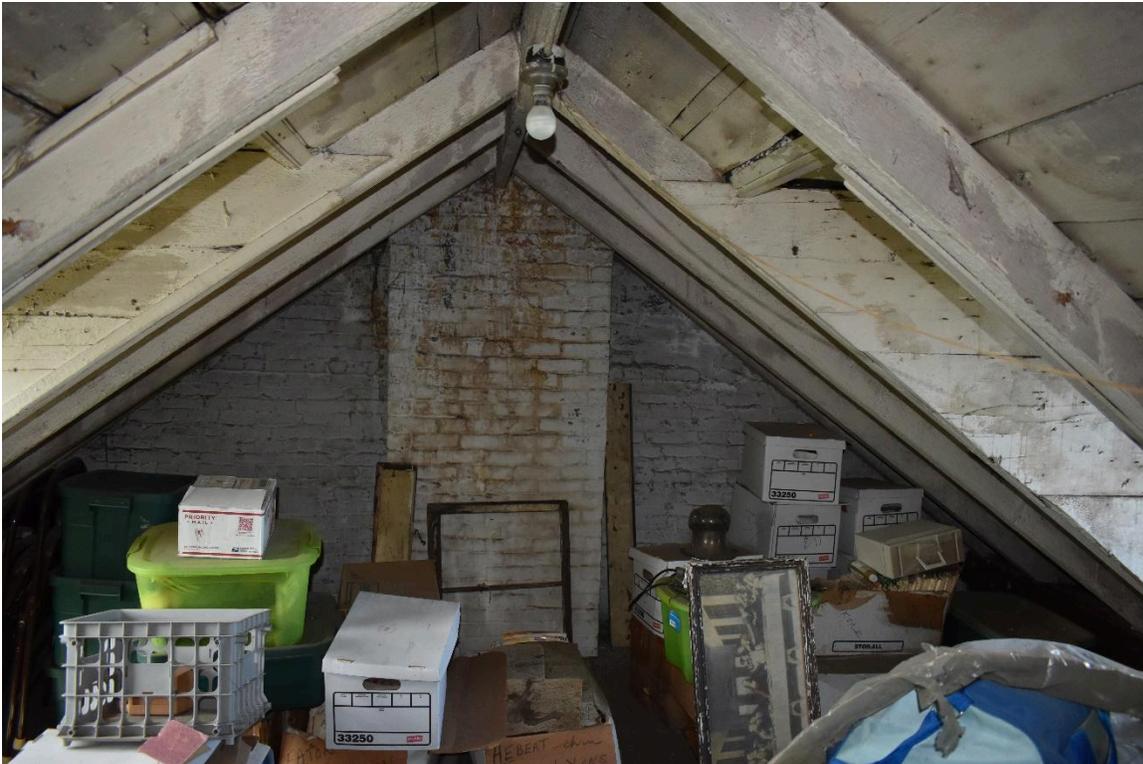
**Figure 16.** Attic with brick end wall and ridge board, looking southwest. Photo by The Public Archaeology Laboratory, Inc.

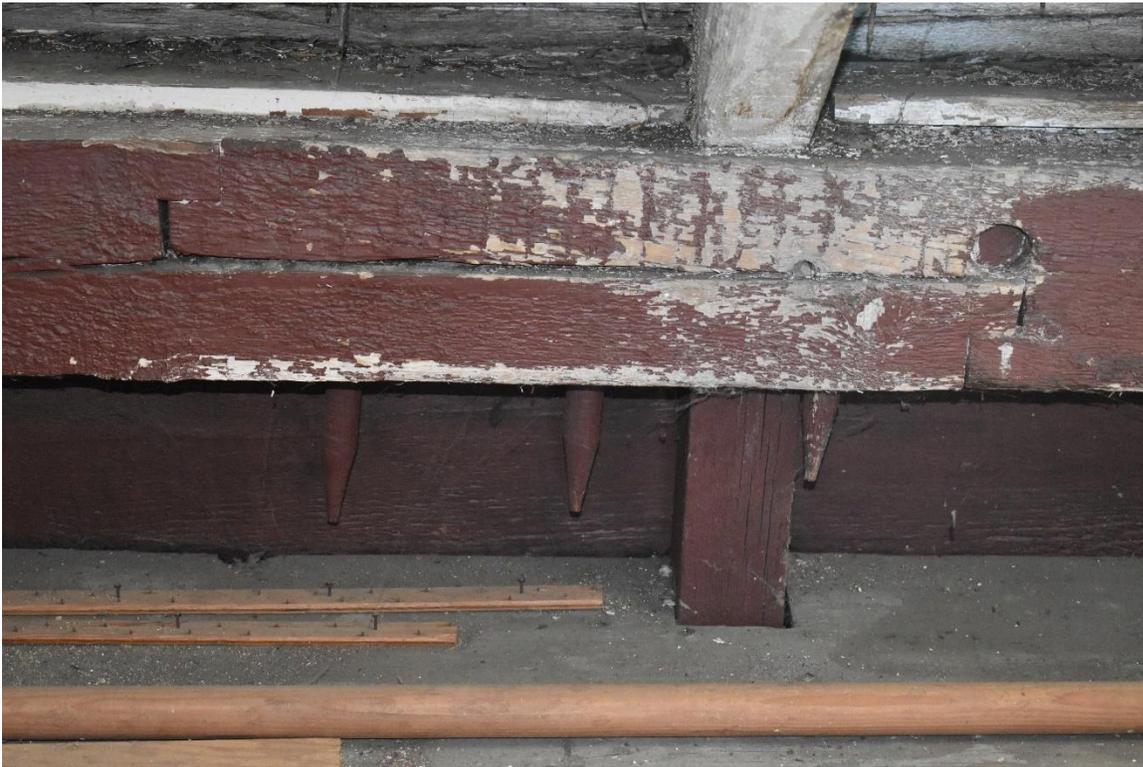
**Figure 17.** Attic, showing sistered eave plate with dowels, rafter (white), and secondary post (red).  
Photo by The Public Archaeology Laboratory, Inc.

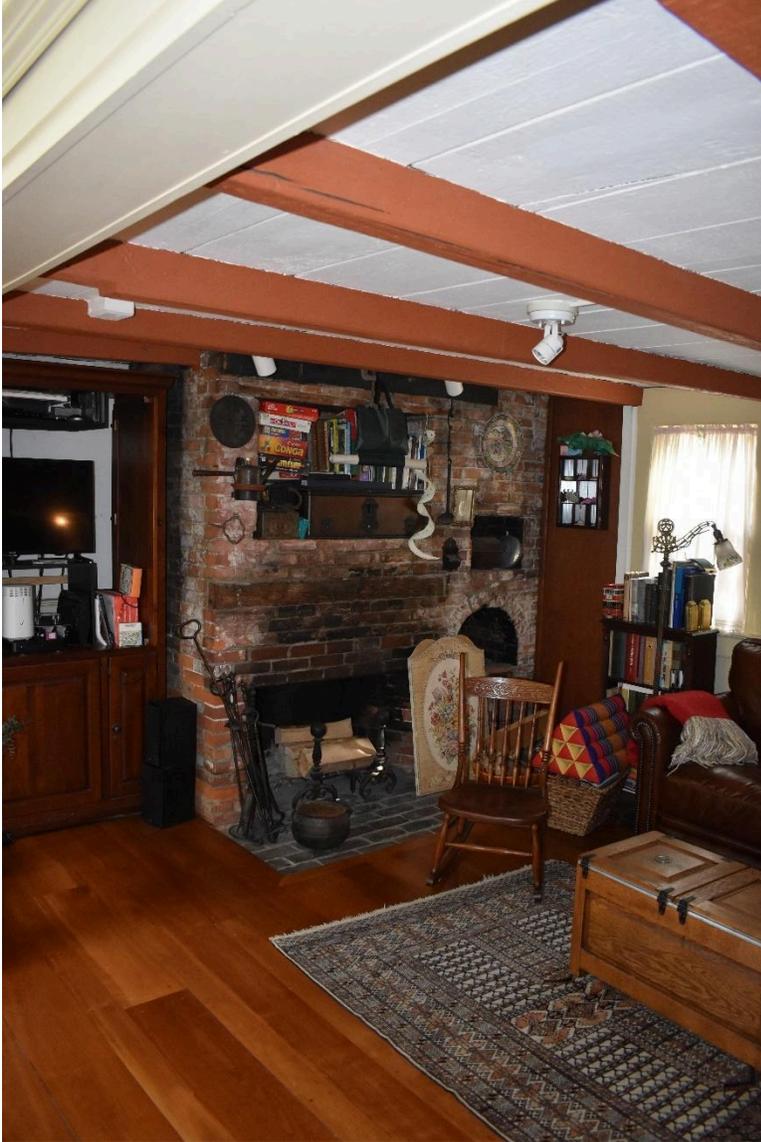
**Figure 18.** First story, rear ell fireplace, looking north. Photo by The Public Archaeology Laboratory, Inc.

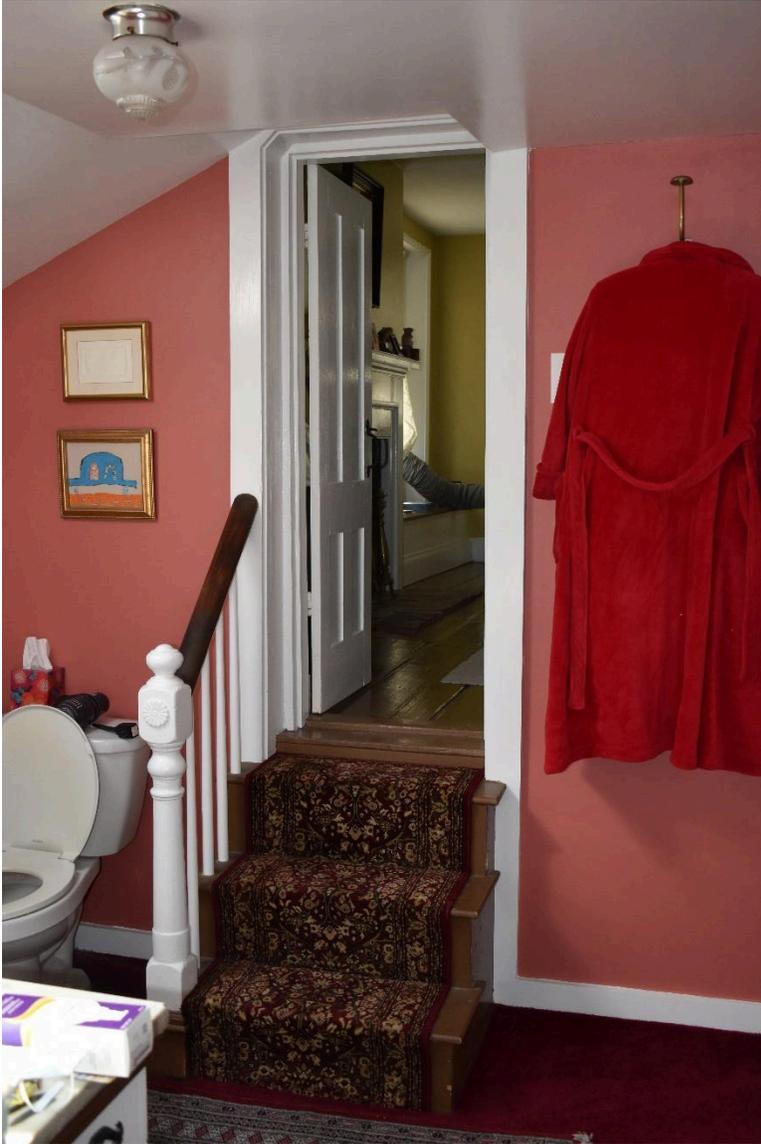
**Figure 19.** Second story, rear ell stairs into main house, second story, looking southeast. Photo by The Public Archaeology Laboratory, Inc.

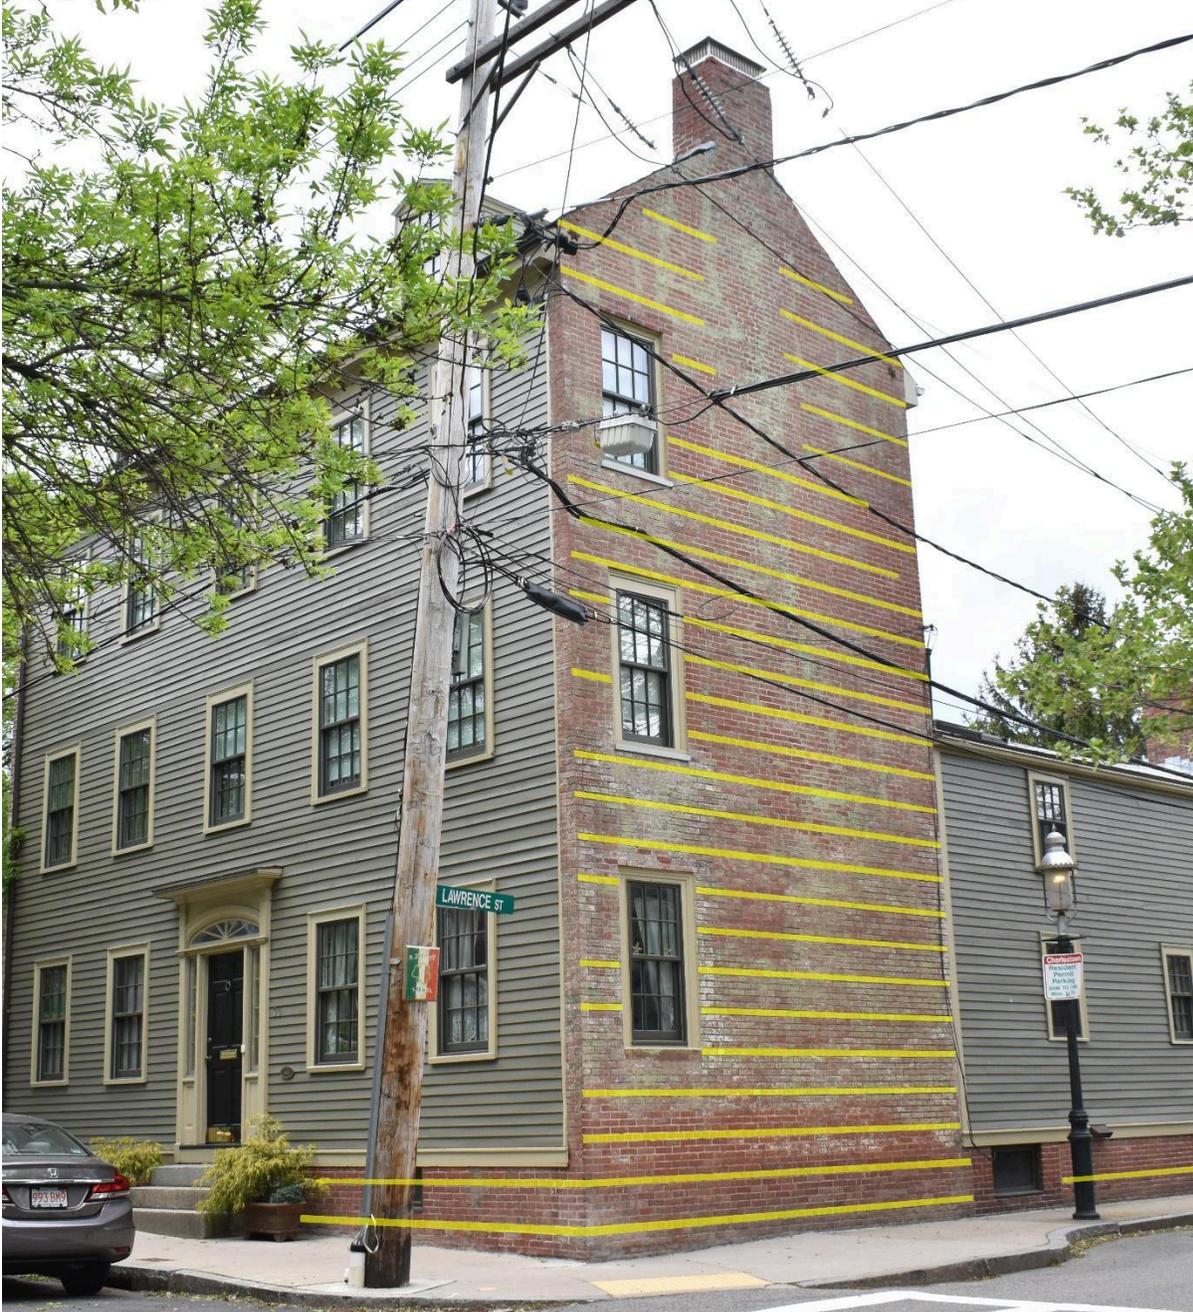
**Figure 21.** 30 Union St.'s east-facing brick end wall with header rows highlighted to illustrate inconsistencies in construction. Deviating header intervals and omission at the chimney stack suggest that the house was originally two or two-and-one-half stories in height.

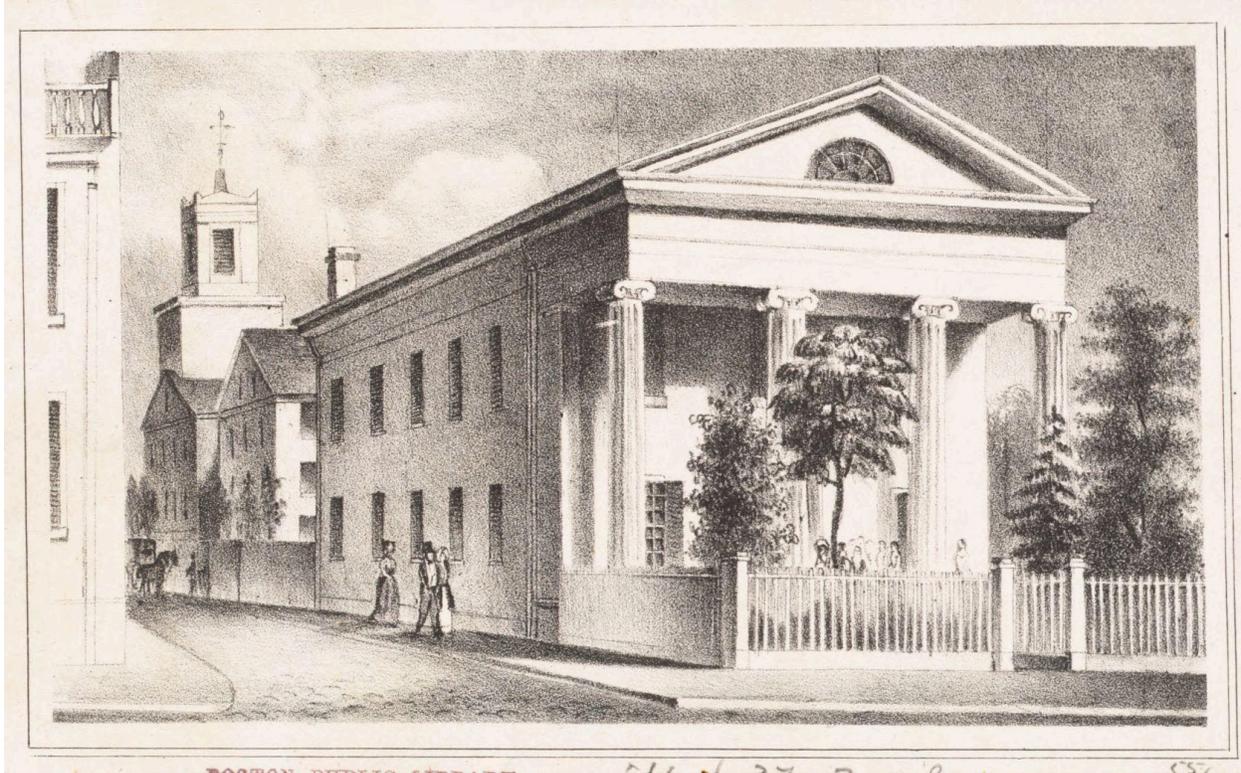
**Figure 22.** Earliest depiction of 30 Union St. (left) across Lawrence St. from the First Baptist Church's Female Seminary (not extant). Illustration shows 30 Union as a two-story building with brick end walls and a balustrade at the eaves.

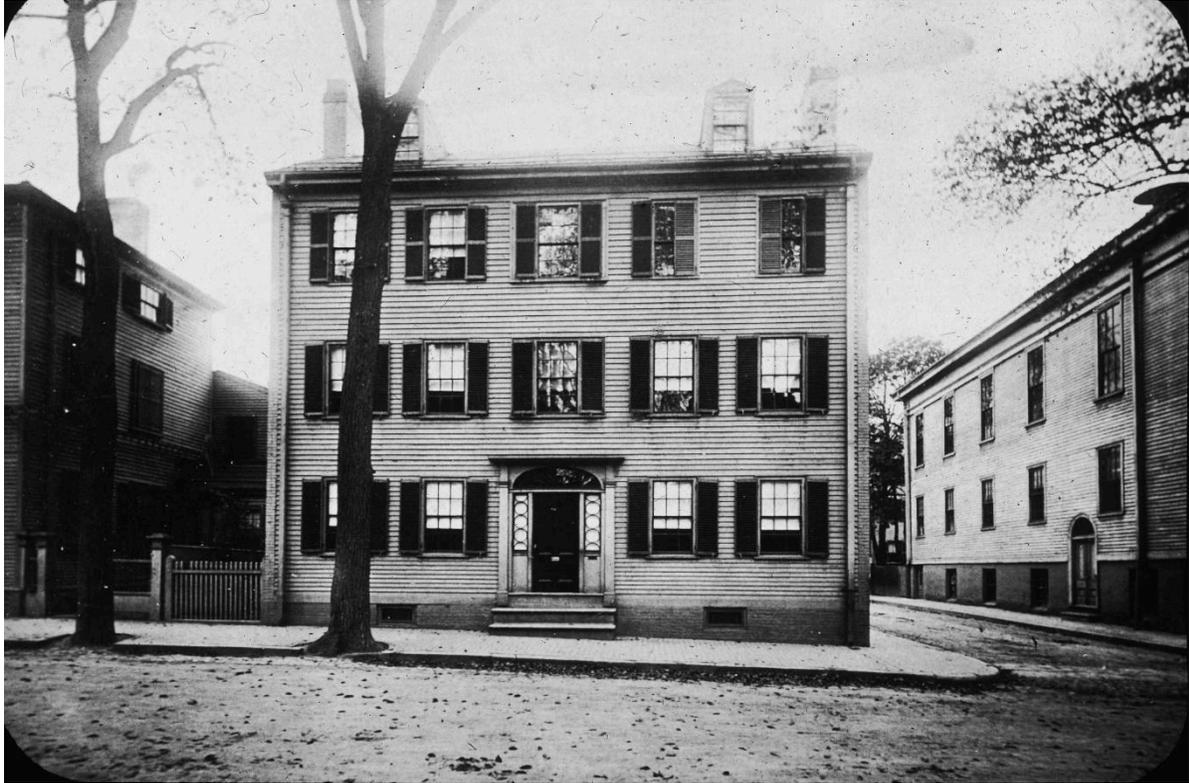
**Figure 24.** A mid- to late-19th century photograph of the Apollos Field House showing the alterations made by the Balfour family (Cutler ca. 1850–1925).

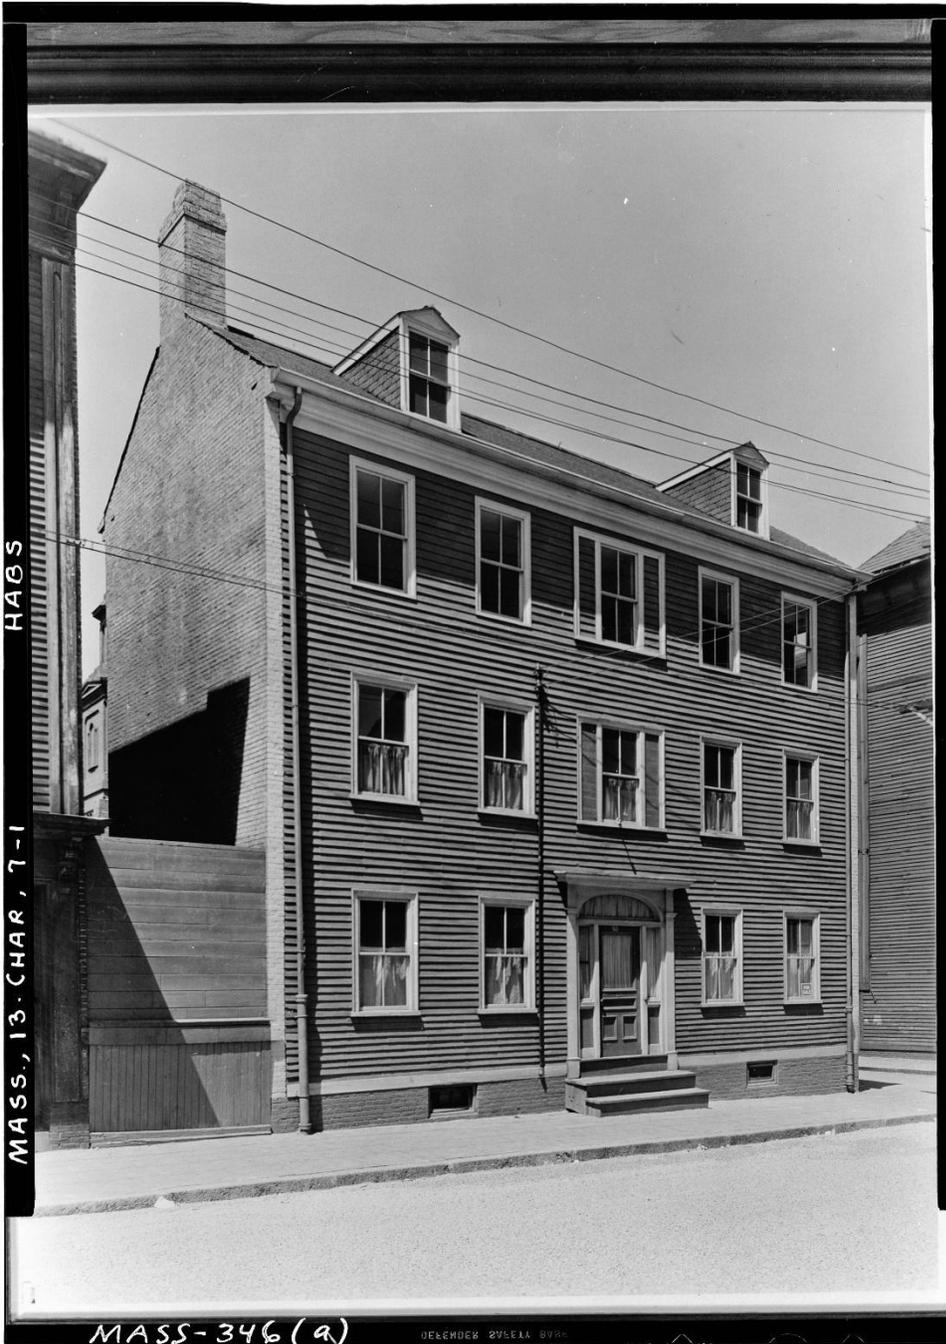
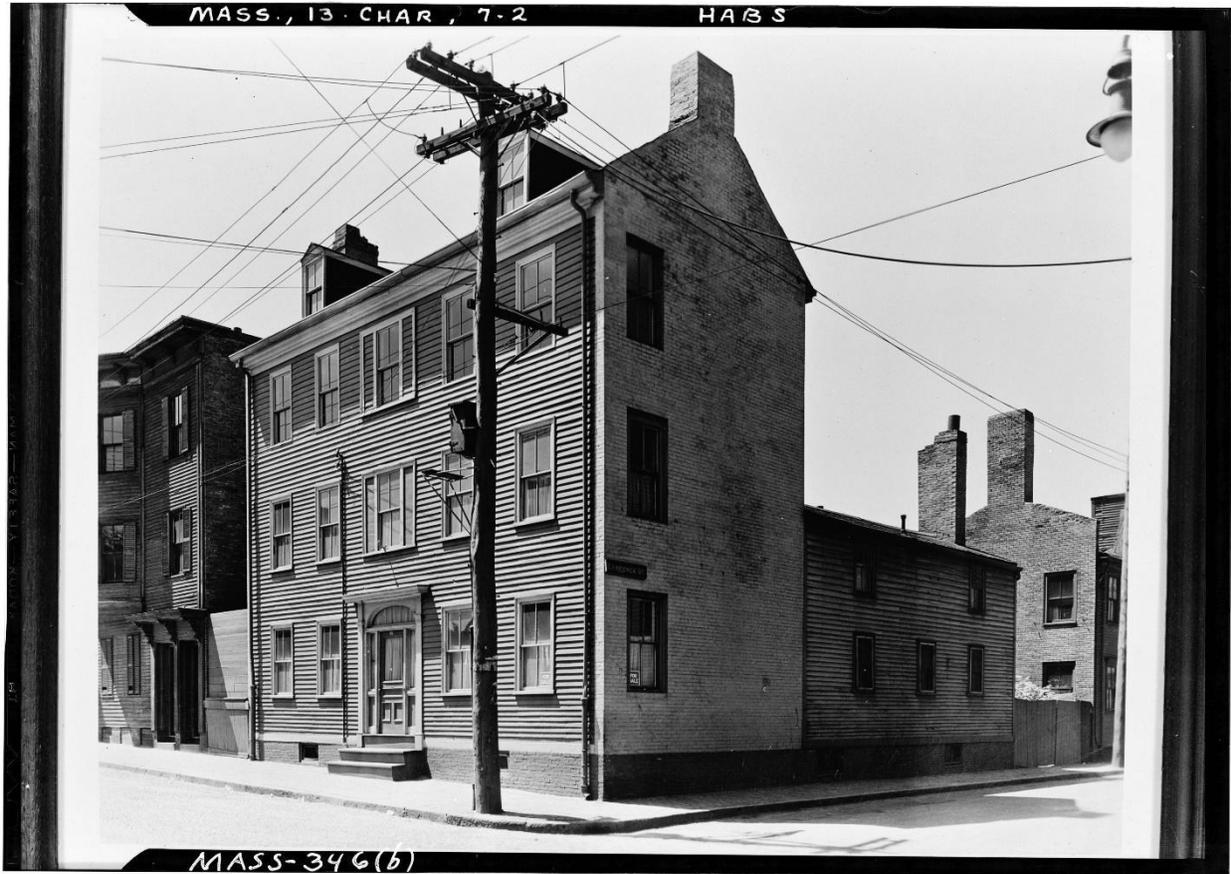
**Figure 27.** A 1933 photograph of the Apollos Field House, looking northeast.  
**Source:** Historic American Buildings Survey 1936.

**Figure 28.** A 1933 photograph of the Apollos Field House, looking northwest.

After Mary D. died in 1904, the property was purchased by John J. Crowley (b. 1865), an Irish grocer (**see Figure 26**). He lived in the house with his wife Ellen (b. 1871) and their eight children.<sup>20</sup> By 1928, it had been purchased by Margaret Mahoney (b. 1868), who lived at 19–23 Union St. and maintained 30 Union St. as a tenement.<sup>21</sup> Mahoney had the slate roof replaced with asphalt shingles in 1928 and likely made other improvements to the property, including replacement of the original six-over-six windows with two-over-two windows; elimination of shutters revealing the tripartite frame arrangement of the center second and third story windows on the façade (*see discussion above*); and removal of the tracery in the entry door sidelights and fanlight.<sup>22</sup> The appearance of the house in 1933 was captured in Historic American Buildings Survey photographic documentation (**Figures 27 and 28**).<sup>23</sup>
