# **Apollos Field House**

## **BOSTON LANDMARKS COMMISSION**

### **STUDY REPORT**

**The Apollos Field House**  
**30 Union Street, Charlestown (Boston), Massachusetts**

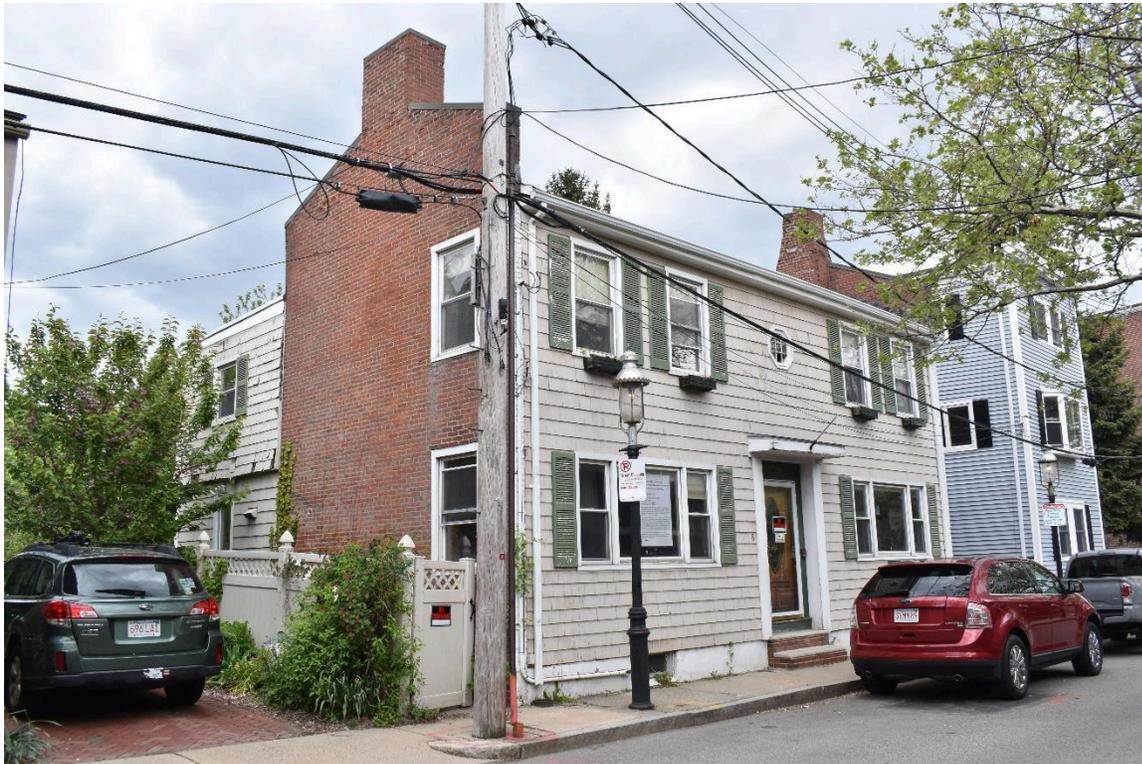
**Photo 1.** 8 Lawrence Street (May 2022), northeast (façade) and southeast (side) elevations, looking northwest.

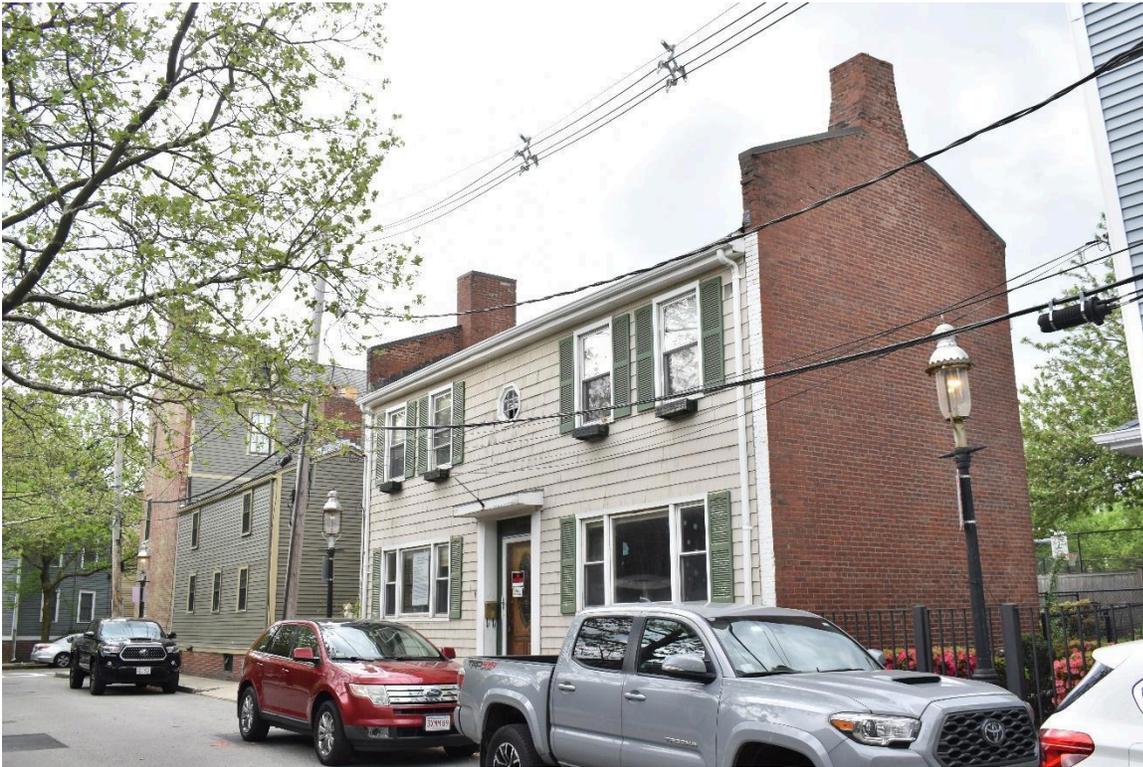
**Photo 2.** 8 Lawrence Street (May 2022) northeast (façade) and northwest (side) elevations, looking south with 30 Union Street behind.

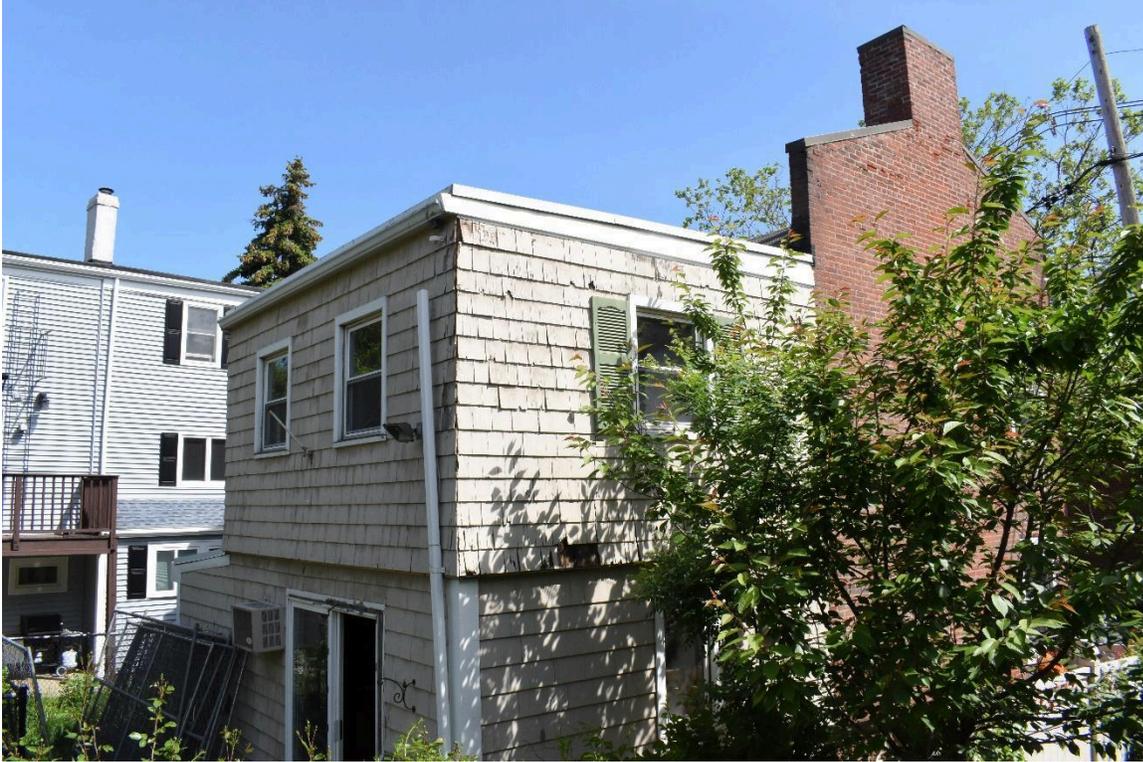
**Photo 3.** 8 Lawrence Street (May 2022), southeast elevation and rear addition, looking north.

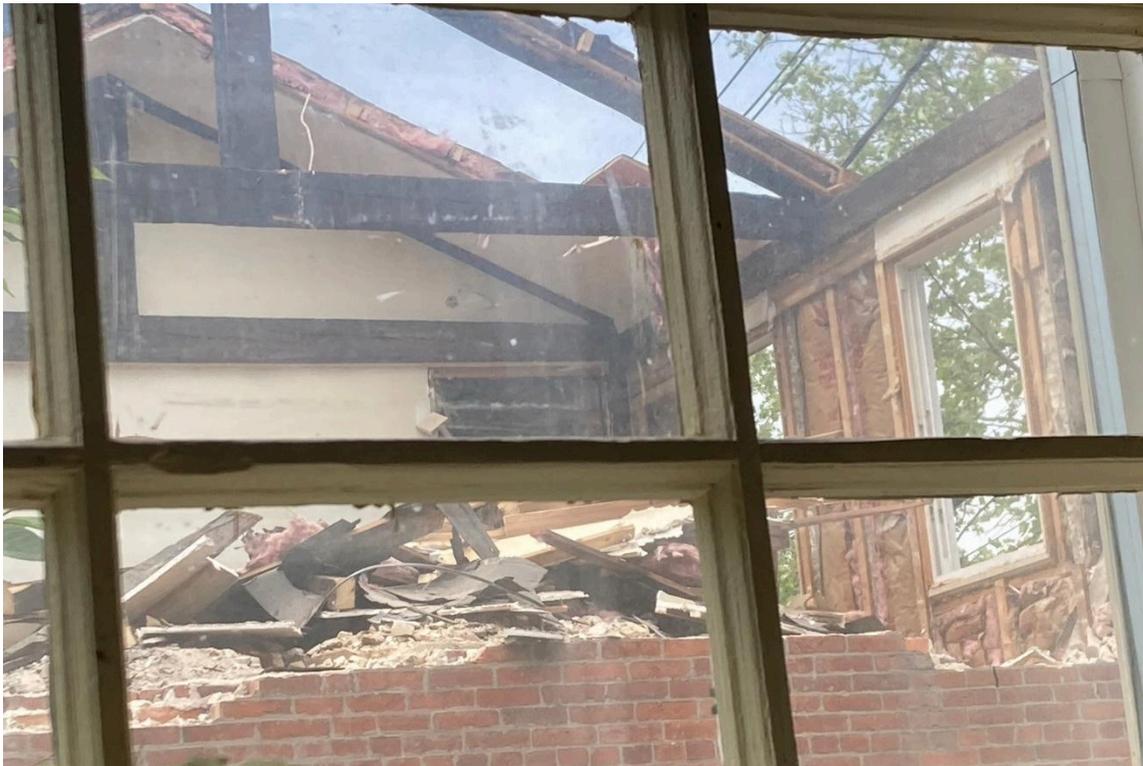
**Photo 4.** 8 Lawrence Street (May 2022, during demolition), view of roof truss system and second-story rooms, looking north.
