PROPOSED HEAT PUMP CONFIGURATION

15 MAY 2025
131 COMMONWEALTH AVE

CATHERINE TRUMAN
ARCHITECTURE & INTERIORS

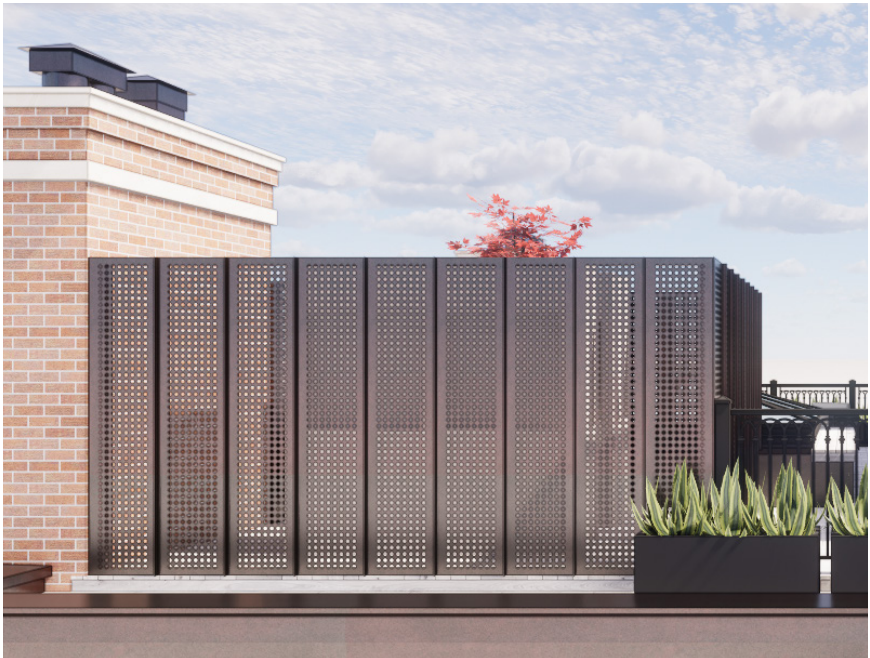
SIMILAR TO APPROVED SCREEN
AT 161 COMMONWEALTH AVE.

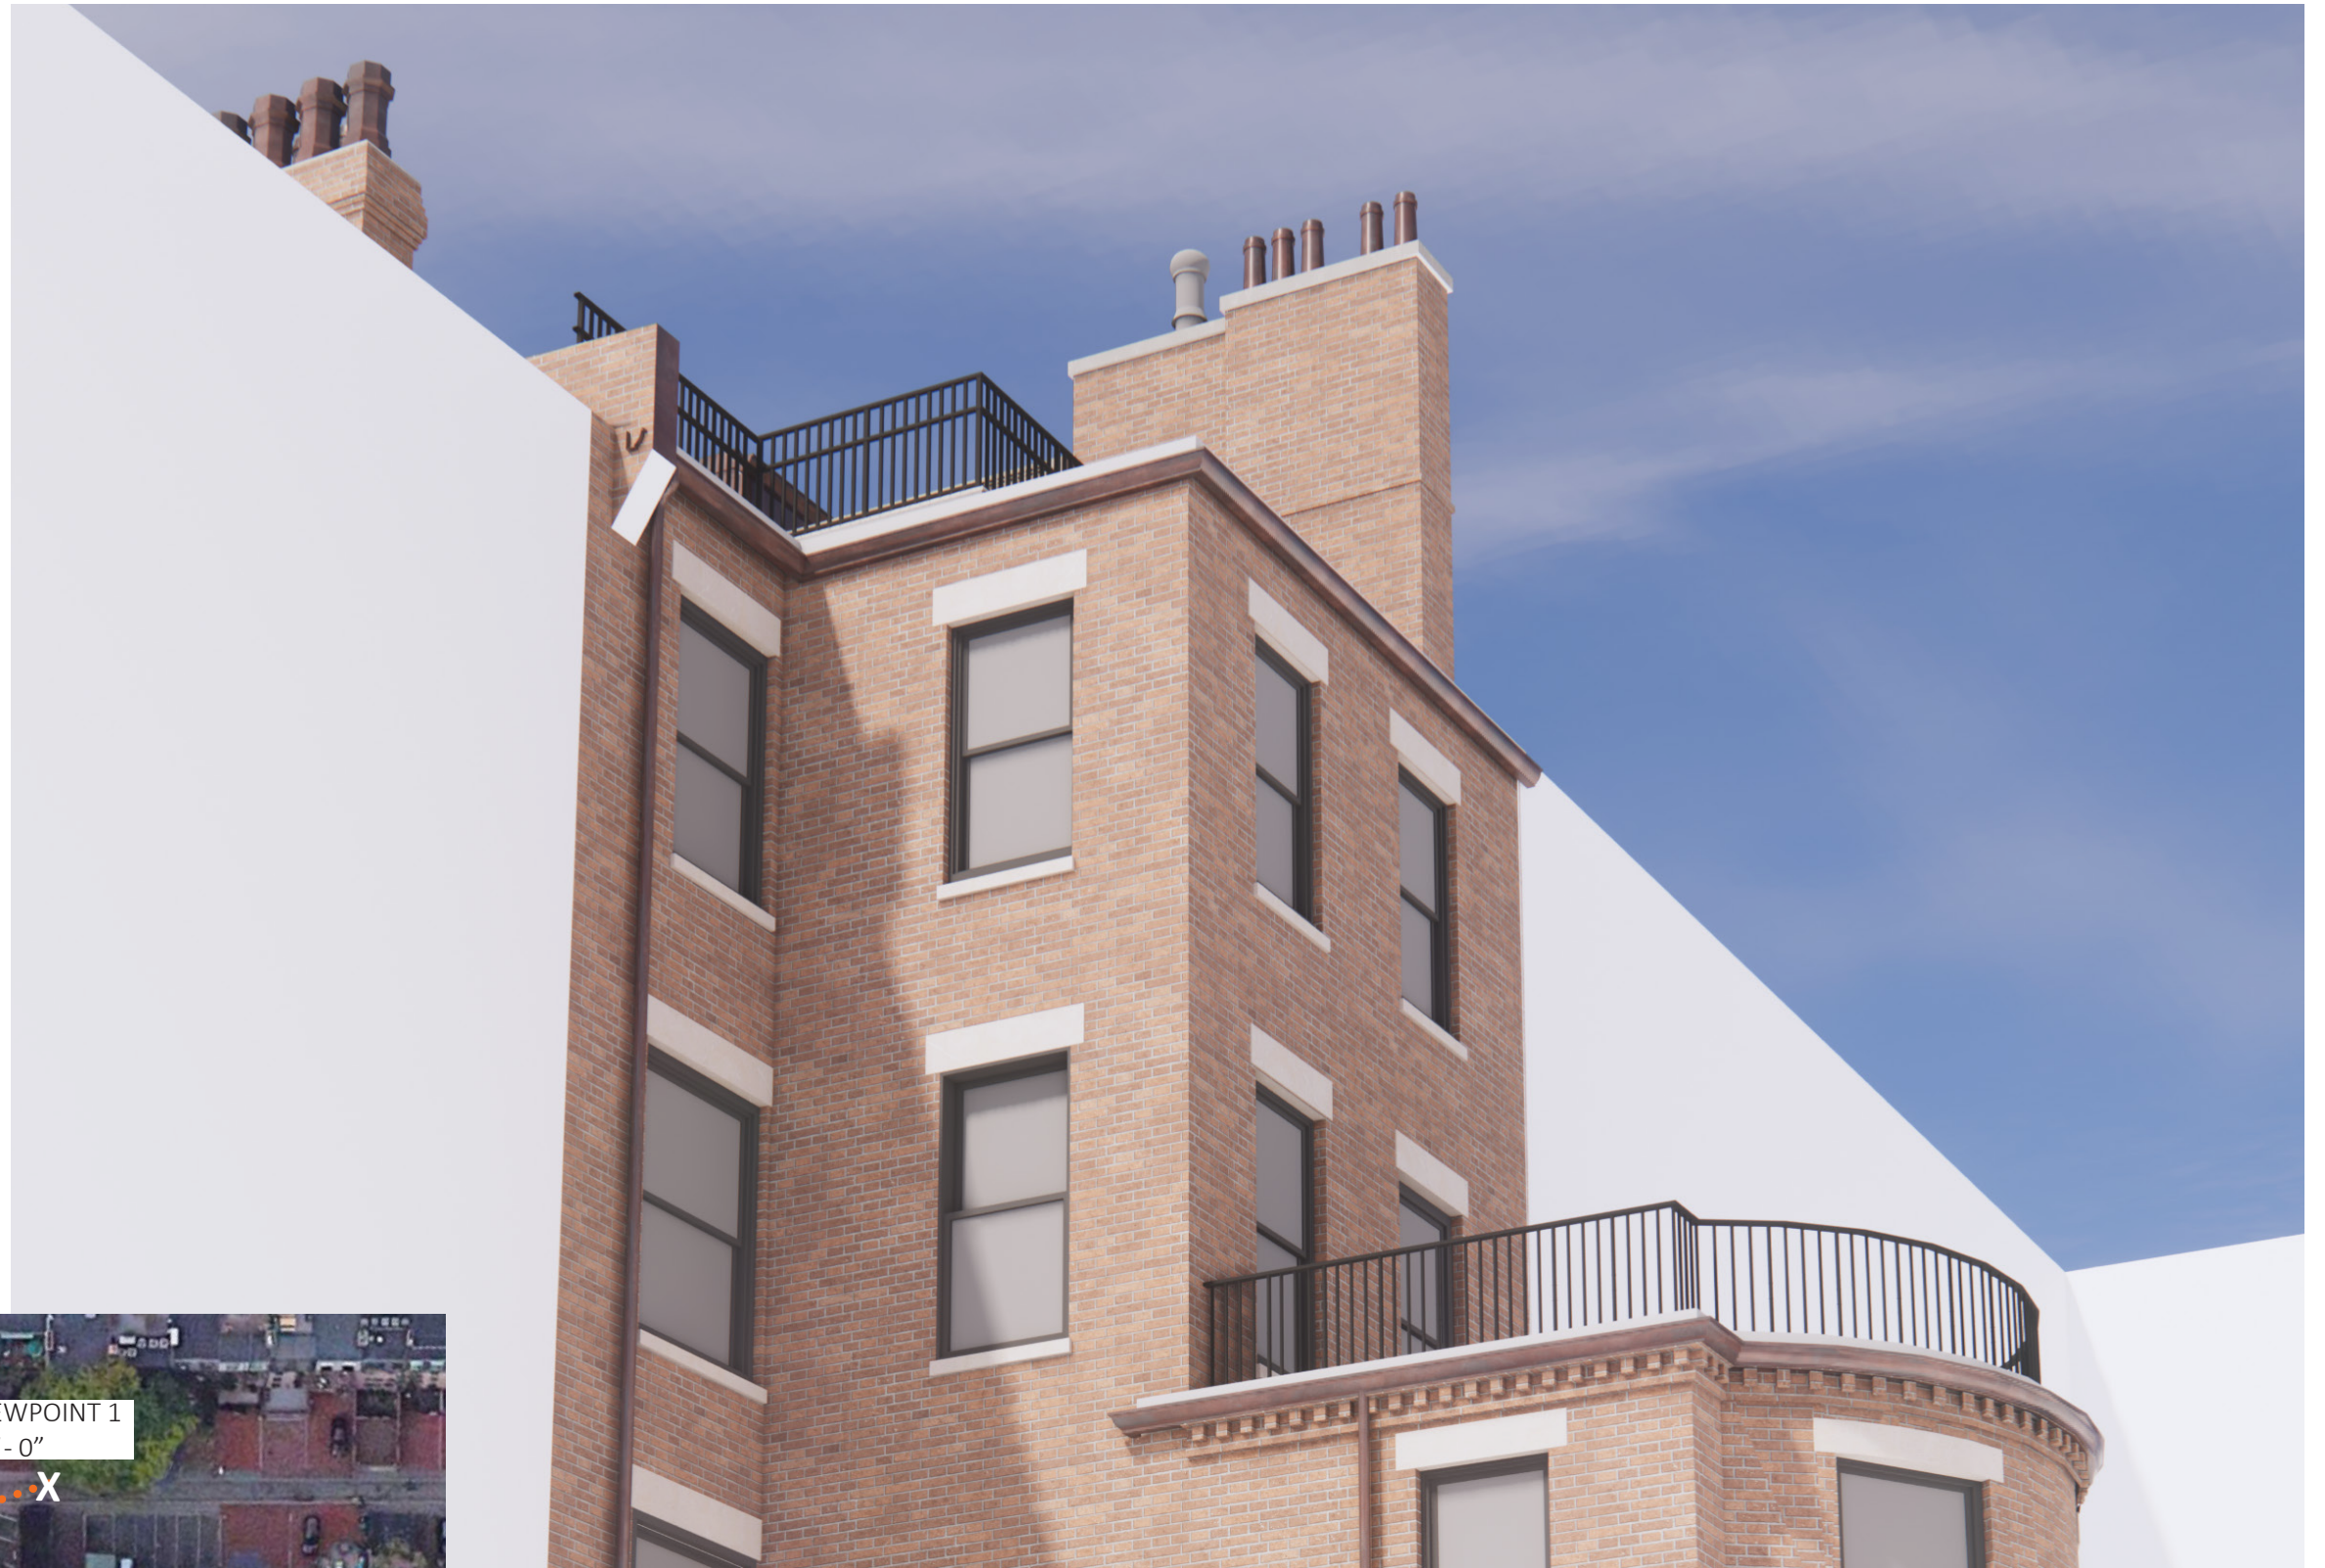
PROPOSED HEAT PUMP CONFIGURATION
VIEWPOINT 1 - NOT VISIBLE

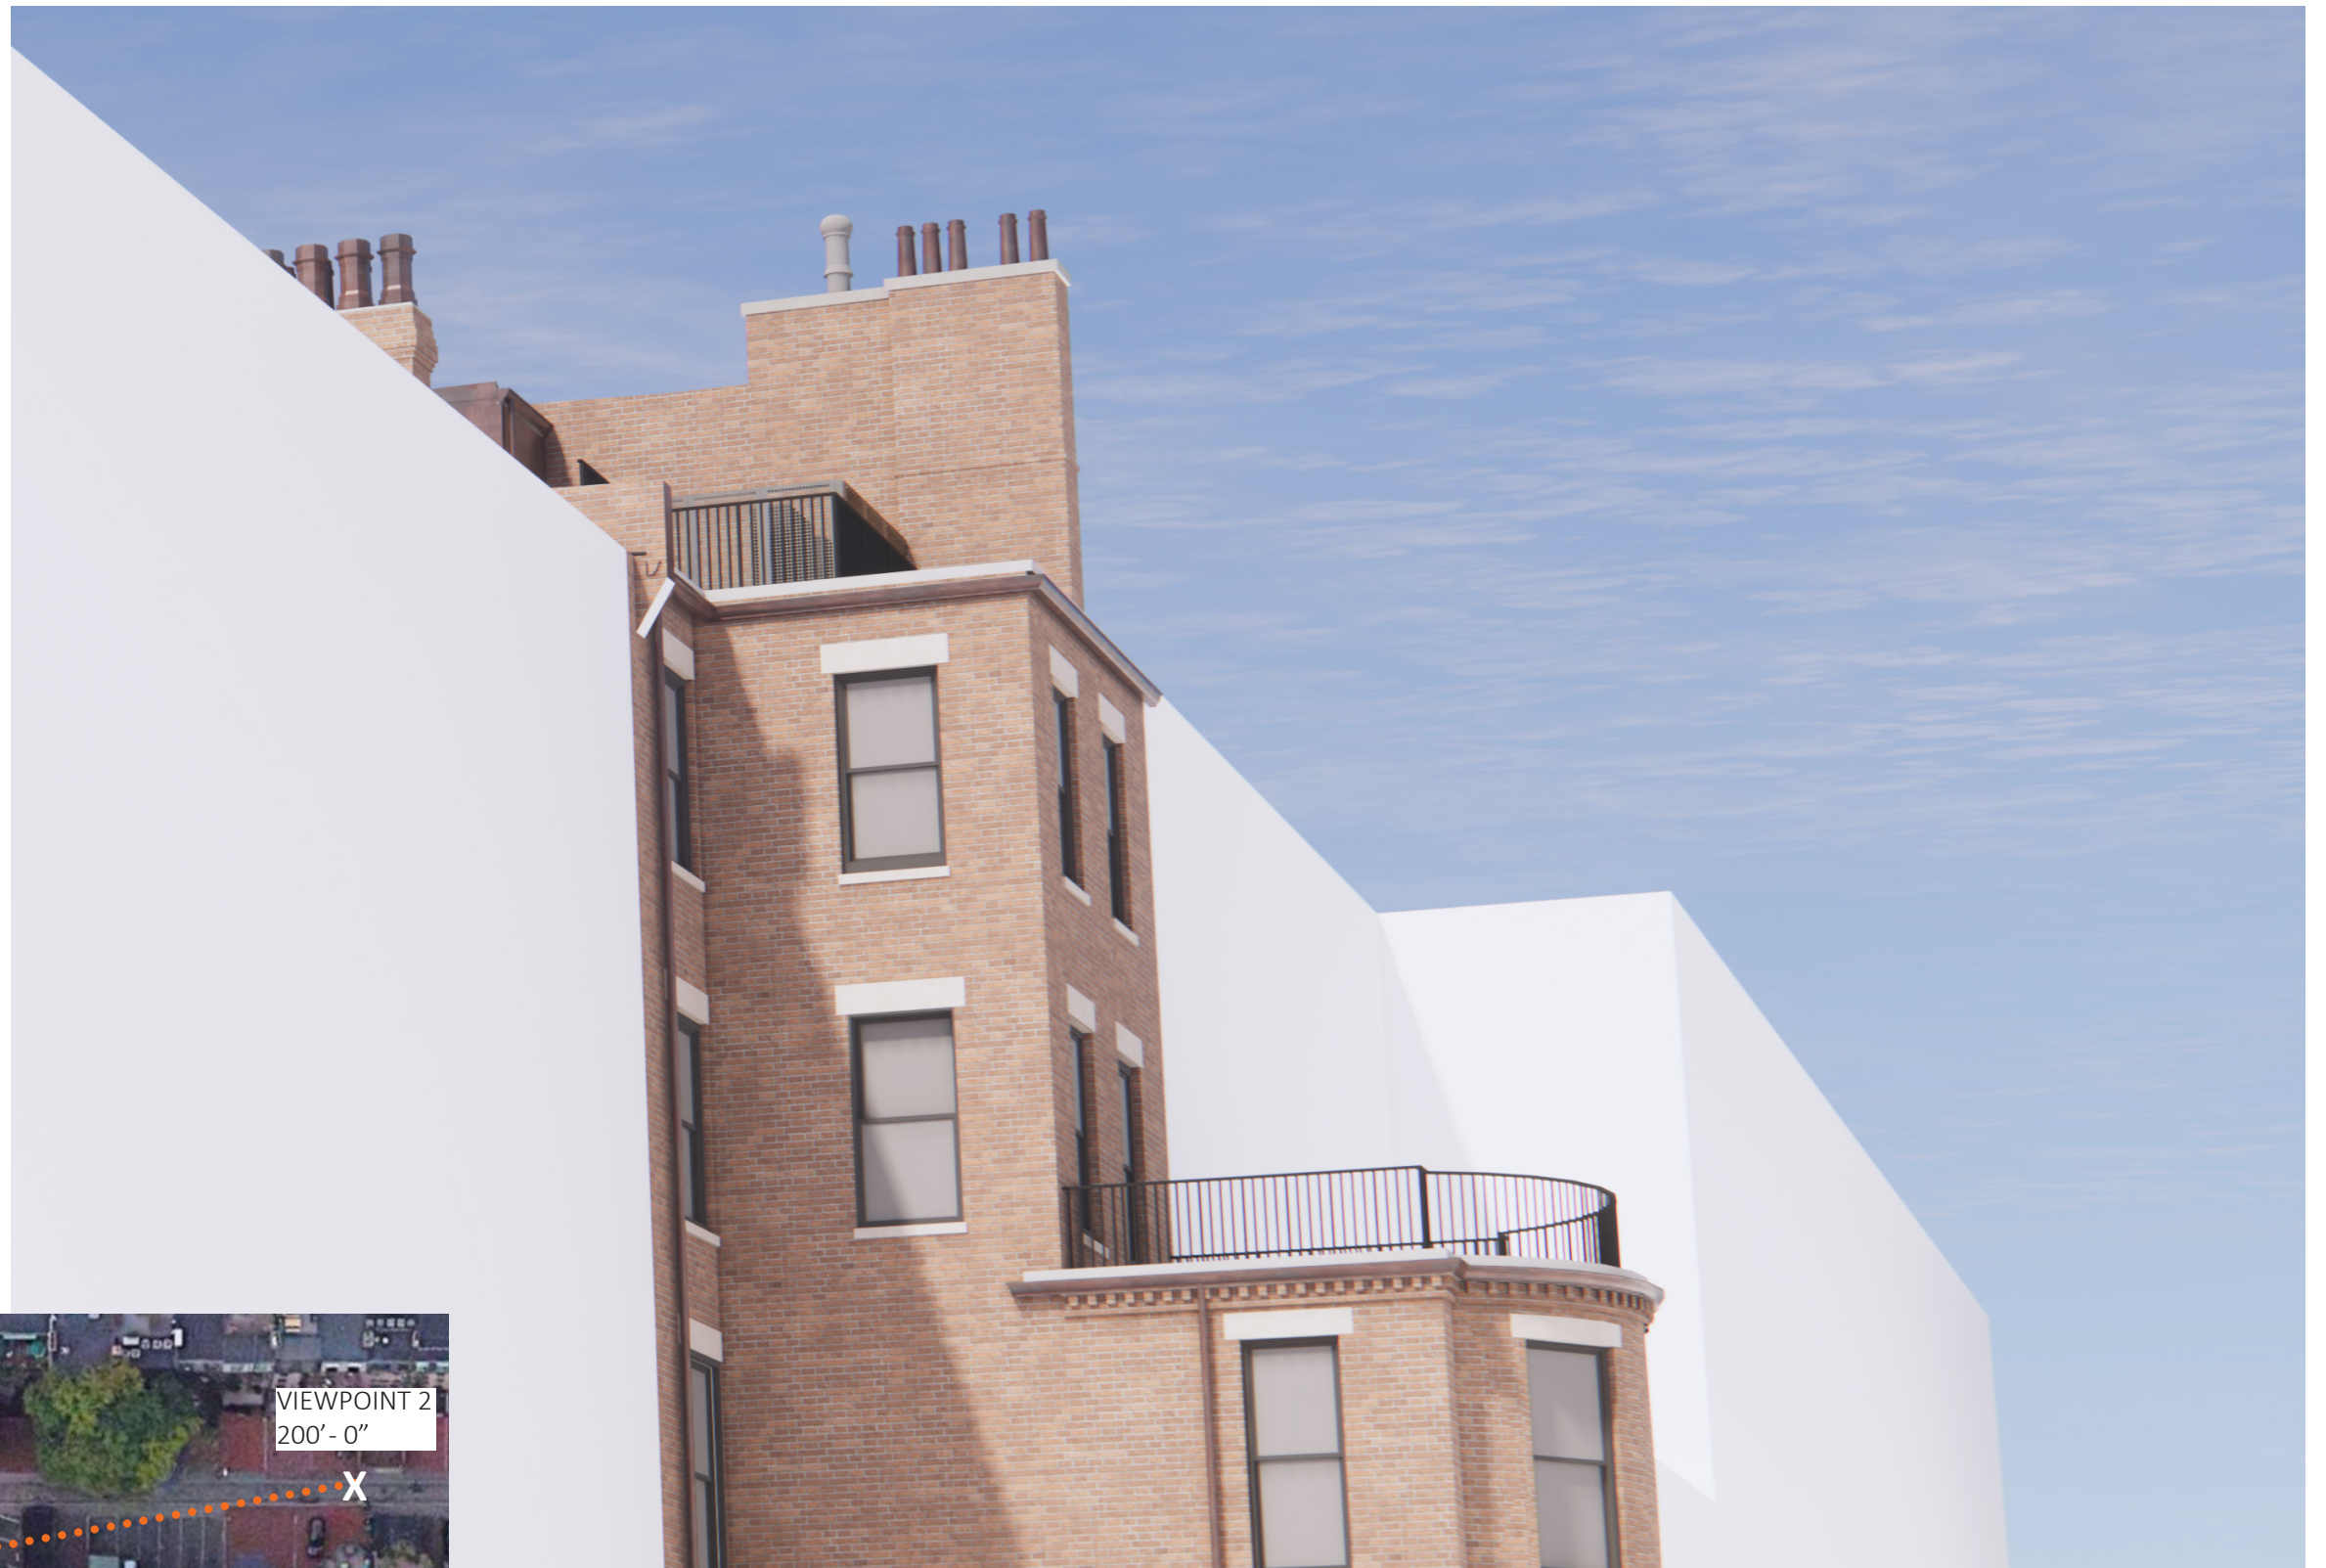
PROPOSED HEAT PUMP CONFIGURATION
VIEWPOINT 2
